**The Bahamas  
Maritime Authority**

**ANTHEM OF THE SEAS**

**Report of the marine safety investigation into a heavy  
weather incident on 7<sup>th</sup> & 8<sup>th</sup> February 2016**

## Anthem of the Seas – Marine Safety Investigation Report

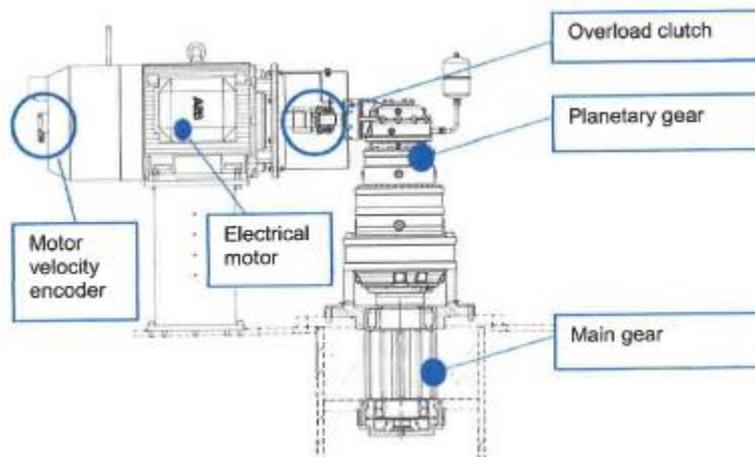
Figure 4: Steering motor unit parts (source: AN Propulsion Study report by ABB, DNV-GL, Elomatic, MeyerWerft, RCCL, VTT)

Each Azipod unit consists of four clutches, one on each motor. Clutch release events occurred primarily due to water slamming against the Azipod unit, this eventually led to the complete failure of all four clutches on the port side. A complete failure of one clutch and damage to the remaining three clutches on the starboard side.

A review of different clutch types was conducted by ABB. Used clutch type (KTR-SI Compact DK) was found to be the most suitable for the system.

A new split type coupling was introduced and installed on all pods allowing for easy onboard replacement in case of failure.

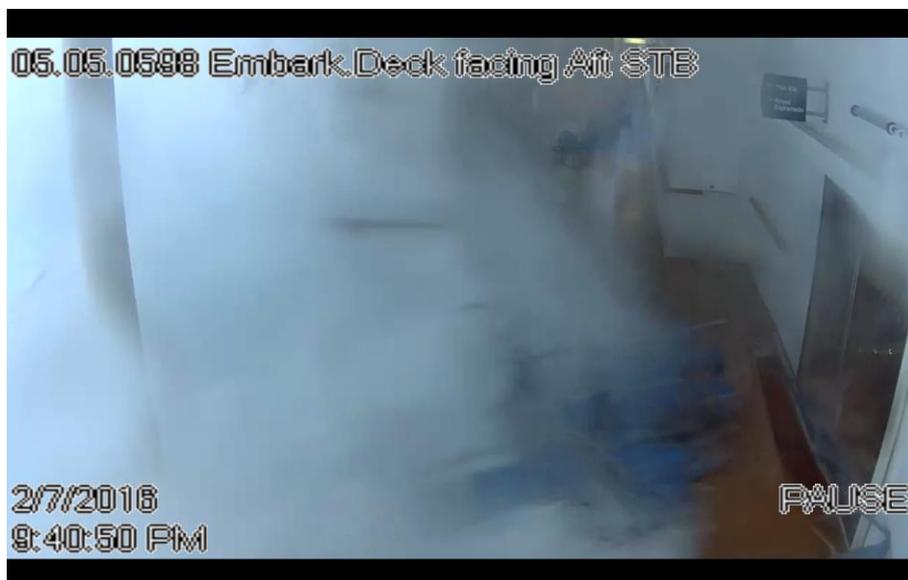
Figure 9: CCTV screenshots show seas breaking on the lifeboat embarkation decks

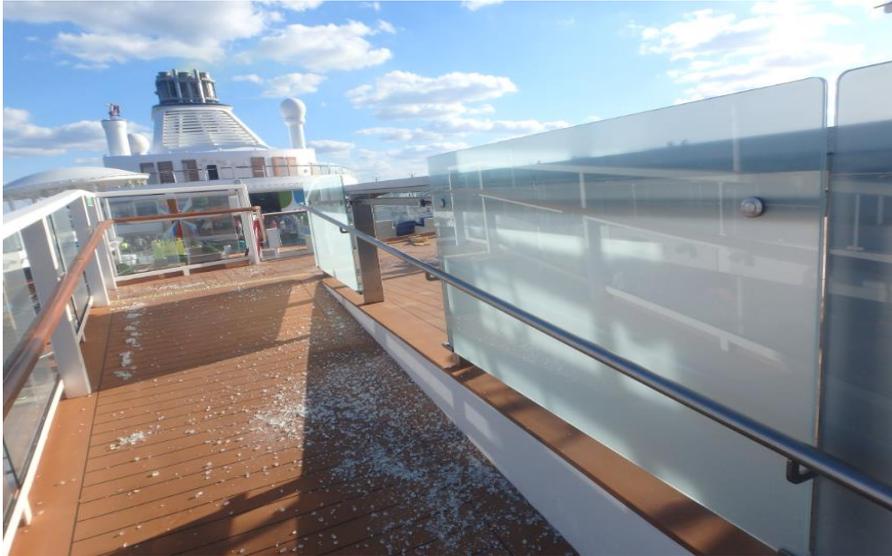
**Figure 10: Broken glass on deck**

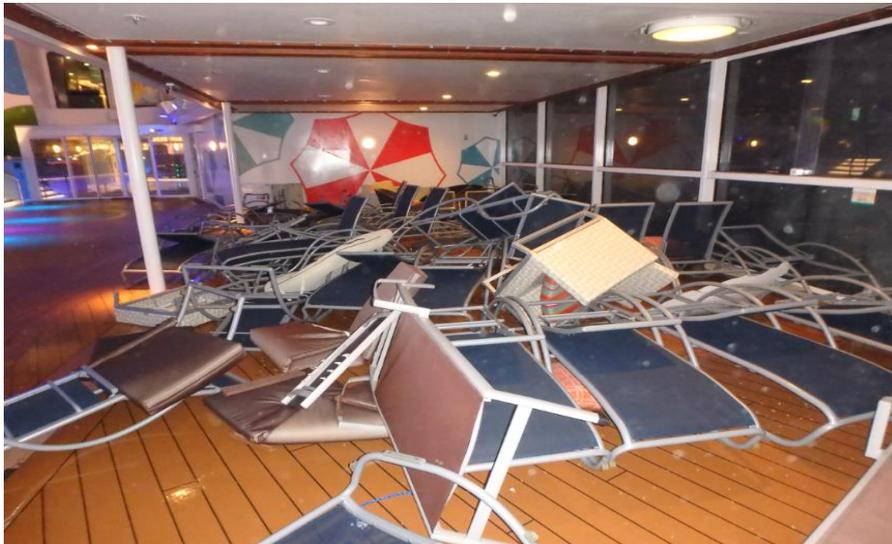
**Figure 11: Damaged seats near the pool area**

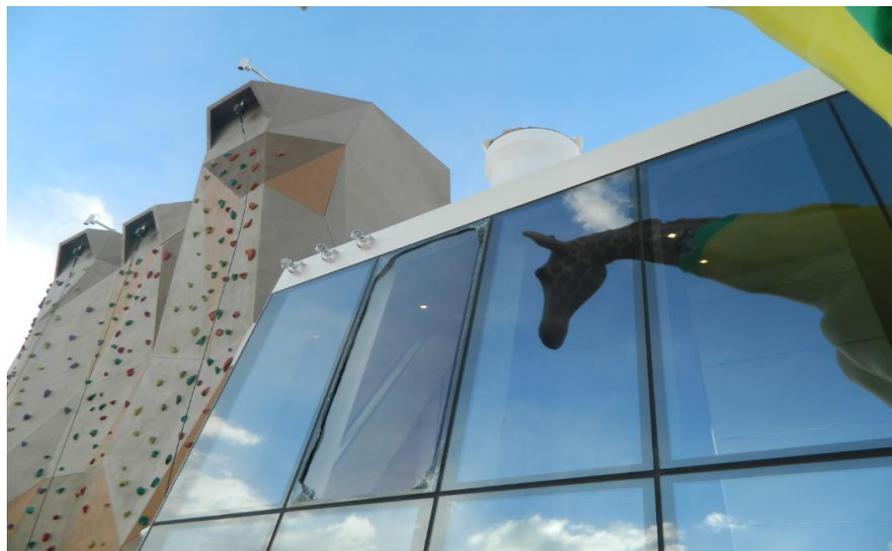
**Figure 12: Broken glass window**

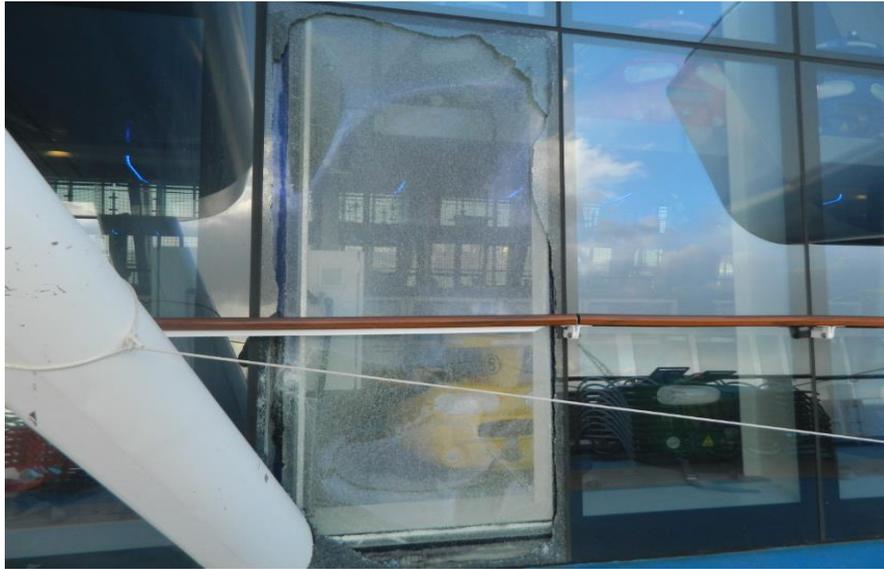
**Figure 13: Broken glass on the deck**

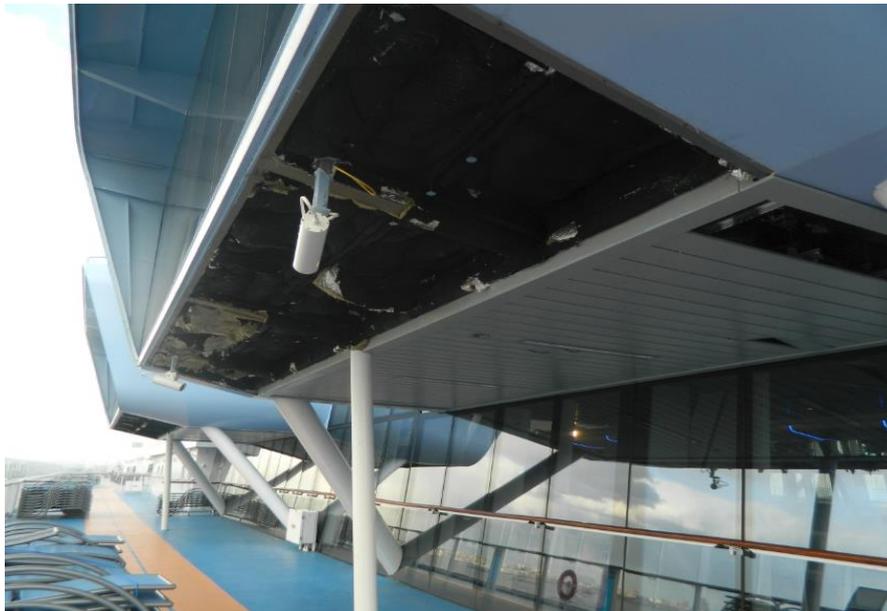
**Figure 14: Damaged ceiling on deck**

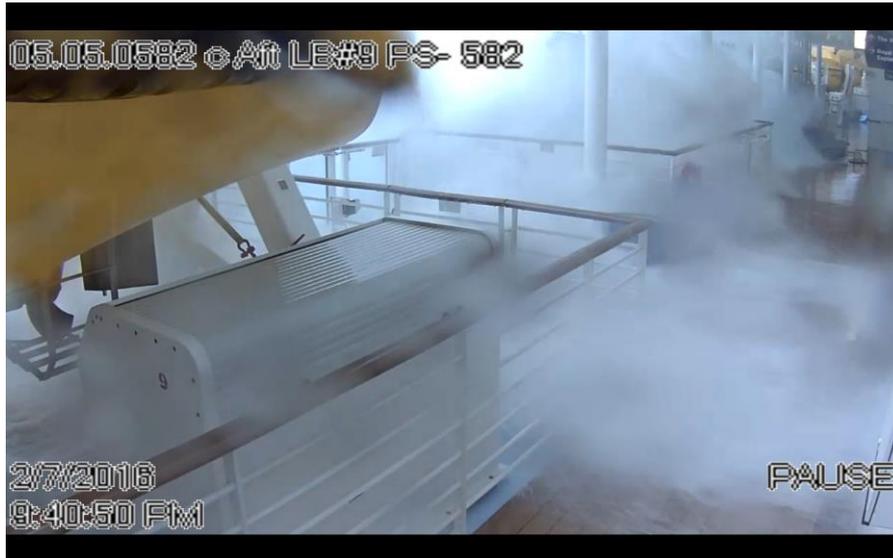
Various lifeboats on both starboard and port boat decks were damaged. Mostly the reported damaged was due to the water ingress in the engine compartment, damage to plexiglass and battery charger failure. Also, multiple painter lines were pulled out from the overcapacity life rafts.

Figure 15: Seawater breaking on the lifeboat embarkation decks
