**The Bahamas  
Maritime Authority**

**Report of the investigation into  
the structural failure of  
Cargo Hold No.1  
“SETSUYO STAR”  
Fully laden with Iron Ore  
from Brazil to China  
June 2006**

Date of Issue : 5 May 2008

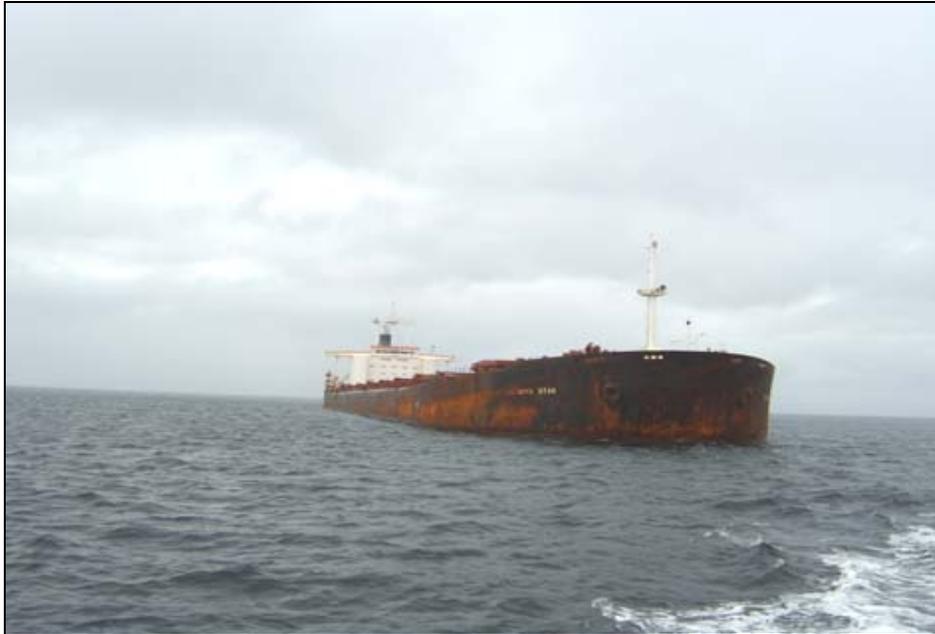
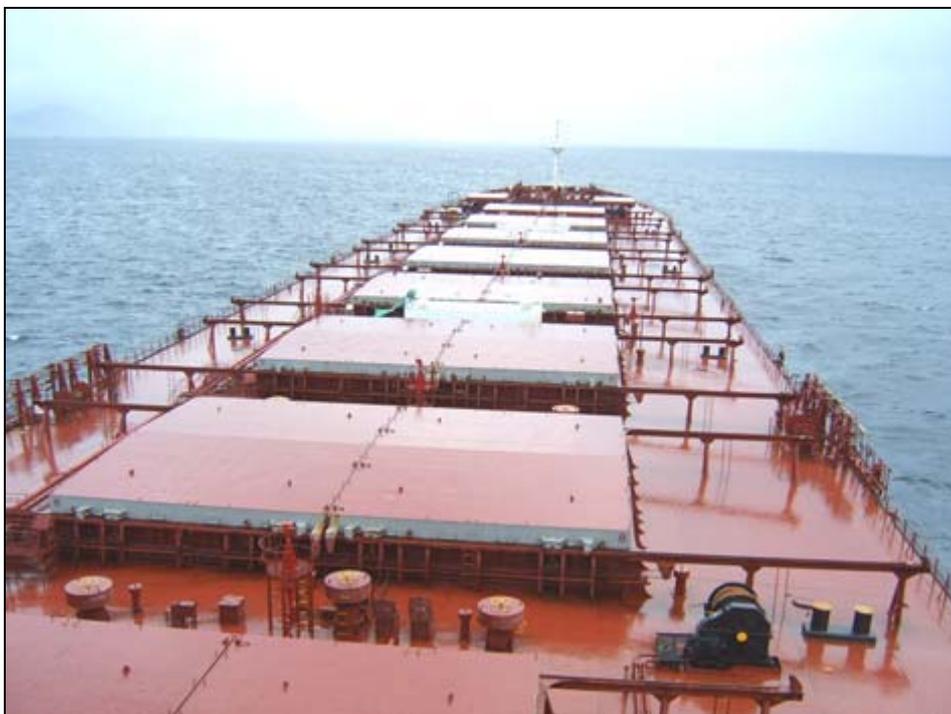
**2.11** Photographs of the vessel at False Bay, South Africa in June 2006.

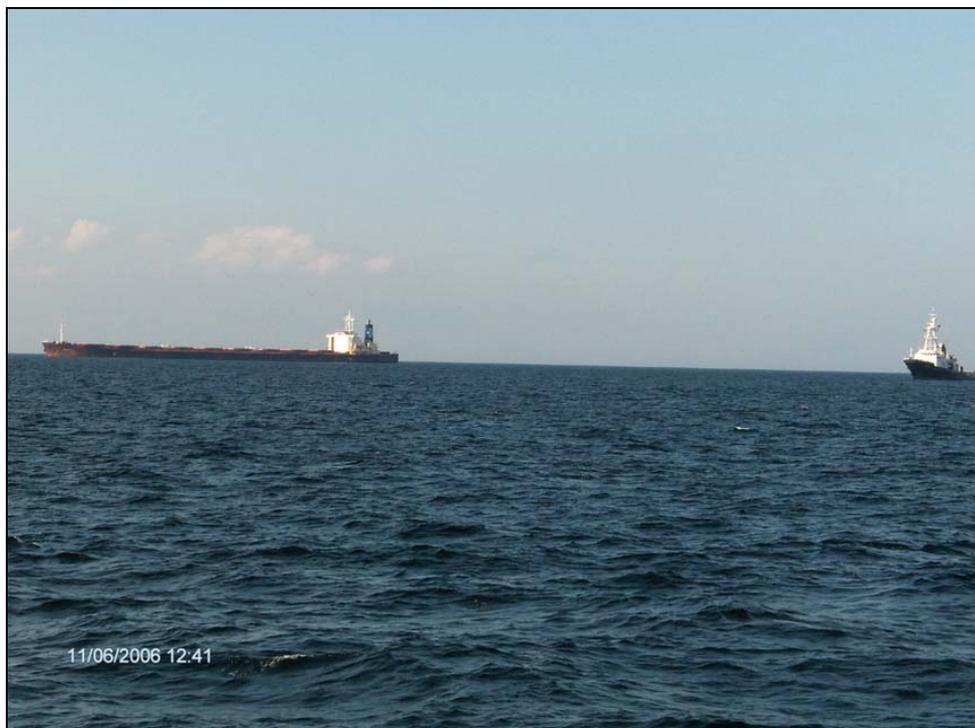
- 3.9** The Vessel at anchor, together with a tug escort at False Bay, South Africa.

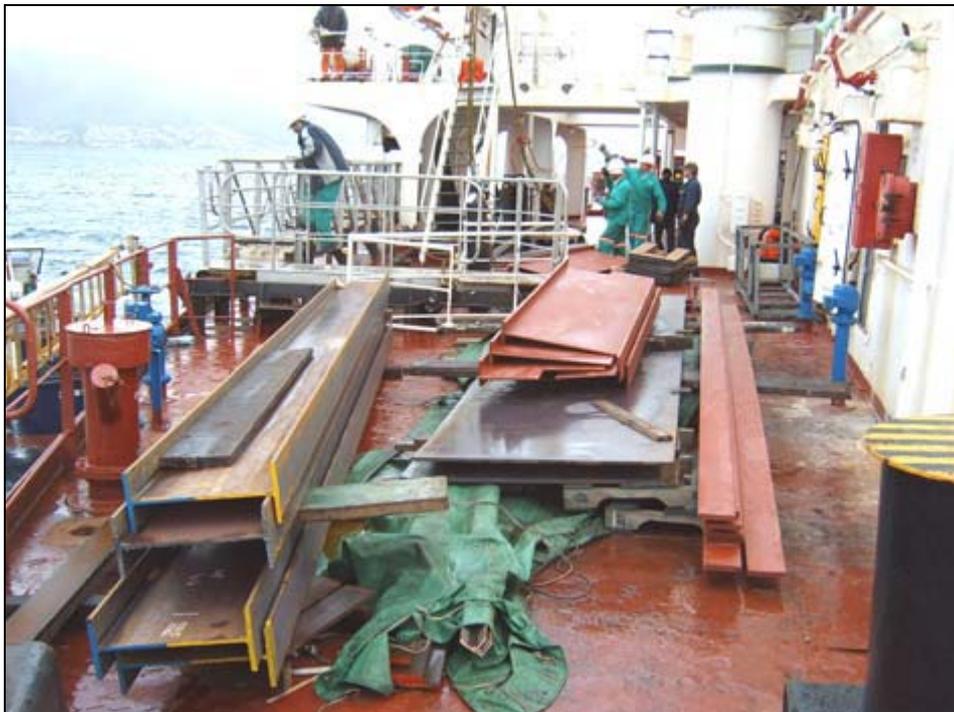
- 3.11** Temporary repairs at False Bay, photograph of repair material being brought on board the vessel.

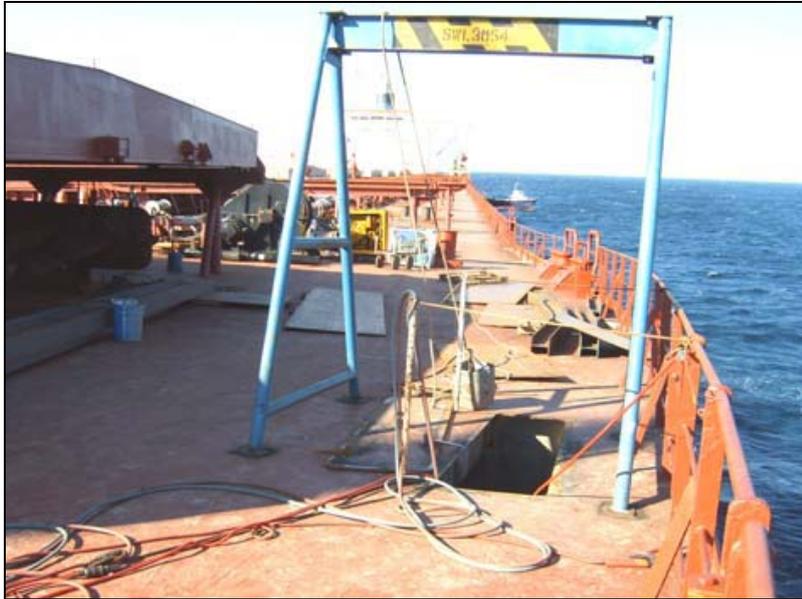
Access was cut through the deck of the vessel in order to position and weld the new steel in place, photograph taken on the port side of cargo hold No.1

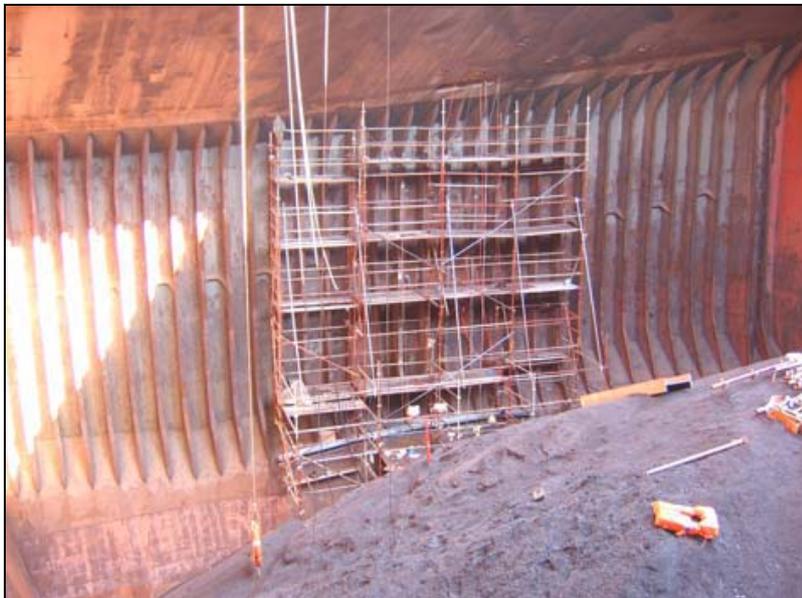
Inside cargo hold No.1 – Port side, temporary repairs in progress at False Bay, the Iron Ore cargo can be seen in the foreground.

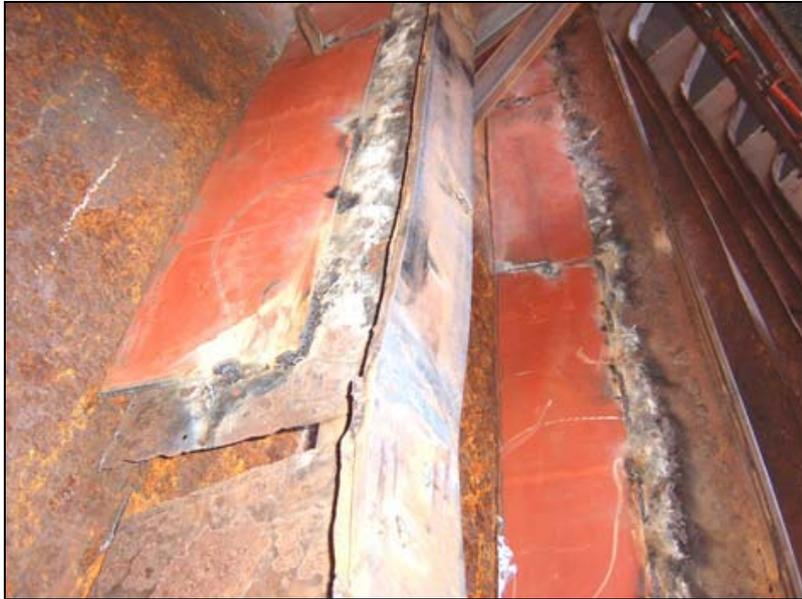
Cargo hold No.1, Port side, frames 312 and 313, temporary repairs in progress, new steel welded to badly corroded / wasted frames.

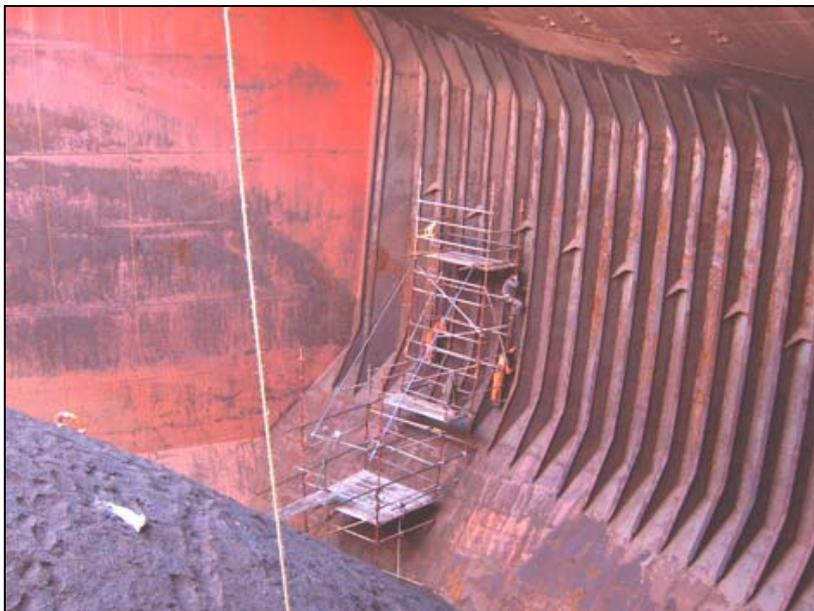
Cargo hold No.1 – Starboard side, temporary repairs in progress at False Bay.

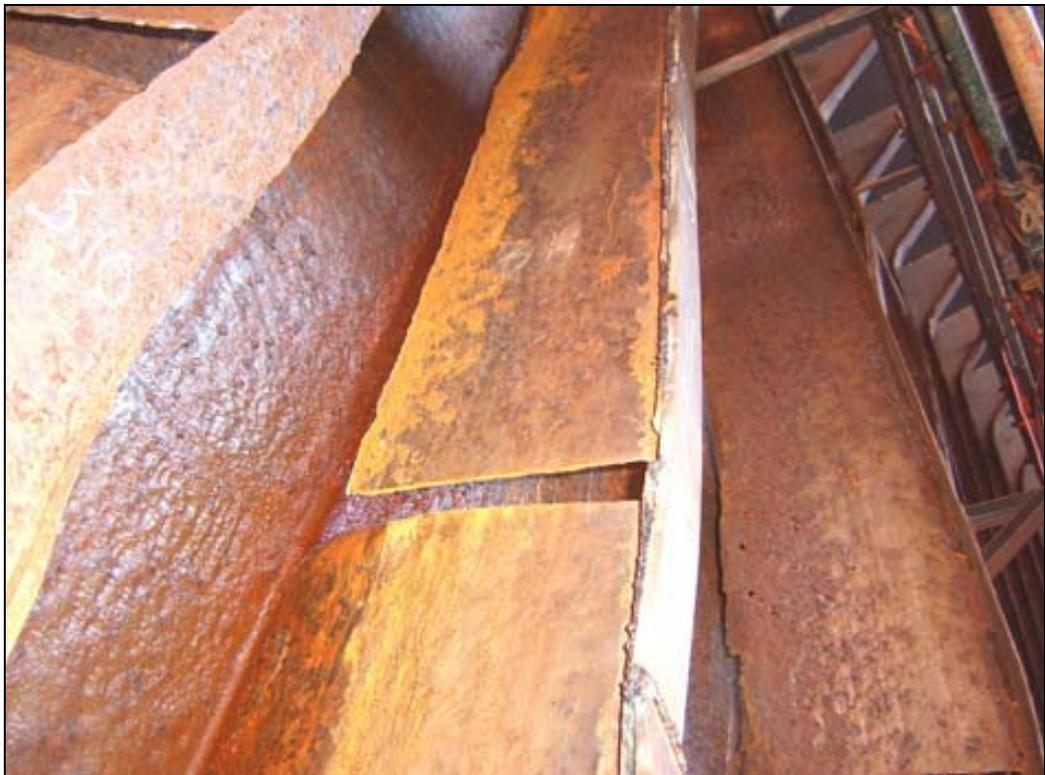
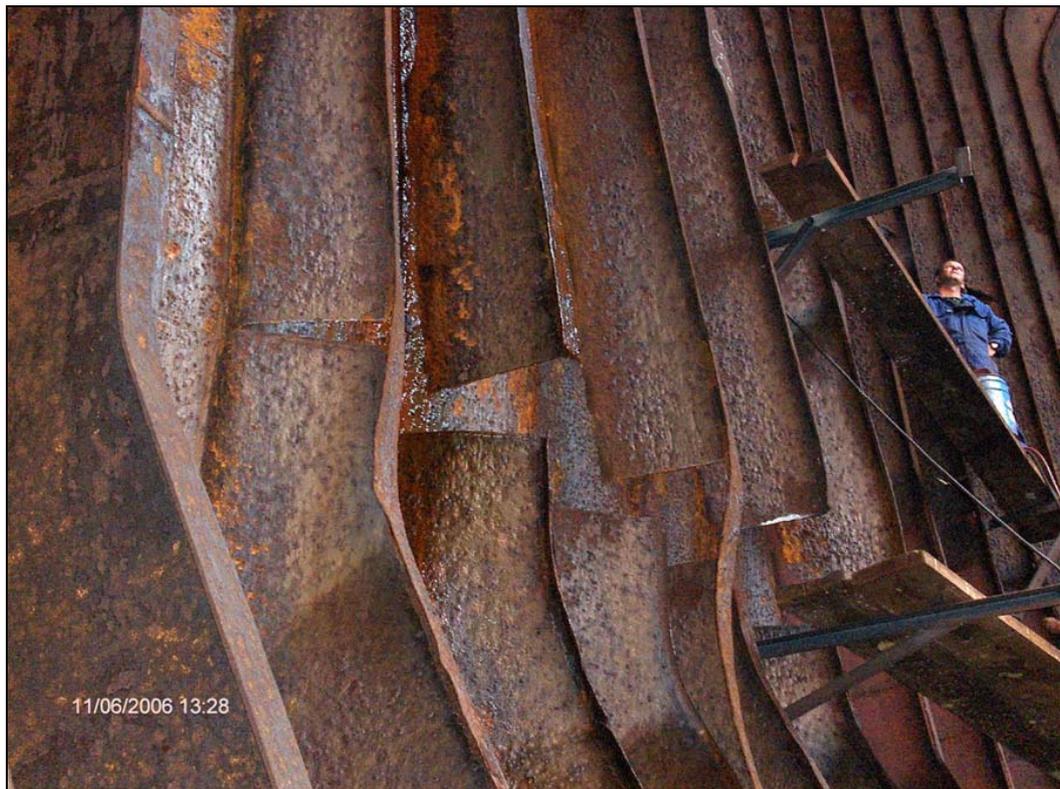
- 4.2 Side shell frames 310, 311, 312, 313 and 314 were detached from the shell plating and tripped. These frames had also cracked over their full depth in way of the connection to the hopper tank end brackets. A section of web plate at frame 316 was also detached.

Cargo hold No.1 – Port side frames 310 and 311, corroded, tripped and detached.

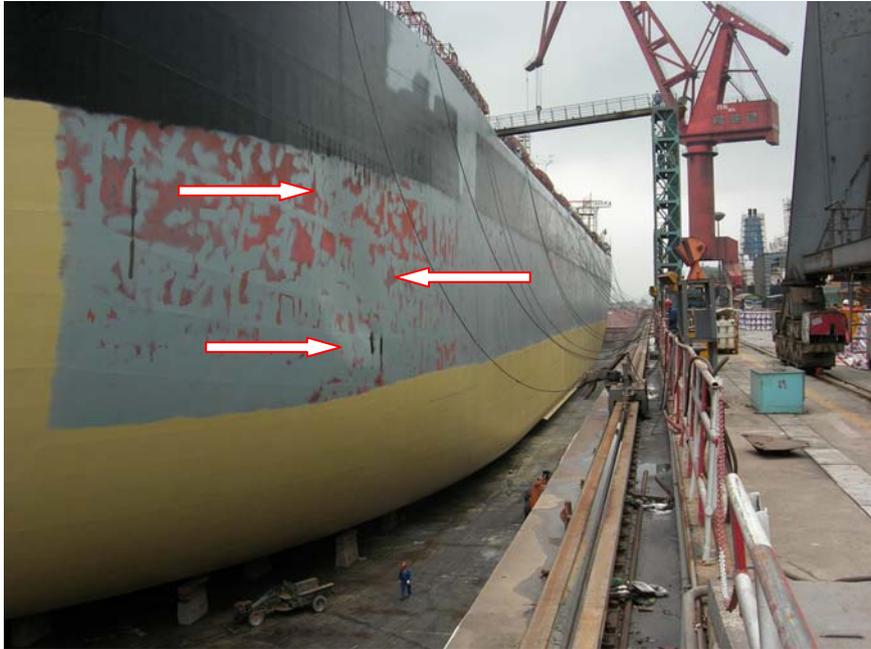
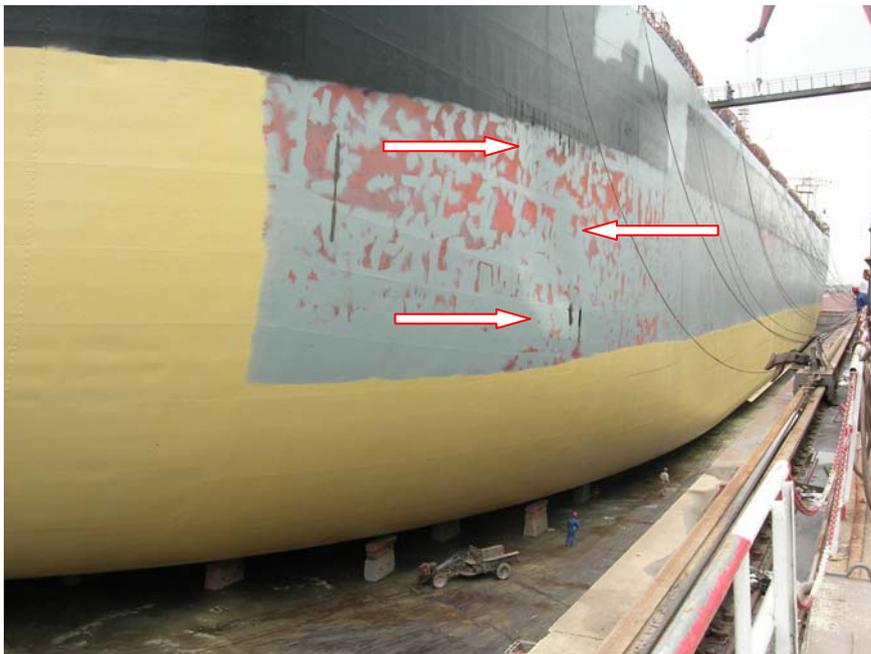
- 4.13** Repairs also included the renewal of the single side skin side shell plating at the port side of cargo hold No.1. Where the frames were detached from this area the plating was reported to be “panting”, even in the relatively calm and sheltered sea conditions at False Bay. The area of damaged plating is clearly indicated and can be seen “set-in” in the repair- yard photographs below. A section of plating 9m deep and 8 m long between frames 309 and 315 was renewed.

- 4.12** At the Repair Yard all side shell frames 293 to 327 at the port side of cargo hold No.1 were renewed between the upper and lower end brackets. All upper brackets were renewed except for frames 326 and 327. The lower brackets of frames 306 to 318 were renewed in their entirety and the lower brackets of frames 294 to 304 were partly renewed. The renewal of frames at the starboard side was nearly as extensive. There was also extensive renewal of the side shell frames in all holds, except hold 6. The Repair Yard record of renewals indicates that renewed frames including upper and lower brackets used web plate of 16mm thickness, stated to be justified as requirement of IACS UR S31. This is a significant increase on the original thickness of 12mm for the frames and 14mm for the lower end brackets.

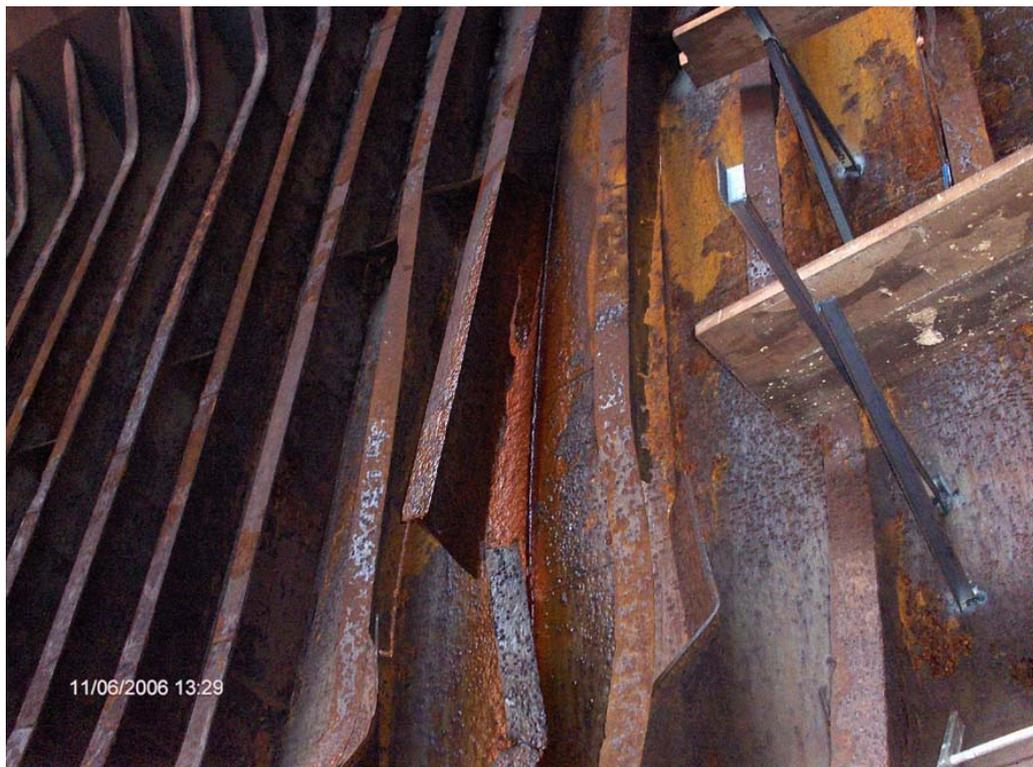
- 4.28** There is clear evidence that there was severe corrosion wastage of frames 310 to 314 at the port side of cargo hold No.1, particularly toward the side shells which became detached from the side shell plating and were buckled. The severity of the corrosion would have resulted in a substantial reduction in the web plate buckling strength. The damage to frames 310 to 314 is typical of that resulting

from corrosion wastage allowing buckling of the web plate and/or detachment of the web plate from the shell plating under the influence of hydrostatic and wave pressure loading. Buckling and/or detachment of the frame from the side shell plate would allow the unsupported plating to “pant” excessively in a seaway and to be set in permanently. The breaking of the frames 310 to 314 on the port side at the connection with the lower bracket and at the connection with the upper bracket is likely to have occurred as a consequence of the detachment and buckling of the web plates. The severity of the wastage and resultant damage can be clearly seen in the photograph below.

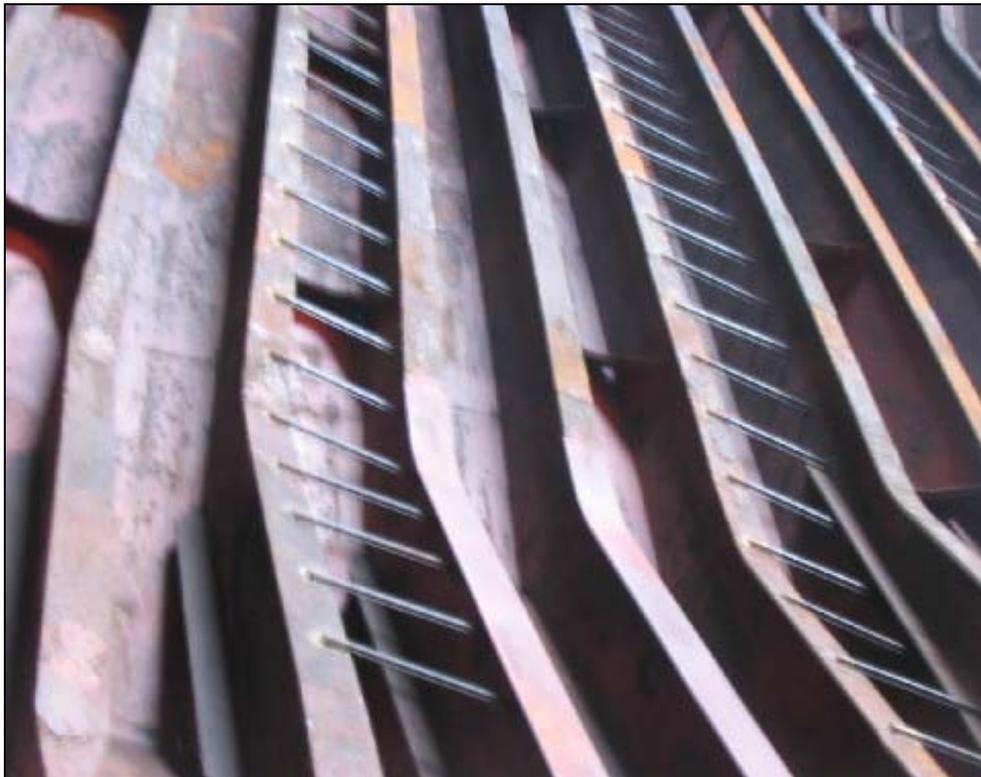
- iv** The lack of proper facilities being available to conduct a “close up” inspection was a major contributory factor within this incident. The photograph below illustrates how the managing owners have elected to address this problem by installing the permanent means of access; they have incorporated within the cargo holds on “SETSUYO STAR” at the repair-yard following the casualty in 2006. Round bars have been welded across every third frame, at Owners’ recommendation, for the purpose of providing access for close-up inspections.

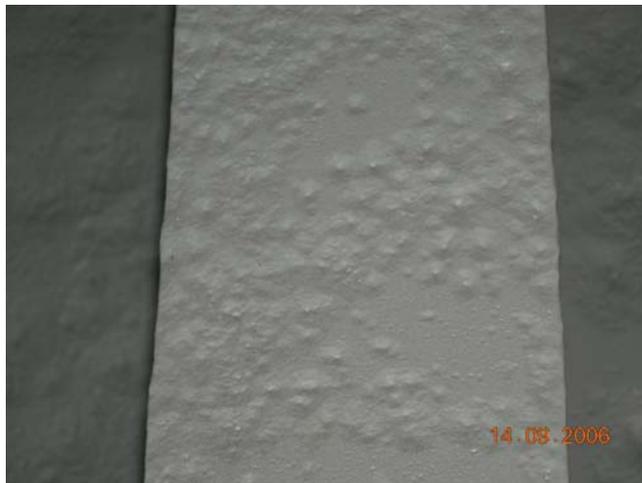
- 4.35** The problems associated with the corrosive effects of coal cargoes and the accelerated corrosive effects that can be experienced in ship’s cargo holds are well documented. The hull structure can become seriously weakened by the accelerated corrosion within a relatively short time frame. Some grades of coal can contain a high level of sulphur and should the coal be loaded in a damp or wet condition and/or become wet during transit due to sweat or water ingress, the resultant damp environment and the subsequent production of sulphuric acid will greatly accelerate the corrosive process. This is often marked by the presence of “pitting” in the cargo hold plating and frames. There is significant pitting evident in the hold plating and frames on the vessel, as shown in the photograph below which was taken in the repair yard and is just one example of “pitting” on a cargo hold frame.

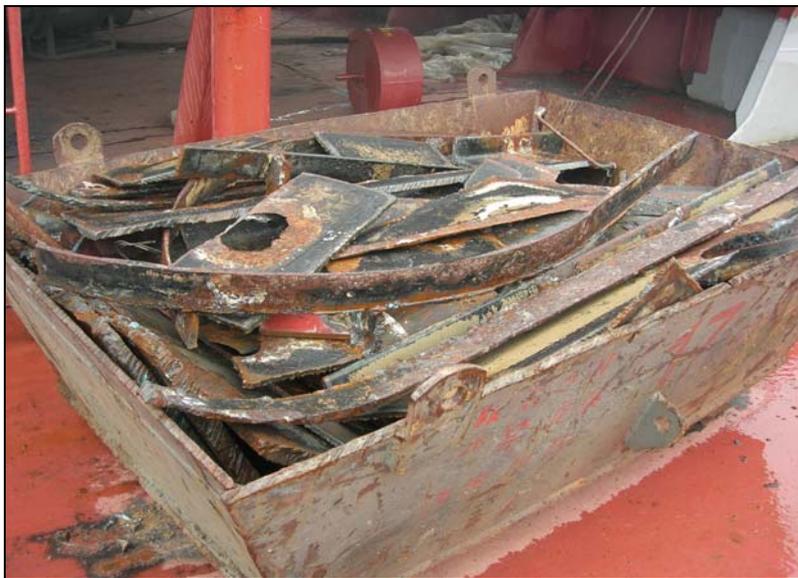
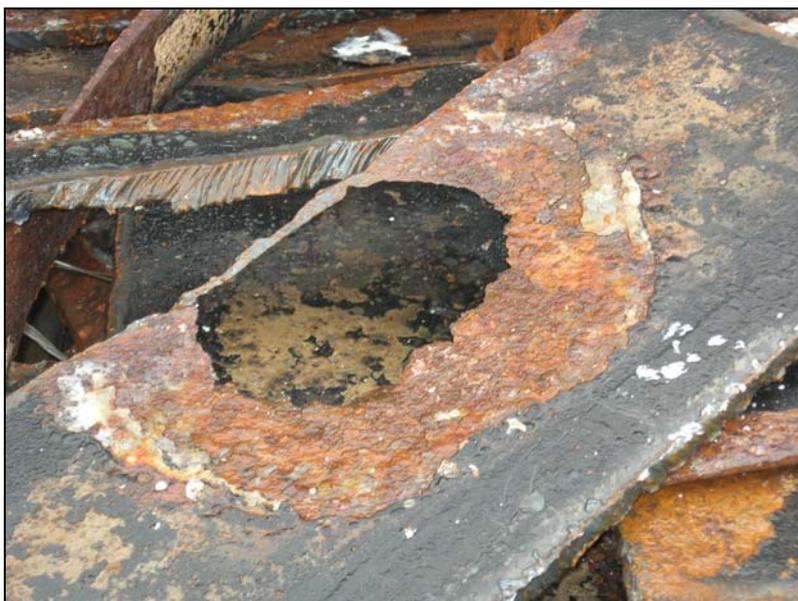
**4.38** See appendix “III” – Repair Yard steel replacement, and the photographs below showing a sample of the corroded / wasted steel work which was cropped out of the vessel at the repair yard.

**4.38** The steel frame replacement within all cargo holds, with the exception of hold 6, following the incident was very extensive. Hold 6 was a designated ballast hold, within which the hold protective coating was reported to be in much better condition than the other non-ballast holds. The action of flooding this hold with ballast water following the carriage of a corrosive cargo, together with the much better intact protective coating would have substantially reduced any residual corrosive effect on the hold structure, more effectively than water-jet washing.
