**The Bahamas
Maritime Authority**

“MONARCH of the SEAS”

**Report of the investigation into
hazardous material release during
pipe work renewal.**

2nd September 2005

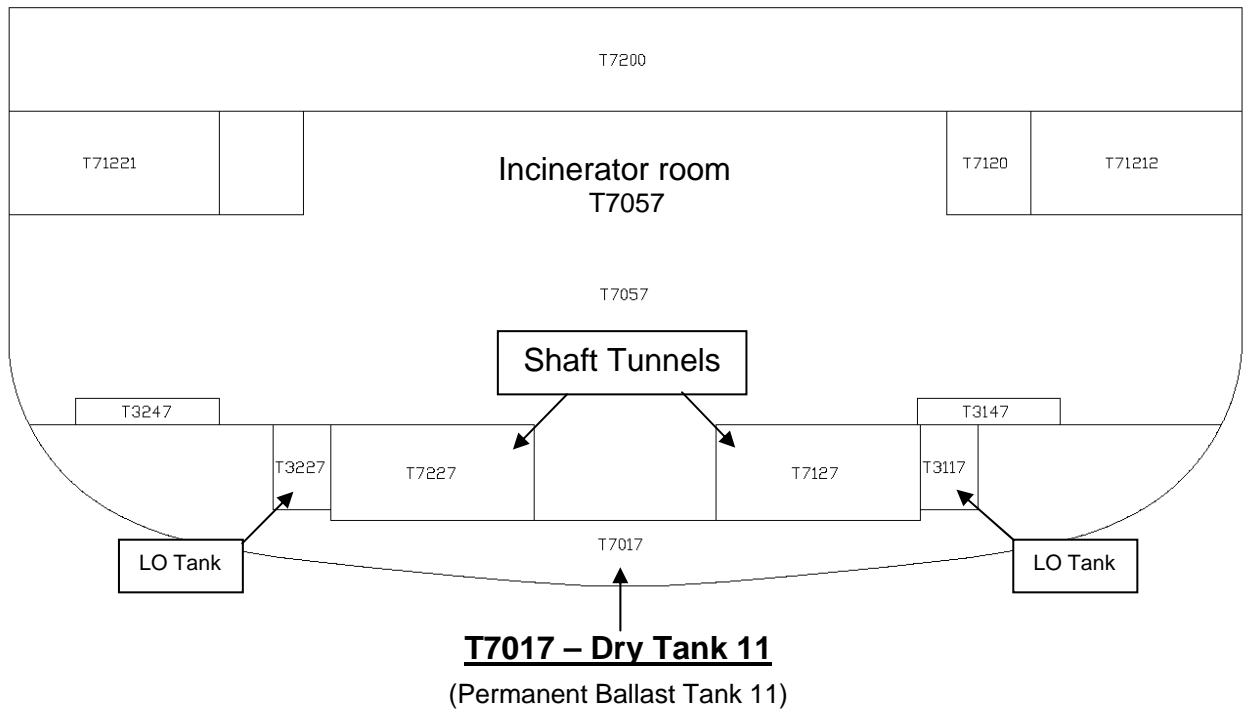
Hull Space T7017, Cross Section & Location

- 4.2 **TANK:** The tank was designated on ship’s drawings as hull space T7017 a dry void with a volume of 433.7 m³.
(See Appendix 1 Hull Space T7017 Cross Section & Location)
Hull space T7017 was a shallow double bottom tank with a ‘U’ shape, the upper port and starboard sections of which each had an individual vent which terminated in the engine casing on deck 1 just aft of the Engine Control Room. The port and starboard shaft tunnels were situated inboard of the upper sections of the tank.
The tank had one sounding pipe located on the tank top, which was below the highest level of the tank and near the centreline of the ship.
The tank was also connected to the bilge system through a small pipe from the bottom of the tank.

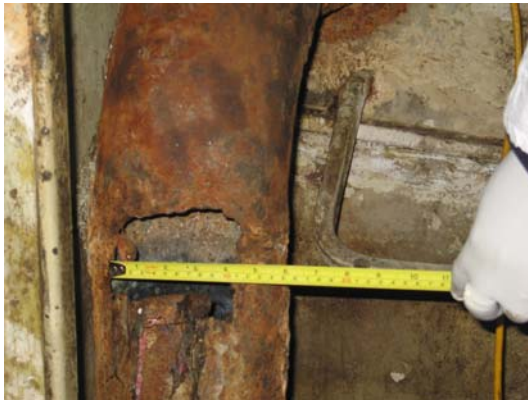
- 4.18 Both sections of pipe inside the tank were inspected (at dry dock in January 2006) and found to be holed, one hole in overboard line and two holes in the line from the Windjammer to the hydro extractor. A pipe patch was found on the pipe coming from the Windjammer booster pump indicating that this piping had been previously repaired. *(See Appendix III - Pictures of holed pipe work in tank)*

Hole in overboard pulper pipe.
Width approximately 4 1/2 inches.

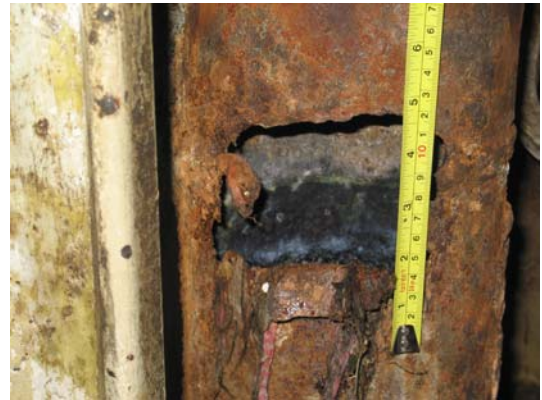
Hole in overboard pulper pipe.
Length approximately 3 inches.

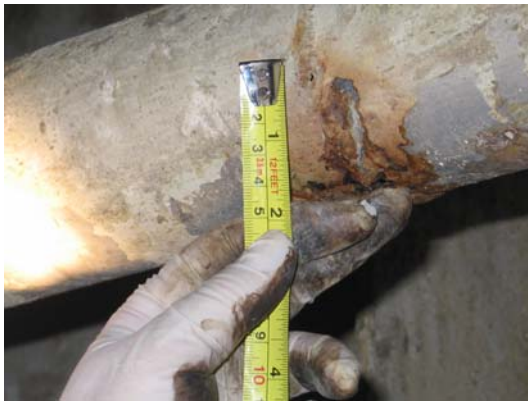
First hole found in pipe leading from Windjammer
booster pump going to incinerator room.

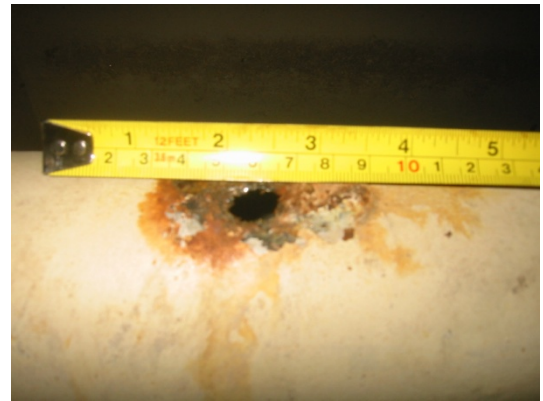
Second hole found in pipe leading from
Windjammer booster pump going to incinerator
room
