Bahamas Maritime Authority

**Report of the Investigation into
The Premature Release of the
Port Lifeboat on *M.V. Pac Monarch*
at Vancouver, Canada,
on 26 October 2000.**

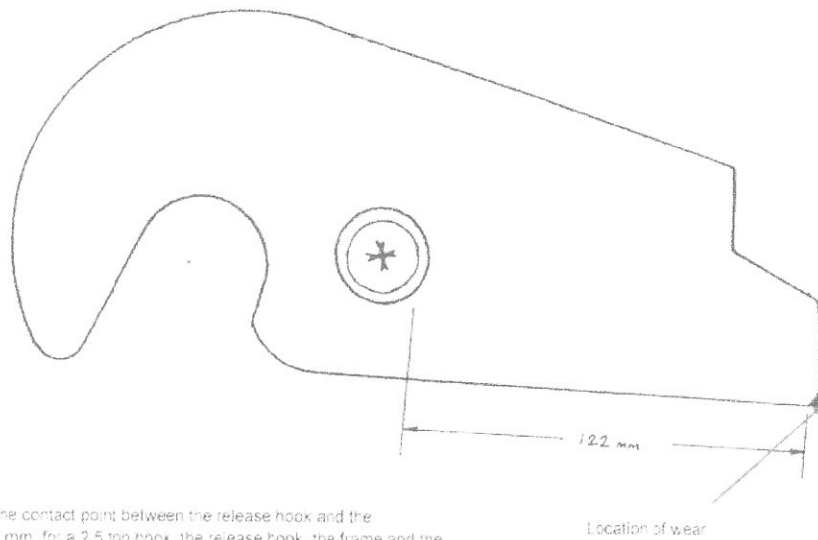
Fig.3

6.7 The wear on the contact surface of the hook, (fig.3, Annex 2 and Replacement Standard, Manufacturers Instruction Manual, Annex 3) determines the limiting dimension of 122mm. The vessel was only 6 months old at the time of the accident and the boat had apparently been launched only 4 or 5 times, but this dimension on one of the hooks was already found to be 121.7mm. - below the minimum allowed for the hook to remain in a safe condition.

When the wear at the contact point between the release hook and the frame reaches 122 mm, for a 2.5 ton hook, the release hook, the frame and the lever should be replaced.

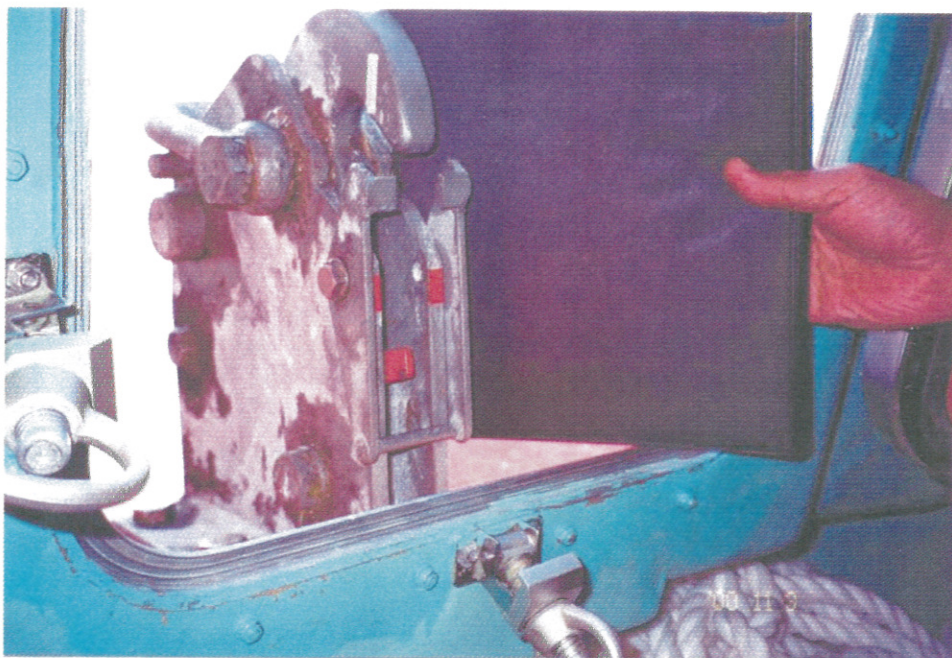
6.8 The red reference mark on the Cable Reset Lever does not line up with the 'red' alignment marks on the cheek plates on both the forward and aft hook assemblies. This applied to the 4 boats fitted on *M.V. Pac Monarch* and sister vessel *M.V. Pac Emperor* as well as the associated manufacturers' engineering drawings. With the passage of time and wear on the landing surfaces this situation may create an acceptance in the minds of those operating the boat that increasing misalignment is acceptable. (Photo. 1 & 2, Annex 2).

Photo 1. Forward hook partly released. Light indicating fully engaged

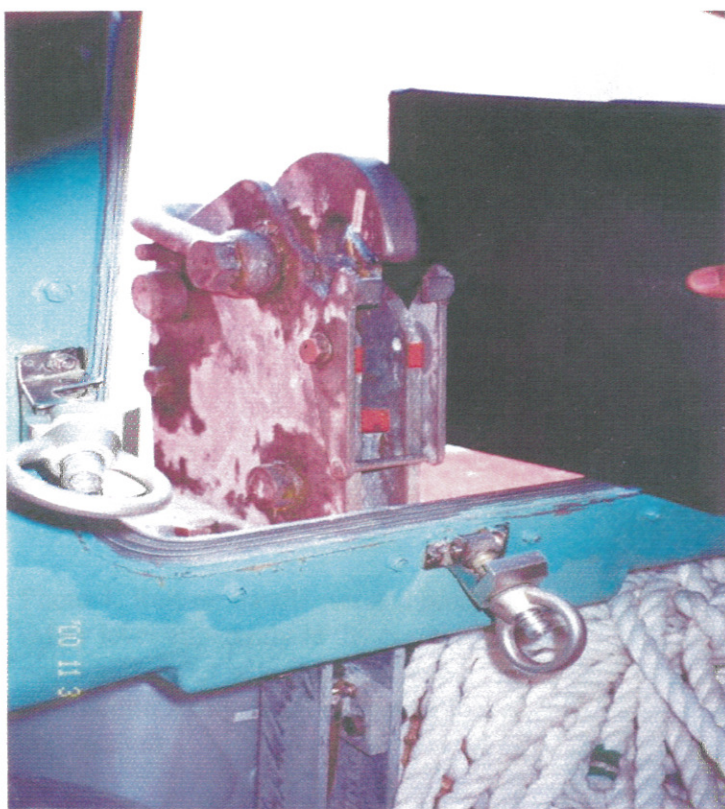
Photo 2. Position where light changes to reset

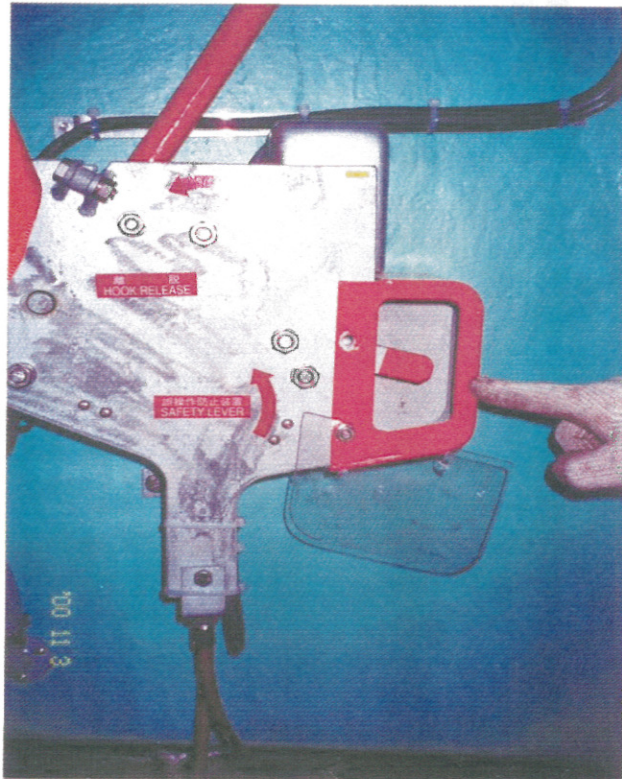
Photo 3. Release handle set and secured. Safety Lever in correct position.

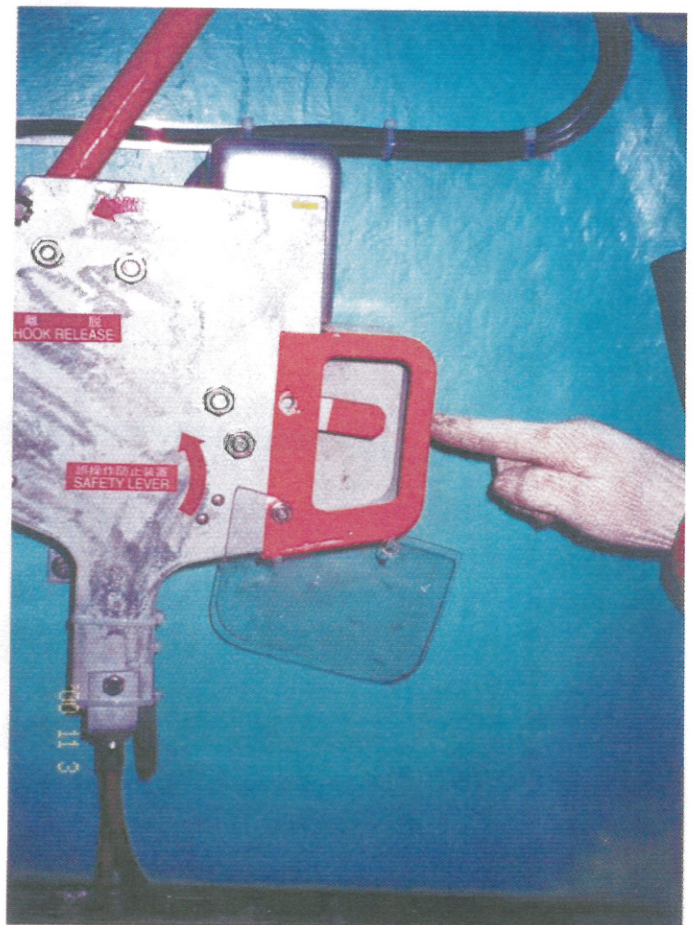
shown that this can create conditions where the panel lights can provide a false indication of the status of the Cable Connection Arms and Interlock Lever. Therefore, when either or both the Cable Connection Arms are not being blocked by the Interlock Lever, the panel indicator lights incorrectly indicate that they are. A test on the starboard lifeboat, No.1, revealed that the indicator light in the control box showed that it was safe, even when an unsafe condition existed. The difference in the position of the interlock in the release mechanism between the safe and unsafe position was too small to be discernible.

Photo 4. Release handle set and secured, safety lever apparently in the correct position, but not securing the Cable Connection Arm. Light indicating locked and secured

- 8.3. consider providing a viewing port on the side cheek of the central release mechanism to allow a direct view that the interlock (10) is actually blocking the Cable Connection Arm (12) when the mechanism has been reset,
- 8.4. consider fitting the aft hook with the open end facing forward so that the 'red' alignment marks are easily viewed when being reset by the lifeboat crew,
- 8.5. verify the 'red' marks in 8.4 align correctly before delivery,
- 8.6. revise the design of the hook with a view to reducing the wear at its contact point with the Blocking Lever.

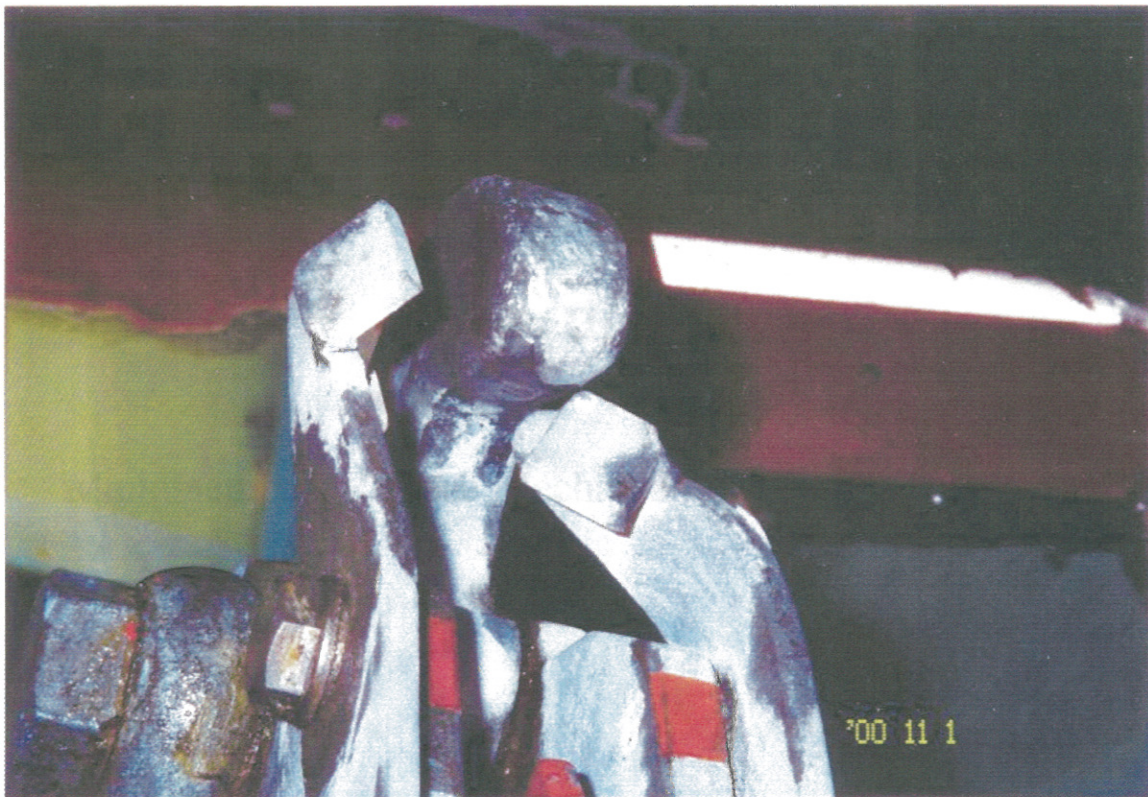
5.2 The aft hook latches were bent to port, the inner one quite severely (Photos. 7 & 8), and the hook had a scouring mark on the inner face.

6.11 The cause of the damage to the aft hook latches has not yet been determined. Under normal circumstances the hook releasing would not cause the latches any damage and there was no report of any damage when the boat was recovered 2 days earlier.

Photo. 7 Damage to after hook latches

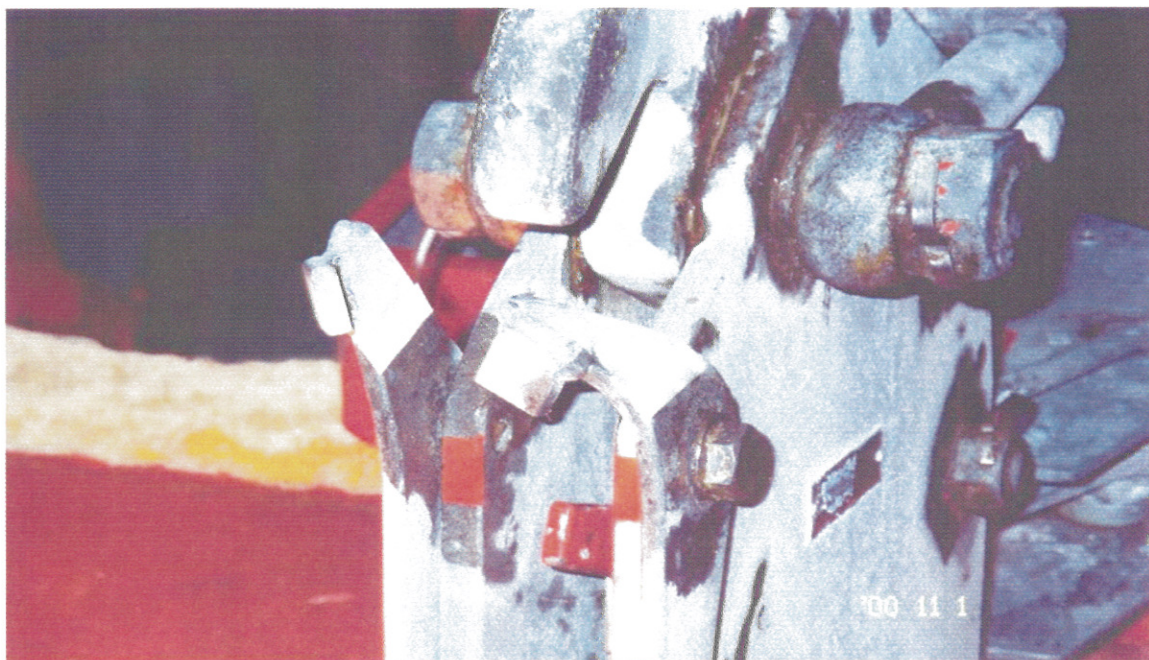
Photo 8. Damage to aft hook latches
