**The Bahamas  
Maritime Authority**

**“M.V Bulk Jupiter”**

**IMO Number 9339947**

**Report of the marine safety investigation into the loss of a bulk  
carrier in the South China Sea on January 2<sup>nd</sup> 2015**

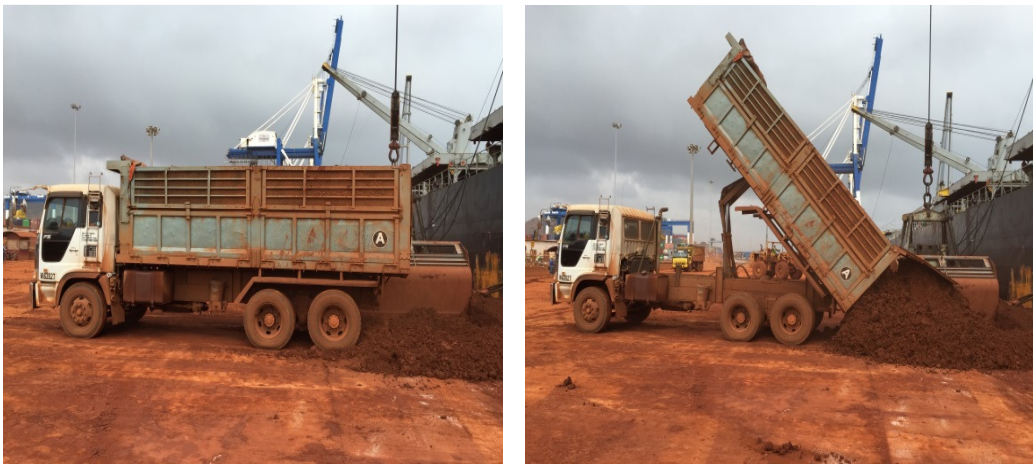
- 2.4.9 The loaded trucks, which are generally not covered as shown in figure 6, if coming from within the port or nearby stockpiles, dump the cargo on to the quayside (Figure 6).

Figure 6: Truck unloading Bauxite on quayside

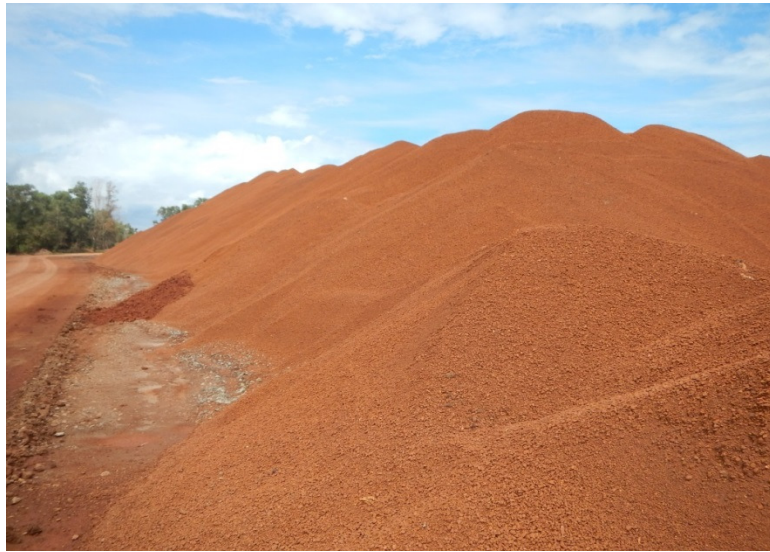
Figure 8: Open storage of processed Bauxite

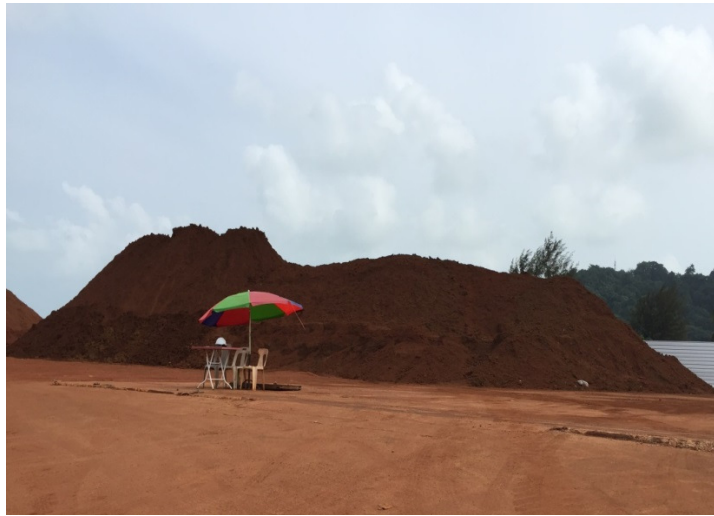
port so as not to delay loading operations. None of the stock piles were covered (Figure 10 and 11) and there was no evidence of any tarpaulins that could be used in the event it rained.

Figure 10: Uncovered stockpile in port

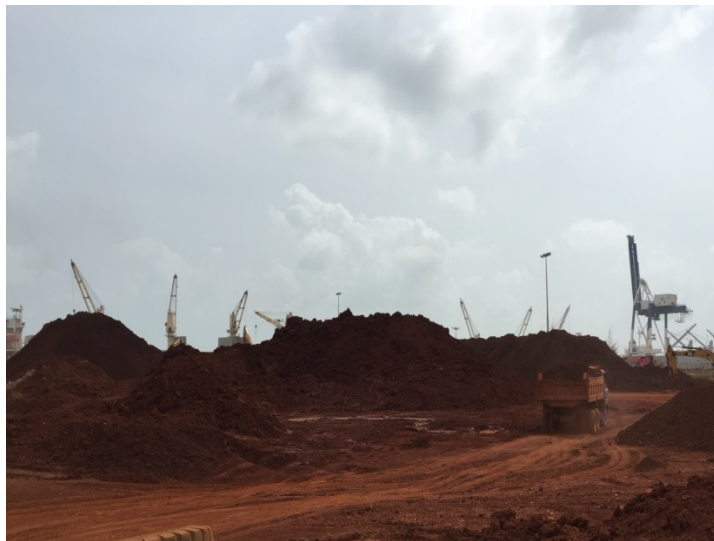
Figure 11: Open storage of Bauxite in port

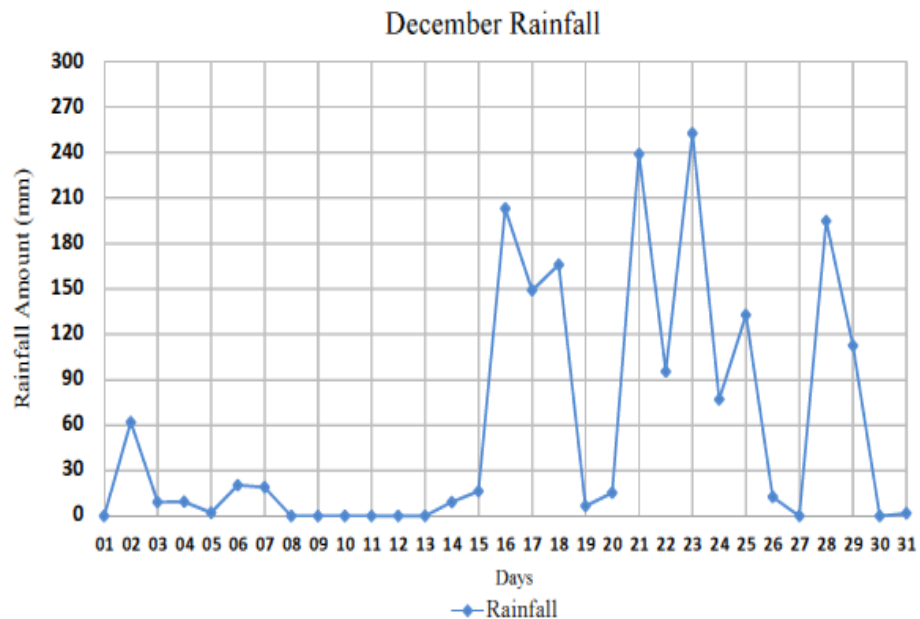
Figure 22: December rainfall in Kuantan

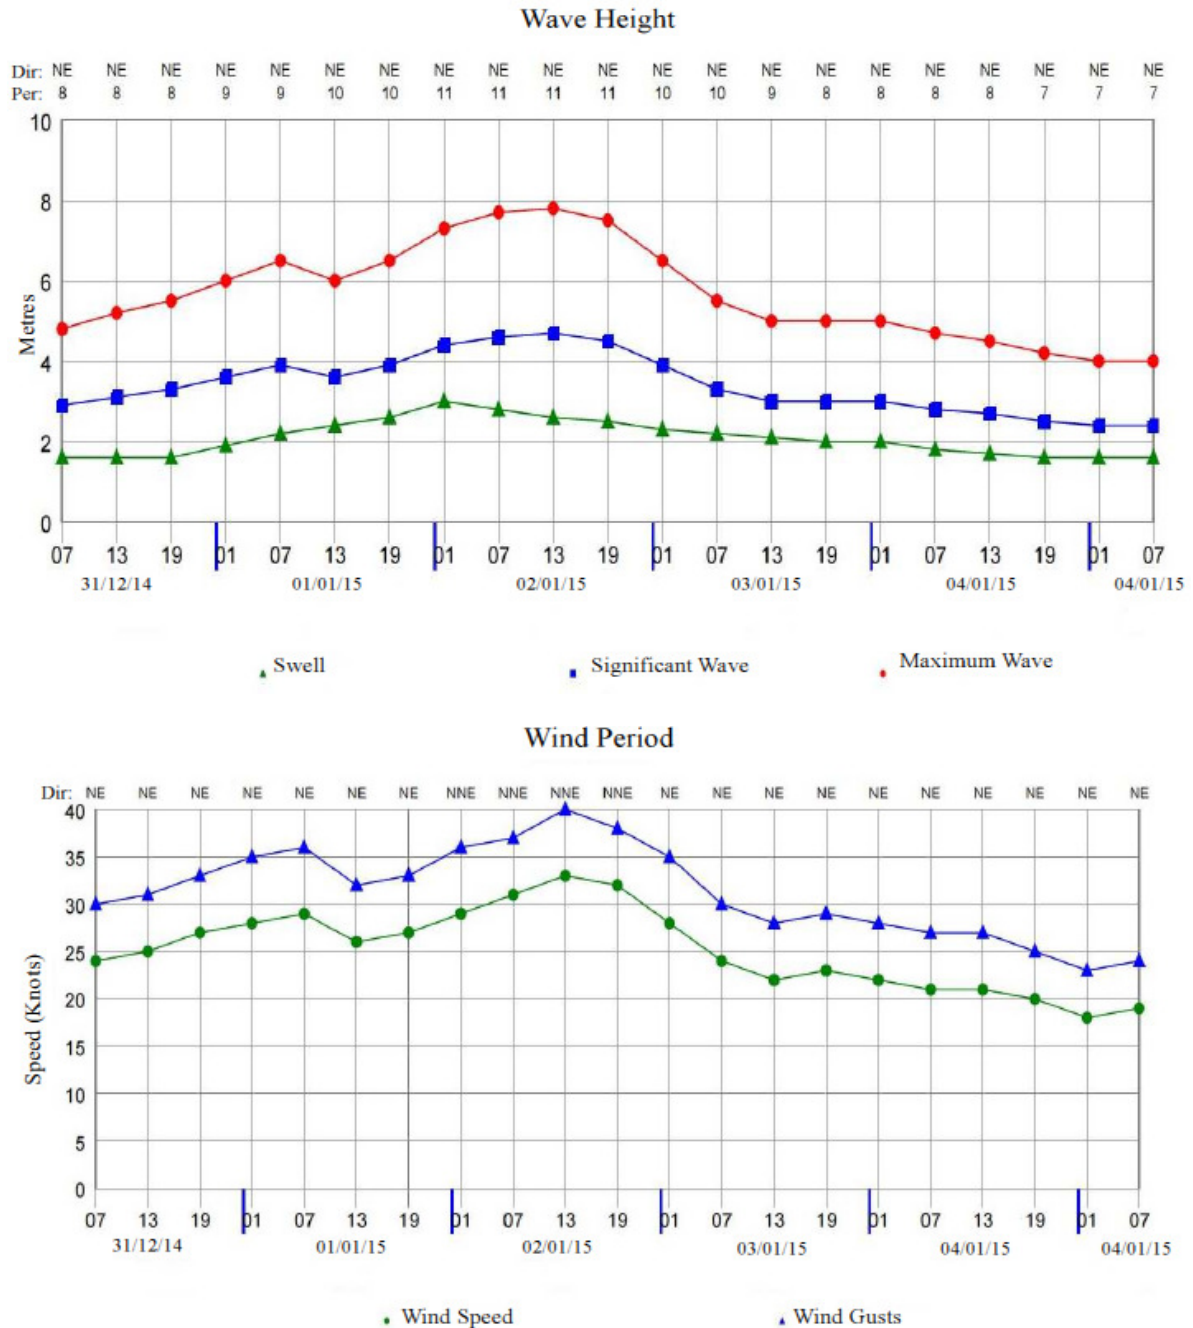
- 4.5.1 The statement provided by the Chief Cook contains several factors that are possible indications of an unstable cargo. However the downgraded tropical depression delivering gale force winds and very rough seas apparent from the description of the vessel's motion are also worthy of consideration as a contributory factor.
- 4.5.2 A weather report produced by 'm.v Toisa Dauntless' at 1000 on the 3<sup>rd</sup> January descibed the conditions as North Easterly wind 30kts, wave height of 5m. The recorded weather experienced over the period (see Figure 27) provides data on wave height and wind periodicity for the duration of the SAR operation. The data provided by 'm.v Toisa Dauntless' is considered an accurate reflection of the experienced conditions, particulalry when aligned with that of the recorded data from other sources.

Figure 27: Actual recorded data for wave height and wind strength for the region

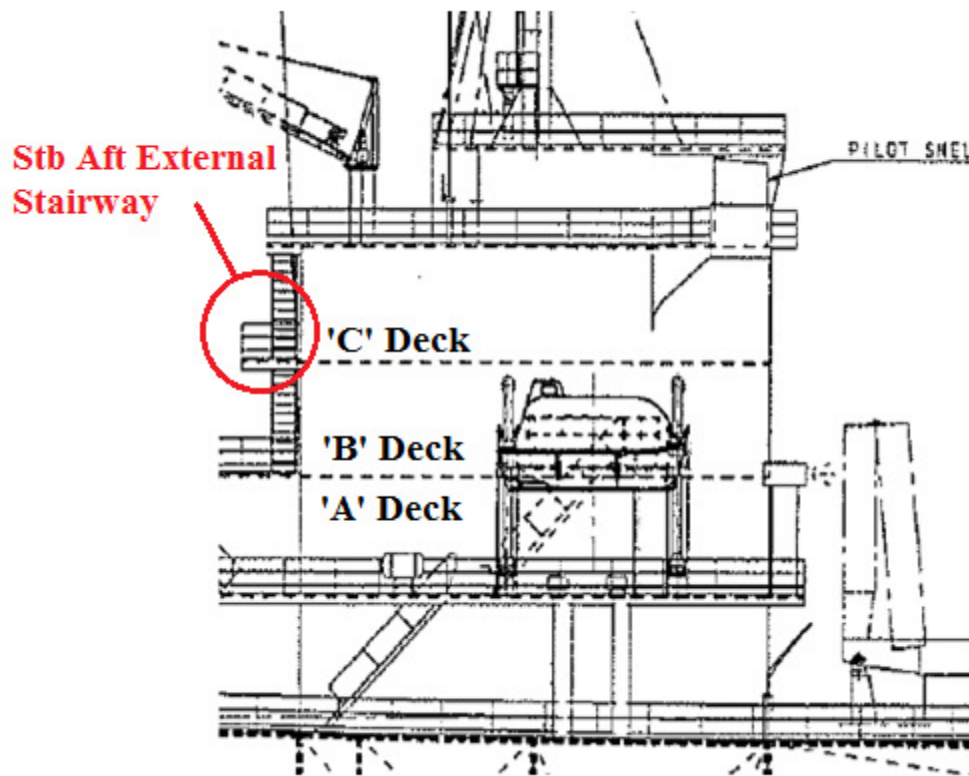
Figure 28: Master and Chief Cook disembarkation location

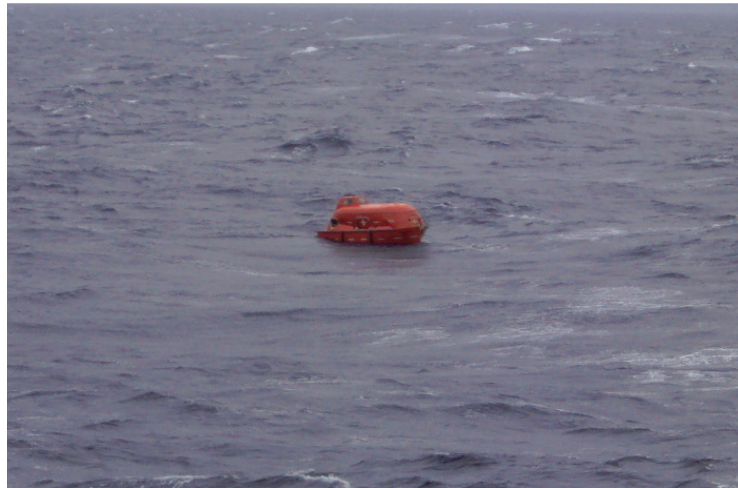
Figure 29: Bulk Jupiter lifeboat as seen from 'm.v Zim Asia'

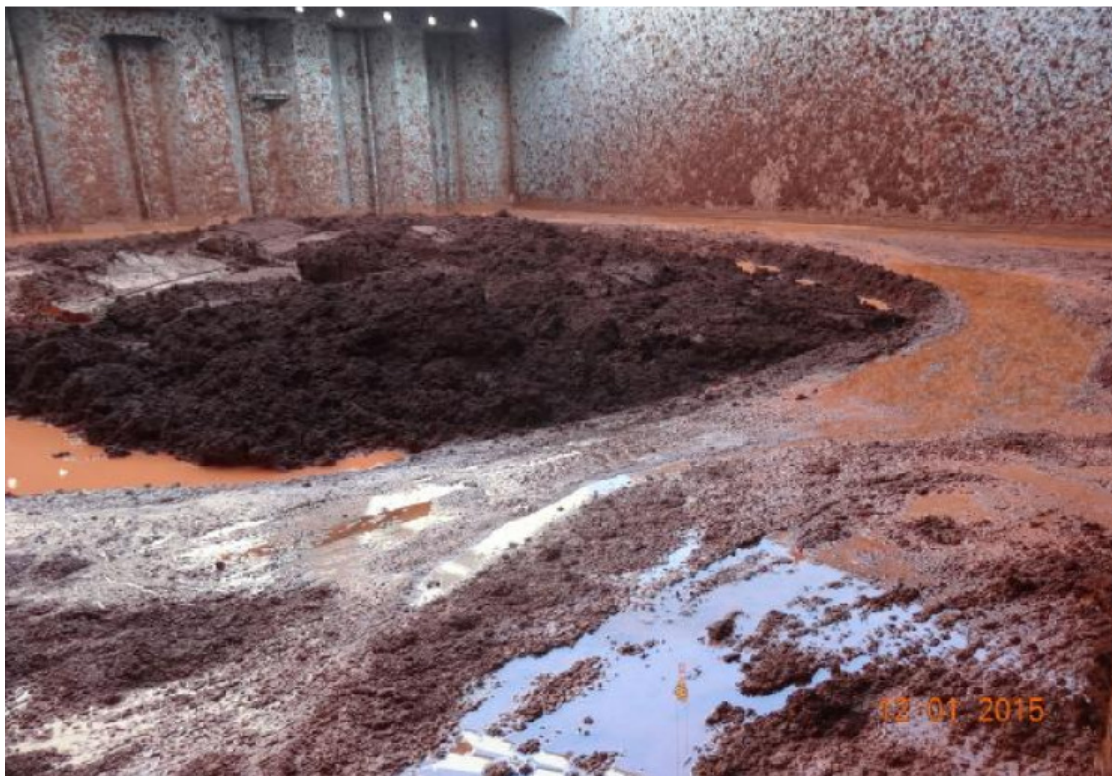
Figure 34: General view across hold No. 4 on board 'm.v Orchid Island', note extensive splatter on bulk head

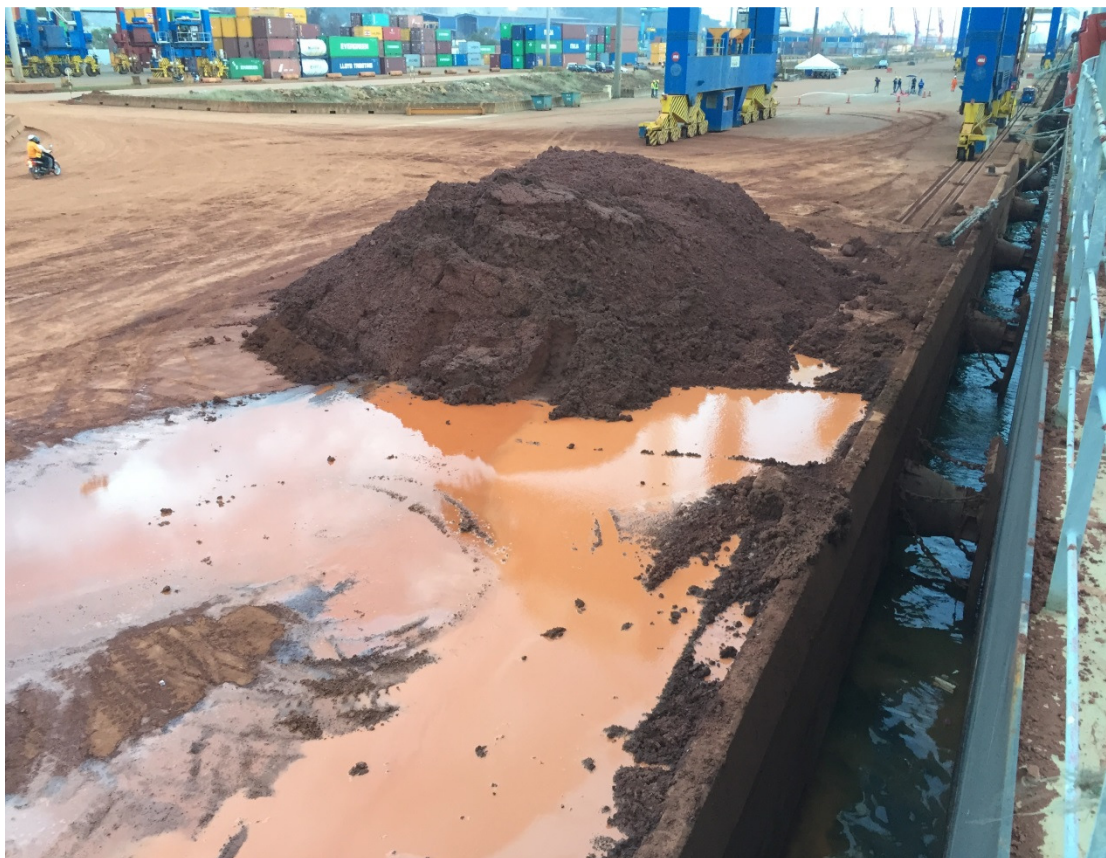
Figure 35: 'm.v Medi Okinawa' alongside container berth, Kuantan, embarking Bauxite
