**The Bahamas
Maritime Authority**

**Report of the investigation into the sinking of the
“MOL Comfort” in the Indian Ocean**

Date of Issue: September 2015
Bahamas Maritime Authority
120 Old Broad Street
LONDON
EC2N 1AR
United Kingdom

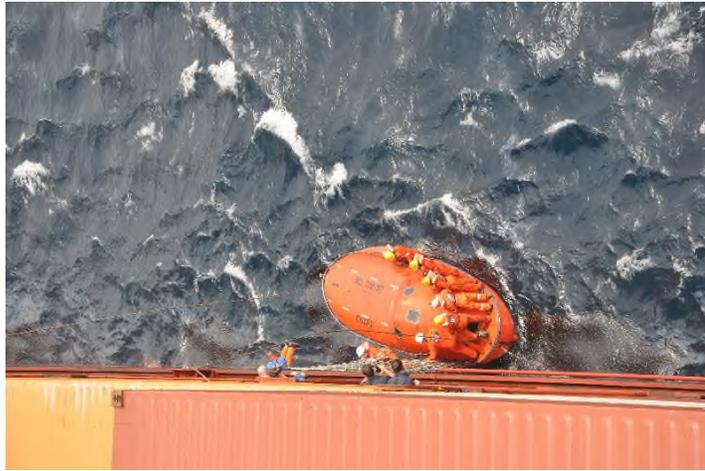
- 3.20 On arriving alongside the Yantian Express, at approximately 1110 hours, the lifeboat occupants attempted to climb the cargo net rigged by the Yantian Express into the starboard pilot embarkation door. Unfortunately the rough weather conditions, reported to be Beaufort 7 with 5-6m SW waves, along with oiling of the cargo net meant that some crew members were washed into, or slipped, the sea and lifebuoys had to be deployed to save these individuals.

Figure 1 Lifeboat alongside Yantian Express

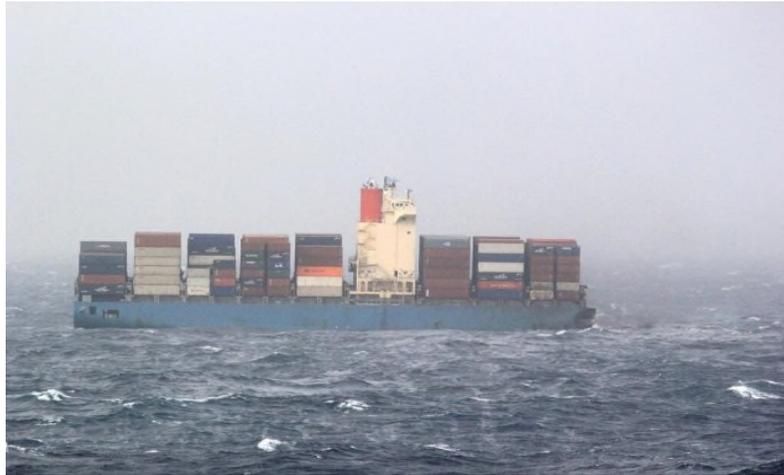
- 3.21 By 1136 all 26 members of the crew had successfully boarded the Yantian Express and it was released from OSC duties by MRCC Mumbai to resume its passage. Shortly afterwards, at 1148 hours, it was noted that the MOL Comfort had broken into two sections which were drifting away from each other.

Figure 2 After section of MOL Comfort

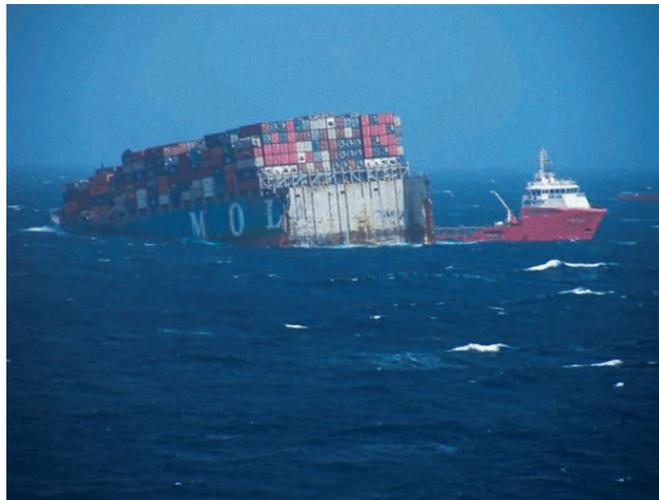
- 3.24 Four salvage boats arrived on scene on the 24th June and on 26th June had attached a tow to the fore part. Attaching a tow to the after part of the ship was proving to be extremely challenging, however, as it had assumed a position some 30° down by the “head” and containers were being lost into the water. Weather conditions were described as being very challenging with wind speeds of 30-40 knots and a 7-8m swell.
- 3.25 On 27th June it was reported that the fore section was under tow with escort tugs in a stable condition towards the Arabian Gulf but that the aft part was continuing to take in water, rolling heavily and losing containers overboard. The after part subsequently sank on the same day in 3000m water depth at 0748 UTC in position 14°25'50" N 066°26'18" E. Approximately 1700 containers sank along with the aft part which also contained about 1500 tonnes fuel oil.

Figure 3 Fore section with tow vessel

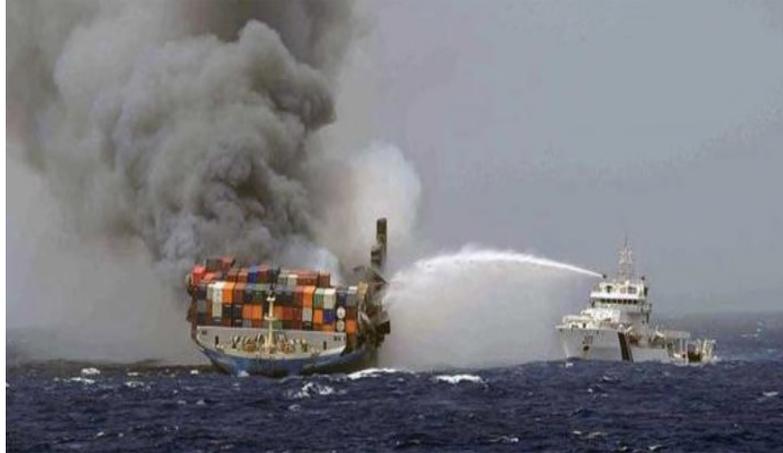
Figure 4 Fore end fire-fighting by “Samudra Prahari”

- 3.29 Despite the assistance of the “Samudra Prahari” the fire continued unabated and the fore part of the MOL Comfort finally sank at 1900 UTC on July 10th in position 19°56’29”N, 065°24’45” E in over 2000m water depth along with approximately 2400 containers and 1600 tonnes of fuel oil.
- 3.30 The salvage team remained in the area until 12th July to monitor for floating containers and pollution but in the absence of either eventually departed the scene.

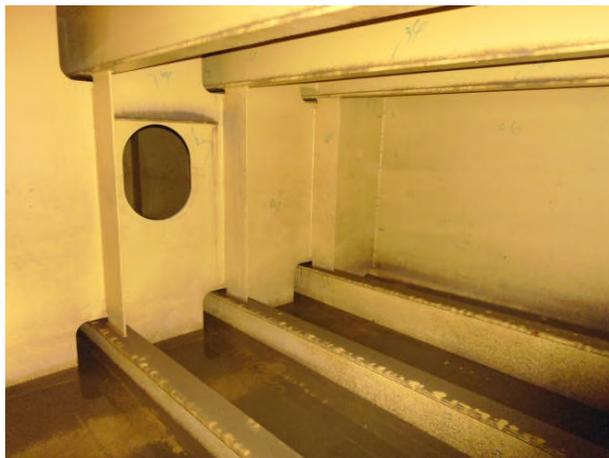
Tank	Frames ³	Defects/remarks
5 Port wing ballast	162-194	No signs of corrosion, buckling or cracks noted.
5 Stbd wing ballast	162-194	No signs of corrosion, buckling or cracks noted.
6 Port wing ballast	130-162	No signs of corrosion, buckling or cracks noted.
6 Stbd wing ballast	130-162	No signs of corrosion, buckling or cracks noted.
5 Port double bottom ballast	162-194	Bottom Shell found deformed in way of Fr.183, between side girders 3 & 9. Otherwise no signs of corrosion or cracks noted. Up to 30 cm of water was present in the tank. Complete examination of the bottom plating not possible.
5 Stbd double bottom ballast	162-194	Bottom Shell found deformed in way of Fr.183, between side girders 3 & 9. Otherwise no signs of corrosion or Cracks noted. Up to 30 cm of water was present in the tank. Complete examination of the bottom plating not possible.
6 Port double bottom ballast	130 - 162	Bottom Shell found deformed in way of Fr.151, between side girders 3 & 9. Otherwise no signs of corrosion or cracks noted. Lower longitudinal stiffener on Side girder No.9 found deformed at Fr.151, deflection in the region of 20mm. Up to 30 cm of water was present in the tank. Complete examination of the bottom plating not possible.

6 Stbd double bottom ballast	130 – 162	Bottom Shell found deformed in way of Fr.151, between side girders 3 & 9. Otherwise no signs of corrosion or Cracks noted. Up to 30 cm of water was present in the tank. Complete examination of the bottom plating not possible.

4.28 Duct keel in way of Hold Nos.5 & 6 examined. Slight deformation of bottom shell in way of Fr.151 starboard noted, otherwise no sign of deformation, corrosion or cracks noted.

Figure 5 General view of condition – MOL Competence No.5 port double bottom
