**The Bahamas
Maritime Authority**

M.V. CMA CGM BERLIOZ

**Report of the marine safety investigation into the
disappearance of a person in the Red Sea on the
21st March 2017**

Date of Issue: 07th June 2017
Bahamas Maritime Authority
120 Old Broad Street
LONDON
EC2N 1AR
United Kingdom

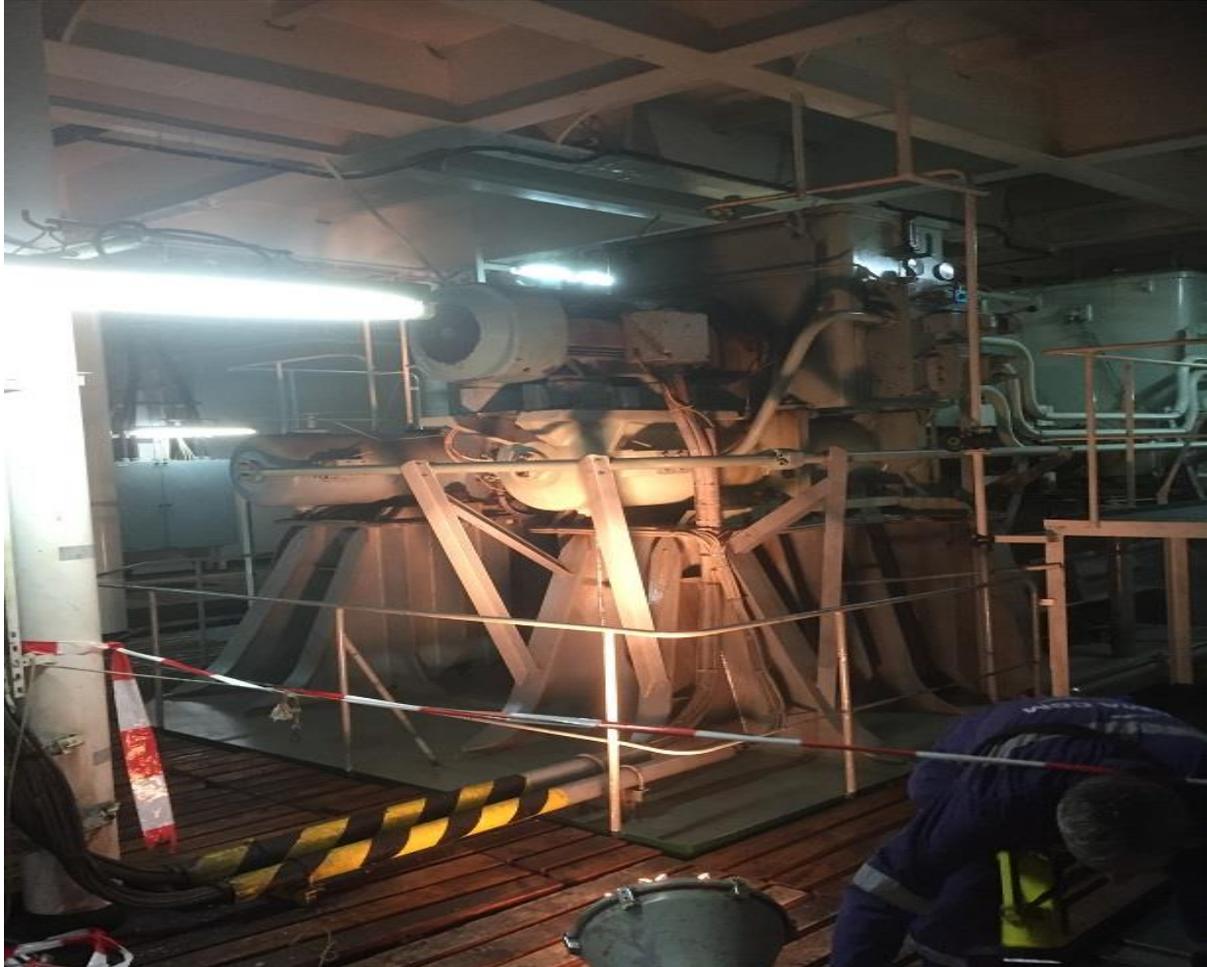
- 4.2.7 From his seat the foreman had no line of sight to the stairwell access door as the steering gear was located between the two positions and fully obstructed the view as seen in figure 4.

Figure 4: Foreman's view of stairwell access door obstructed by the steering gear

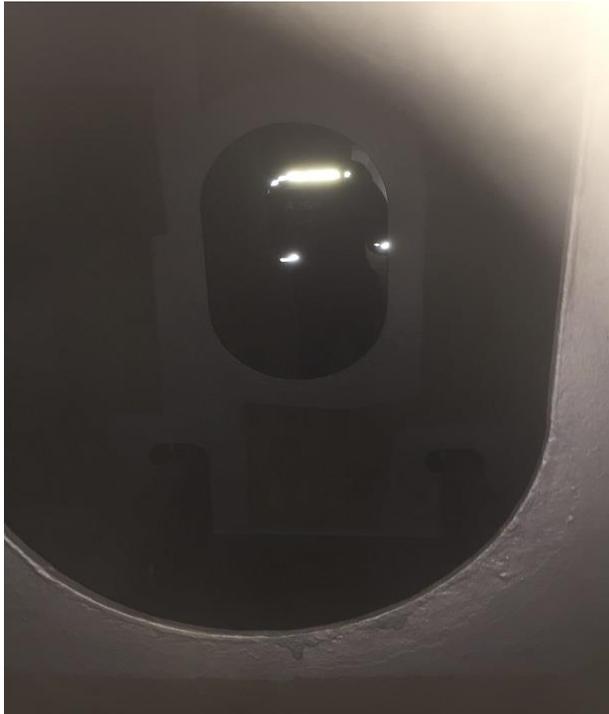
- 4.2.11 The remaining man, being inexperienced, was assigned as the in-tank safety man. His position was in the compartment next to the bottom of the tank access ladder from the manhole. His role was to keep watch on the hydro-blasting team and co-ordinate between them and the safety standby man (foreman) located outside the tank.
- 4.2.12 On the day of the incident the hydro-blasting team was working some 5 bays away from the access ladder and were not directly visible to the in tank standby man. He was also not visible to the external standby man.

Figure 5: View through tank to work site from standby man position.

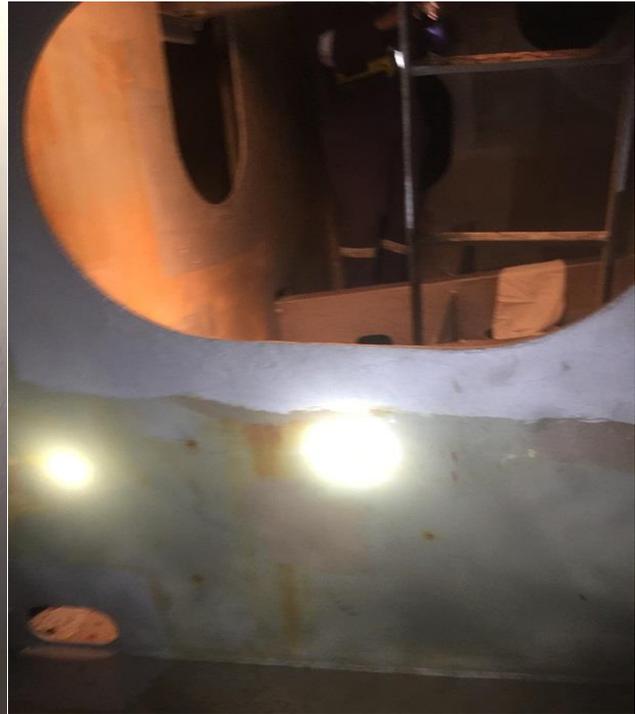
Figure 6: View of tank access ladder from standby man position

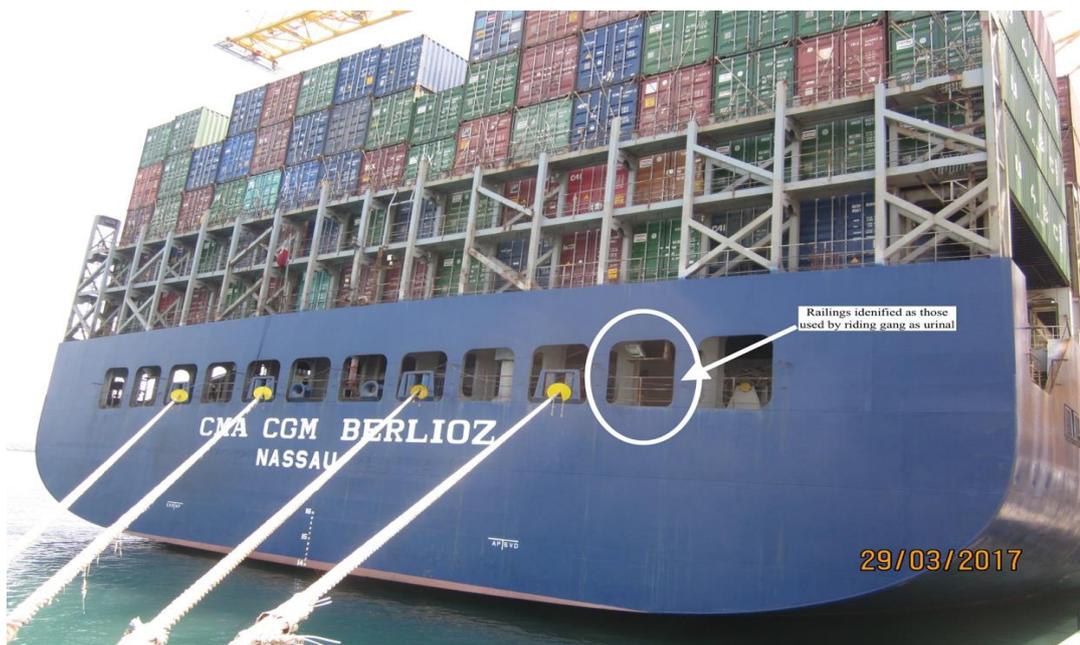
- 6.1.17 The section of aft rails on the starboard side of the mooring deck identified by the riding team as their preferred urinal (Fig. 8) were found to be in good condition and of an appropriate height. Outside of the railings a steel wire was rigged between strong points across the transom. This is used for hanging razor wire when the vessel transits high risk piracy areas. At the time of the incident the razor wire was not rigged but the rigging wire was.

Figure 8: Vessel transom showing subject section of ship's side rails

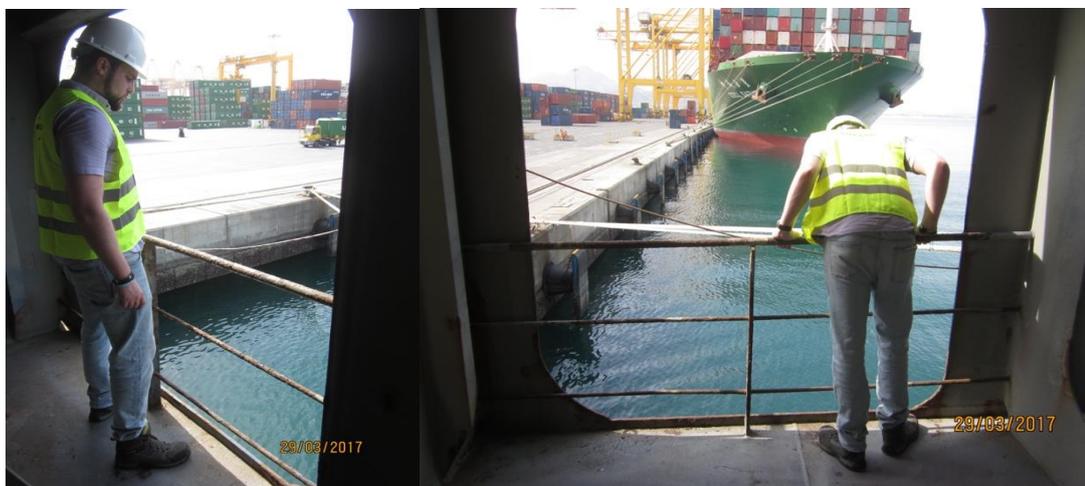
6.1.18 The investigation looked at how feasible it would be to fall over the stern whilst relieving oneself. It was thought unlikely, given the slight sea conditions at the time of the incident, unless a person were to stand on the 1st or 2nd rail, that an accidental fall would likely occur. The individual in figures 9 & 10 was reported as being just marginally taller than the missing man.

Figures 9 & 10: The aft railings identified as the area used by the riding team.

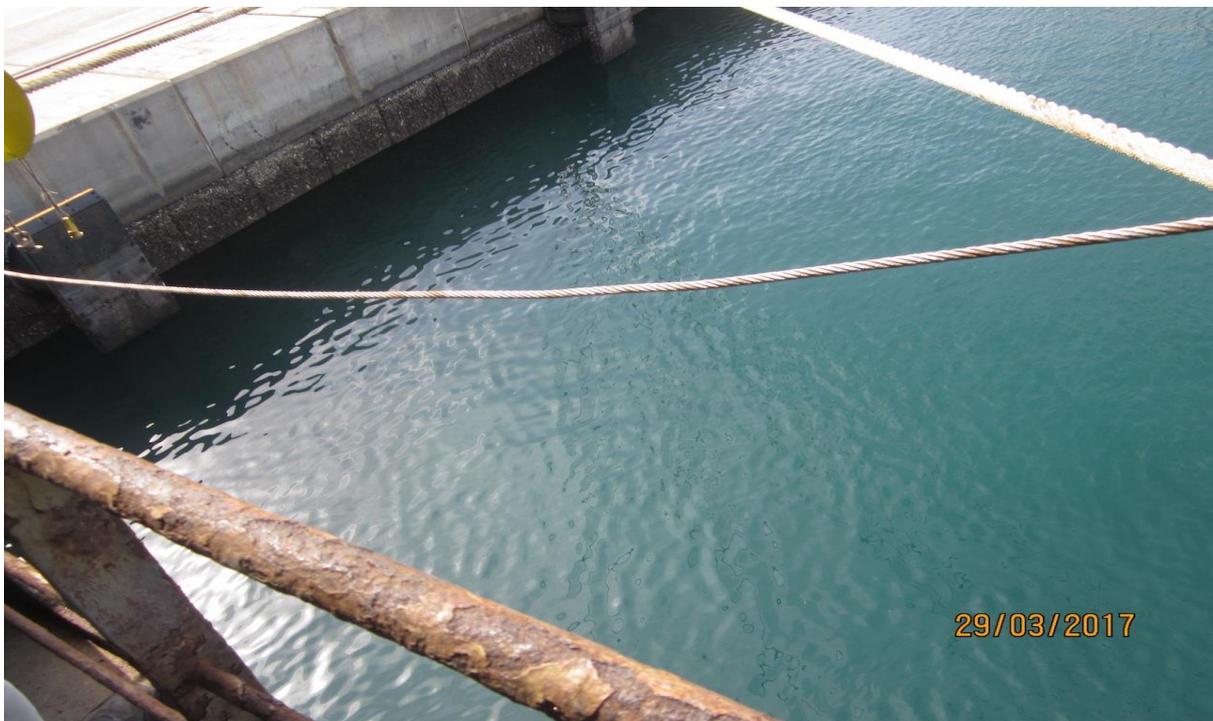
2. Razor wire rigging wire outboard of the aft rails

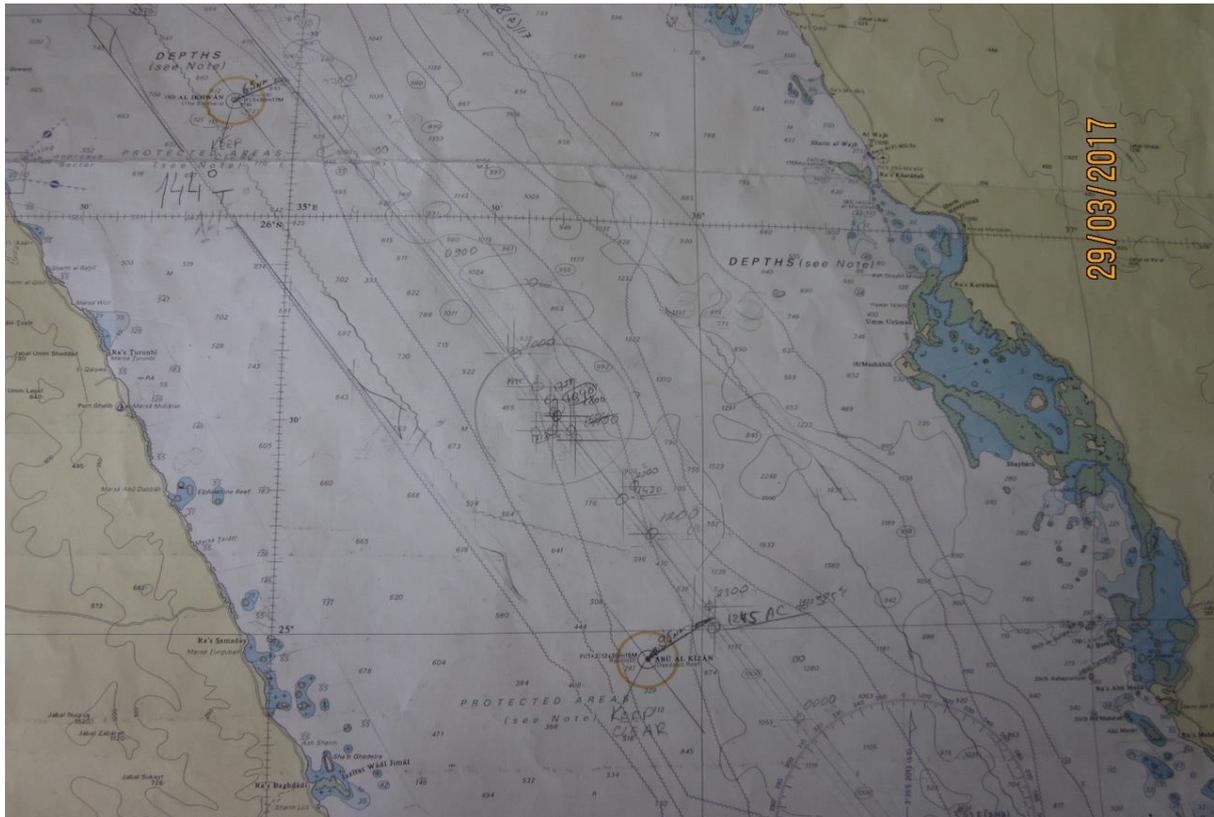
3. Navigational chart extract showing MoB location

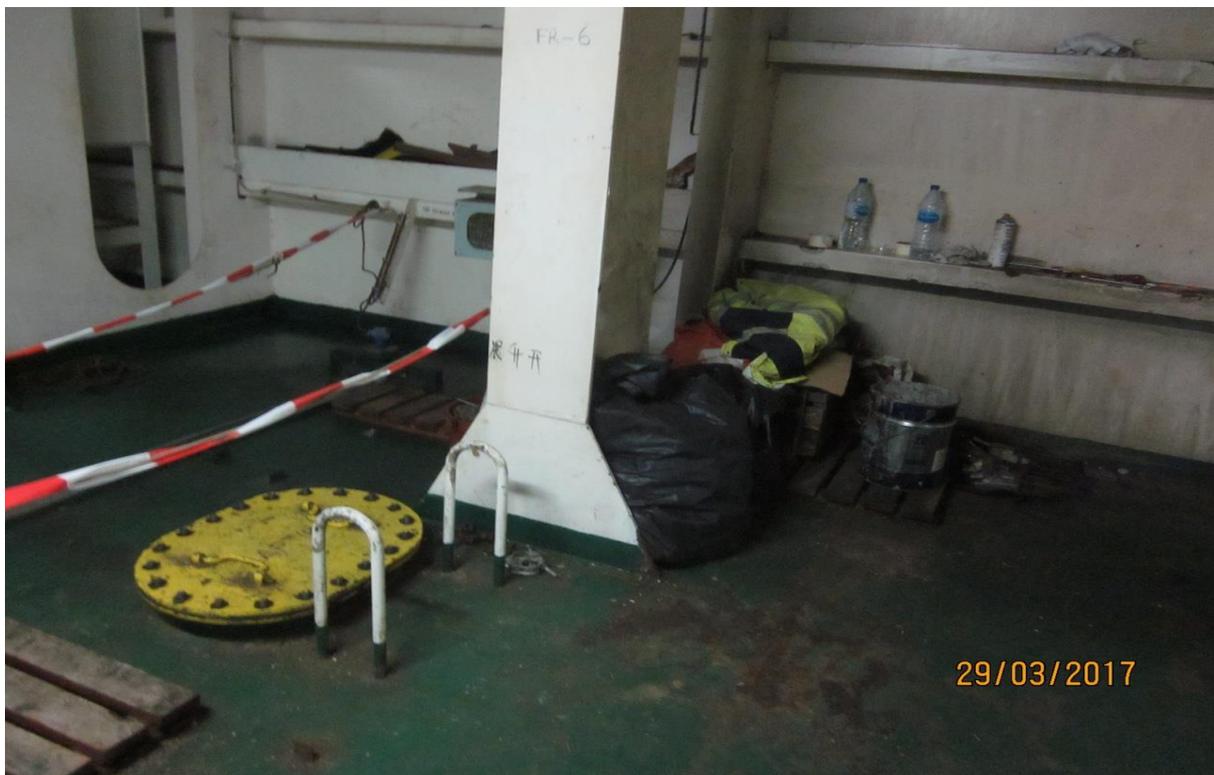
4. Aft peak tank man hole used for access. The foreman sat on a chair to the right side of the white handrails

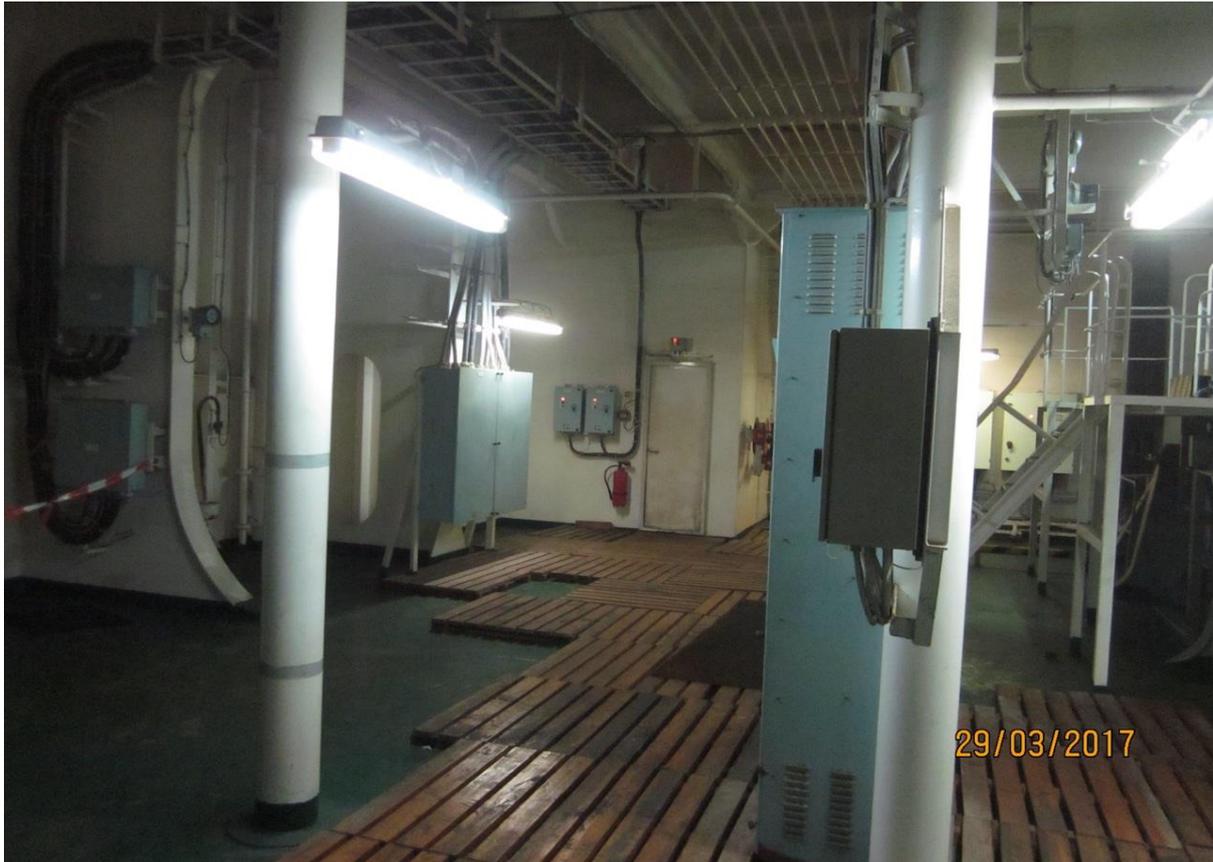
5. View across steering gear forward end to stairwell access door
