**The Bahamas
Maritime Authority**

**Report of the investigation into
Mooring breakout causing
gangway fall from quayside**

BLACK WATCH

29th October 2008

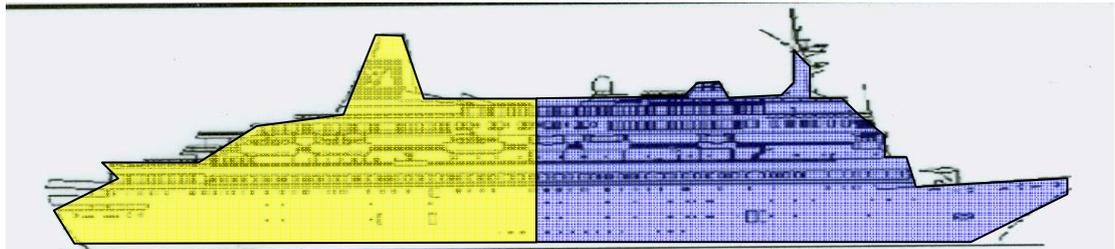
- 4.5 The resulting modified mooring plan forward created a situation in which 5 “breast” ropes were taking the majority of the lateral wind load. These ropes were 4 Karat MAXI (78.4 tonnes) and one WINCHLINE (68.4 tonnes). The springs would have been taking very little load initially as they are designed for longitudinal restraint.

Figure 4.5: Profile of vessel showing approximation of topside areas in forward (blue) and after (yellow) sectors either side of approximated centroid of total area.

The total nominal static load strength of the forward breast ropes (undamaged) would have been approximately 382 tonnes. This strength would be reduced by depression out of the horizontal and deflection at fairleads but in the case of the forward ropes the depression angle was smaller than it was with the after ropes. The forward ropes had been led to the opposite side of the pier to create a better lead. Assuming therefore that symmetry distributed the wind pressure approximately evenly between forward and after sectors (see figure 4.5), the forward five (breast) ropes would be taking a load of approximately 89 tonnes at 40 knots but this would have risen to 138 tonnes during the gust at the time of the incident. The springs would not initially be taking any load. This is considerably less than the combined nominal strengths of the ropes.

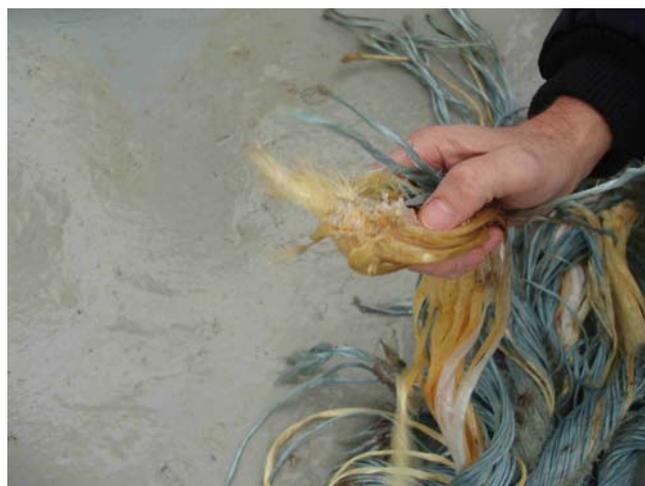
- 4.15 Each rope that parted did so in the vicinity of the fairlead, strongly suggesting that this was the point of maximum stress on the rope. This is not unexpected as it is the section of rope that is subject to the smallest radius. The smaller the radius, the greater the weakening of the rope until ultimately the radius becomes a cutting edge. Manufacturers should be able to provide more detailed data on minimum recommended radii.

- 4.22 The broken ends of the ropes were examined during the Preliminary Inquiry. Figure 4.22 shows a typical sample. The strands have all parted at approximately the same position longitudinally, indicating a rapid parting. This is further reinforced by the concentrated fusing of the central (yellow) strands, also visible in the figure, which indicates an extreme concentration of stress at this point prior to failure. The most likely cause of such failure is probably the shock loadings imposed immediately prior to the incident when the vessel began pitching and heeling. Whilst there is long term chafe damage visible on the vessel’s outfit of ropes, this is not so severe that there is discontinuity of the main strands.

Figure 4.22: Above: Outer (blue) and inner (yellow and white) fibres have parted at the same position. Together with the fusing apparent on the inner fibres indications are that the parting of the rope depicted was very rapid.

- 4.24 VDR records indicate a very rapid escalation of events. Based on the heading recording the period during which ropes were parting probably spanned a maximum of two minutes between 14:12 and 14:14. The evidence of the broken rope (Figure 4.22) supports this conclusion.

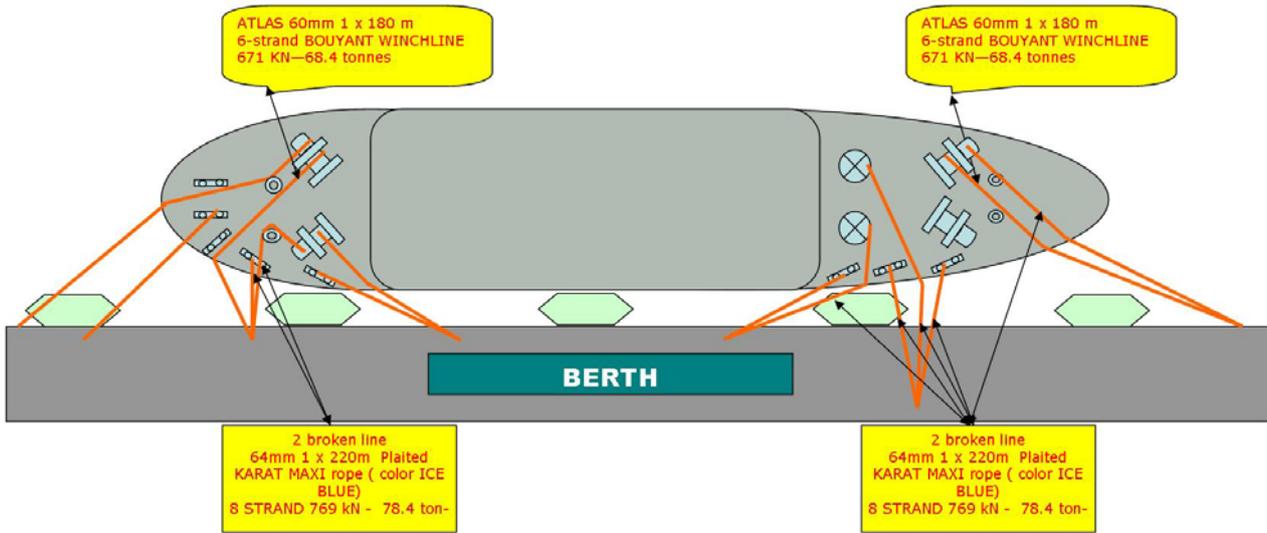
BILBAO FIRST BERTH MOORING ARRANGEMENT

- 3.5 Mooring patterns were the same as those used by the Fred Olsen vessel BOUDICCA during an earlier stay at the same berth. BOUDICCA and BLACK WATCH are vessels of similar size and windage characteristics. (See Appendix I for mooring patterns)

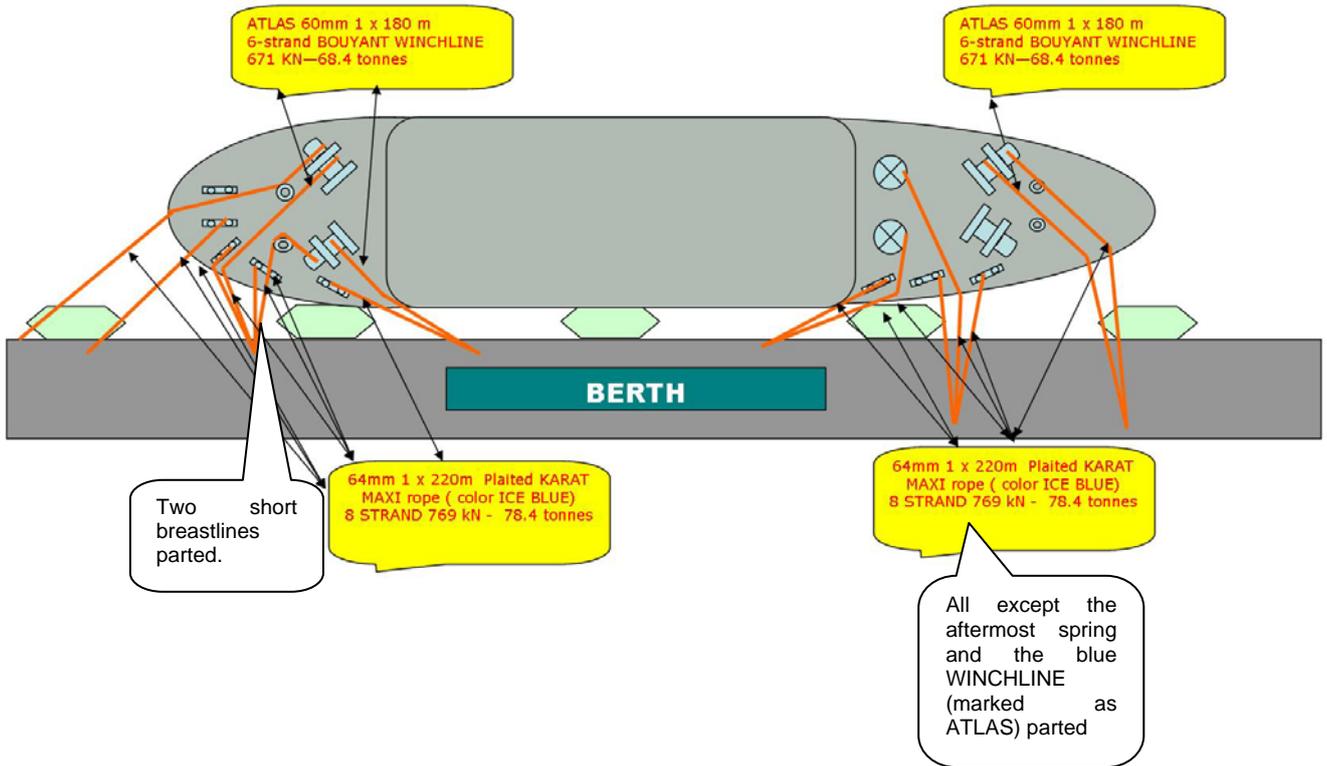
BILBAO MOORING ARRANGEMENT-SHIFTED LINES

- 3.7 The wind force was first observed to be gusting at approximately 10:00. Subsequent to that time action was taken, which was not logged, but was estimated by the Master to be at about 11:00 and by the 2nd Officer as 10:30. Moorings forward were adjusted using ship’s staff on shore. The two headlines (one WINCHLINE (68.4 tonnes BL) and one Karat Maxi (78.4 tonnes BL)) were shifted to a position further aft converting them into breastlines. This was done to create an improved lateral resistance to the increasing wind force that was shifting to a broader angle on the beam.

- 4.21 By moving the headlines further aft the Master did indeed provide a greater lateral constraint but the lead of the ropes through the fairleads would have been passing around a sharper angle. This would have introduced a stress concentration at the fairlead that with the original leads of the two headlines would otherwise have been fairly low, the ropes originally following a line of minimal, almost non-existent deviation. Whether the more oblique angle of the ropes as longer headlines would have imposed sufficient force to part the rope has not been assessed. It is fairly certain however that extension of the longer rope would have allowed a similar moving off the berth when the wind forces increased as they did. The master’s decision to shorten the lead therefore is consistent with good seamanship. He had to assume that the fairlead design was sufficient to allow the angle now imposed in the rope without causing sufficient damage to part the rope.

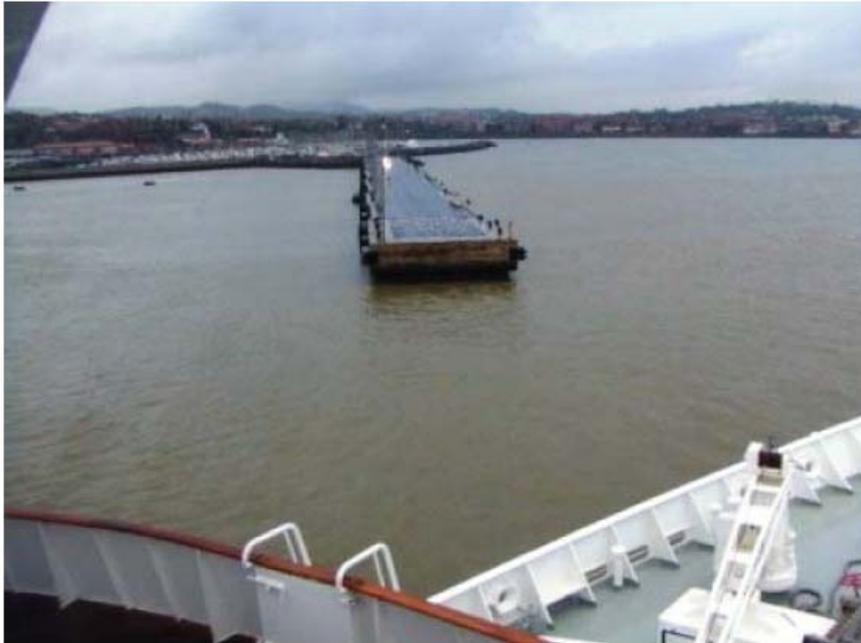
Gexto pier,
cruise berth.

- 3.4 The tide was flooding at the time of the incident. High Water (Springs) was due to occur at 16:18. At Gexto Pier this meant that a current would have been flowing between the caissons supporting the pier taking the vessel away from the pier and placing the moorings under tension. The half tide conditions at the time would have meant the current was likely to be at its maximum. During berthing on the ebb the vessel had noted a tidal effect across the end of the pier. (see Appendix II)

Note the
current setting
out from the
river.

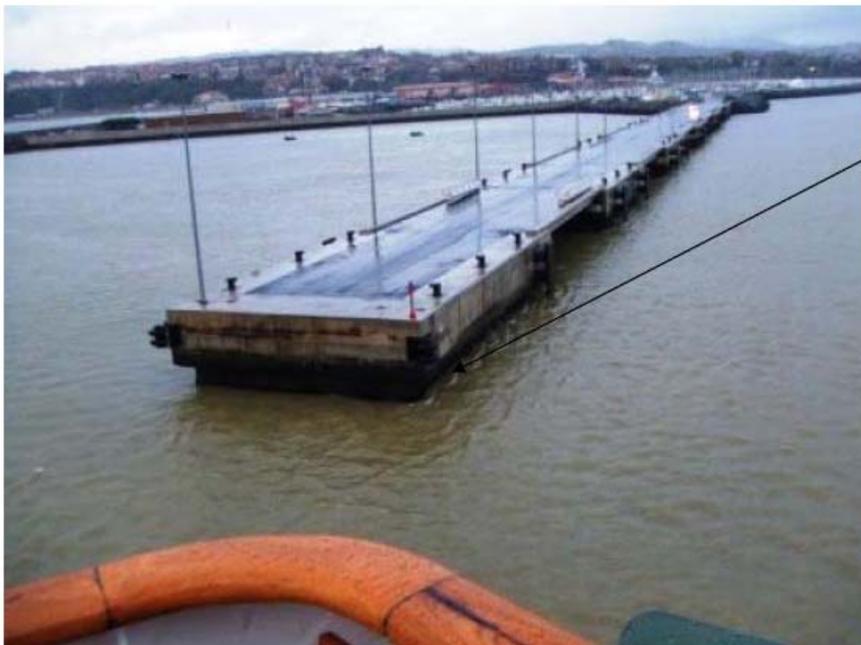
The vessel swung off the south side of the berth prior to berthing when the above photographs were taken. These show the construction of the berth. They also show that the ship’s staff were aware of the tidal current - at this stage ebbing - flowing through the pier.

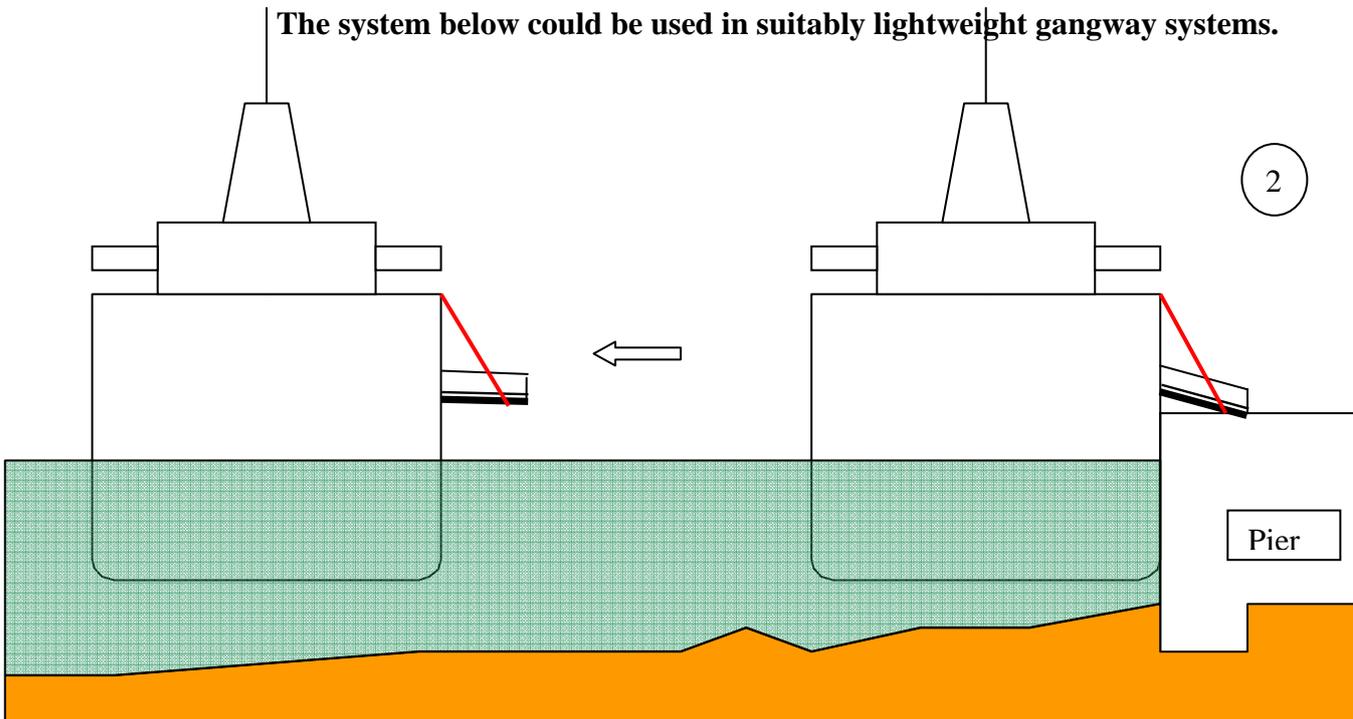
- 5.4 The gangway support system for circumstances where the vessel’s own gangway is used is currently a system involving a single point of failure when support is lost at the outboard end in the event of the vessel moving off the berth. In view of the fact that the system is specifically provided for the safe access of personnel to the vessel this situation should not be accepted as inevitable since a consequence of a collapse could very easily be fatality or serious injury. Instead, some method of providing back-up support of the outer as well as the inner end of the gangway should be sought and introduced.(see Recommendations).

Position A: Vessel alongside pier with ship's brow gangway rigged in style of custom and practice (Scenario 1)
 Position B: Vessel after separation from pier with brow gangway still attached, scenario 1 by inboard end only and therefore hanging vertically, and scenario 2, with additional topping support at outer end. (marked in red) This could also be provided by crane and bridle.
 N.B. Topping support in scenario 2B has been raised to level gangway so as to remove hazard of falling for personnel on gangway at time.
It is likely that, many existing gangway designs will be too heavy in construction for this arrangement in which case an operational intervention system should be introduced in conjunction with a vessel/shore gap monitoring system and alarm.

- 6.8 **Gangway:** The simplest mitigation for the principal hazard of the falling gangway already exists in commonly operated lifting practices elsewhere, such as in construction and in the offshore industry. The principle is evident in lifting policy in these industries and in some cases in legislation, some of it affecting ships in certain territories regardless of flag. The principle is that personnel should never be lifted in any apparatus that is not robustly protected from falling. Elevators for example have more than one supporting wire. In the offshore industry personnel baskets are equipped with safety strops to guard against the highly unlikely possibility of failure of the primary lifting apparatus. Essentially, the single point of failure is eliminated. When a gangway is supported permanently from one end only (the vessel), the other (outboard) end, being temporarily supported only by the surface upon which it is resting (the quay), it could be regarded as a single point of failure in the unlikely but proven possible circumstance where the resting surface is removed, i.e. when the gangway is pulled off due to its attachment to the vessel now adrift.

- 6.9 Mitigation against this single point of failure should be sought. In shore mechanised gangways it already exists in the support system that holds the gangway up regardless of the presence of the vessel. The ship’s gangway however does not operate in the same way – but in some cases it could.

The system below could be used in suitably lightweight gangway systems.

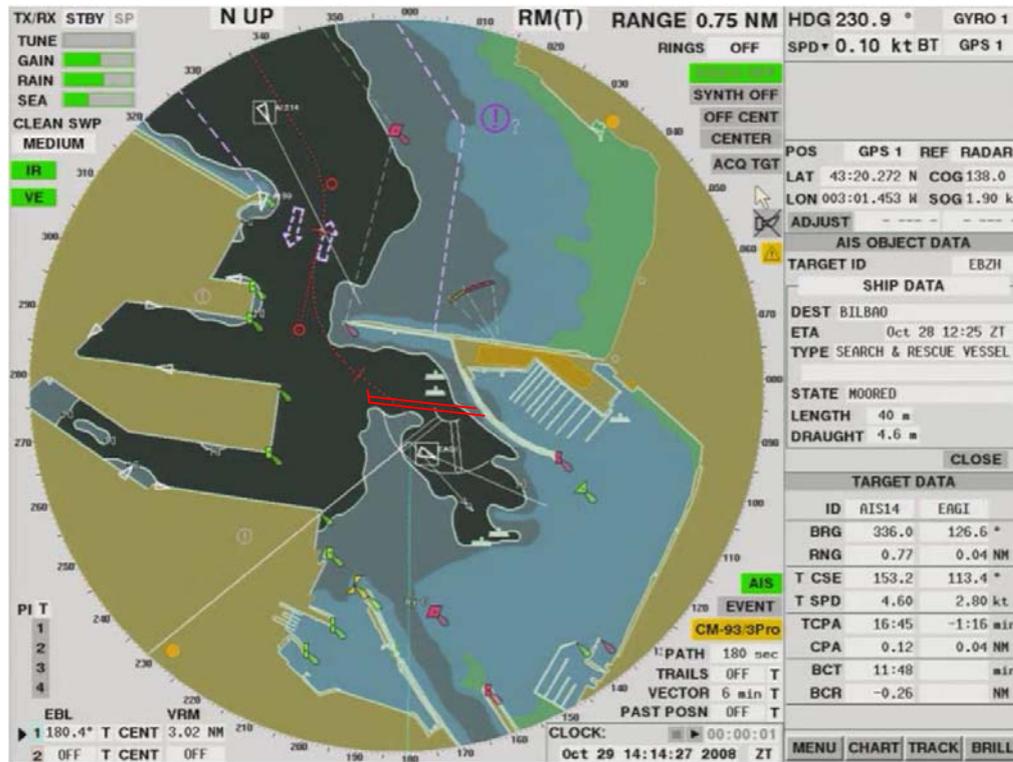
Figure App.IV.2

Radar/AIS/ECS display. Heading is 230.9. i.e. transient between moored and equilibrium positions.

The vessel has broken adrift forward and is pivoting on the after moorings.

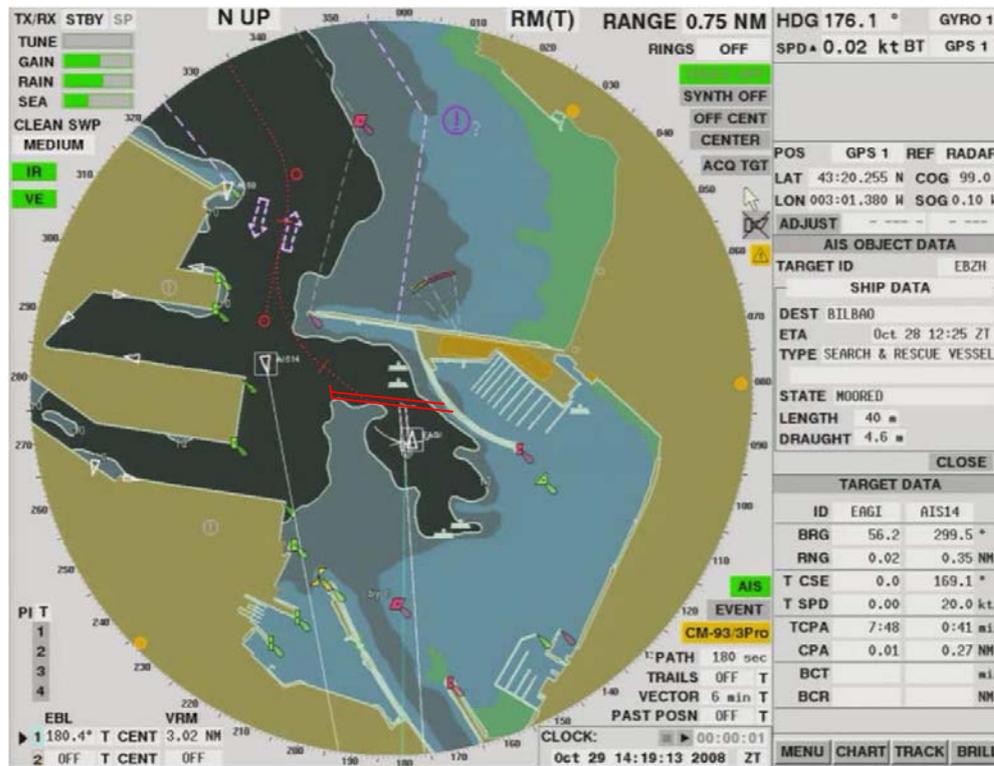
Figure App.IV.3

Radar/AIS/
ECS display.
Heading is
176.1. i.e. in
equilibrium
downwind
(and tide)

Time: 14:19:13
