**M.V MARINE STARS**

**Report of the marine safety investigation into the death of  
the Captain of the m.v. Marine Stars on the 26<sup>th</sup> March  
2017, South of the Mozambique Channel**

Date of Issue: 04<sup>th</sup> July 2017  
Bahamas Maritime Authority  
120 Old Broad Street  
LONDON  
EC2N 1AR  
United Kingdom

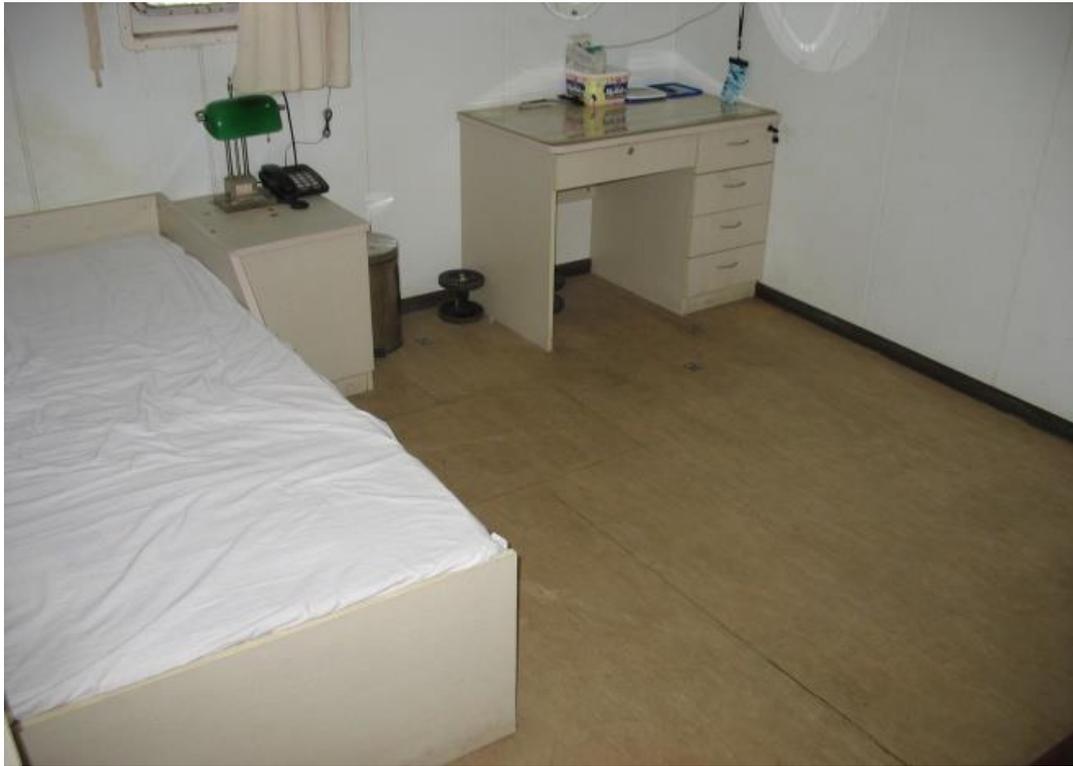
Figure 1: Captain's bedroom

- 4.12 At about 0900 the Deck Cadet heard a thud coming from the Captain's bedroom followed shortly by a cry for help. He rushed inside the Captain's bedroom and found him lying on the floor beside the bed. With a lot of difficulty, he managed to pull the nearly collapsed Captain into his bed before running down to the Chief Officer's cabin for assistance.

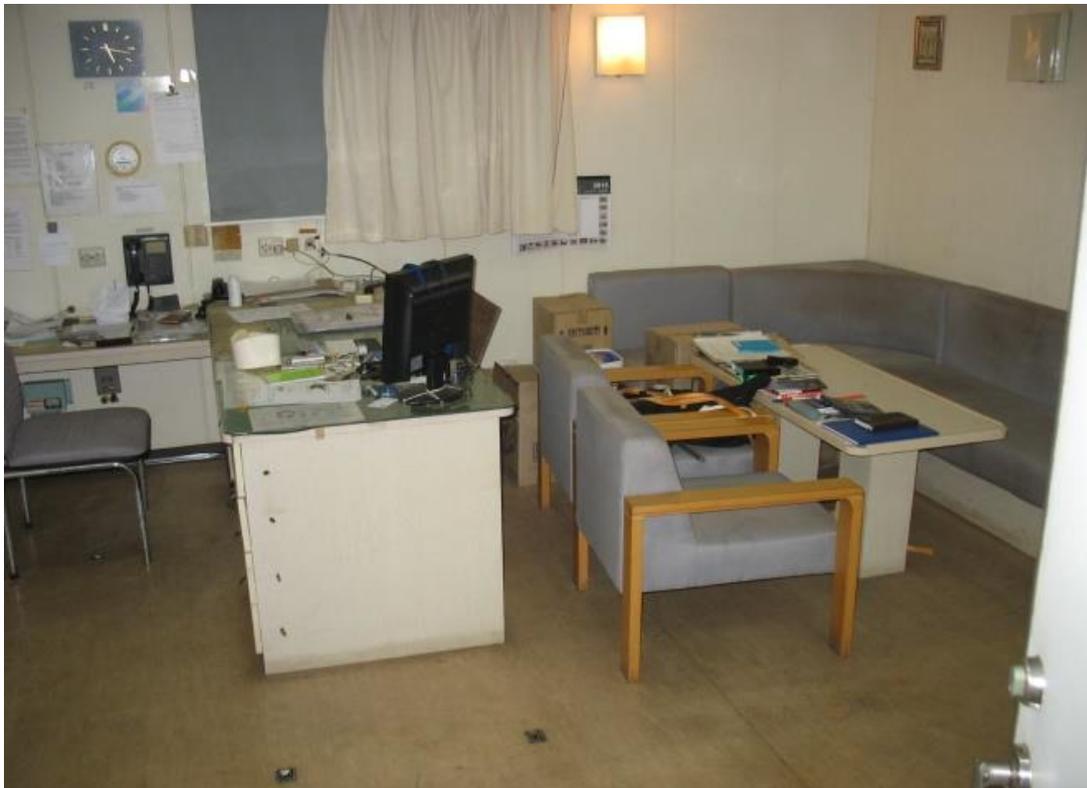
Figure 2: Captain's office

- 4.10 He was followed a few minutes later by the Deck Cadet who, upon entering the Captain's office saw him seated on the settee and using his laptop. The Deck Cadet believes that it was approximately 0830 when they started to watch a movie on the laptop.
