**The Bahamas
Maritime Authority**

“mv Sea Spirit”

**IMO Number 8802868
Official Number 730911**

**Report of the investigation into the capsizing of a zodiac craft and
passenger fatality at Fjortende, Juli-Bukta Norway on the
17th June 2013**

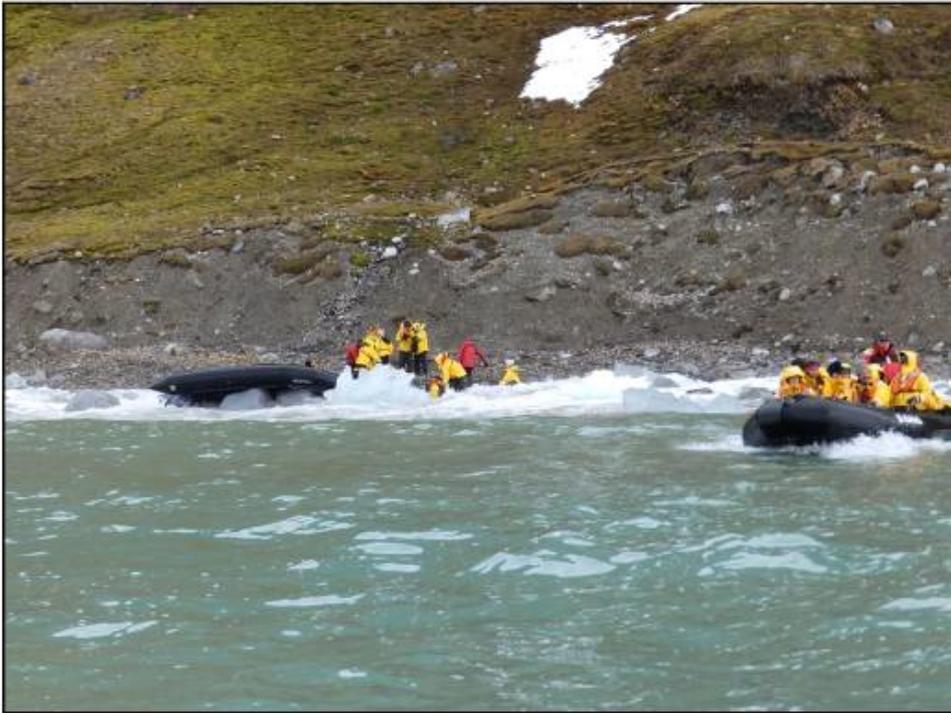
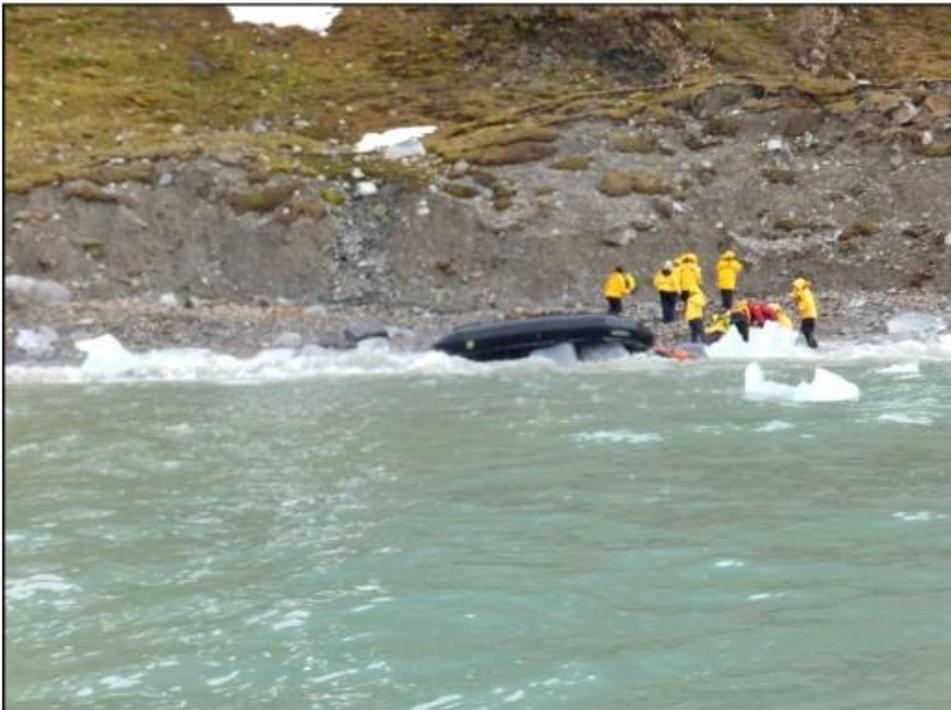
Appendix 1: Photographs of the capsized zodiac craft ‘Poseidon’

- 4.12 It is also noted from one statement that when assistance was dispatched the medical personnel were unable to land on shore due to the heavy swell. This information is consistent with a hypothesis that there was a rapid increase in sea state. However, there is no objective evidence to support this and the photographic evidence in **Appendix 1** does not indicate a heavy sea state.

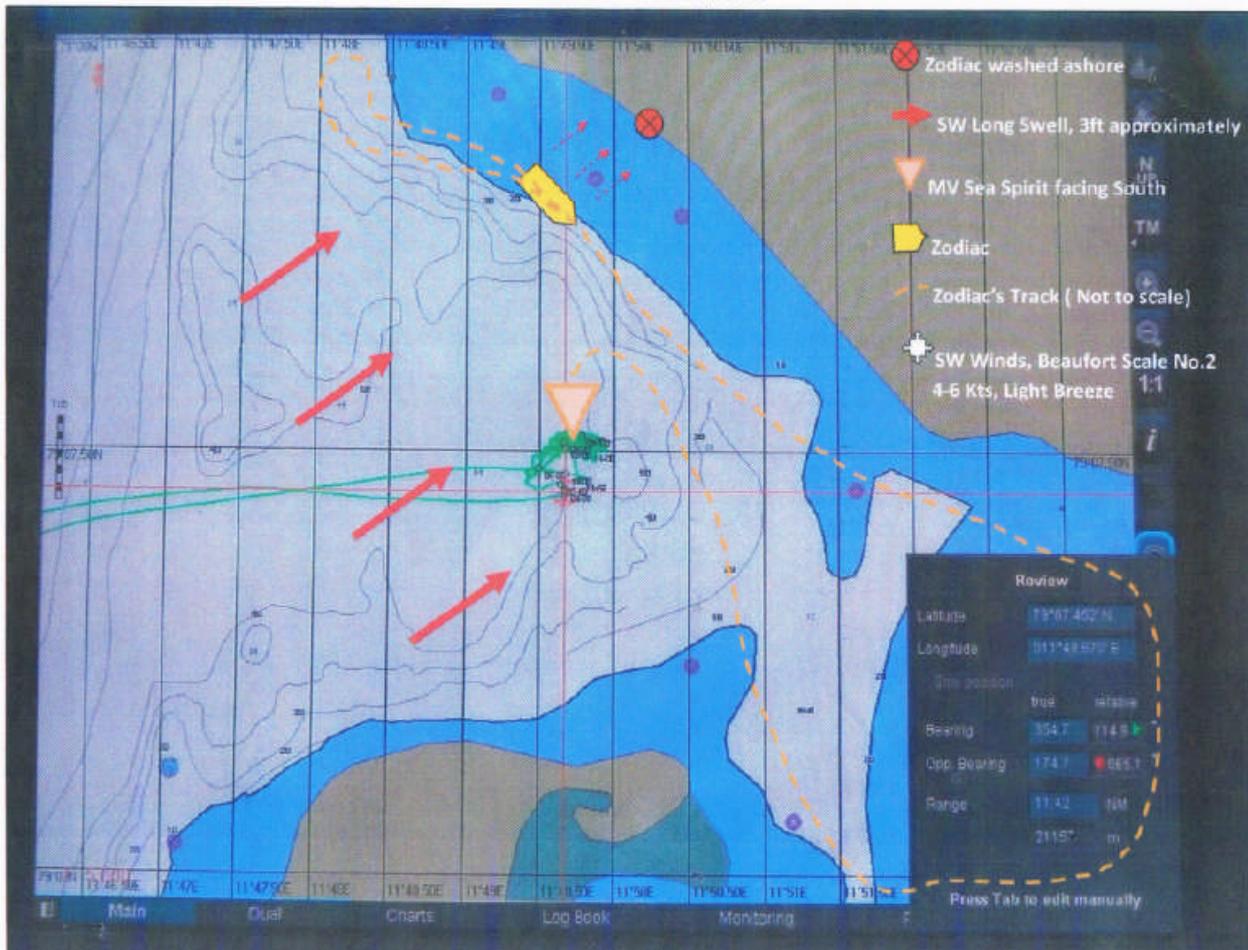
Appendix IV: ECDIS Screenshot Indicating Prevailing Weather Conditions

Diagram depiction of Incident Not to scale.
