**The Bahamas
Maritime Authority**

GENTING DREAM

**Report of the marine safety investigation
into a 10-year-old passenger fatality
on 18th November 2019**

Genting Dream – Marine Safety Investigation Report

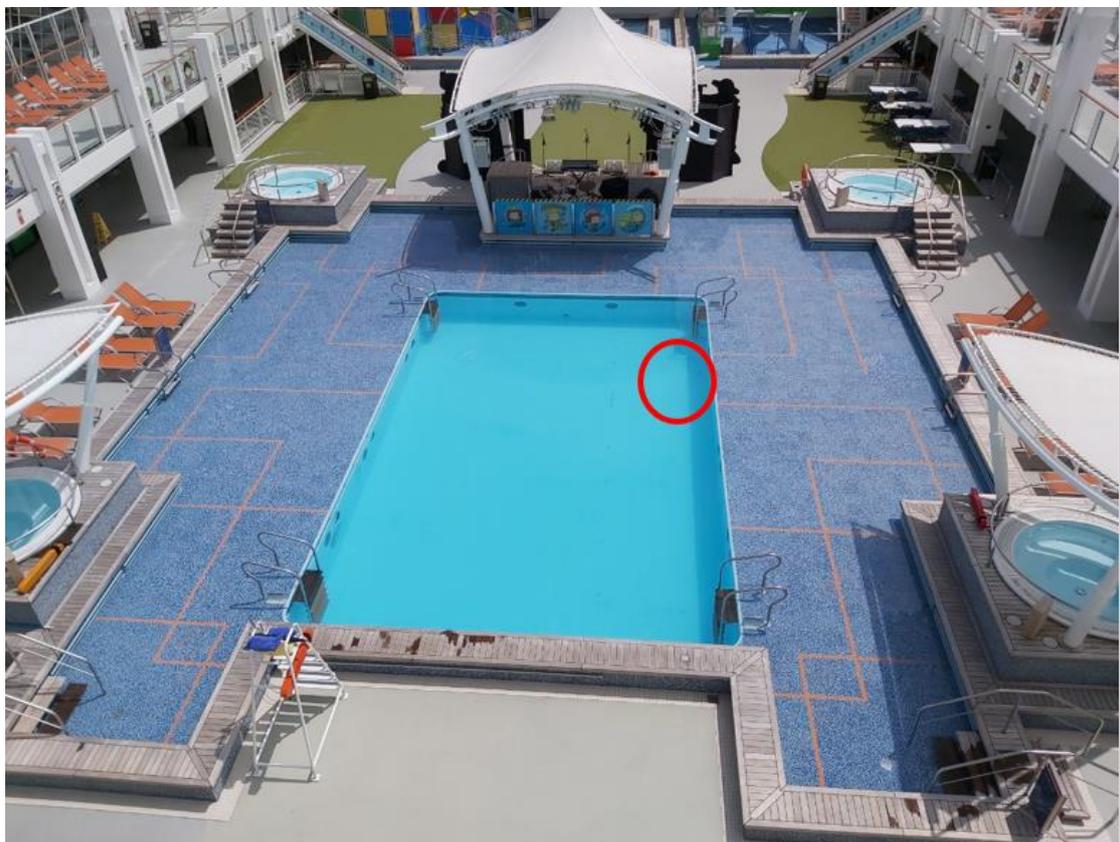
Figure 11: Approximate location of the victim at the time of the incident

At 1735 hours, the victim entered the pool again. From CCTV footage, it was seen that the victim was out of reach of the edge of the pool and submerged in the water with continuous struggles. At this time, there were at least 12 of passengers in the immediate vicinity however the victim's plight went unnoticed.

At 1738 hours, the victim had stopped moving and he was submerged underwater.

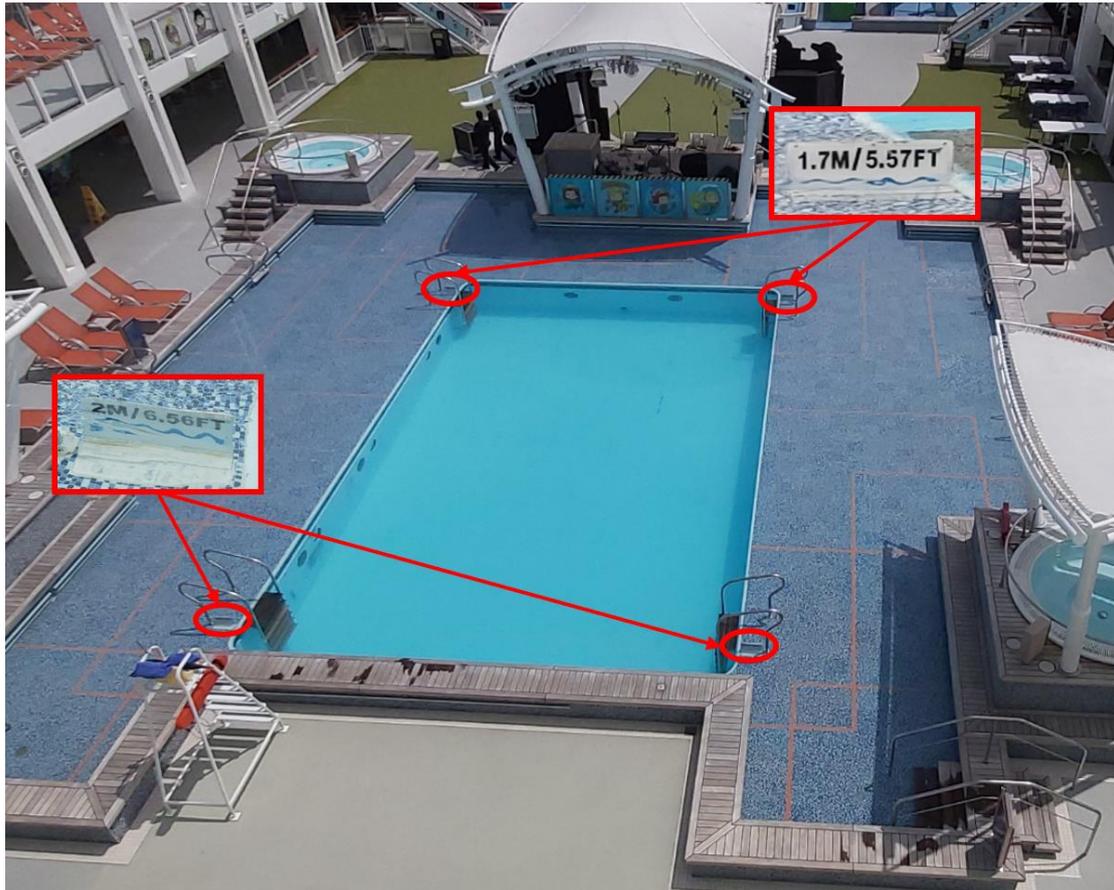
Figure 12: Depth markings on the main pool

At the time of the investigation, the depth markings of the pool were found to be inconsistent with the actual depth of the pool.

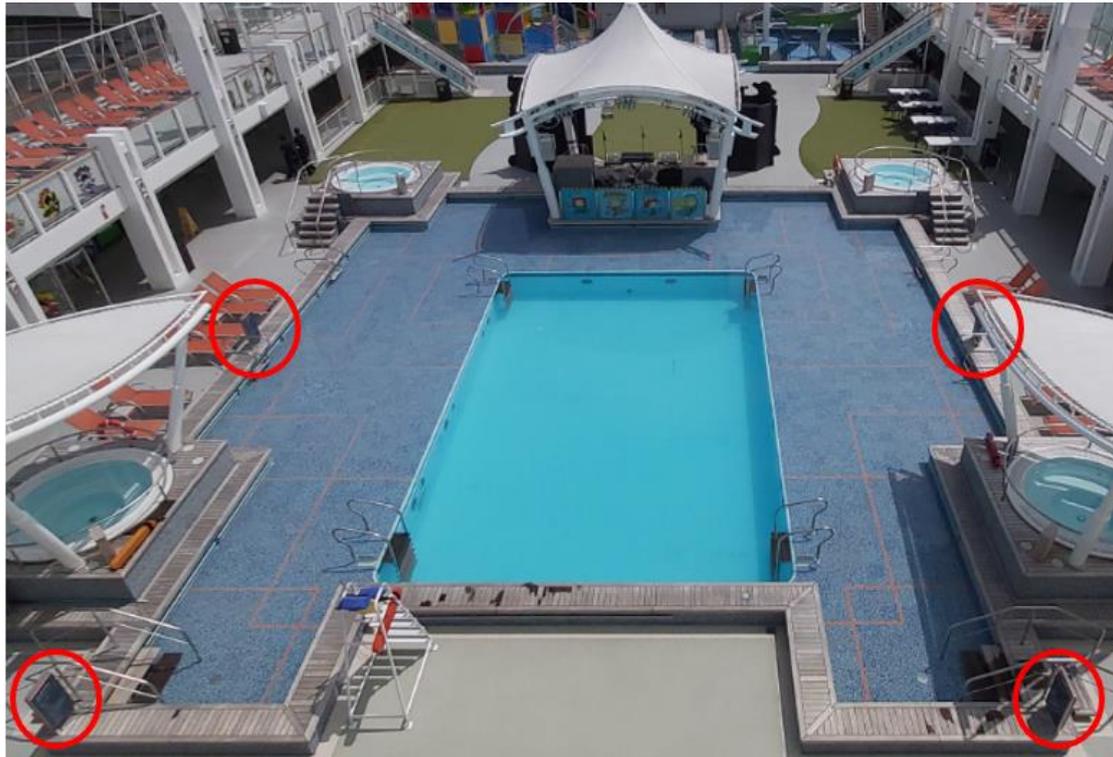
Figure 13: Locations of main pool safety information

Pool's safety information was displayed on boards and these were placed on four locations in the vicinity of the main pool (as seen in figure 16).

Onboard Genting Dream, the pool's safety information boards were only available at the four locations around the pool. No signage or information was available in guest areas or passenger cabins to provide information with regards to the pool or highlight the hazards related to the pool. Accurate and readily available safety information is crucial for the passengers accessing the pool, to make them aware of the potential hazards and risks.

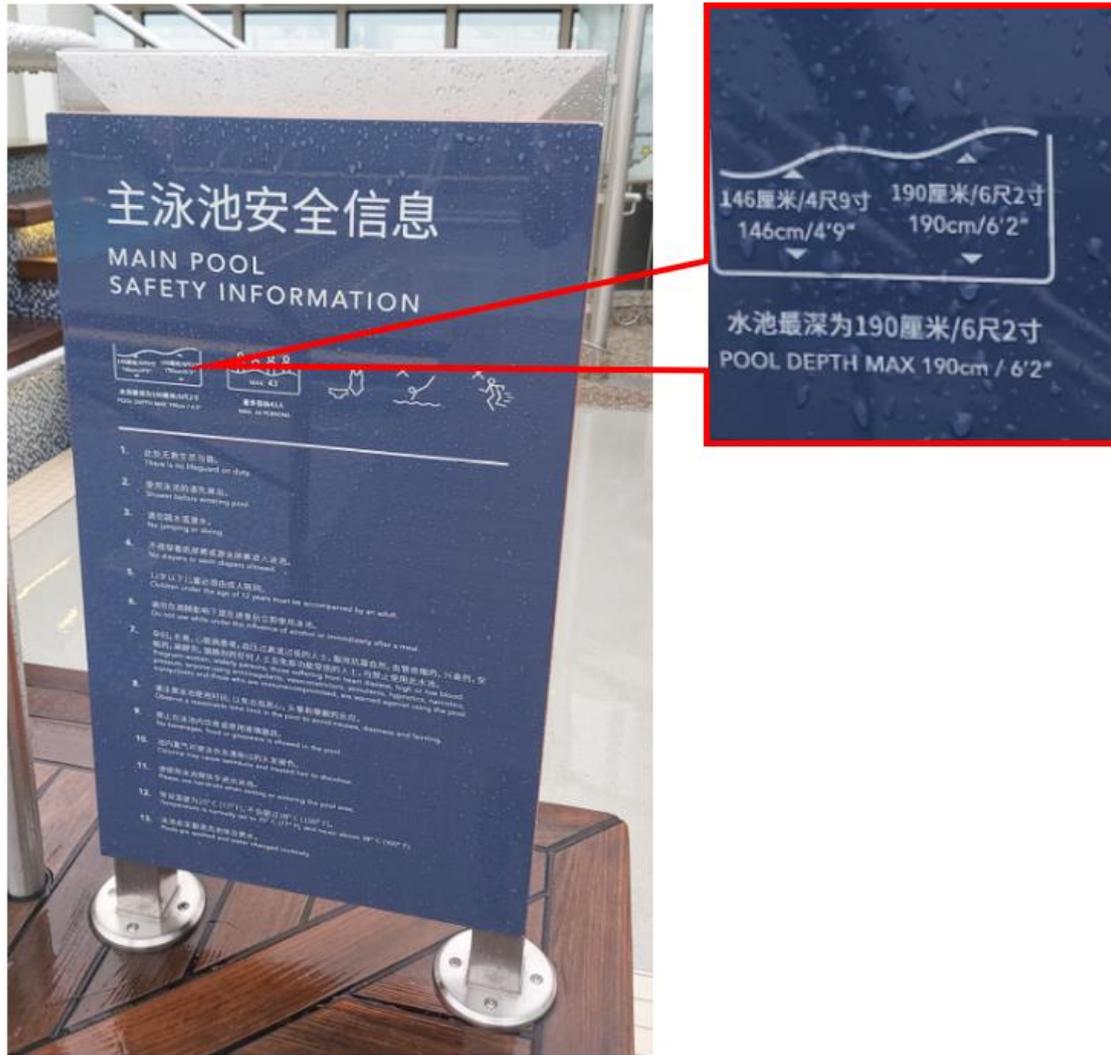
Figure 14: Main pool depth markings on the safety information

The safety information also had a pictogram with the depth of the pool indicated on it. These depth markings were also found to be inconsistent with the actual depth of the pool.

Holistically review design and promulgation of pool safety information to ensure passengers are adequately informed of hazards.

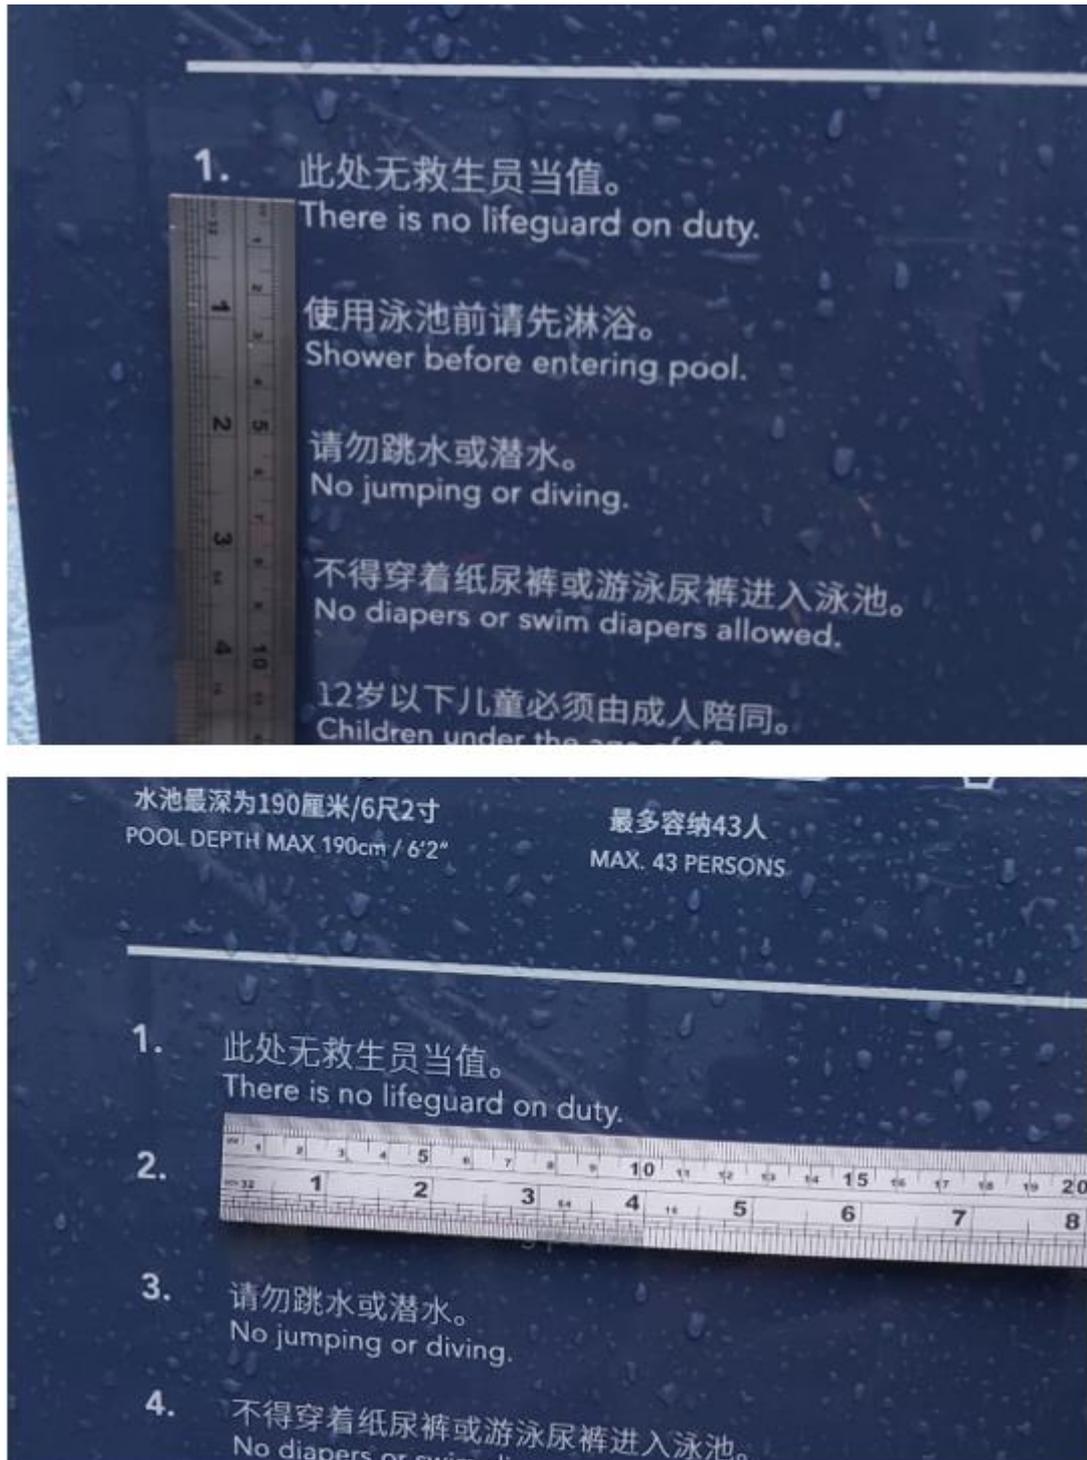
Figure 16: Size of text on the safety information

The safety information board had a height of 0.72 m and a width of 0.42 m. The font size of the text is 5 mm (14 pt⁹).

To read the safety information, a reader will need to stand within a distance of one meter¹⁰ of the safety information board, as it was not readable from a distance.

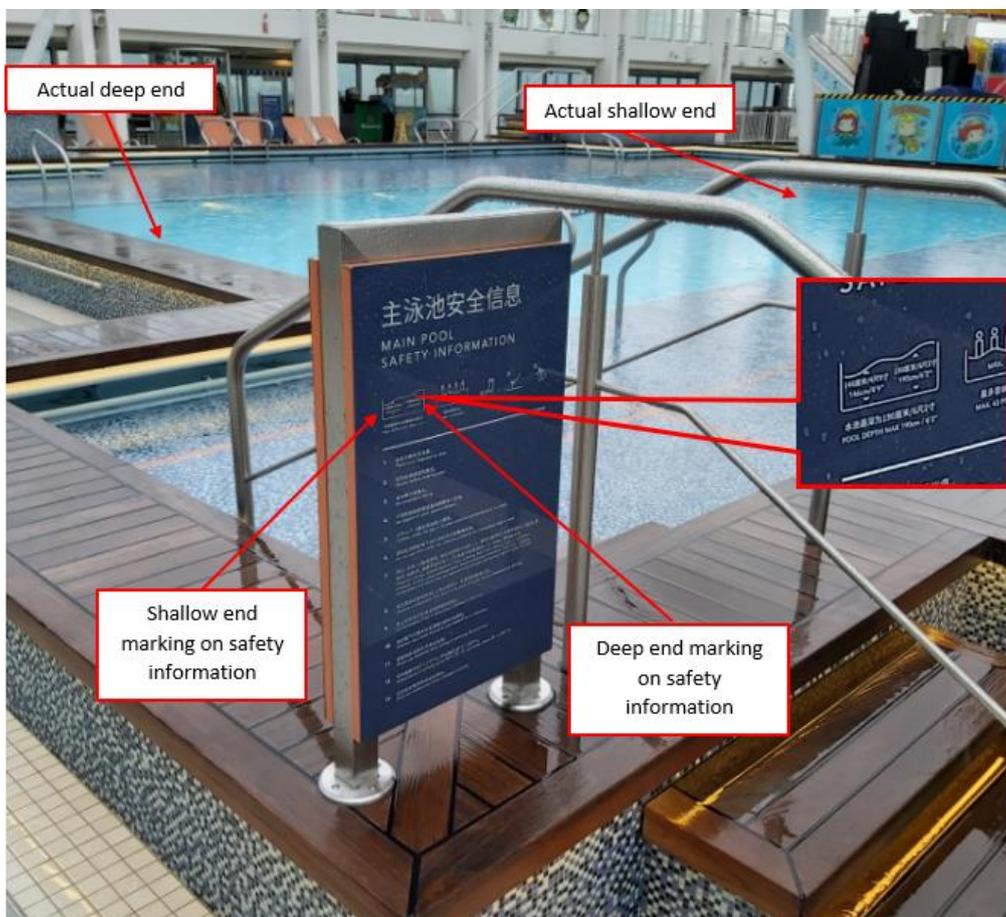
Figure 17: Marking of the shallow and deep end of the pool on safety information vs. actual shallow and the deep end of the pool

The pictogram on safety information showing the depth of the main pool had the markings indicating the shallow end and deep end of the pool. This pictogram did not correspond to the main pool’s actual depths. For example, the safety instruction on forward port side of the main pool, when seen from a direction facing the main pool, corresponds to the deep end which is opposite to the reality (refer to Figure 20).

Either one side of all four safety instructions had the pictogram for the main pool’s depth corresponding to the wrong direction compared with actual depths of the main pool.

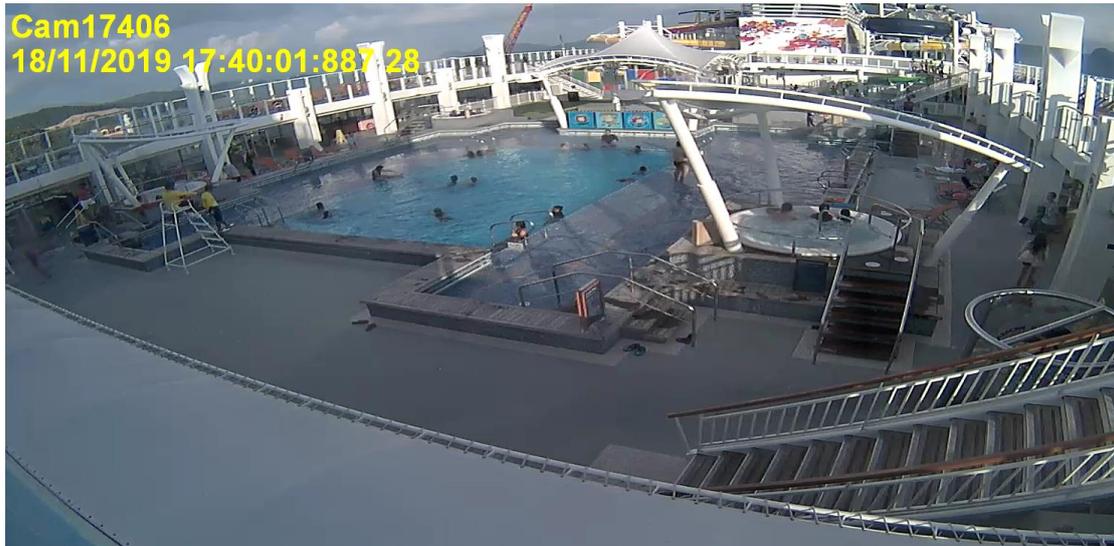
Figure 19: CCTV footage screenshot of the main pool at 1740 hours

At the time of the incident, there were 18 people in the pool. At this time, one Deck Steward was seated on the highchair, one Deck Steward was standing next to the highchair facing the main pool and the third Deck Steward entered the male washroom area on the pool deck.

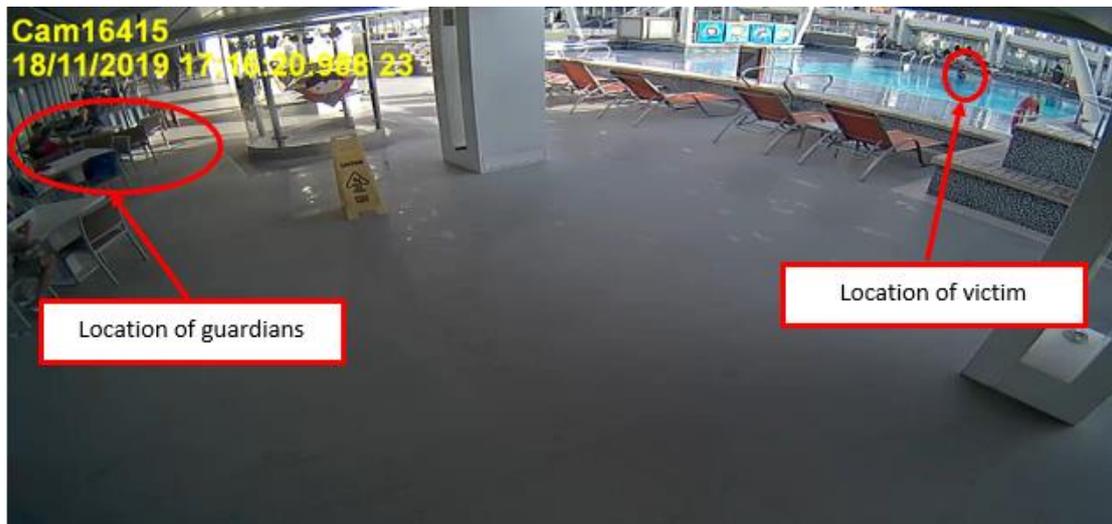
Figure 23: Location of the guardians and the victim just before the incident

The main pool safety information stipulated the requirement for the children under the age of 12 years to be accompanied by an adult. The victim was 10-years-old. His guardians were seated at the starboard side seating area on deck 16 in the vicinity of the main pool and were not accompanying the victim in the pool.

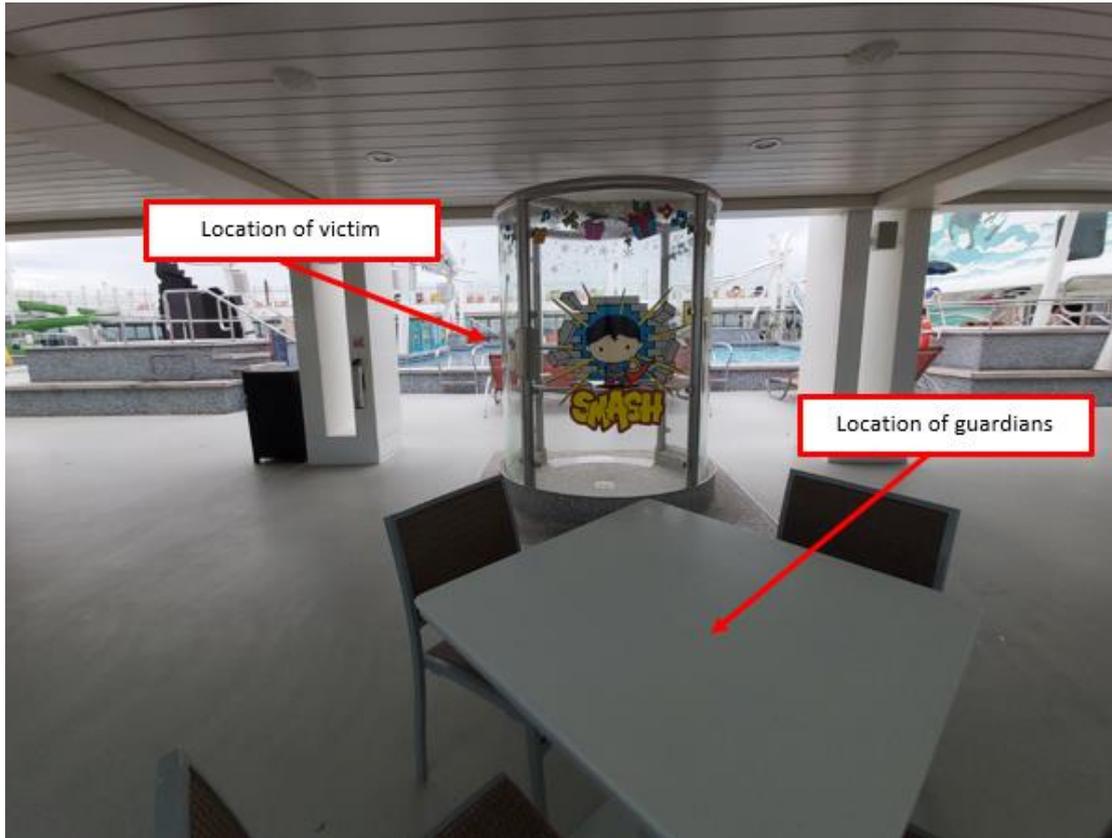
Figure 24: Location¹⁴ of the guardians and the victim

The tables, chairs and sun chairs on deck 16 in the vicinity of the main pool are not fixed to the deck surface. At the time of the investigation, the tables, chairs and sun chairs location and orientation may have been different from the actual location as they were on the day of the incident. However, from the CCTV footage review and examining the area post-incident, it is highly likely that the guardian's view of the pool and victim's location could have been partially blocked by a shower booth and sun chair(s).
