### **M.V. STENA SPIRIT**

**Report of the marine safety investigation into a  
fatality of a Passenger on a Passenger/Ro-Ro vessel on  
20 September 2018**

## M.V. Stena Spirit– Marine Safety Investigation Report

Date of Issue: 26 March 2019  
Bahamas Maritime Authority  
120 Old Broad Street  
LONDON  
EC2N 1AR  
United Kingdom

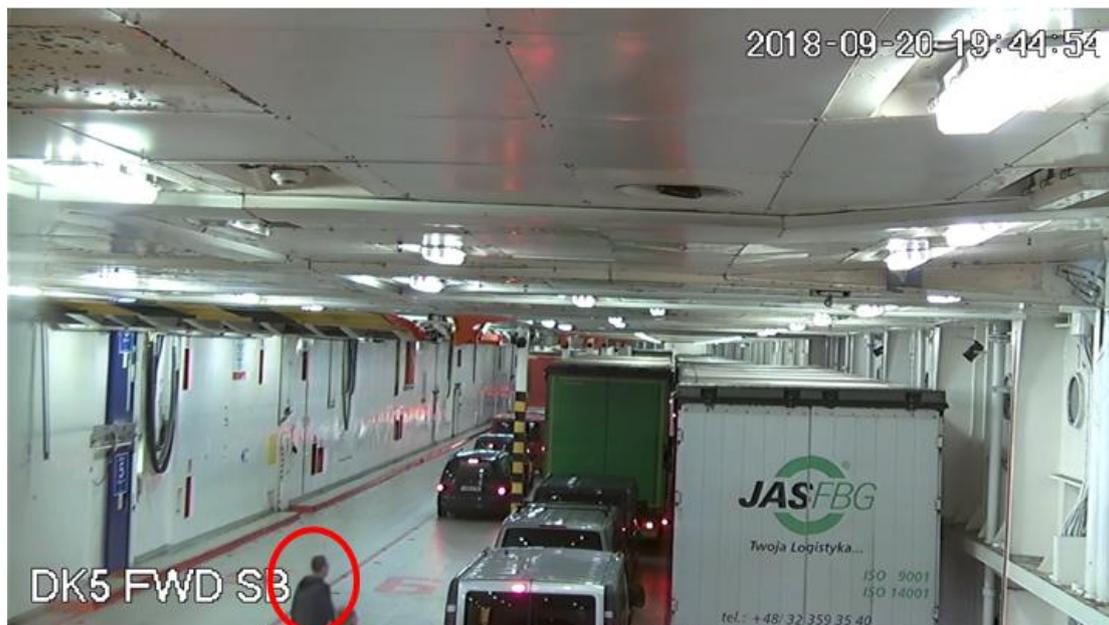
Figure 3: CCTV footage screenshot with the appearance of the passenger on deck 5

- 4.4 At 1946 hours the passenger appeared at the port side of car deck 5, towards lane 6 (figure 3).
- 4.5 A moment later the passenger was observed to go in the space between the car and an HGV in lane 7 towards lane 8.

- 5.1.1 From the CCTV footage the passenger first appeared on the vehicle deck, towards the midship section of the vessel in vicinity of lane 6 and proceeded towards the port side, lane 8 (figure 3). He then went around the vehicles and the SOW three times. It is clearly visible in the CCTV recording that the passenger's movements were disoriented as he walked on the deck and between the vehicles.

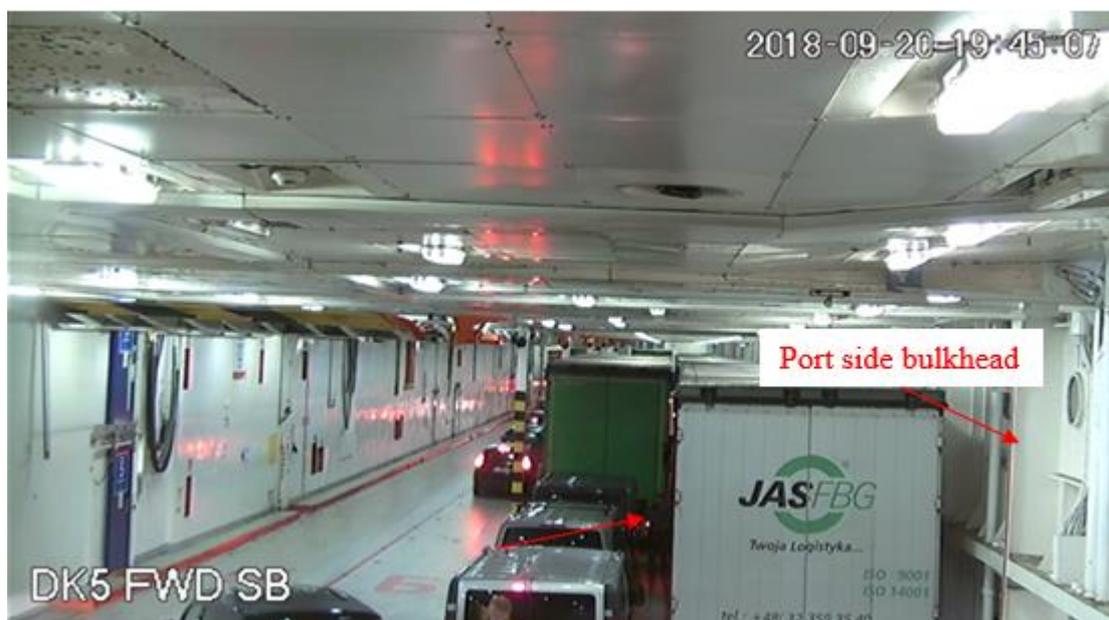
Figure 4: CCTV footage screenshot with the passenger going in between the two HGVs towards the port side bulkhead

5.3.4 The distance between the vehicles at the time of the incident remains unknown. From the CCTV camera images (figure 4) it can be seen that the

vehicles were at close proximity at the time of the incident. However, the deceased was seen to walk around the vehicles. It cannot be concluded from the evidence available why the deceased decided to pass underneath the carriage of a vehicle instead of pass between the accessible space between them.

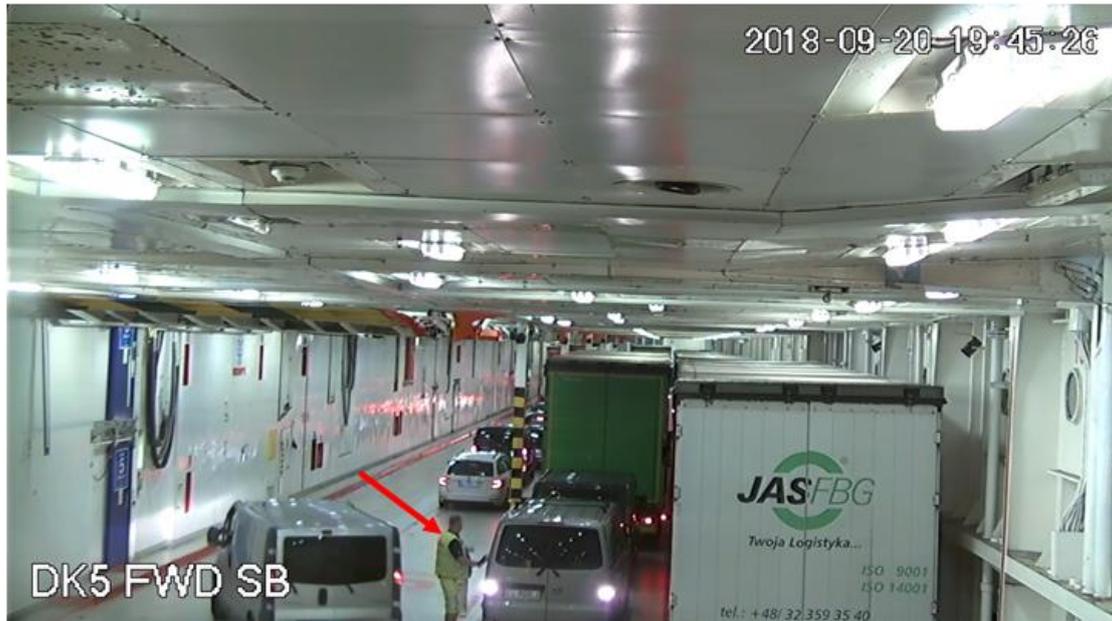
- 4.6 A SOW was guiding cars towards lane 6 for the purpose of unloading (figure 5), while the passenger had gone in the direction of lane 8 towards the port side bulkhead and disappearing from view.

Figure 5: CCTV footage screenshot with SOW guiding the vessel towards lane 6 for unloading

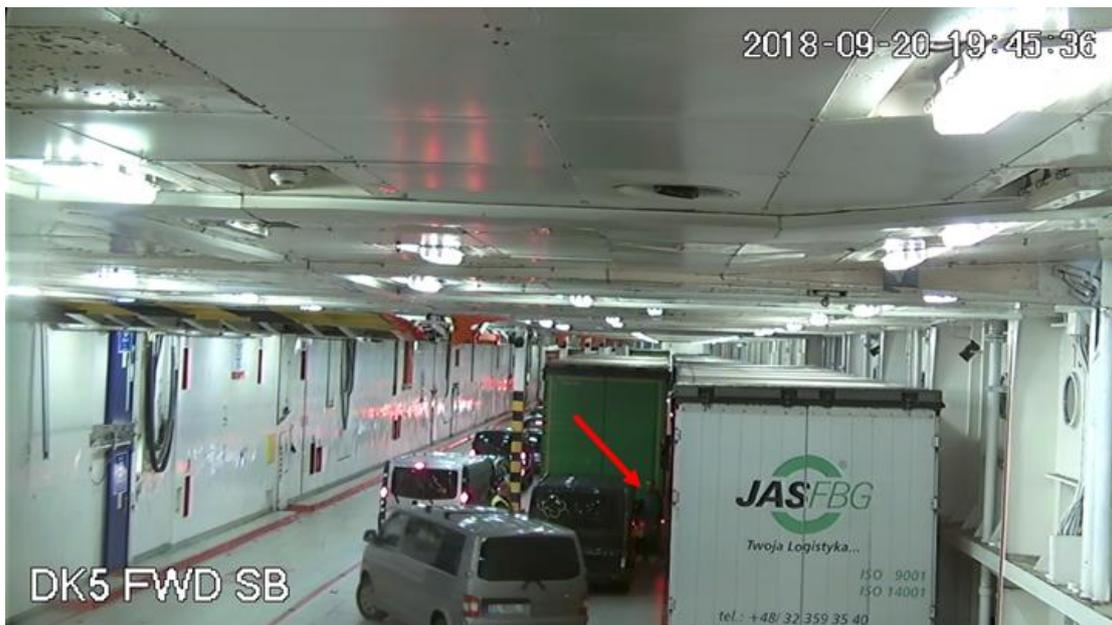
- 4.7 A few seconds later the passenger reappeared in lane 7 between a car and HGV (figure 6) and went around the car and subsequently went in front of the HGV.

Figure 6: CCTV footage screenshot with the passenger reappearing in lane 7

- 5.1.3 From the evidence available during the course of the investigation, it is inconclusive why the deceased was walking around the vehicles (Figure 6, 7, 8 and 9). However, it is probable that he was trying to search for the HGV driver he had made arrangements with to undertake the next part of his journey.

5.2.8 At various instances the passenger walked around the vehicles and the SOW (figures 6, 7, 8 and 9). From the CCTV footage it was observed that the passenger's movements were disoriented. However, the passenger was not questioned or approached for any suspicious behavior while he was walking on the vehicle deck. Passengers walking on deck were considered a normal activity, as passengers often walk around the deck to find their respective parked vehicles. Hence, no suspicion of any abnormal activity was observed by the SOW.

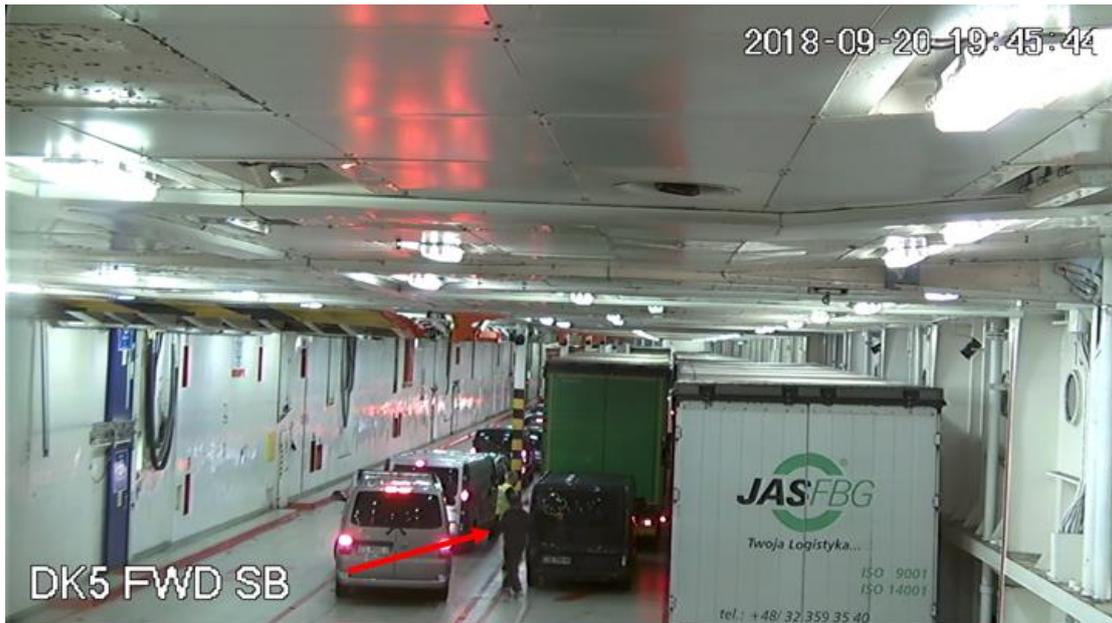
Figure 7: CCTV footage screenshot with the passenger going around the car

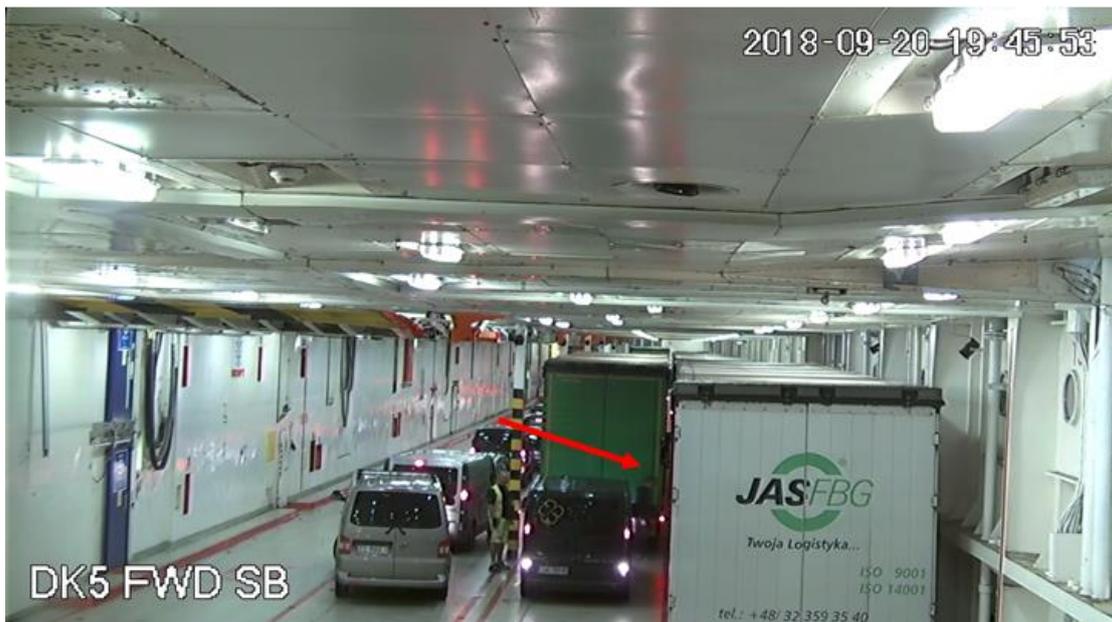
Figure 8: CCTV footage screenshot with the passenger going again in front of the HGV

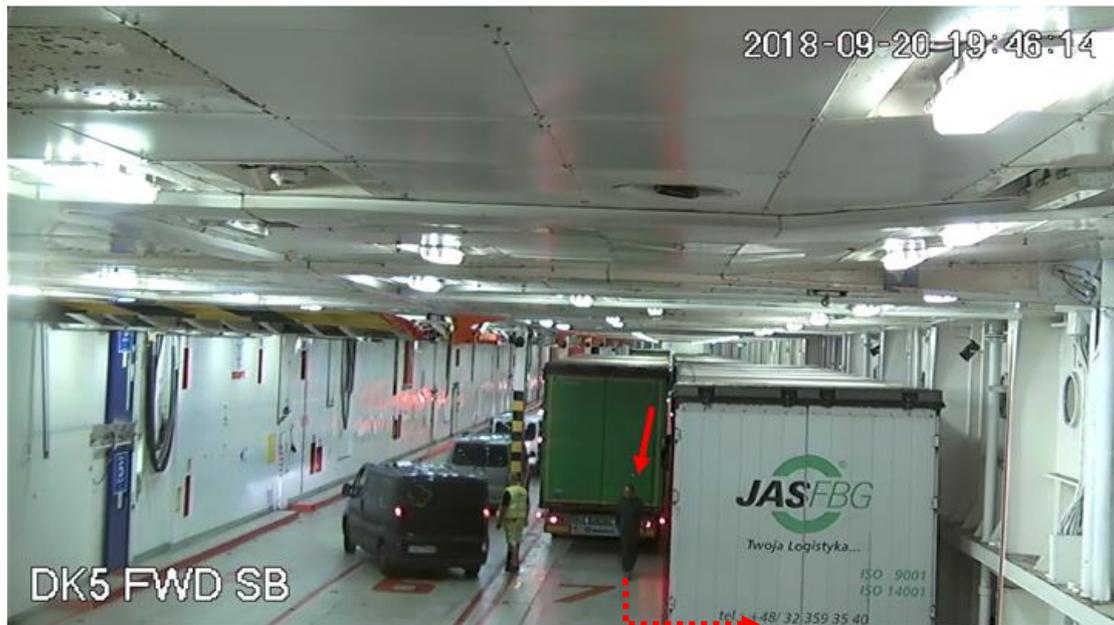
- 4.8 At 1948 hours the passenger reappeared in lane 7 from the space in front of the HGV in lane 8. He walked around the side of the HGV and towards the port side bulkhead of the vessel (figure 9 and figure 10).

Figure 9: CCTV footage screenshot with the passenger reappearing in lane 7

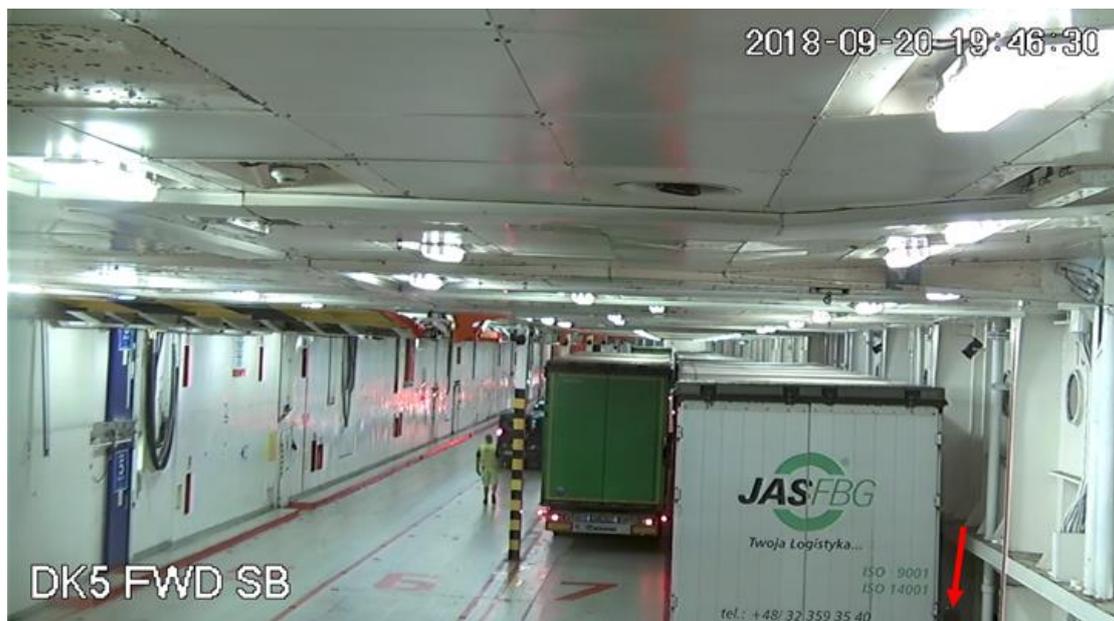
Figure 10: CCTV footage screenshot with the passenger going into the space between the HGV and port side bulkhead

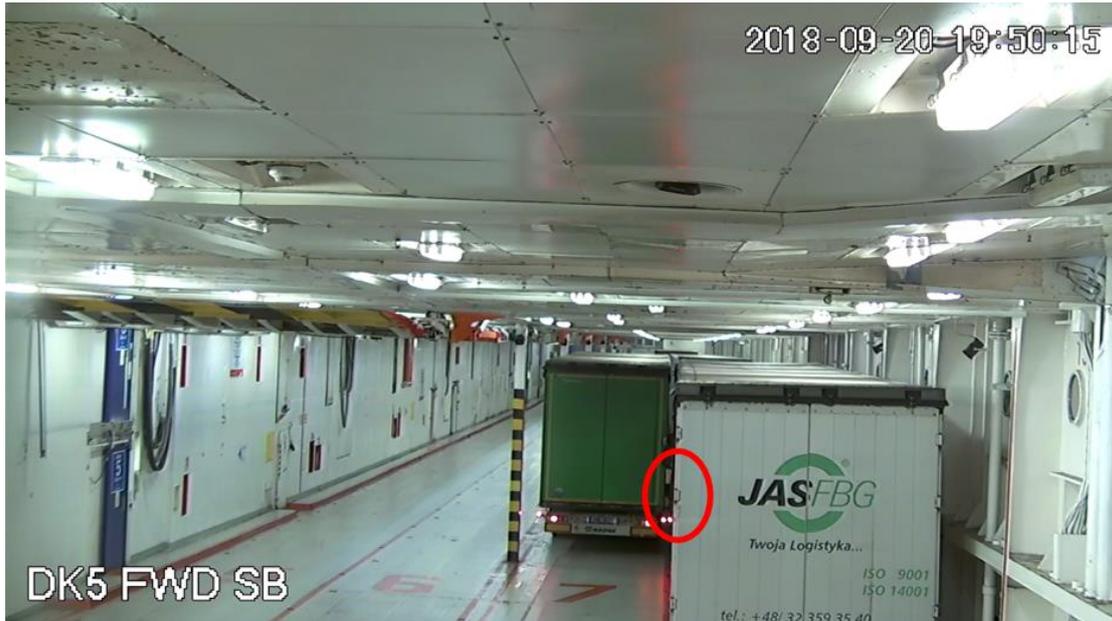
- 4.9 At 1952 hours, the passenger was crawling below the HGV from lane 8 towards lane 7 (figure 11).

Figure 11: CCTV footage screenshot with the passenger crawling below the HGV

- 5.1.4 From the CCTV footage it was observed that the passenger was crawling below the vehicles from lane 8 towards lane 7. At this instant, the vehicle on lane 7 was guided to move forward and the passenger was crushed under the vehicle's left rear tyre.

- 7.1 It is recommended to include within the Vehicle Deck Safety Procedures, a procedure to ensure the safety of passengers and crew during cargo operations, specifically related to the loading and unloading of vehicles.
- 7.2 Consider providing additional training to staff in identifying and assisting passengers who appear lost and are unable to locate their respective vehicle.

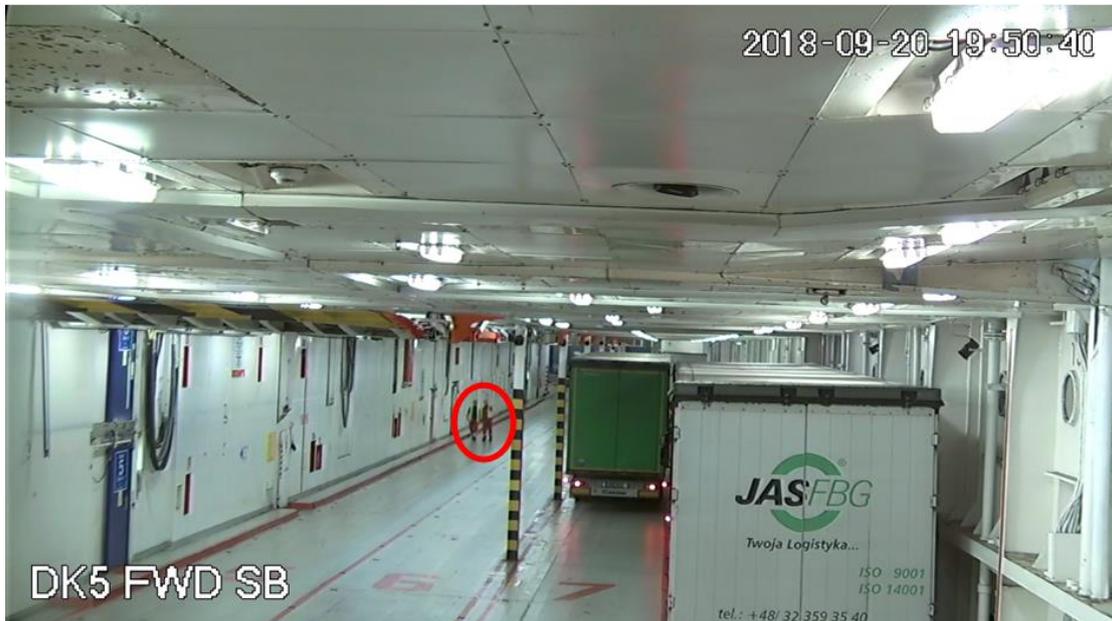
- 4.10 At this time, the SOW was instructing the HGV on lane 7 to move ahead. Unbeknownst to the SOW, the passenger was under the HGV and was crawling in the direction of lane 6, when the HGV simultaneously moved forward, resulting in entire weight of the left rear tyre of the HGV coming into contact with the passenger.
- 4.11 The two SOWs were walking toward the forward section of the vessel when one of them heard the crushing noise and saw the passenger under the rear left tyre of the vehicle in lane 7.

Figure 12: CCTV footage screenshot with location of the SOW at the time of the incident

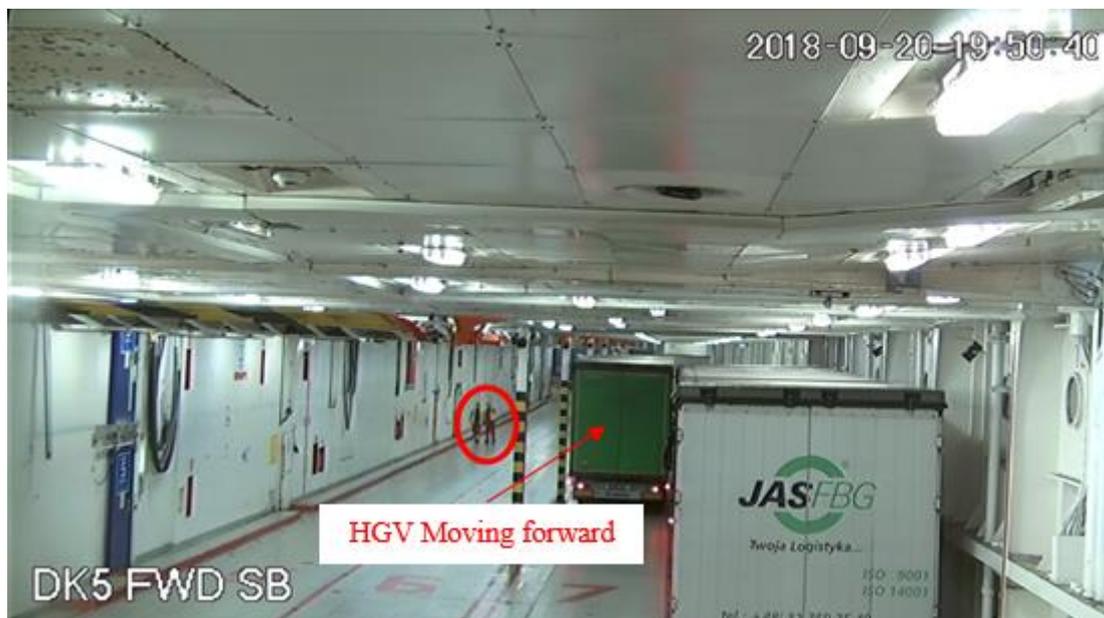
5.2.5 The 2 SOWs were walking toward the forward part of the vessel when one of the SOWs heard the crushing noise. He saw the HGV moving and the deceased under it. He immediately stopped the unloading operation.

Figure 13: The 2 SOWs walking towards forward of the vessel and HGV moving forward

5.2.6 The third SOW was in front of the HGV pictured within figure 13, guiding the vehicle off the vessel.

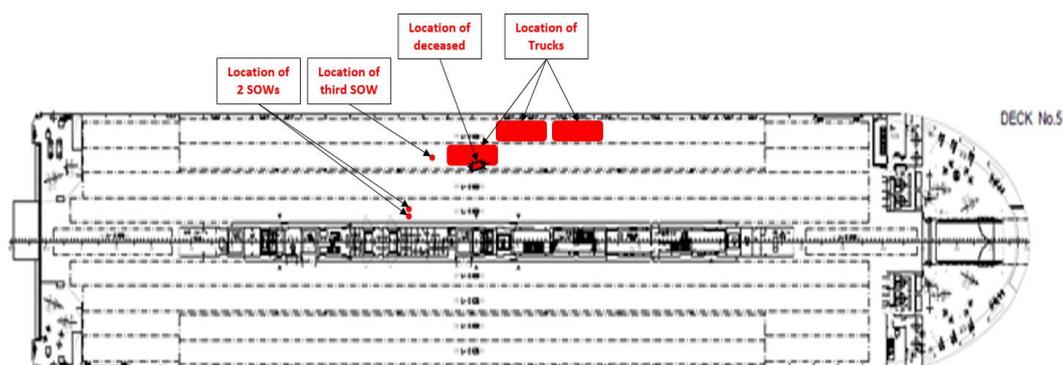
Figure 14: Illustrative diagram<sup>3</sup> with location of SOW, Deceased and Vehicles

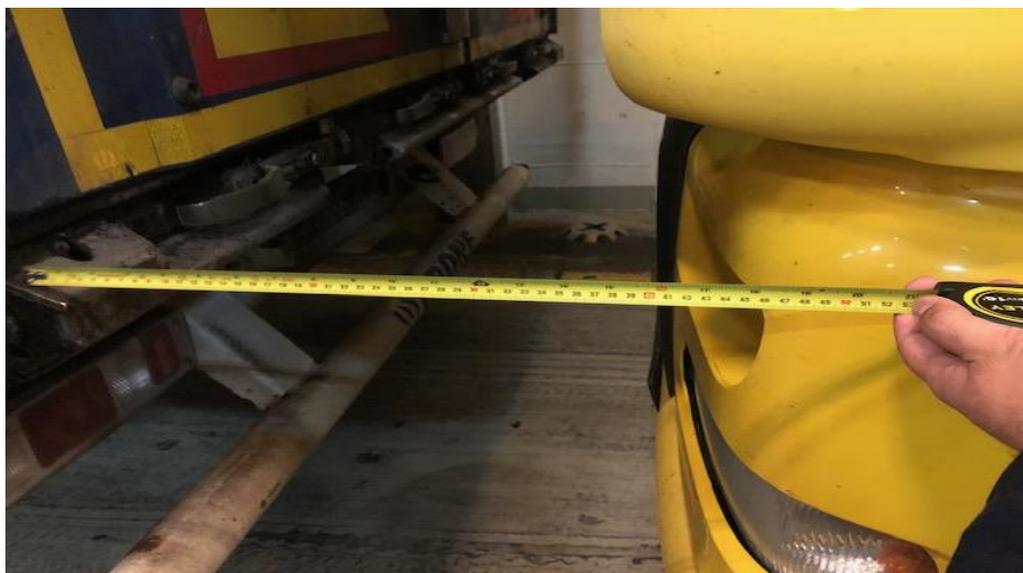
5.3.3 At the time the investigation was conducted (on 7 October 2018) the vessel was not loaded at maximum capacity and it was observed that the vehicles were parked at a distance of 40-45 cm. The Chief Officer informed the investigator that this distance could be less if there were more vehicles onboard.

**Figure 15: Distance between the parked vehicles<sup>4</sup>**

- 8.1 Although access for emergency response team was not required after the incident. It was identified in the CCTV that access between vehicles was limited when fully loaded. Possibly preventing emergency response personnel wearing breathing apparatus from access between vehicles. The owners should consider developing guidelines to ensure access on deck and between the vehicles in case of an emergency is sufficient for emergency response personnel.
