**The Bahamas
Maritime Authority**

M.V. Norwegian Escape

**Report of the marine safety investigation into serious
crew injuries on a Passenger vessel
on 27 November 2018**

Date of Issue: 21 October 2019

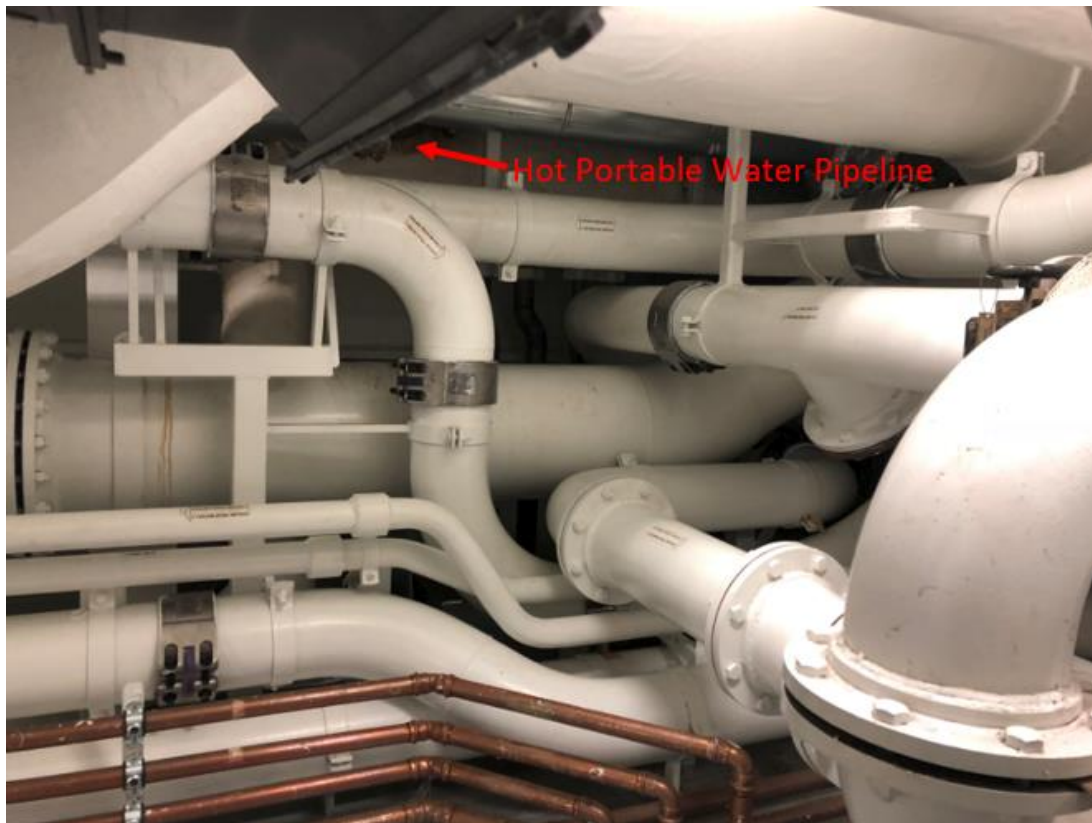
- 2.1 On 26 November 2018, the vessel was underway to Port Canaveral with 1729 crew members and 3921 passengers on board. At 1030 hours the Assistant Engineer observed a leakage around the vicinity of insulated hot potable water pipe in Engine room on deck 2. The Assistant Engineer informed the First Engineer and it was decided to tighten the coupling to stop the leak.

Figure 4: Location of hot potable water pipeline where leakage was observed

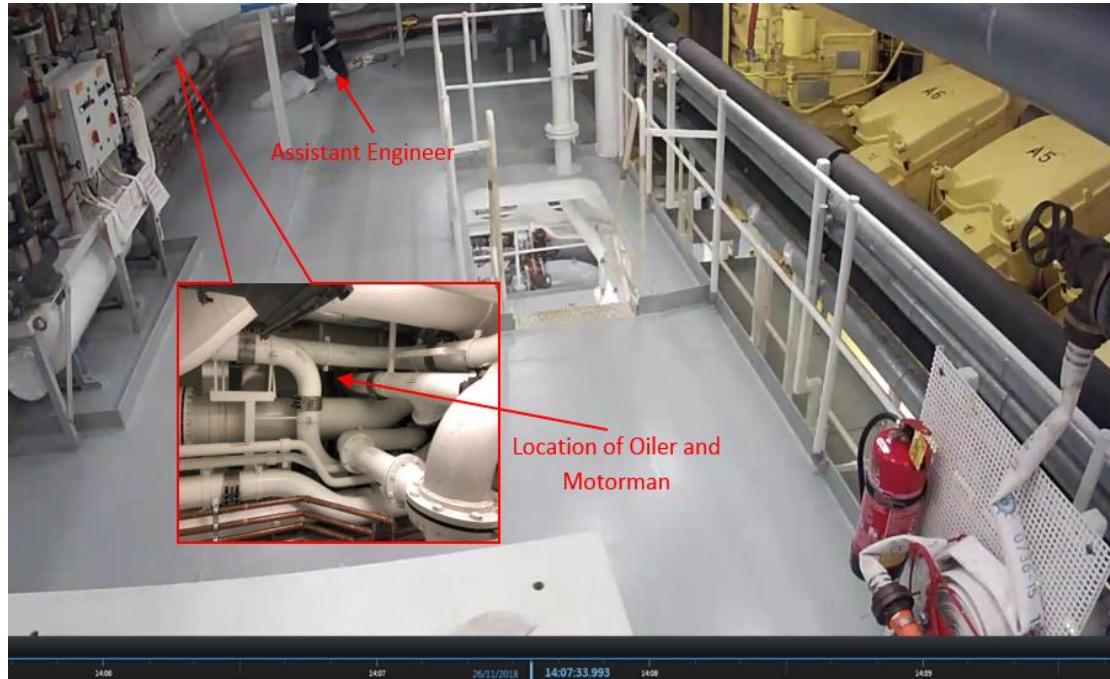
Figure 8: Location of Oiler, Motorman and Assistant Engineer at 1407 hours

- 4.19 A few moments later as the Motorman tried to tighten the aft coupling having found that the bolt on coupling was loose. Subsequently the coupling failed, resulting in the pressurized release of steam and hot water.
- 4.20 The Assistant Engineer escaped the area using the staircase to deck 1.

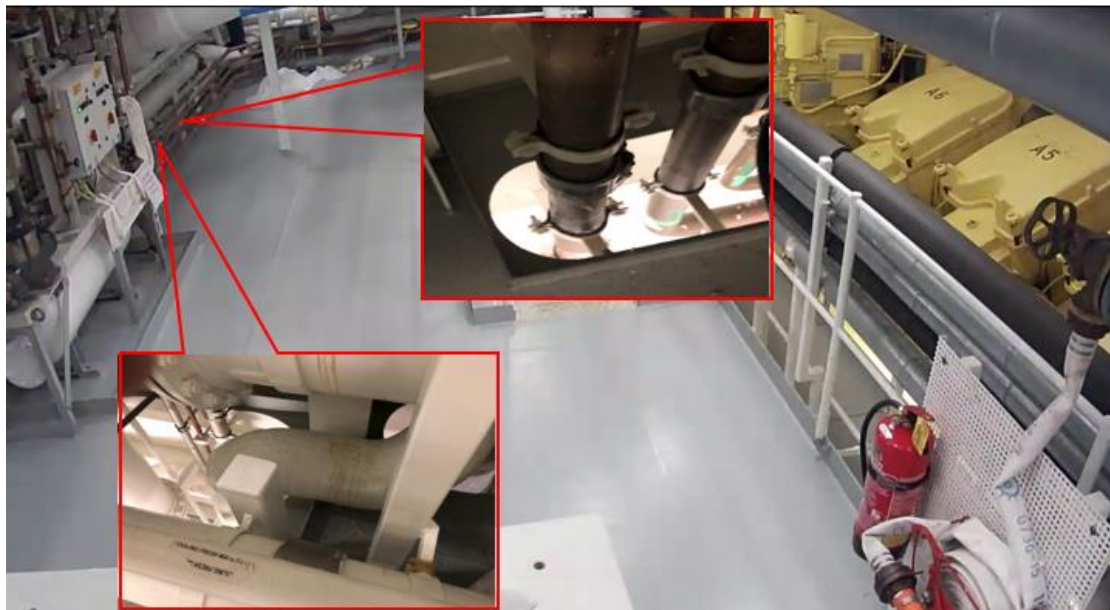
- 4.21 In the immediate vicinity of the leak, located beneath the Motorman and Oiler were two access holes which provided open access for pipelines running between decks 1 and 2.

Figure 10: Location of opening access for the pipelines on deck 2-floor plate

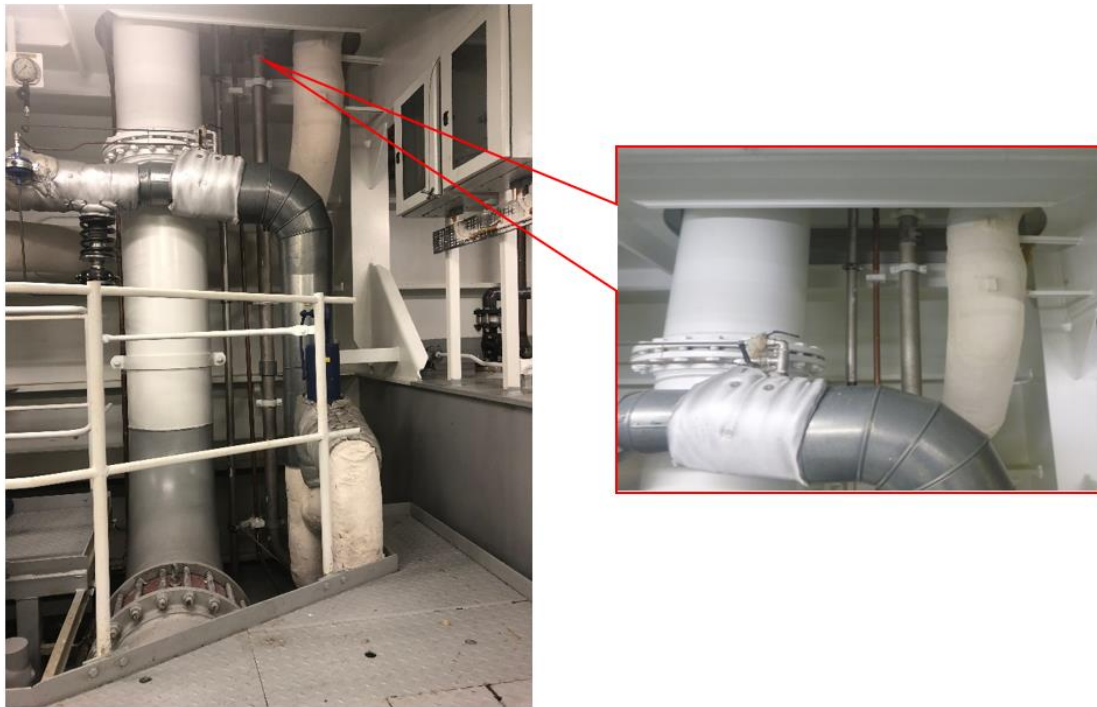
Figure 11: Location of opening access for the pipelines as seen from deck 1

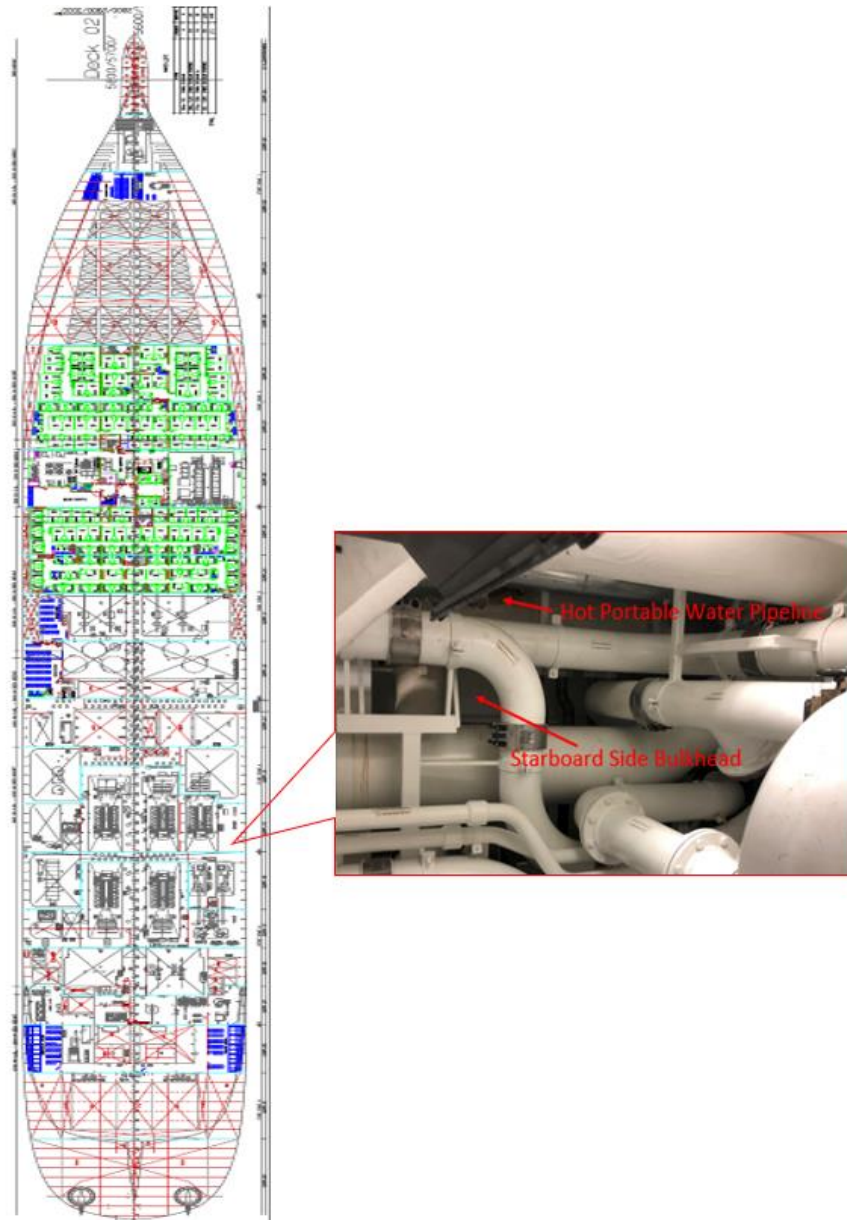
- 5.1.1 The leakage was observed by the Assistant Engineer from the hot potable water pipeline on deck 2, compartment 15.

Figure 14: Location of the leak on hot potable water pipeline in deck 2, compartment 15

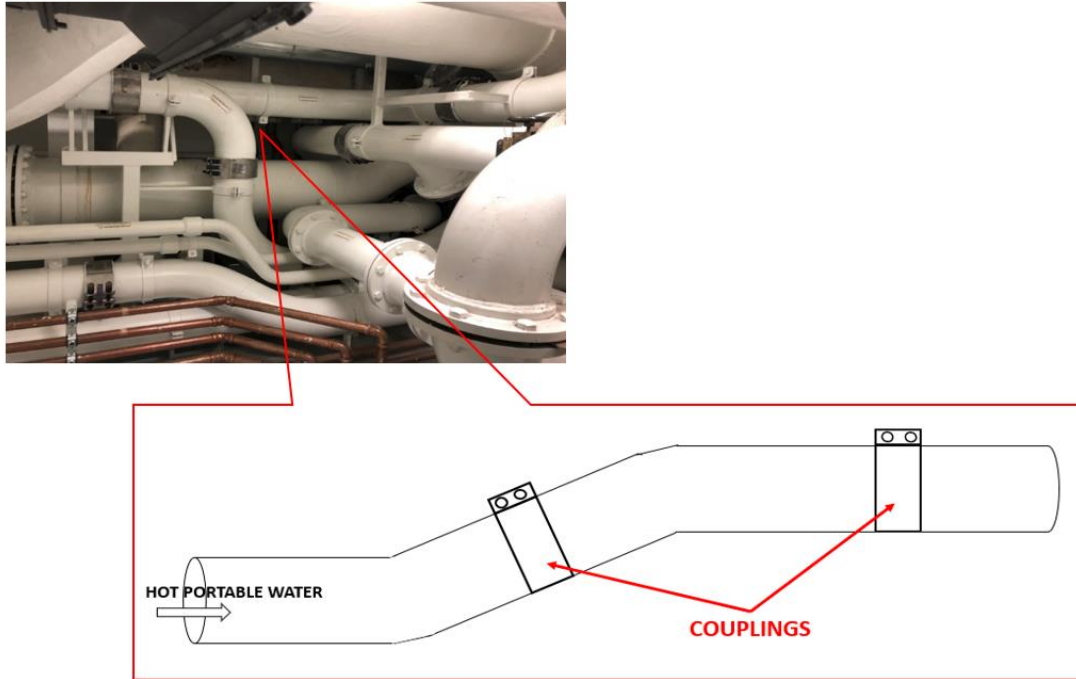
- 5.1.2 In the vicinity of the leak the hot potable water pipeline section had 2 couplings.

Figure 15: Location of couplings⁵ on deck 2

- 5.1.3 The vicinity of the leak had limited access restricting one person to enter at a time. Both personnel had to climb in from the space between pipelines to access the coupling where the leak was identified.
- 5.1.4 At the time of the incident, due to the steam and water coming from the pipeline at a pressure of 8 to 9 bars where the coupling failed, the Oiler and Motorman were unable to escape through the same access from where they entered.
- 5.1.5 The deck floor in the vicinity had an opening access for the purpose of passing pipelines down to deck 1. At the time of the incident, the Oiler and Motorman utilized one of the two openings as a means of escape.

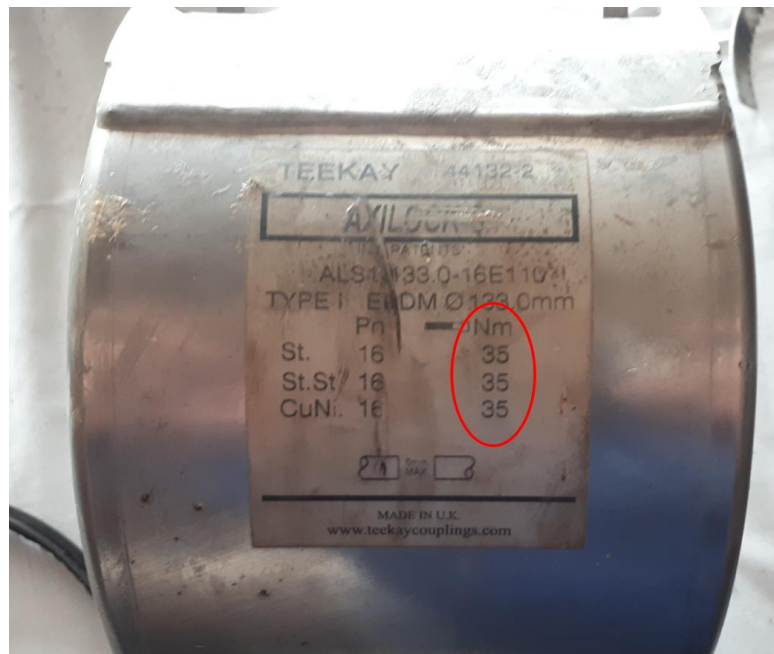
- 5.3.4 The tightening torque for screws can be found on the coupling label. The product brochure also provides the guidance for the required tightening torque value for screws on the coupling at the time of installation.

Figure 16: Tightening torque value for screws on coupling's label

- 5.3.5 Under installation guide of the product brochure it states: *'The couplings do not require any maintenance and must not be retightened once the torque has been reached. We recommend you mark the coupling once the screws have been torqued up. This will ensure that you and others know that the screws have been tightened. If you are unsure as to whether the screws have already been tightened, loosen the screws completely and repeat the installation from scratch.'* The dismantling instructions on the product brochure of the coupling also state: *'Ensure that there is no pressure in the pipes at the joint to be removed'* and *'Protect yourself and equipment from spilling liquid'*.

- 5.3.6 The crew members did not follow the installation guidelines by loosening the screws completely. Instead, they attempted to rectify the leaking coupling by tightening the coupling, hence changing its torque, while the pipeline was still under pressure.

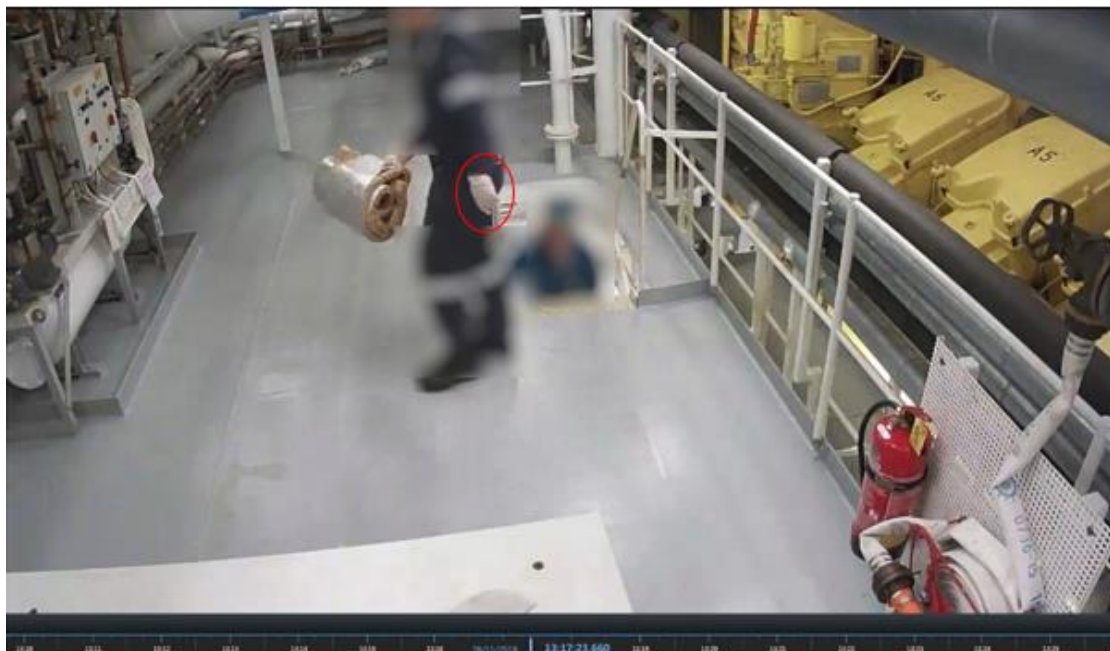
- 5.5.1 From the CCTV footage it was observed that the Motorman and Oiler were wearing white coloured gloves while carrying the new roll of insulation material and tools to deck 2.

Figure 17: CCTV footage screenshot of the Oiler wearing white coloured gloves

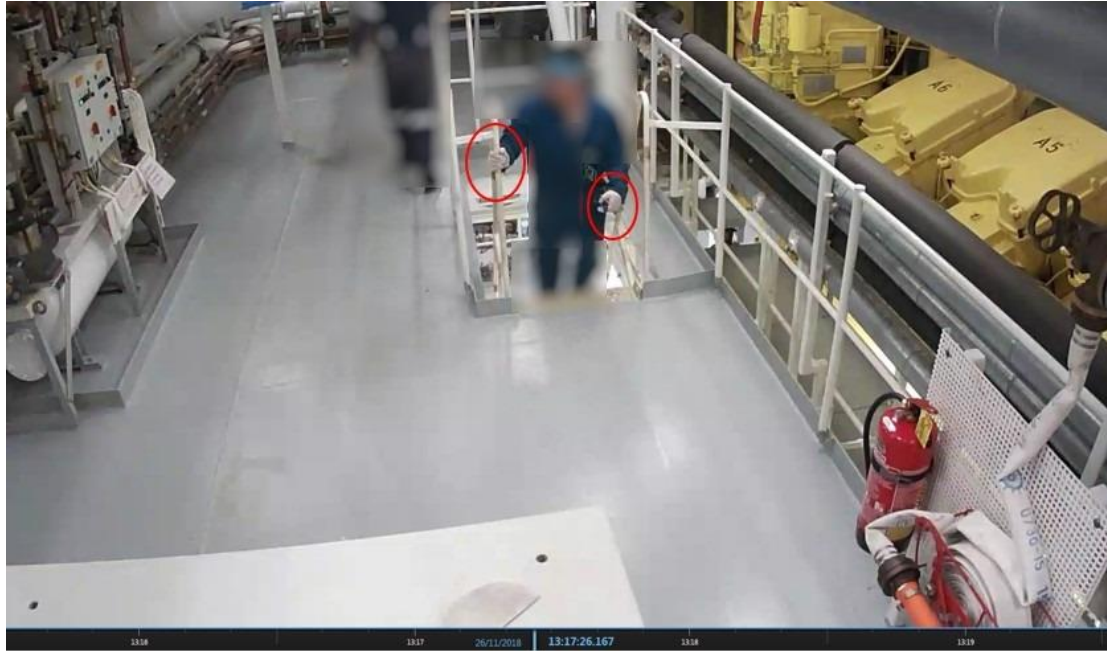
Figure 18: CCTV footage screenshot of the Motorman wearing white colored gloves

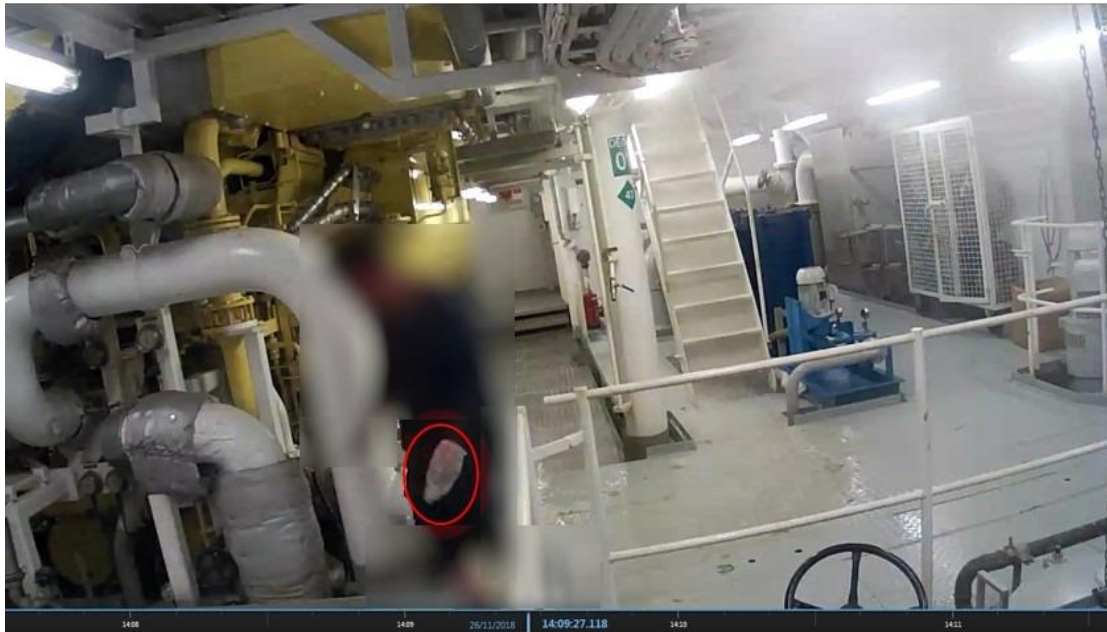
- 5.5.2 After the incident the gloves were observed to be inflated, most likely due to exposure to hot water and steam. The make and type of gloves could not be identified from the evidence available.

Figure 19: CCTV footage screenshot of the inflammation of glove after the incident

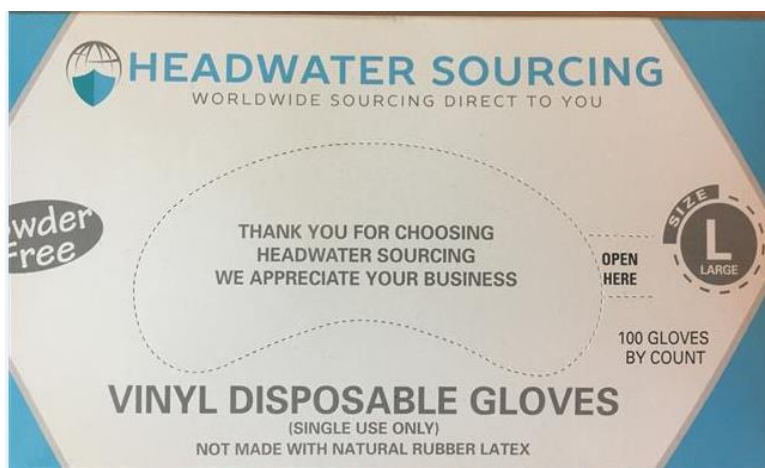
- 5.5.3 As per the information provided by NCL, white poly-cotton type gloves and single-use vinyl disposable gloves are available onboard to the crew members. However, considering the inflammation of the gloves post-incident as seen in CCTV footage, it was observed that the crew members were using single-use vinyl disposable gloves at the time of the incident.

Figure 20: Type of single-use Vinyl Disposable Gloves available onboard at the time of the incident

- 5.5.4 The single-use vinyl disposable gloves available onboard at the time of the incident had a maximum temperature limit of 40°C and were not appropriate to be used while working on the hot potable water system which contained water at 65°C.

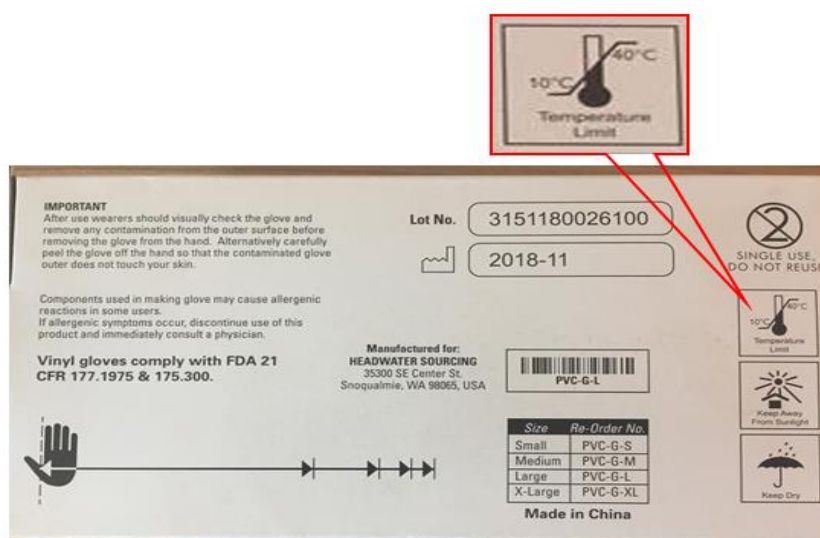
Figure 21: Operational information of the Vinyl Disposable Gloves available onboard

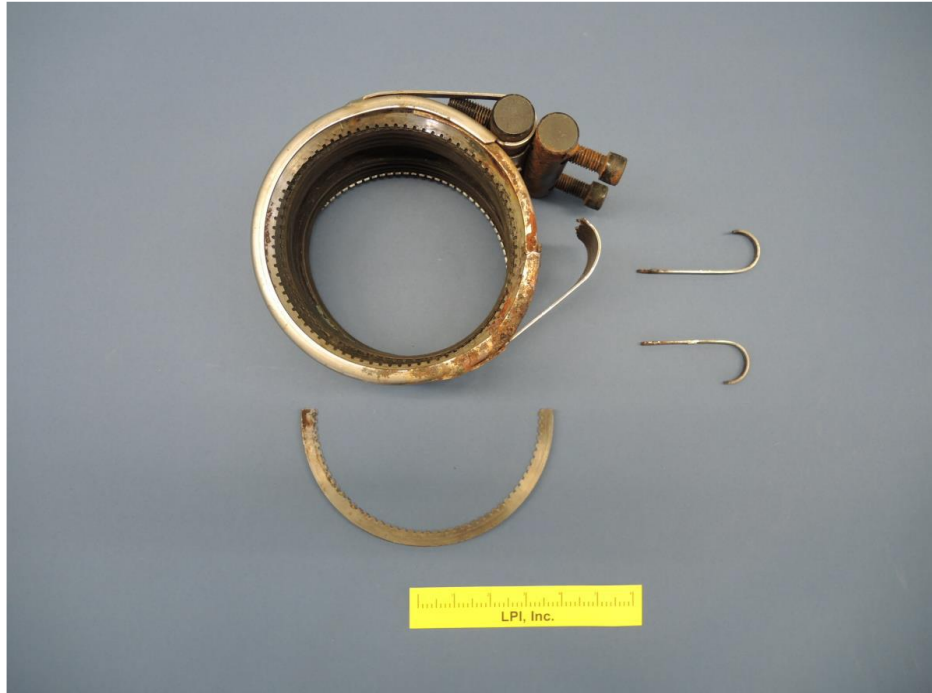
- 5.6.2 Results of the analysis revealed that the submitted pipe coupling failed as a result of stress corrosion cracking (SCC) of its casing. SCC is a failure mode by which a material which is susceptible to SCC fails under the influence of exposure to a corrosive service environment and tensile stresses. Type 304 stainless steel⁶ is highly susceptible to SCC in a chloride containing environment. The presence of corrosion product/deposit on the outer casing surface and Energy Dispersive X-ray Spectroscopy (EDS) analysis of this corrosion product/deposit confirmed that a chloride containing electrolyte was present during service, most likely the chlorinated water carried by the pipe system. The stress was present as residual stress from manufacture of the sheet stainless steel, installation and bending of the casing about the pin.

Figure 22: Failed coupling as received by LPI, Inc.

- 5.6.3 The source of the water was likely leakage through the gasket-to-cooper pipe interface. It could not be determined if the leakage occurred as a result of a deteriorating gasket or due to faulty installation of the coupling.

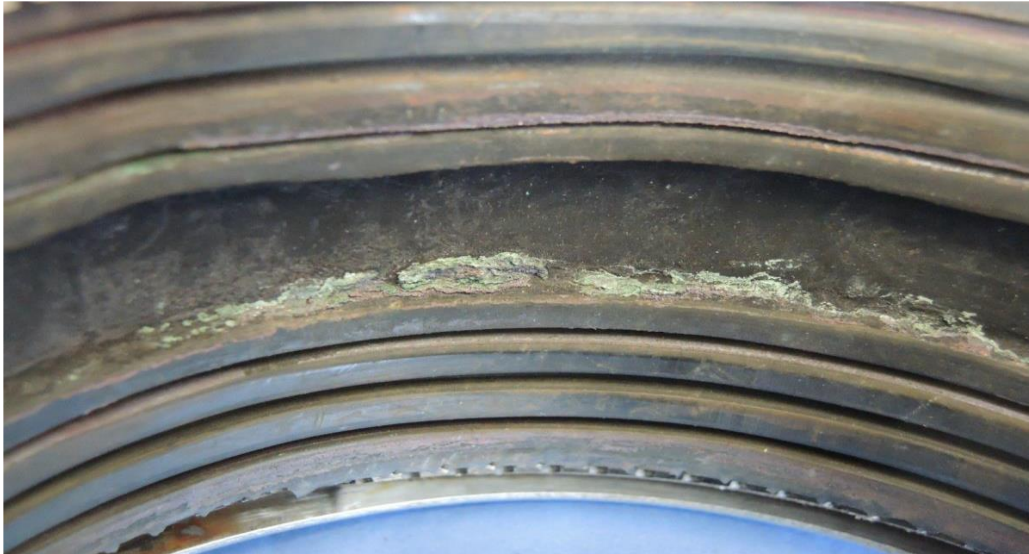
- 5.6.5 Examination of the gasket material performed by Analyze, Inc. indicated that hardening of the incident gasket material could have been caused by auto-oxidation promoted by the presence of copper ions. In addition, a likely leak path exhibiting some greenish/turquoise copper oxide was observed through the gasket-to-copper pipe interface. This would allow chlorinated water from the pipe system to seep through the gasket-to-copper pipe interface providing the condition to create SCC on the outer casing. However, faulty installation of the coupling could have also caused such a condition and could not be ruled out as a root cause.

Figure 23: Greenish/turquoise deposit in the center of the gasket

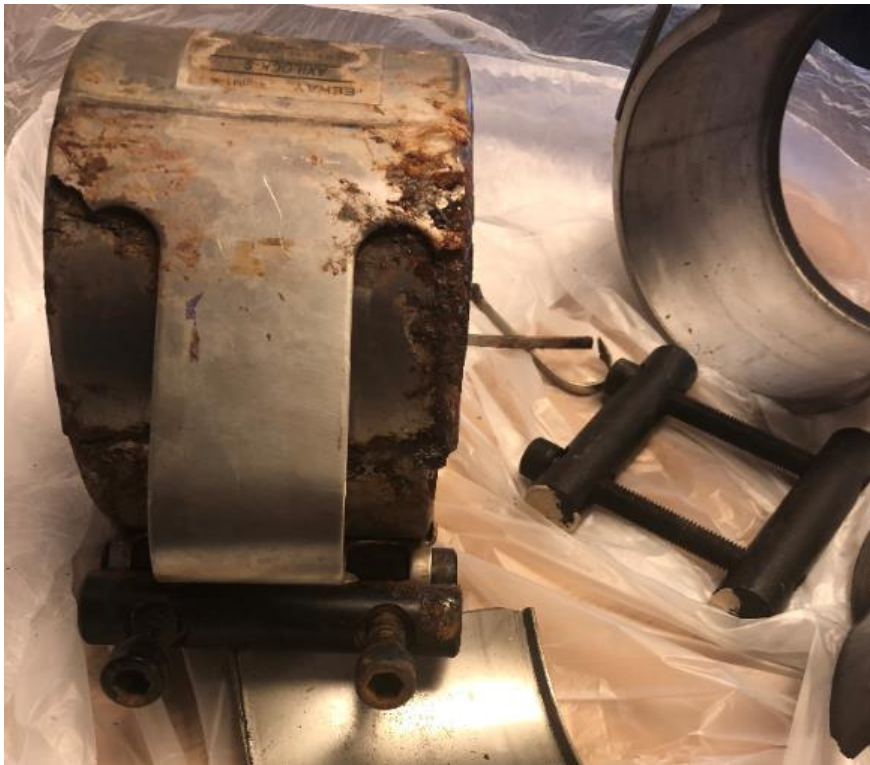
- 5.6.6 Elevated water temperature in the pipe and the presence of insulation around the pipe outer surface retaining the seeping water around the coupling further could have accelerated the SCC process.

Figure 24: Failed coupling recovered after incident

- 6.6 The laboratory evaluation determined stress corrosion cracking due to exposure of chlorinated water as the cause of coupling failure. The chlorinated water source is likely to be through the gasket to pipe interface. However, it could not be determined if the leakage occurred as a result of a deteriorating gasket or due to faulty installation of the coupling.

- 7.7 Consider producing a specific guideline or procedure for maintenance of coupling in case of any defect or leakage.
