**The Bahamas
Maritime Authority**

M.V. VISION OF THE SEAS

**Report of the marine safety investigation into a man
overboard in the Gulf of Mexico on the 8th December
2017**

Date of Issue: 24 April 2018

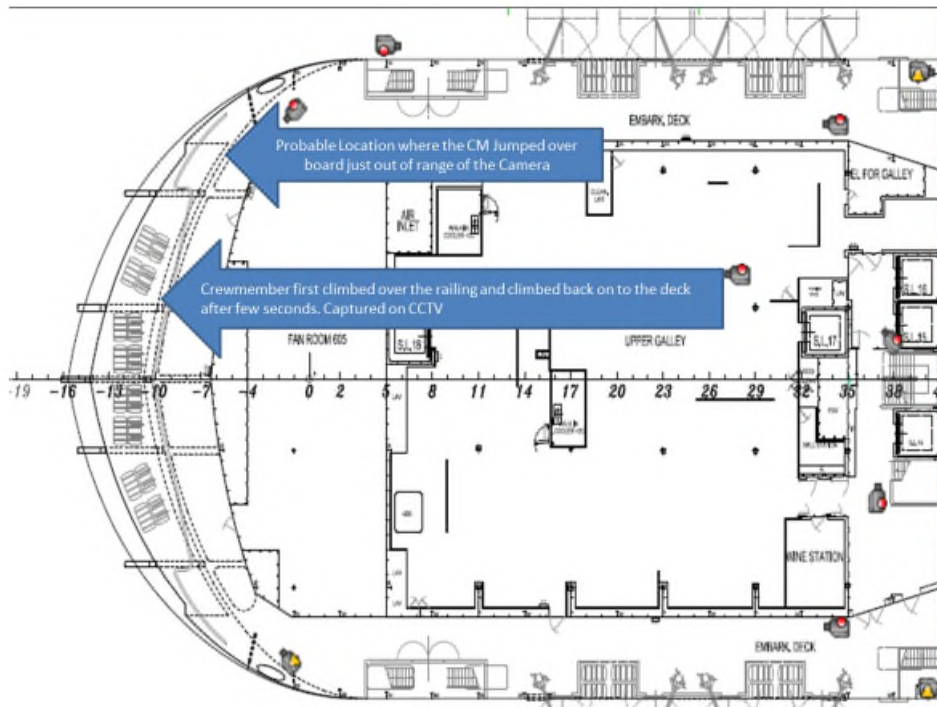
3.12 The stern section of Deck 5 is shown below, the positions that the crew member initially climbed over the stern rail and subsequently is believed to have jumped overboard are indicated. The location of CCTV cameras is marked on this diagram. The camera facing aft adjacent to the electrical box for the galley was impeded by a floodlight and did not have full coverage of the aft port quarter.

Figure 1: Stern section of Deck 5 showing prior movement and probable incident location

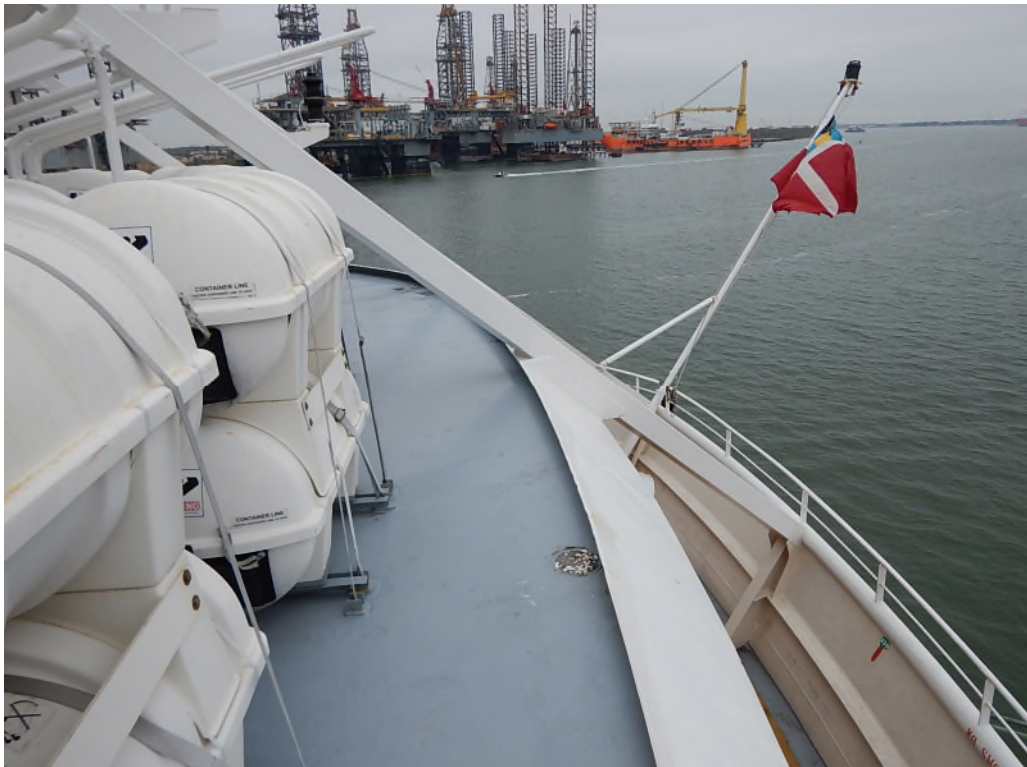
3.13 The initial position where the crew member climbed over the rail did not afford a direct access to the sea, Deck 4 below extends aft beyond Deck 5 as seen in Figure 2 below.

Figure 2: View outboard of the stern rail on Deck 5 looking to starboard where the crewmember climbed between the liferafts at 05:14 hours on 08th December 2017

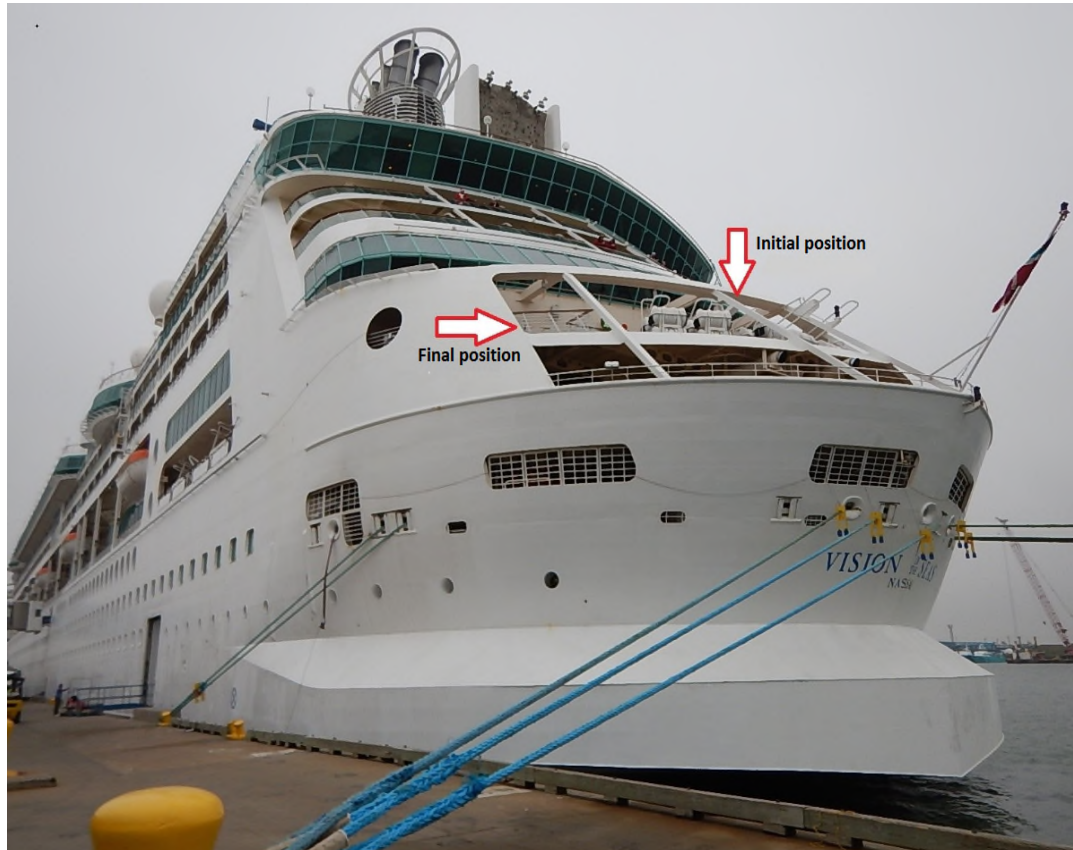
- 3.14 The last known location of the crew member affords a clear drop overboard to the sea. Figure 3 clearly shows the extension of Deck 4 aft, beyond Deck 5 at the initial position where the crewmember climbed over the hand rails.

Figure 3: Initial and final locations of where casualty climbed over the handrails

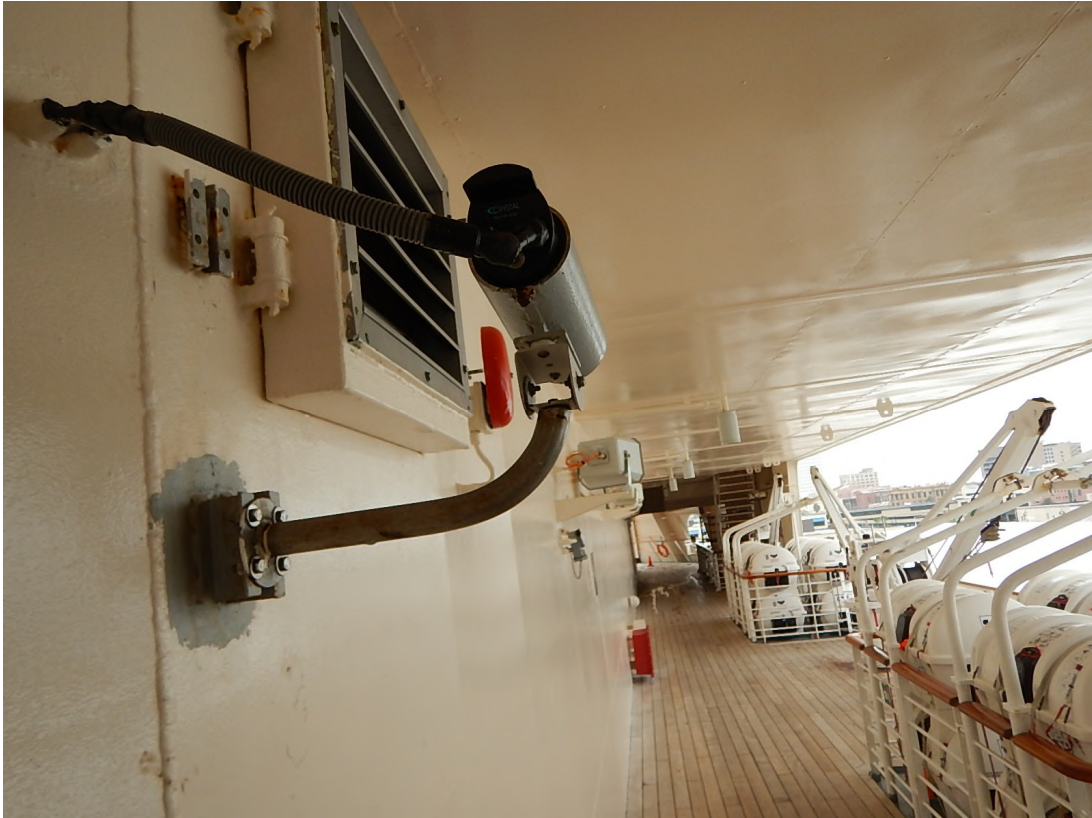
- 4.4 The investigation determined that these procedures were followed in full.
- 4.5 The missing crewmember is a 24-year-old single adult male, in apparent good health. The crewmember was sharing a cabin with his girlfriend of 6 years, also a 24-year-old from Mauritius.
- 4.6 He was last seen on CCTV at the stern of the vessel on Deck 5, camera coverage is blocked where it is believed he deliberately jumped overboard.

Figure 5: Camera view of stern blocked by floodlight (view looking aft on port side Deck 5)

- 6.1 A review of possible impediments to all cameras should be made and rectified where found.

- 7.1 The floodlight blocking the CCTV camera on the port side aft on Deck 5 with a view of the stern has already been relocated.
- 7.2 A new policy has been implemented to locate crew members who do not arrive at scheduled training sessions.

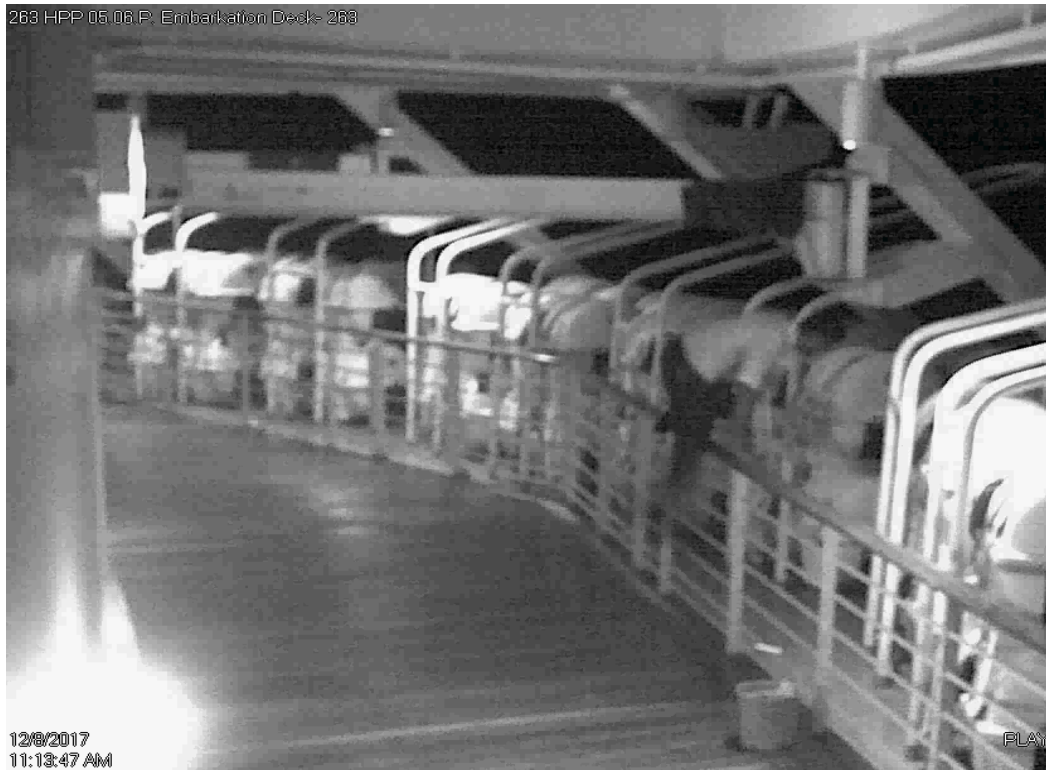
11. Crewmember at 05:14 hours climbing over stern rail

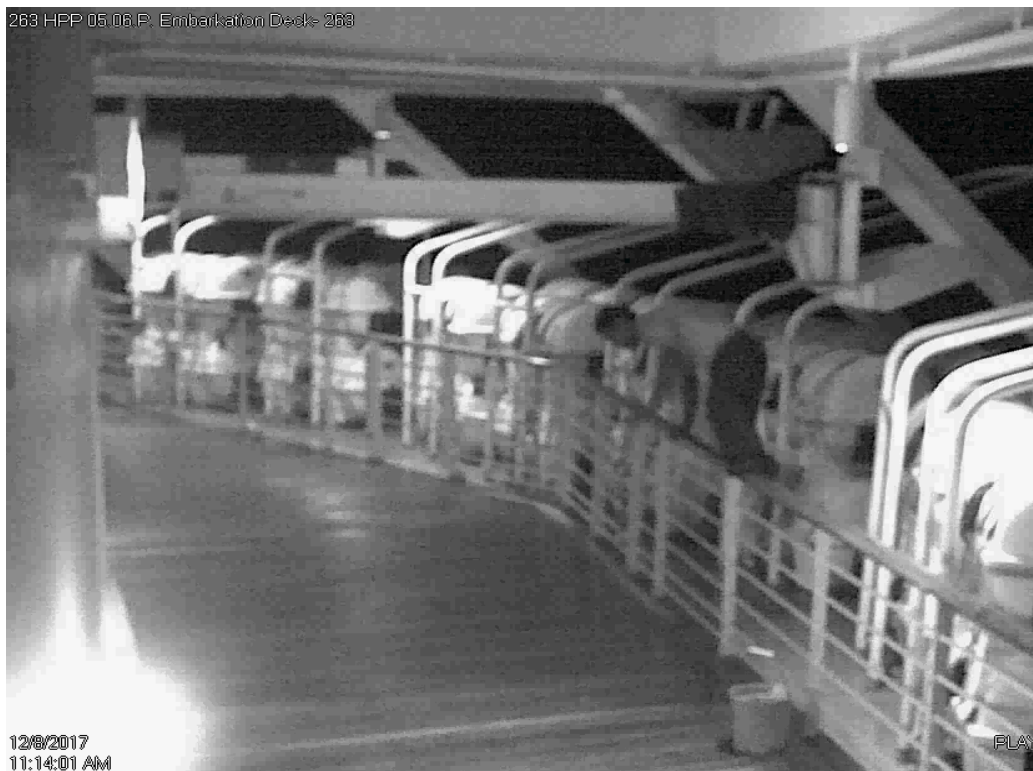
12. Crewmember at 05:14:18 hours returning to stern rail and climbing over

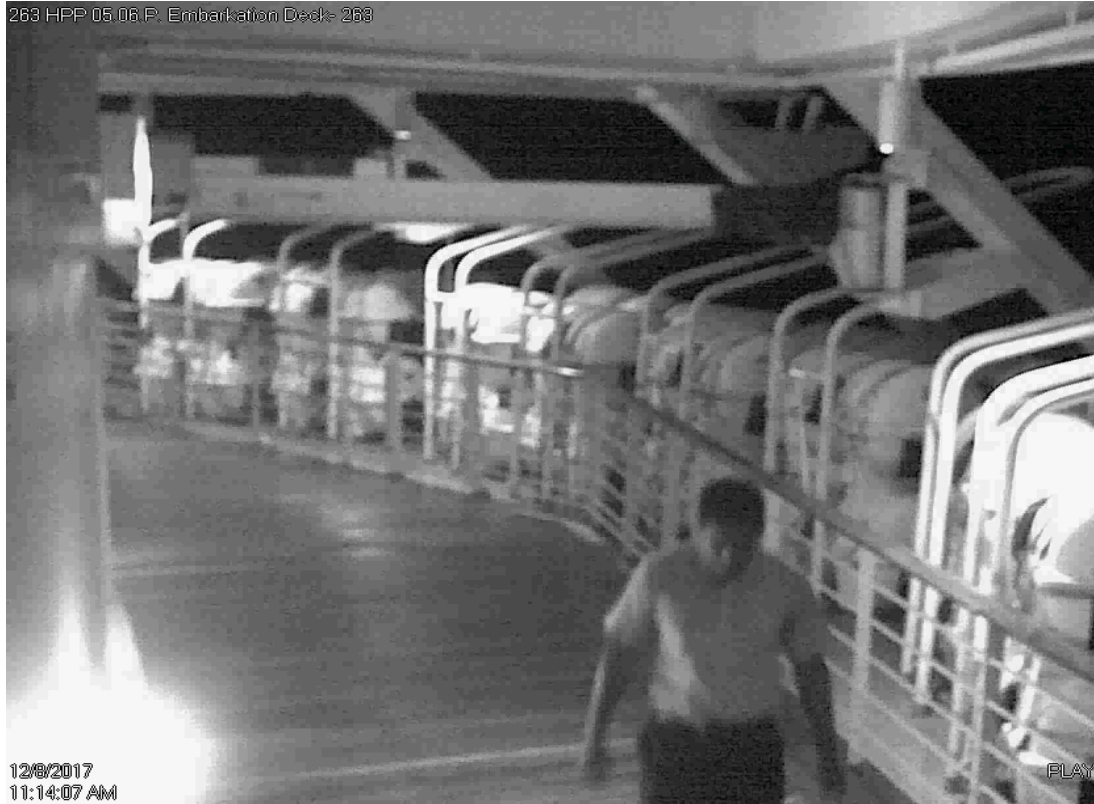
13. Crewmember at 05:14 hours moving to port quarter on Deck 5

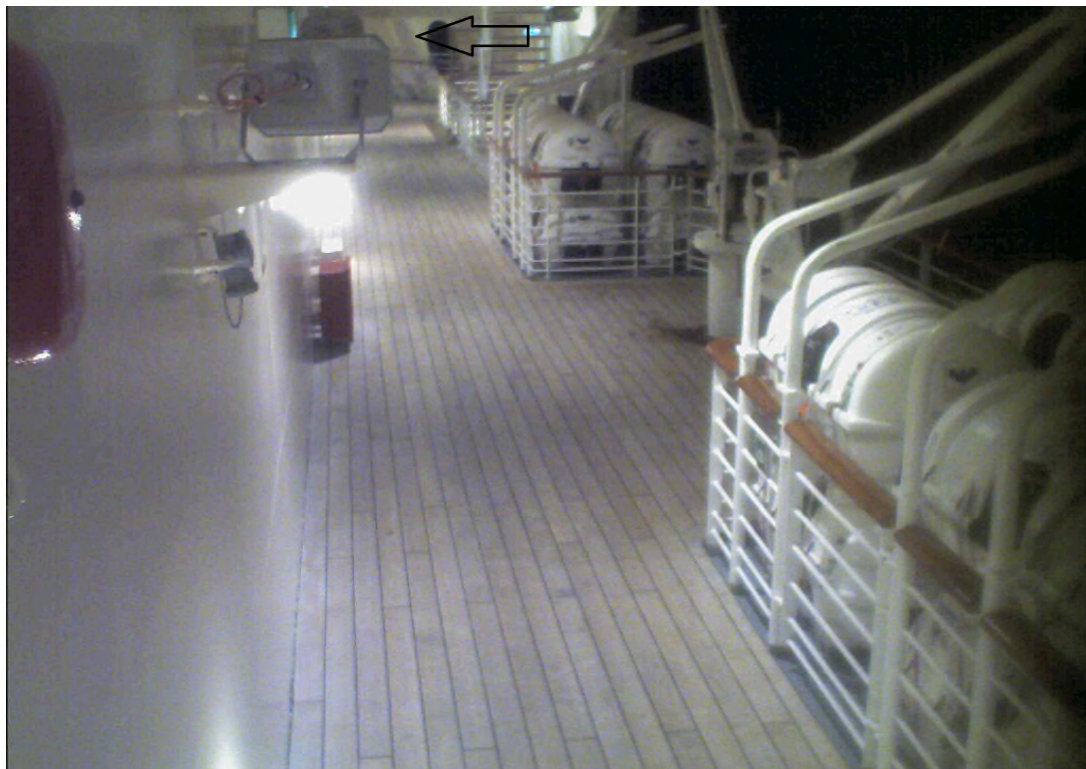
14. Crewmember at 05:14 hours shadow on bulkhead

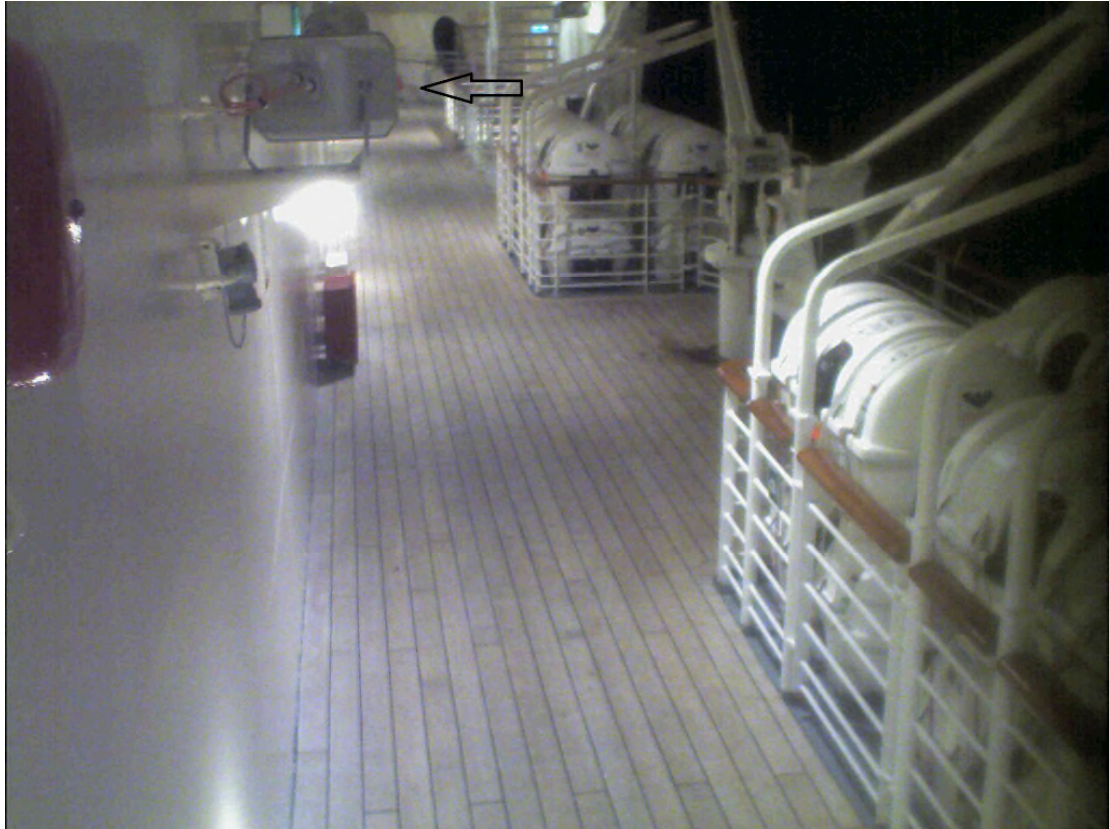
3.11 The crew member was carrying a red bucket which was later found against the handrail aft on the port quarter.

15. At 05:14 hours glimpse of red bucket carried by crew member later found abandoned by handrail

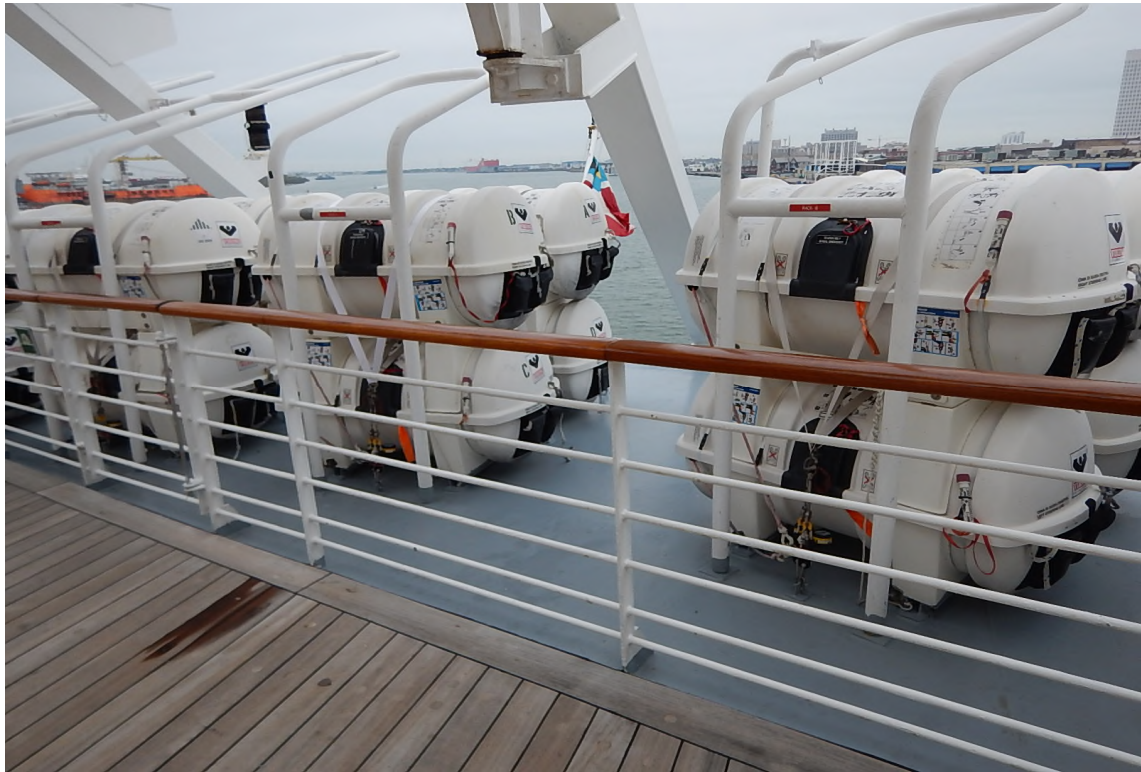
1. Location where crewmember initially climbed over stern rail between liferafts

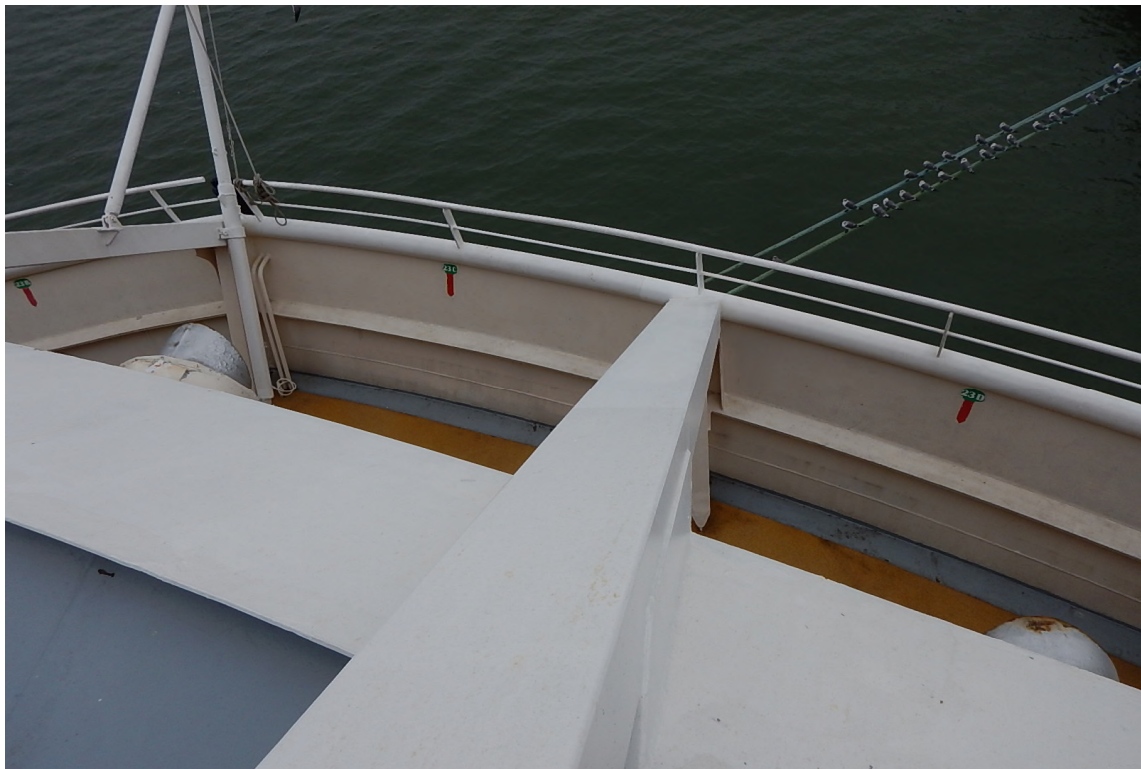
2. View looking down over stern from Deck 5 in way of photograph 1 above

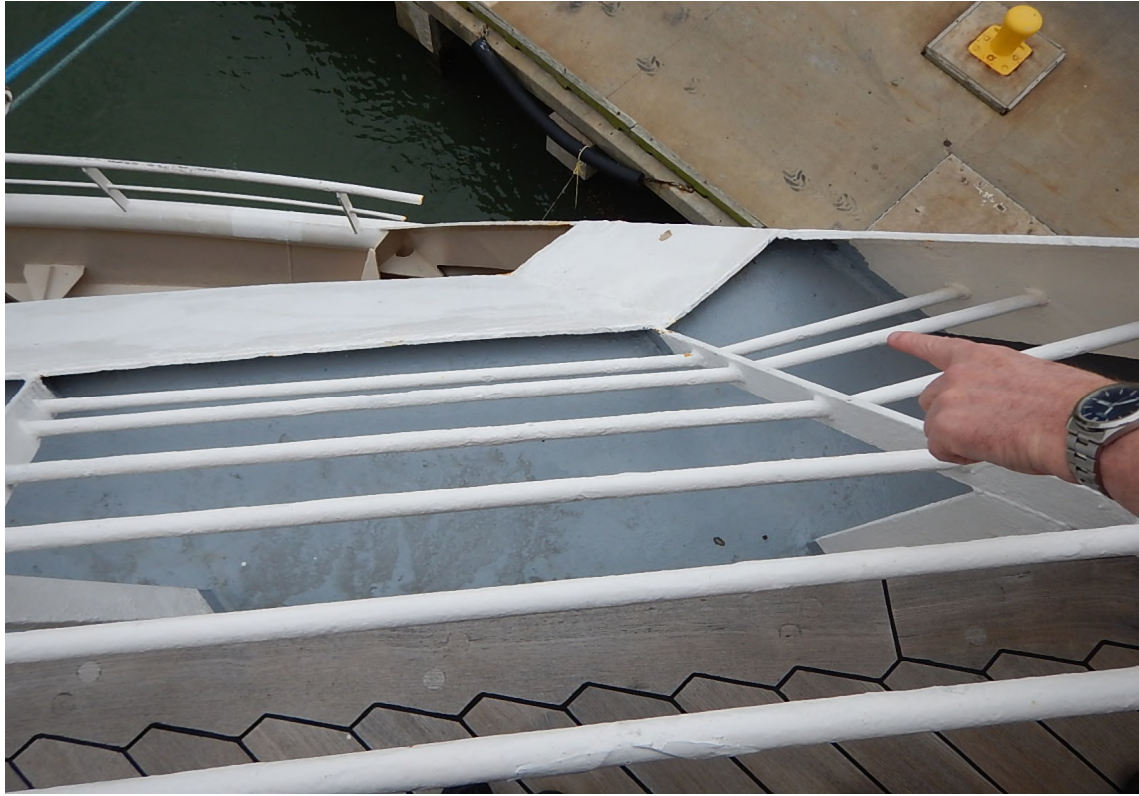
3. View looking down at location on Deck 5 aft port quarter, where crew member is believed to have jumped overboard
