SAFETY ALERT No. 17-14

Unexpected Release of Starboard Lifeboat¹

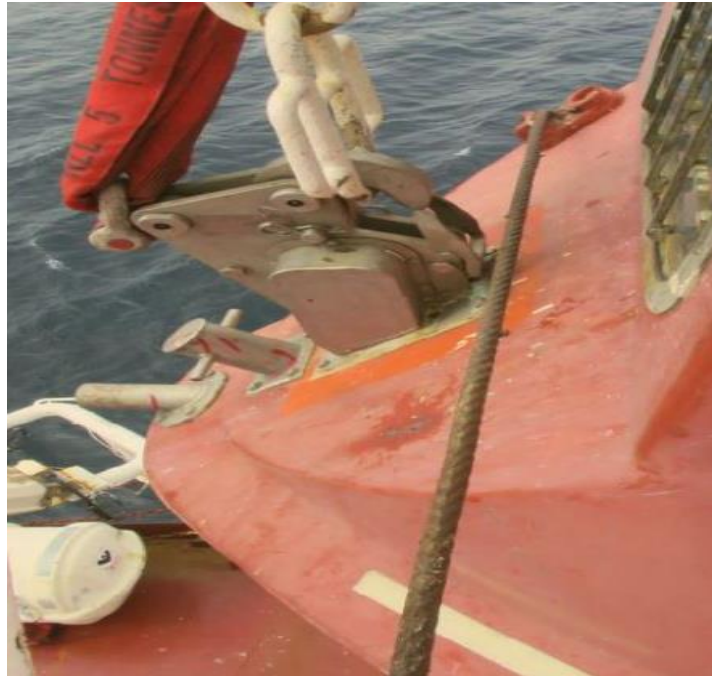
- 5.1 Fouling of the aft gripe wire in between the base of the hook body and the base of the heel of the hook retainer gate restricted any further movement of the aft davit arm. Initially both davit arms moved outboard simultaneously however on approaching 10-15° away from the vertical the aft arm appeared to slow down prior to stopping completely; at which point the brake lever was applied. This indicated that a restriction on the movement of the aft davit arm existed after the arm had moved from the stowed position.

Figure 1: Aft gripe wire and hook mechanism

- 6.1 It should be confirmed that the wire gripe have an unrestricted clear line of travel. Consideration of a deflection plate at the base of the hook body and base of the heel to prevent fouling of the wire gripe is advisable.
- 6.2 Protrusions on the wire gripe could increase the potential for snagging, this could be mitigated by regular inspections to ensure the wire gripe is as smooth as possible.
- 6.3 All retainer gates should be inspected for correct operation. All retainer gate counter weights should be examined for any damage and confirmed that they are sitting flush against the hook body.
- 6.4 Fall Preventer Devices³ should be used to minimize the risk of failure of the release mechanism or on-load release gear.

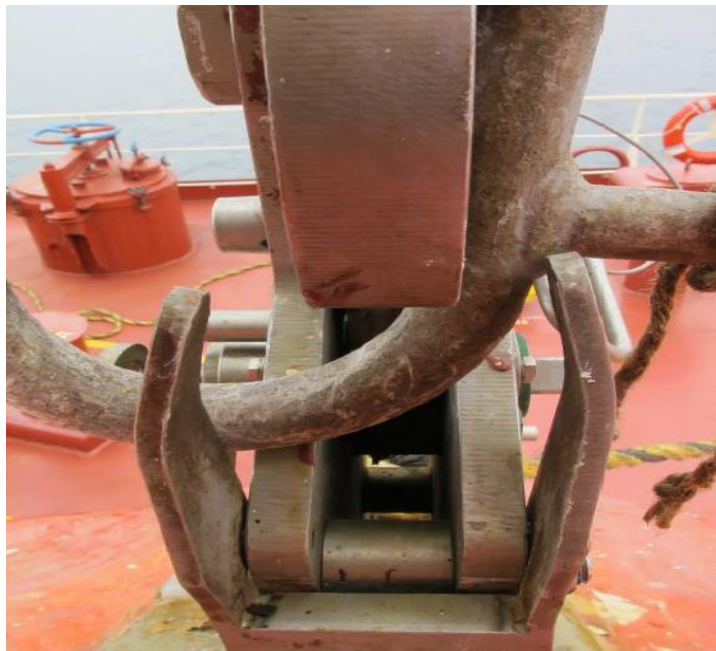
- 5.3 The aft gripe wire which was caught in between the retainer gate and hook body caused the masterlink to be drawn through the gate.

Figure 2: Aft hook mechanism and deformed retainer gate
