SAFETY ALERT No. 18-06

Free Fall Lifeboat Incident During Drill

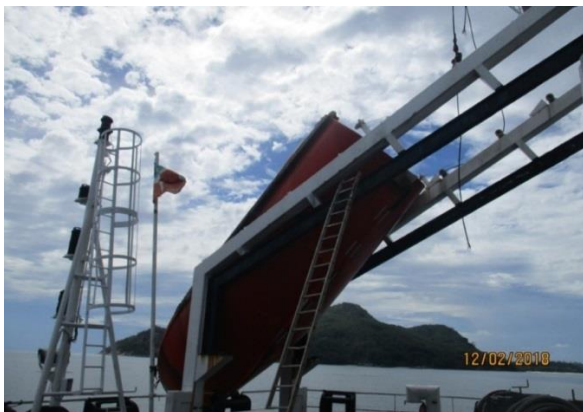
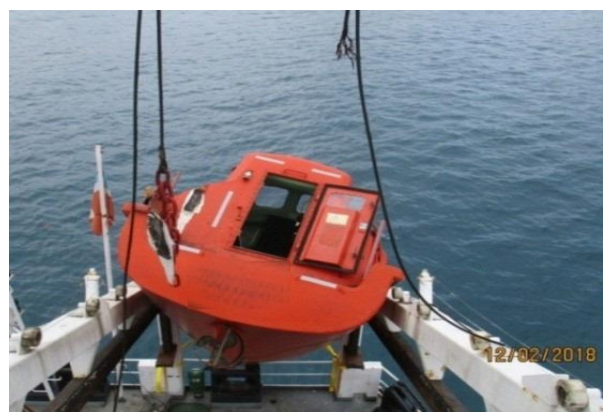
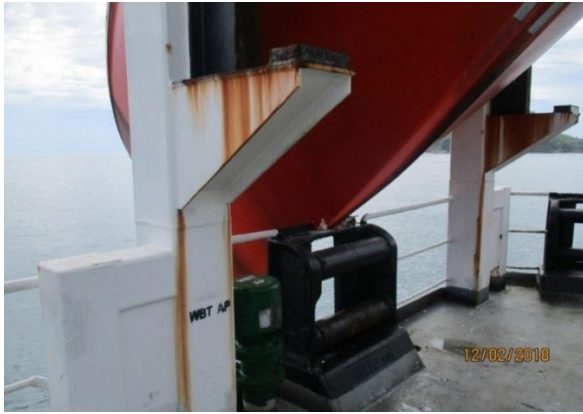
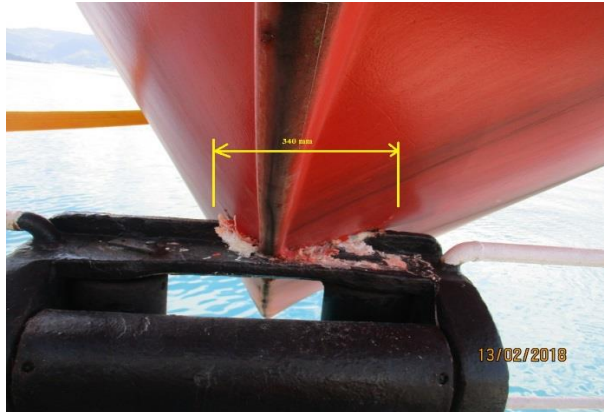
- 2.1. The vessel was carrying out the abandon ship drill and was simulating the launching of Free Falling Lifeboat (FFLB), at Port Victoria. The Chief Officer boarded the FFLB and was responsible to launch the FFLB from inside.
- 2.2. As the hook was released from helmsman position, the starboard side wire sling got parted and the weight of the boat caused subsequent breaking of the port wire slings. The FFLB, slid down rapidly and stopped on the aft fairlead, damaging the bow bottom section and starboard side forward of the boat.
- 2.3. Chief Officer who was inside the lifeboat, experienced a minor injury on his left leg.

- 4.1. It is recommended to review the maintenance and inspection program of the Lifesaving appliances (LSA) and associated equipment to ensure visual inspection to be completed before conducting any safety drill.
- 4.2. Ensure that the officers responsible for inspection of the LSA and associated equipment are familiar with the signs of wear and report the same.
- 4.3. Ensure that LSA and associated equipment certificates and maintenance history are available onboard at all times.

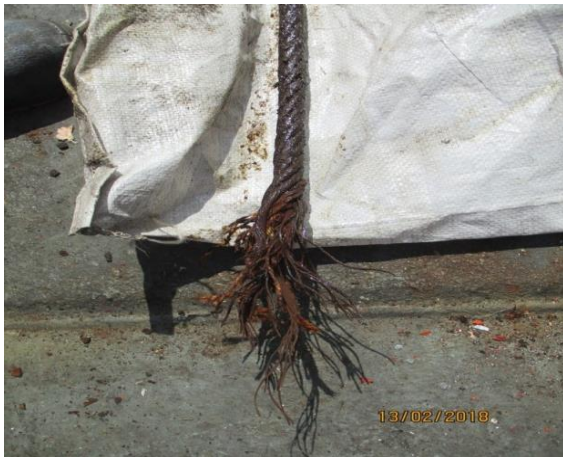
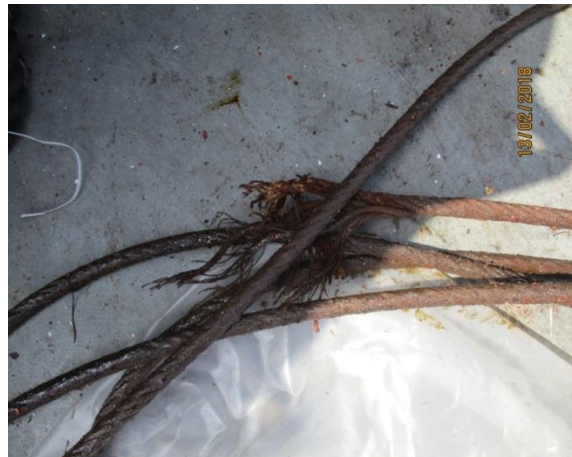
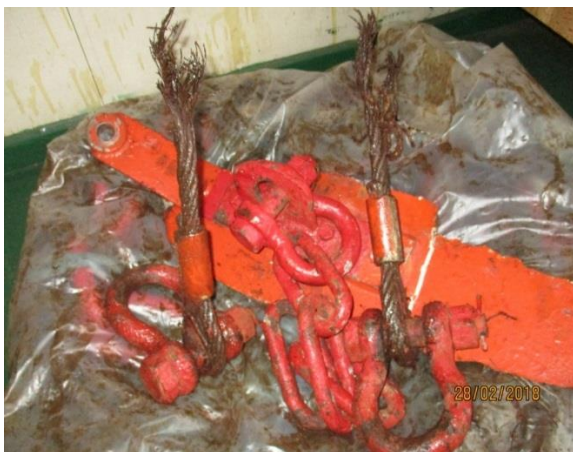
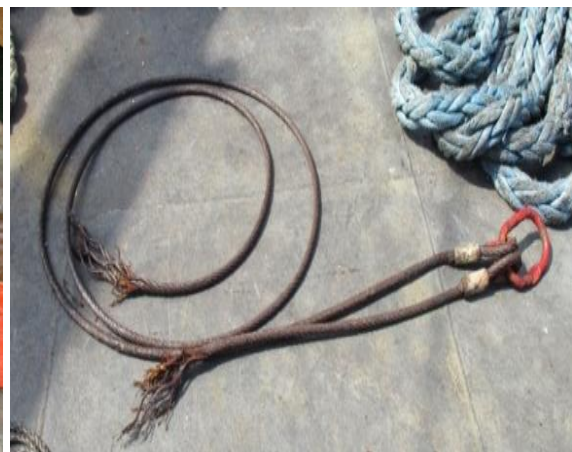
3.1. Corrosion of wire slings due to lack of proper maintenance.

3.2. The visual inspection and wire sling suspension test was conducted in a laboratory.

- 3.2.1. The visual test concluded that the sling wire had significant corrosion and there were protruding single wires from the broken strands at the place of bending on the thimble.
 - 3.2.2. The wire sling suspension test concluded that the maximum suspension strength of the sling was 51.6 KN. As per the report from the laboratory the wire sling of similar dimension should have rope breaking load of 219.29 KN.
- 3.3. The replacement of the wire sling was not conducted in the required period.
