SAFETY ALERT No. 19-02

Serious Crew Injuries on a Passenger Vessel

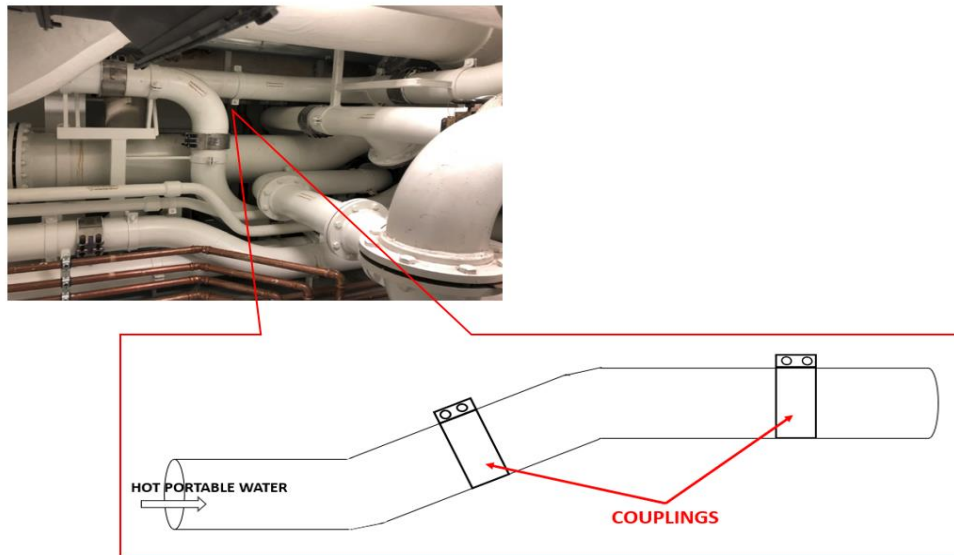
- 2.1. A leak was observed in the area around the insulated hot potable water pipe in the Engine room on deck 2. In the vicinity of the leak, the Hot Potable Water pipeline section had 2 couplings.

Figure 1: Location of couplings² on deck 2

- 3.4. From the forensic evaluation conducted into the failed coupling, it was determined that the coupling failed due to stress corrosion cracking due to the exposure of chlorinated water. The likely source of chlorinated water is the leakage through the gasket to the pipe interface. However, it could not be determined if the leakage occurred as a result of a deteriorating gasket or due to faulty installation of the coupling.
