## SAFETY ALERT No. 19-03

### Hand Injury While Attempting to Secure Crane's Auxiliary Block

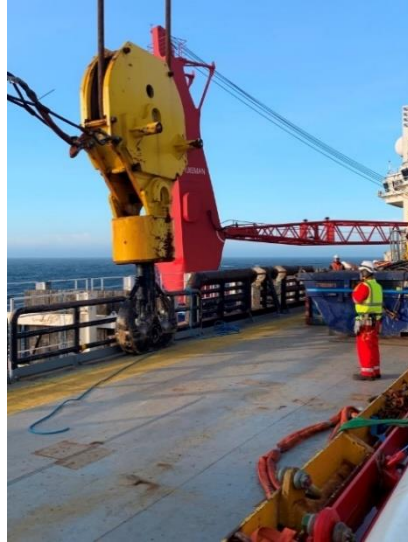
**Figure 1: Location of the auxiliary block of the main crane secured to handrail**
