CONDOR VITESSE

**Report into the Collision between the high speed ferry,
CONDOR VITESSE and the fishing vessel LES
MARQUISES**

**In waters between Plateau des Minquiers and Iles
Chausey whilst en-route from St Malo, France and St
Helier, Jersey**

28th March 2011

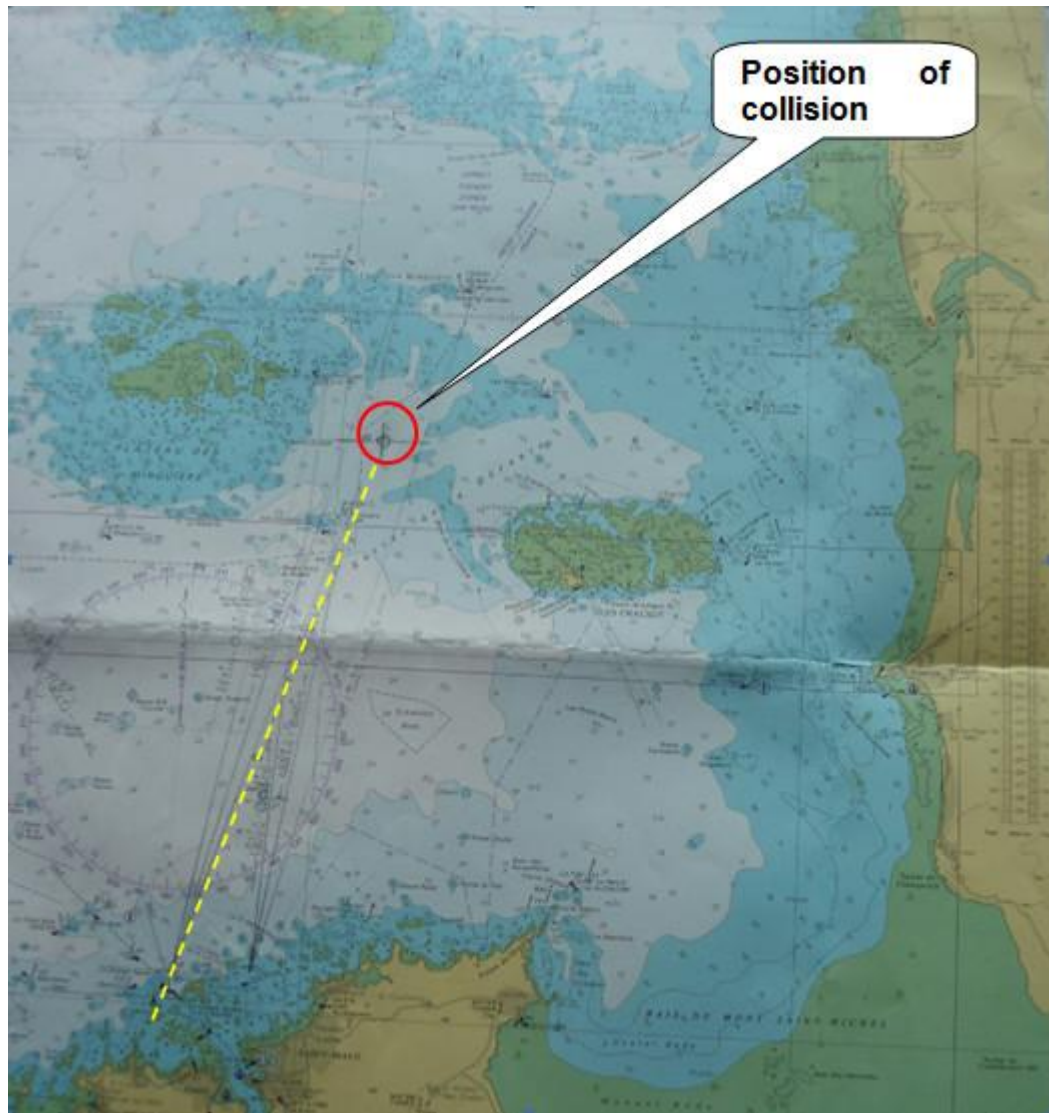
Figure 1: Chart from CONDOR VITESSE showing position of collision and course taken (highlighted in yellow dashes)

- 1.7 Less than one minute after that at 06:42:41 UTC (VDR), the CV collided with LM in position 48 56.173N 001 58.125W as determined by recorded data on the VDR. The position was inside French territorial waters and the French BEA Mer , as a consequence, led the joint investigation with the Bahamas Maritime Authority who are the flag state authority for the vessel.

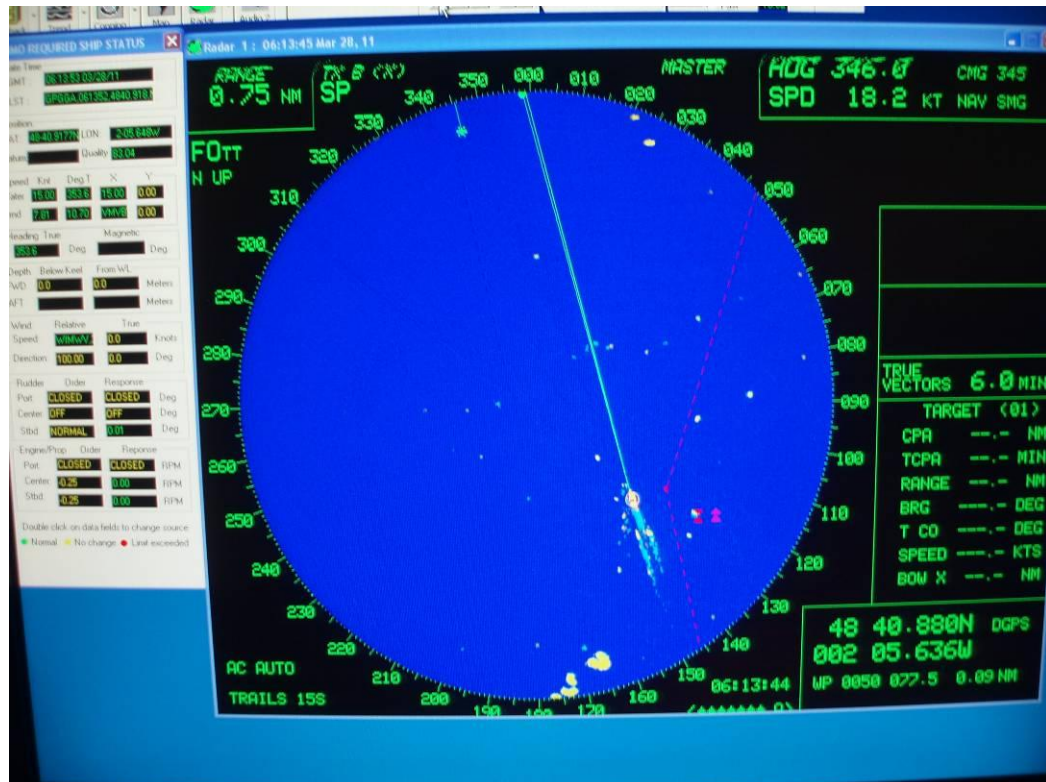
Figure 2: VDR Radar image for 06:13UTC. Clearing Channel: Bunel (west cardinal) Buoy on starboard quarter.

- 4.8 The overall quality of the radar picture that was recorded was good. The smooth sea conditions that existed at the time appear to have enhanced returns to an extent that fishing buoys were, for much of the time, returning strong echoes. The tuning of the radar was also good to the extent that even sea birds in flight were detected; a phenomenon that the Master and Chief Officer and other navigation staff during a subsequent familiarisation voyage confirmed was well understood.
- 4.9 The Radar image change at 06:22, by which time the pulse length had been switched to Medium, was not an unusual pattern. The predominance of clutter in

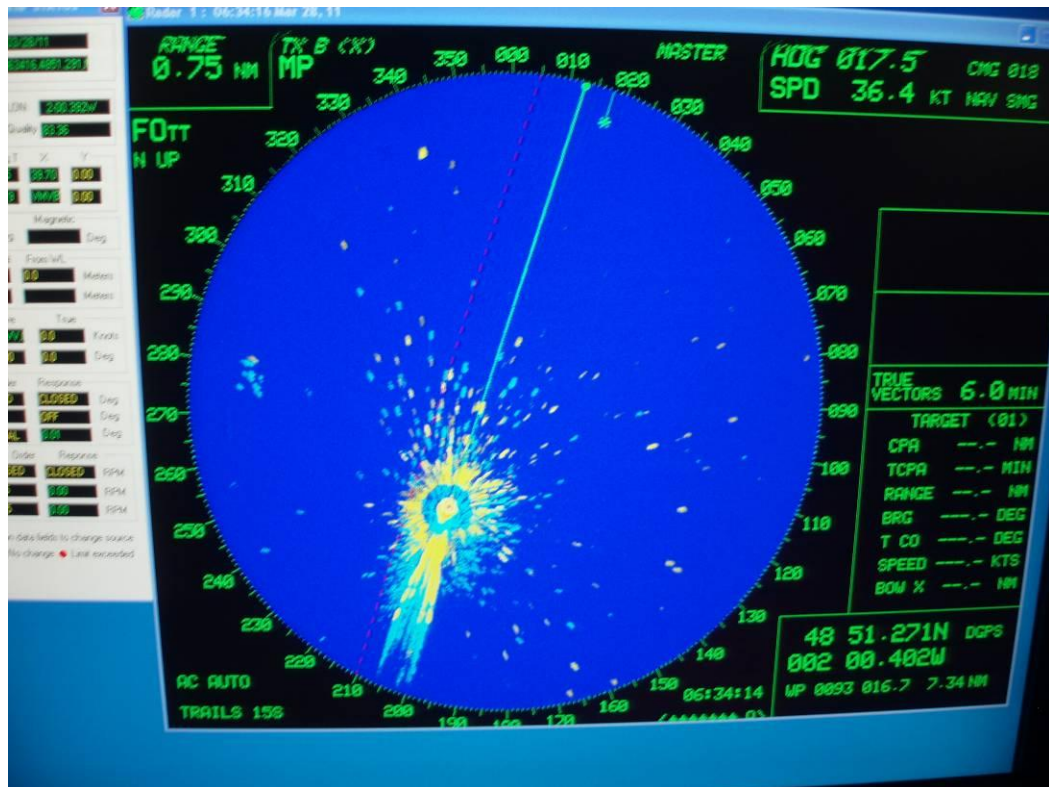
Figure 3: Radar screen after switching to medium pulse.

after sectors is common to many shipboard radars and is related to reflections off the vessel's structure (see Figure 3). Nevertheless, the difference between short pulse and medium pulse is very noticeable and was contributory in obscuring the contact immediately before the collision as well as after the collision when it might have been useful in tracing the wreckage for rescue purposes. The use of medium pulse did however permit better long-range detection on the Chief Officer's slaved display. The radar range on the Master's display was not changed from the relatively short 0.75 miles after the speed was increased to full sea speed.

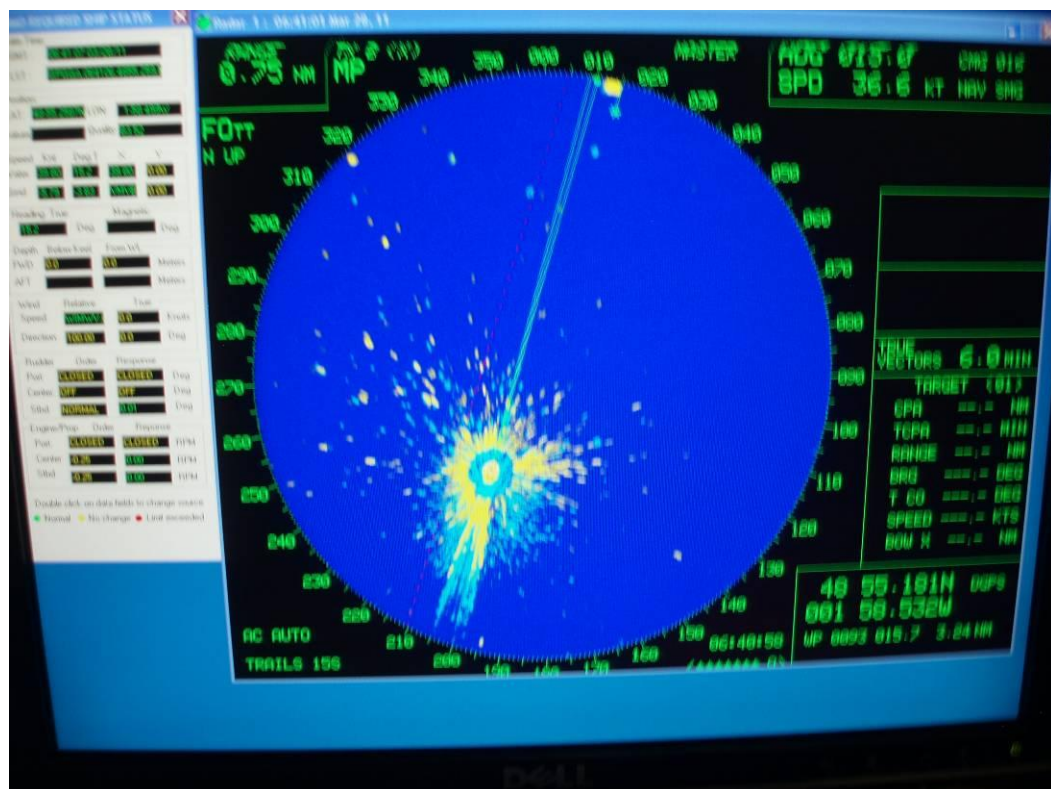
Figure 4: Contact – LES MARQUISES, first detection on Master's radar

- 4.34 In the short period during which it was detected before the collision, the contact of what is now known to have been LES MARQUISES (LM) was clearly visible on the VDR representation of the Master's radar. The contact first appeared on the edge of the offset screen at 06:41, slightly to starboard of the heading line. Because of the offset, the 0.75 mile range of the radar allowed for this contact to be detected on the screen at just over a mile (see **Figure 4**).

- 4.36 The lack of any realisation that at 06:38 a contact was detected close to the starboard side of the heading line on the Master's radar suggests that monitoring of the radar was not continuous and concentration was on matters not associated with the navigation of the vessel. The continued lack of realisation as the contact passed down the starboard side about 100 metres off further reinforces this conclusion. Based on the assumption that no visually detectable contact was seen it also reinforces estimates of visibility of between 20 and 30 metres described by the surviving fishermen. Conversation on unrelated topics continued throughout this period

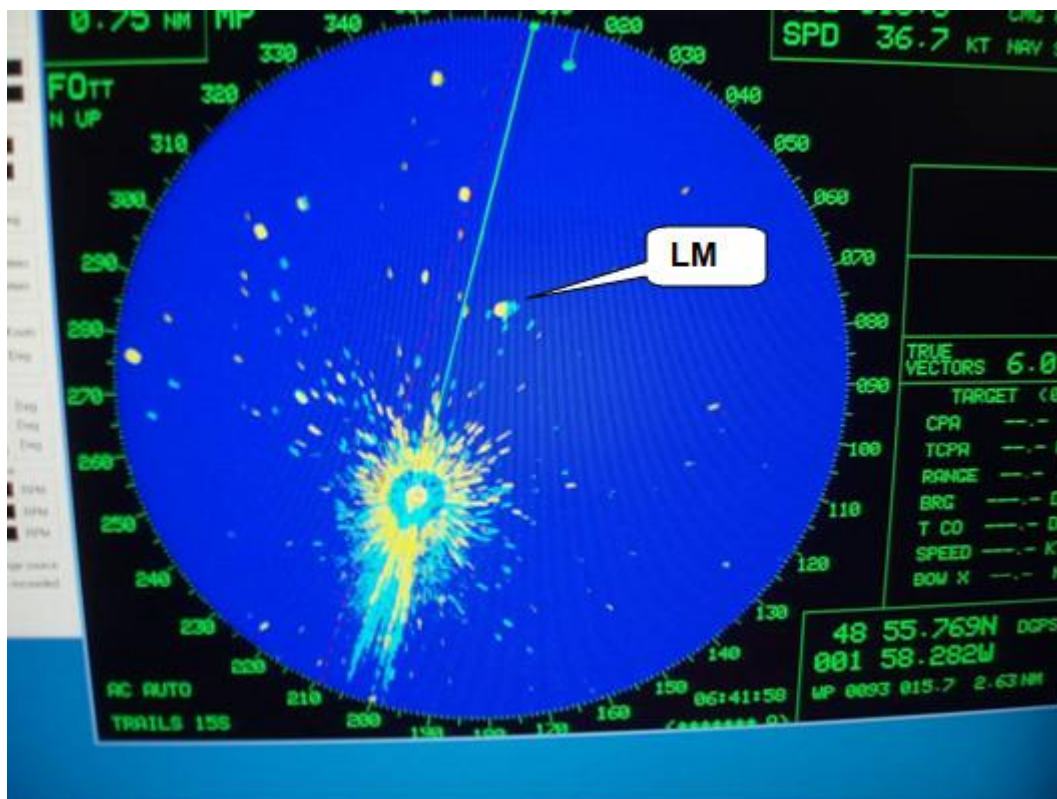
Figure 5: LES MARQUISES (LM) about 0.5 miles on starboard bow indicating slight movement towards heading line. Note pot marking buoys on port bow

- 4.38 The contact was not indicating much motion. After 06:42 the contact did possess a short tail (radar was set up to register tracks, see **Figure 5**) that suggested a westerly progress. Unfortunately, this was towards the vessel's heading line but it still did not generate any reaction in the bridge team.
- 4.39 At interview the surviving fishermen explained that at this time the LM was shooting a line of pots and was indeed heading in a westerly (down tide) direction, having just left one pot and headed for the next. The pots appear to be intermittently visible on the radar screen.

- 4.40 In this area there are numerous pots marked by buoys that, in good conditions are often visible on radar albeit intermittently (see **Figure 5**). HSC navigators are aware of them but there is no formal marking of particular pots on the chart. It is likely that the pots move considerably and cannot be regarded as permanent.

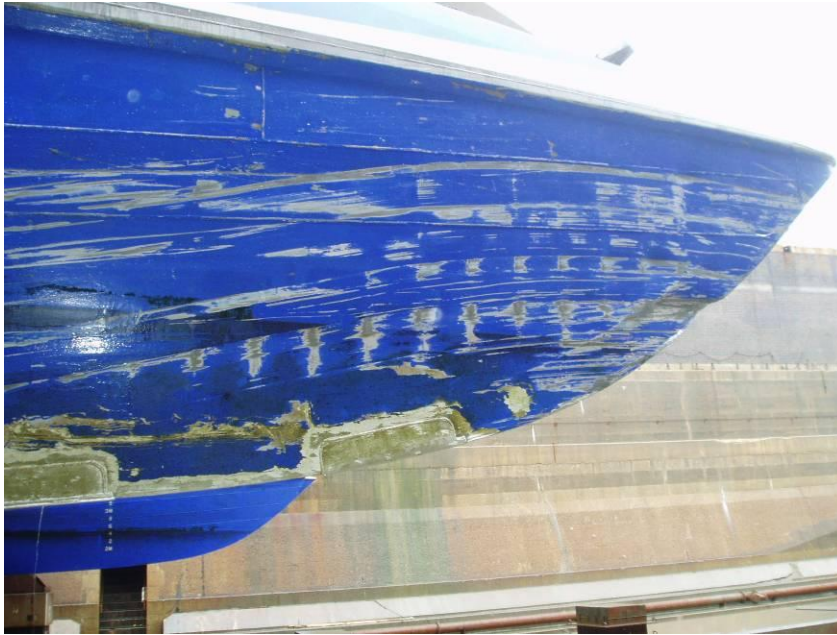
- 4.45 Damage to CV was assessed as penetration of the forward two spaces in the starboard hull (the starboard wavepiercing tip, a small compartment forward of the collision bulkhead and No 1 Stbd Void space containing the attachment point for one of the vessel’s 2 “T” foils). The loss of the starboard T-foil, suggests the hull of LM passed beneath the hull. Damage to LM appears to have been catastrophic. The surviving fishermen described the point of impact as the port side of the wheelhouse. Marks on the starboard hull of CV (see **Figure 6** and **Figure 7**) suggest that she passed over the LM whose hull then failed and the two halves passed up either side of the CV Starboard hull. Scoring could be seen mostly on the outer (starboard) side of the CV hull but some scoring was also evident on the inner (port) side of the starboard hull.

Figure 6: Damage to starboard bow of CONDOR VITESSE.

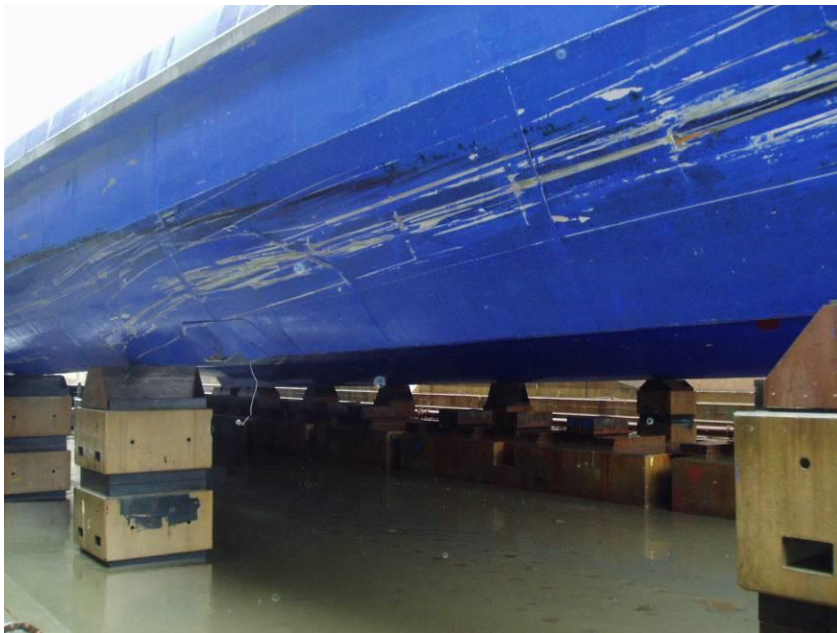
- 3.26 Initial reports identified that water ingress was evident in the forward two compartments of the starboard hull. The aftermost of these compartments also housed the mounting recess of the "T-foil" - a stabilising hydrofoil - and the evidence from damage to the mountings visible within the space was that this had been detached. The damaged mounting was another point of water ingress. Emergency measures were taken that included additional portable emergency pumps and hammering in of wedges to the penetration point.

Figure 7: Damage in way of T-foil. (control cable seen hanging down from the connection recess aperture)
