Report on the investigation of
the fatality on board
passenger cruise ship

Saga Rose

on 11 June 2008

Report No 01/2009
January 2009

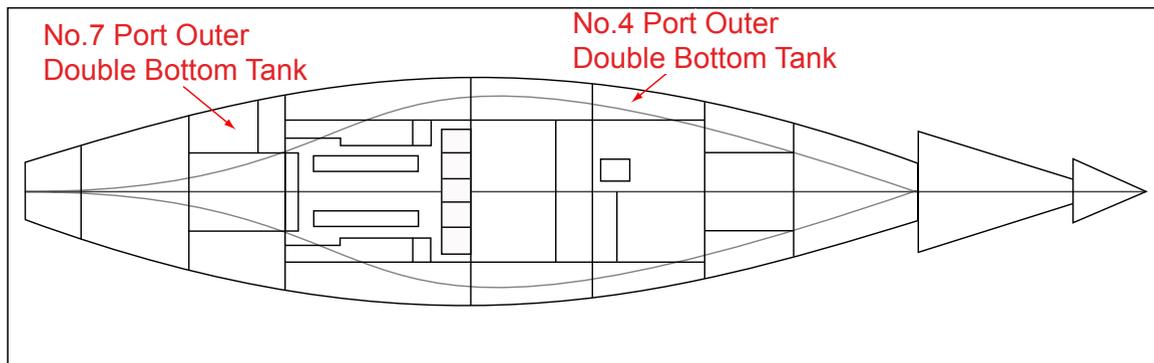
Figure 1

Extract of vessel's tank plan

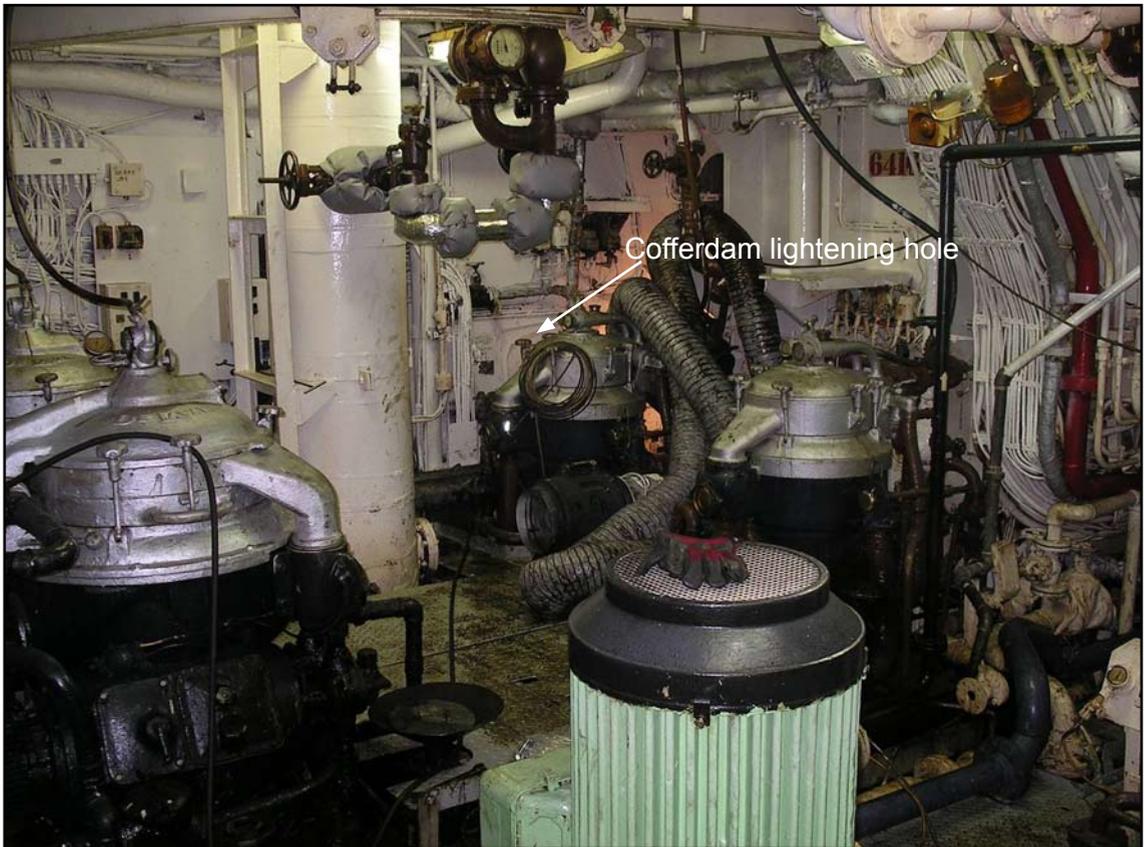
Figure 2

The purifier room

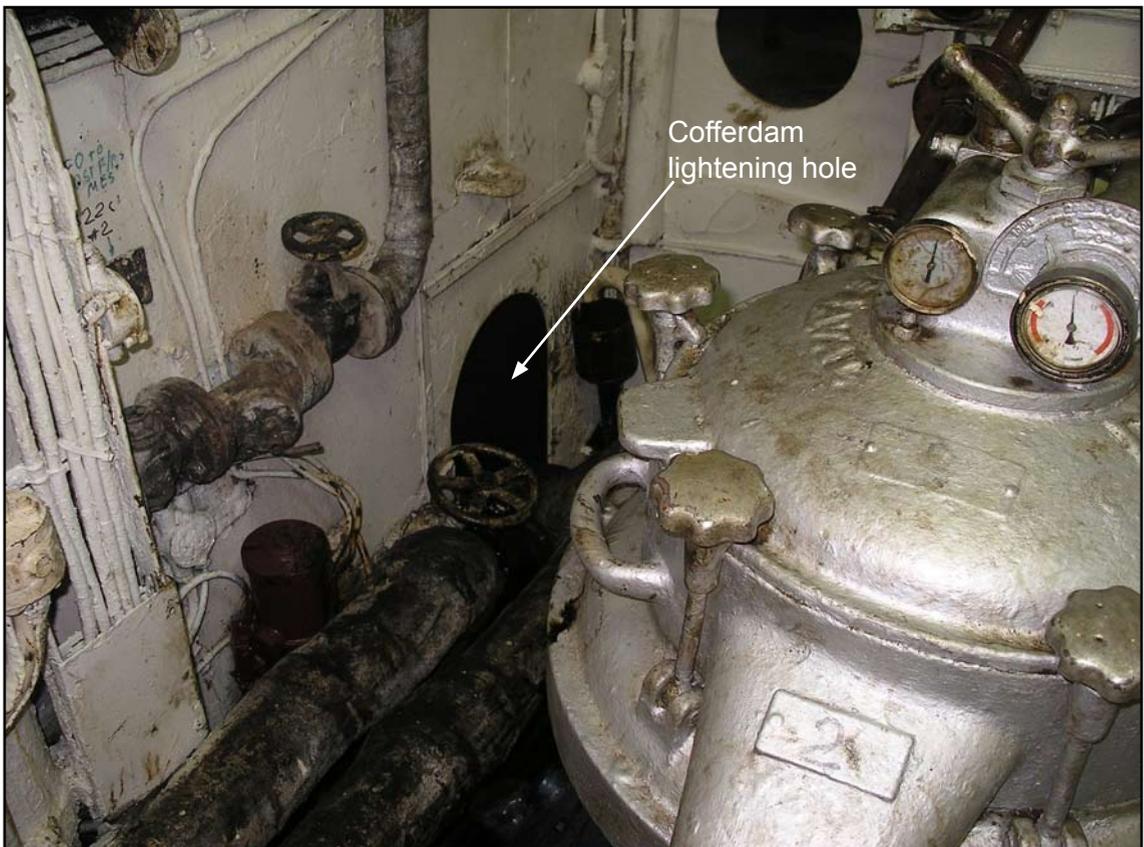
Figure 3

Entrance to the cofferdam (view from the purifier room)

The manhole was at the far end of a 5 metre open cofferdam (**Figure 5**) which was accessed through a lightening hole from the purifier room (**Figures 3 and 4**). The cofferdam was situated between two heated fuel oil service tanks and

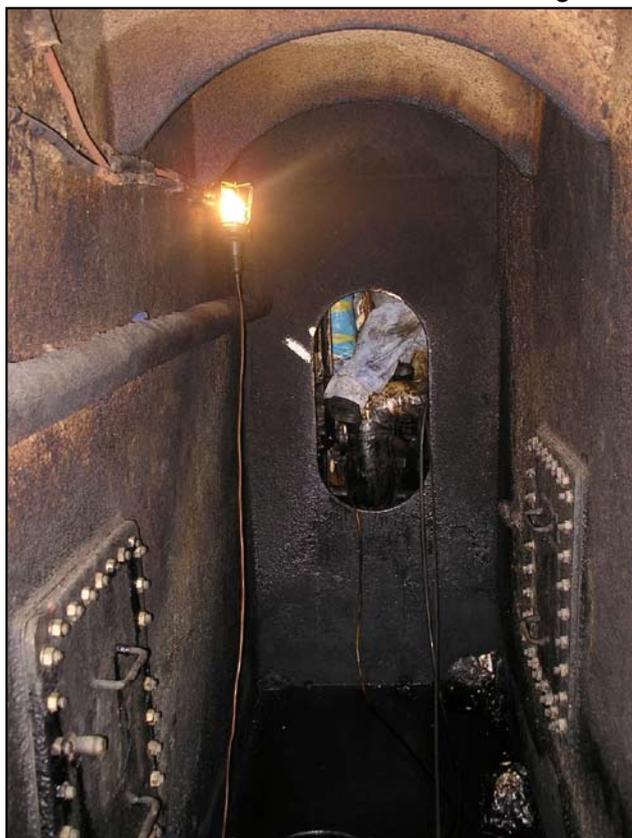
Figure 4

Entrance to the cofferdam (view from cofferdam)

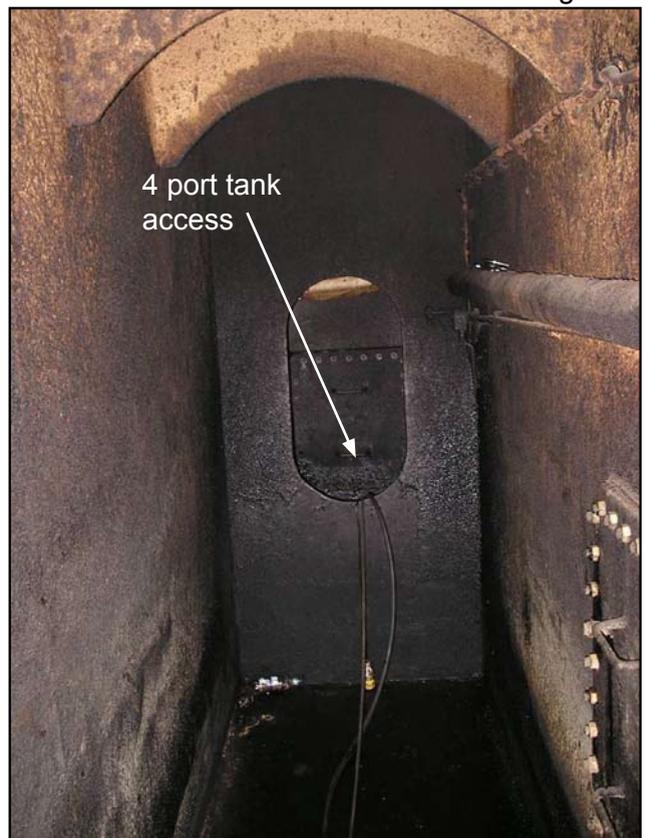
Figure 5

Cofferdam with tank access

the temperature in the cofferdam was between 40° and 50°C. Illumination was provided by a light with a wandering lead, and, other than for access to the double bottom tank, this space was not normally entered.

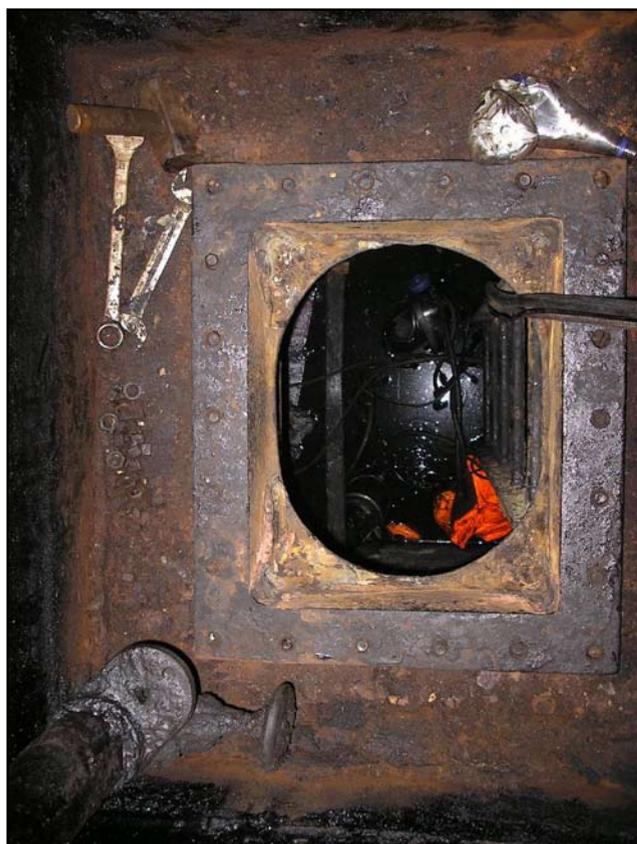
Figure 6

No.4 port outer double bottom tank manhole

Access into the tank was through a single tank top manhole fitted with a steel cover secured by 22 nuts and bolts. The manhole access was oval shaped, but the steel cover was rectangular with dimensions of 800mm x 600mm (**Figure 6**). Following the accident, the manhole cover gasket was found lying in the tank bottom under the discarded breathing apparatus and airlines used during the rescue.

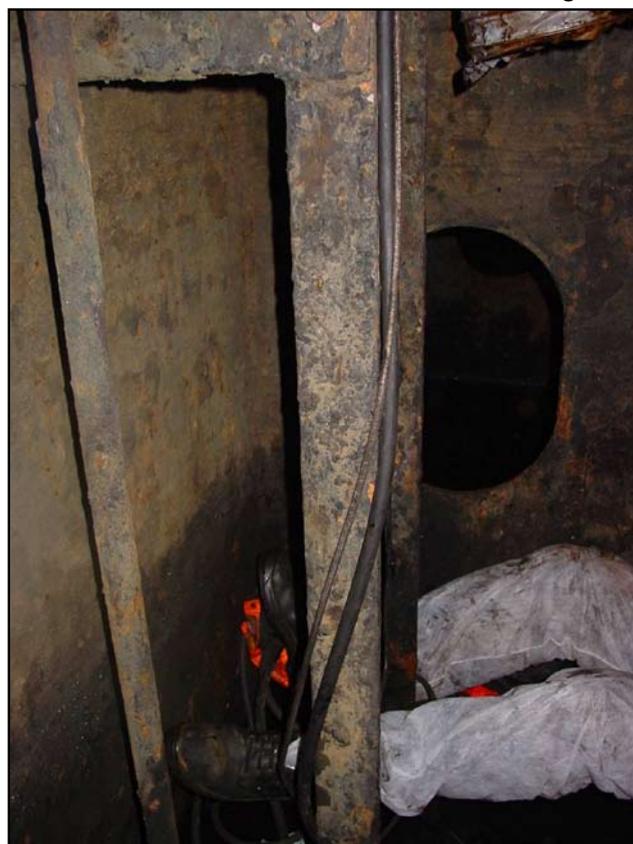
Figure 7

Reconstruction of the position of the second bosun

Although the postmortem report concluded that the bruising to the underside of the second boson's left arm supports the scenario of him reaching into the tank, sliding and tumbling in, this was unlikely in view of the extremely limited room available adjacent to the manhole (**Figures 5 and 6**). It is more plausible that he descended the ladder, and then reached towards the water at the tank bottom with his left hand while holding onto the ladder with his right hand. Once his head was inside the tank, he would have quickly lost consciousness and collapsed onto the protruding frame at the tank bottom (**Figure 6**), with his left arm extended. This scenario is also consistent with the position in which his body was found (**Figure 7**) and the absence of other injuries which would have been likely had he fallen 1.7m, head first into the tank.

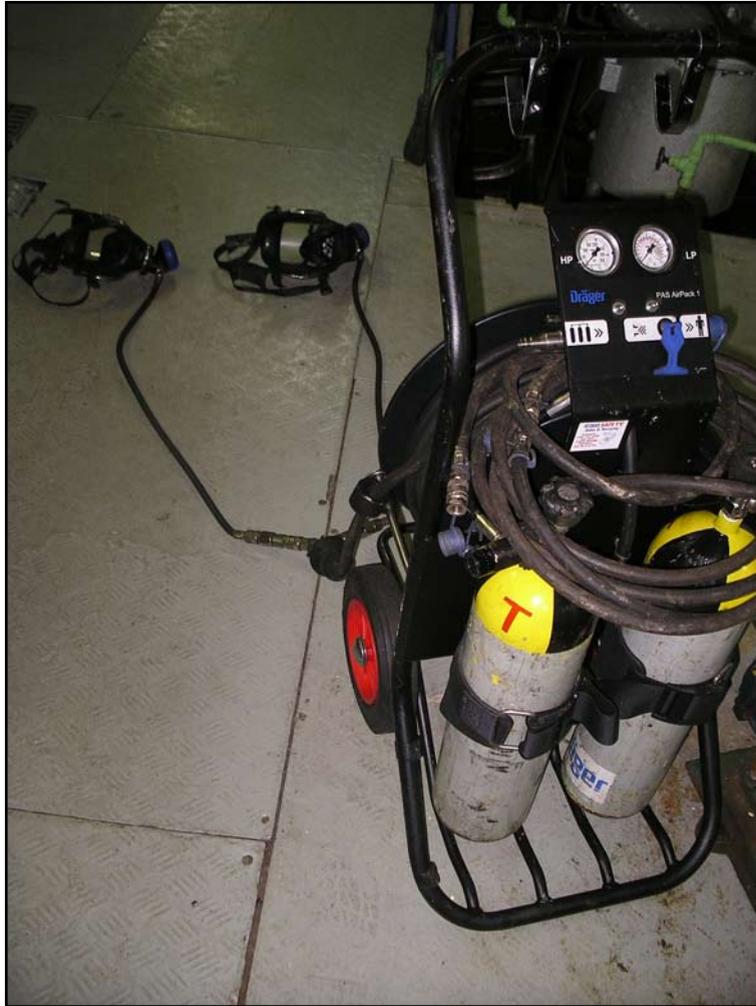
Figure 8

BA trolley set
