Report on the investigation of
The machinery space fire on board

Oscar Wilde

In Falmouth Bay

Report No 3/2011
March 2011

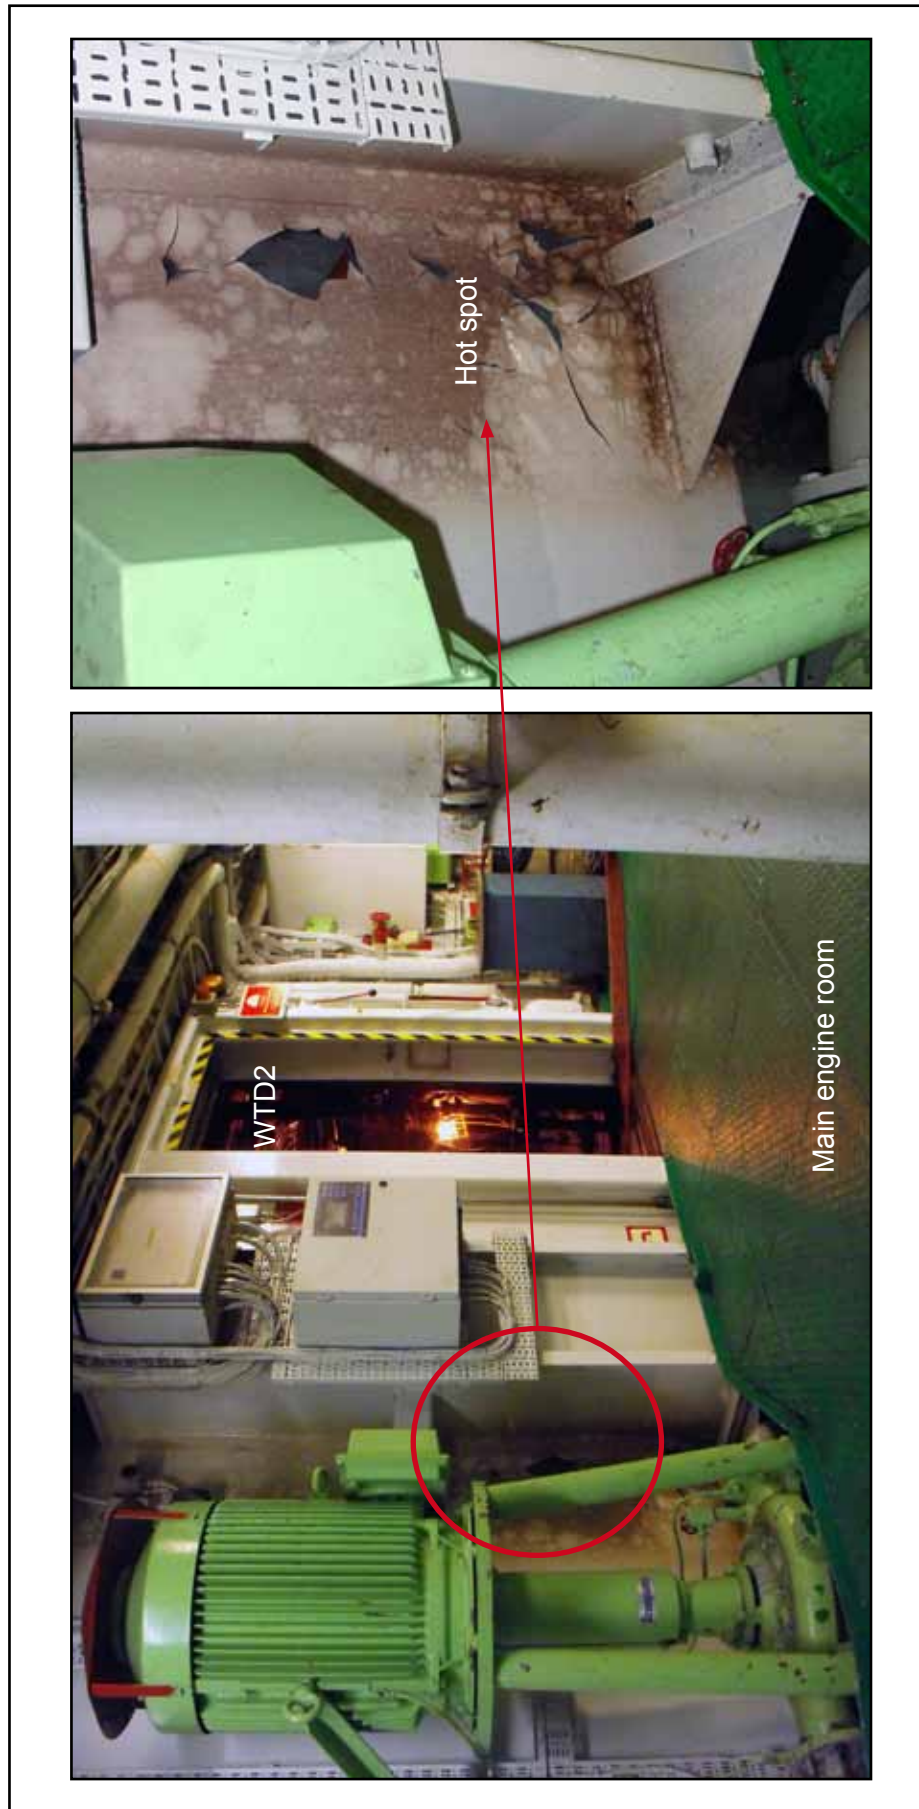
Figure 6

At 1927, the chief engineer reported hot spots on the deck of the lobby area outside the ECR. Two minutes later, the 2/E reported hot spots on the forward main engine room bulkhead next to WTD2 (**Figure 6**). The C/O interpreted this message to mean hot spots had been reported in the fire control station. This caused some confusion on the bridge as the control station was 2 decks above the AER (**Figure 7**).

Hot spots on main engine room bulkhead

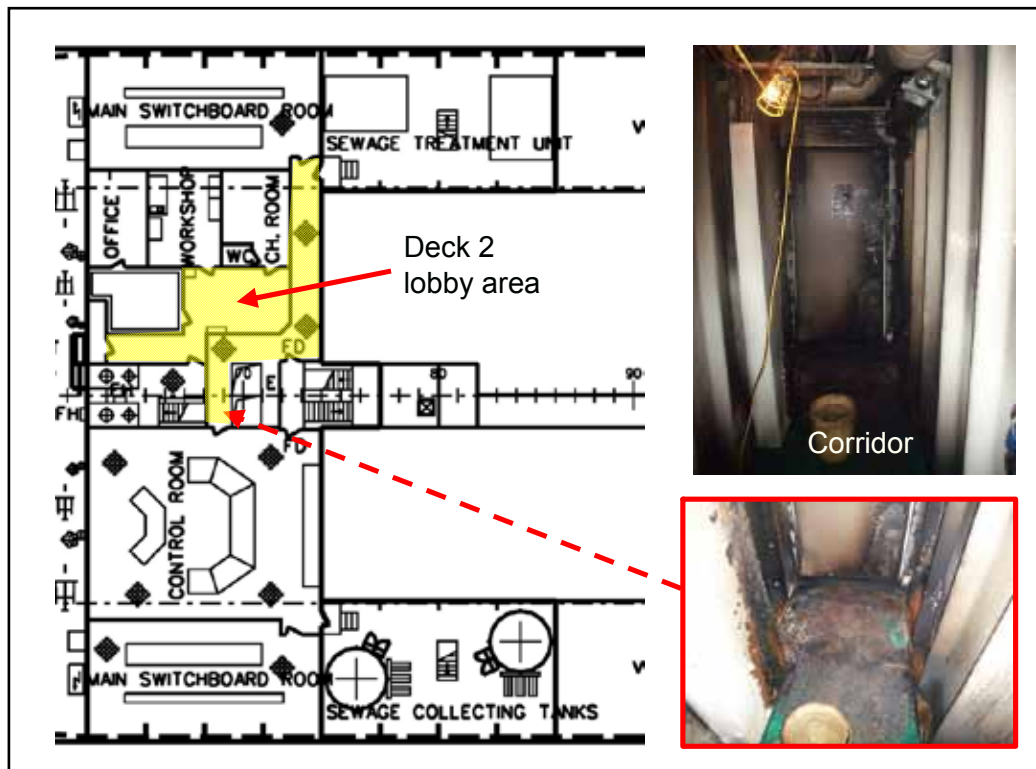
Figure 11

Seat of fire in corridor leading to the engine control room

The seat of the fire in the corridor outside the ECR was located at deck level on a cable tray that ran under a section of raised floor plates. The heat from the flames burnt paint on the bulkhead and ECR door, melted a light fitting and burst a sprinkler head bulb (**Figure 14**).

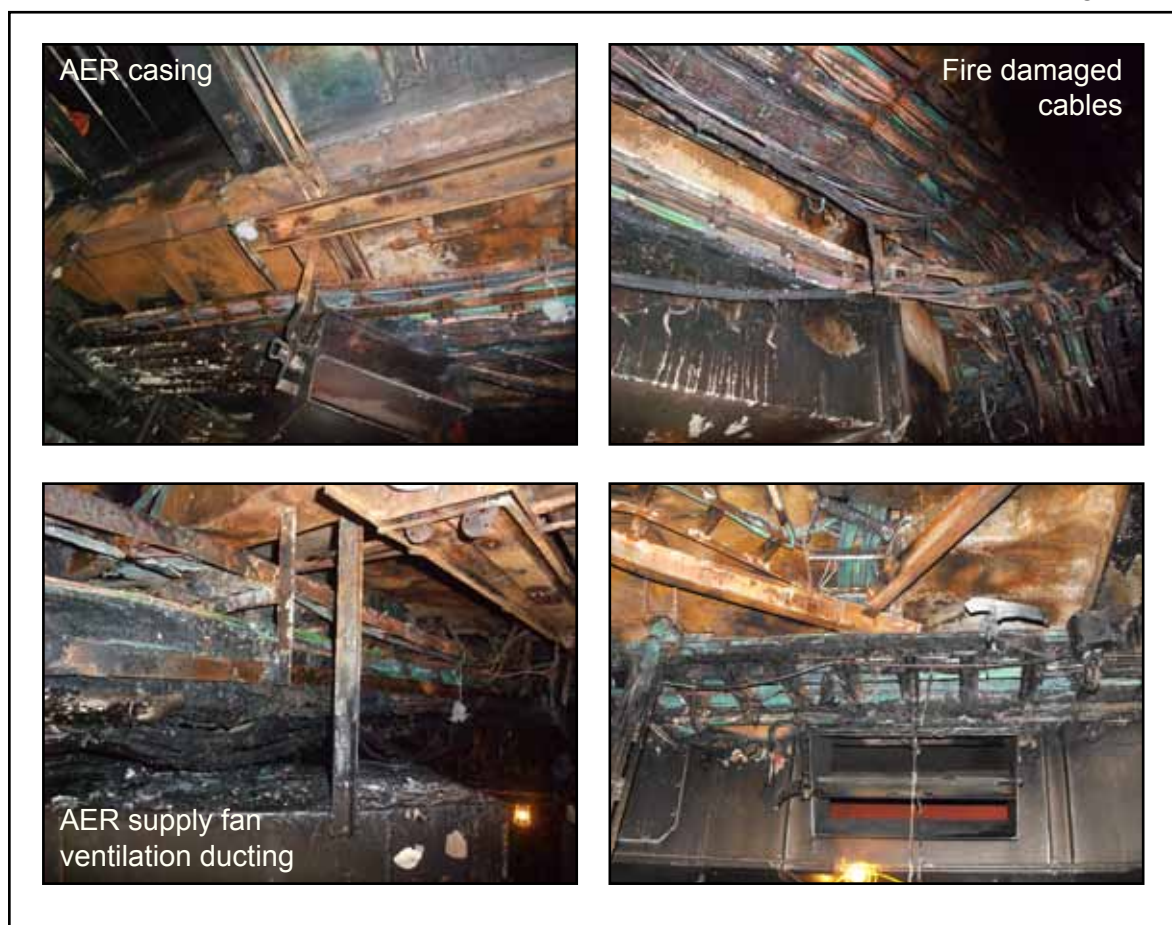
Figure 12

The heat damage and burn patterns on the outboard side of the fuel module indicated that the seat of the fire was low down but had spread to the electrical cables above. Damaged cables included the start/stop control cables for the emergency fire pump. No.3 auxiliary engine was not significantly affected by the heat radiated from the fuel module fire. The greatest damage at deckhead level was evident between the fuel module and the AER ventilation duct openings and starboard forward casing uptake area (**Figure 12**).

Fire damage to deckhead cables in the auxiliary engine room

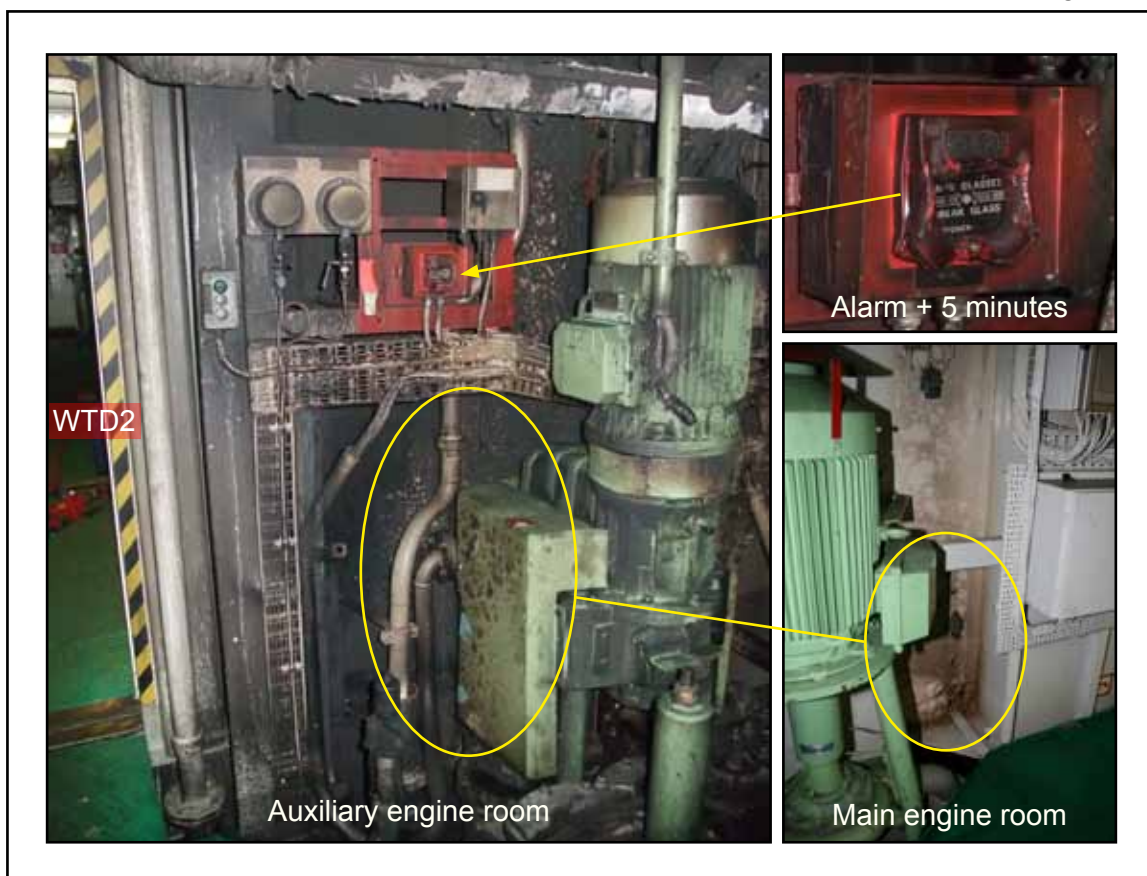
The heat from the bilge fires close to the aft AER bulkhead caused the casing of the manual break-glass fire alarm call point next to WTD2 to melt and the paint on the bulkhead in the main engine room to blister (**Figure 13**). The manual call point alarmed about 5 minutes after the initial flame sensor had activated.

Damage caused by bilge fire

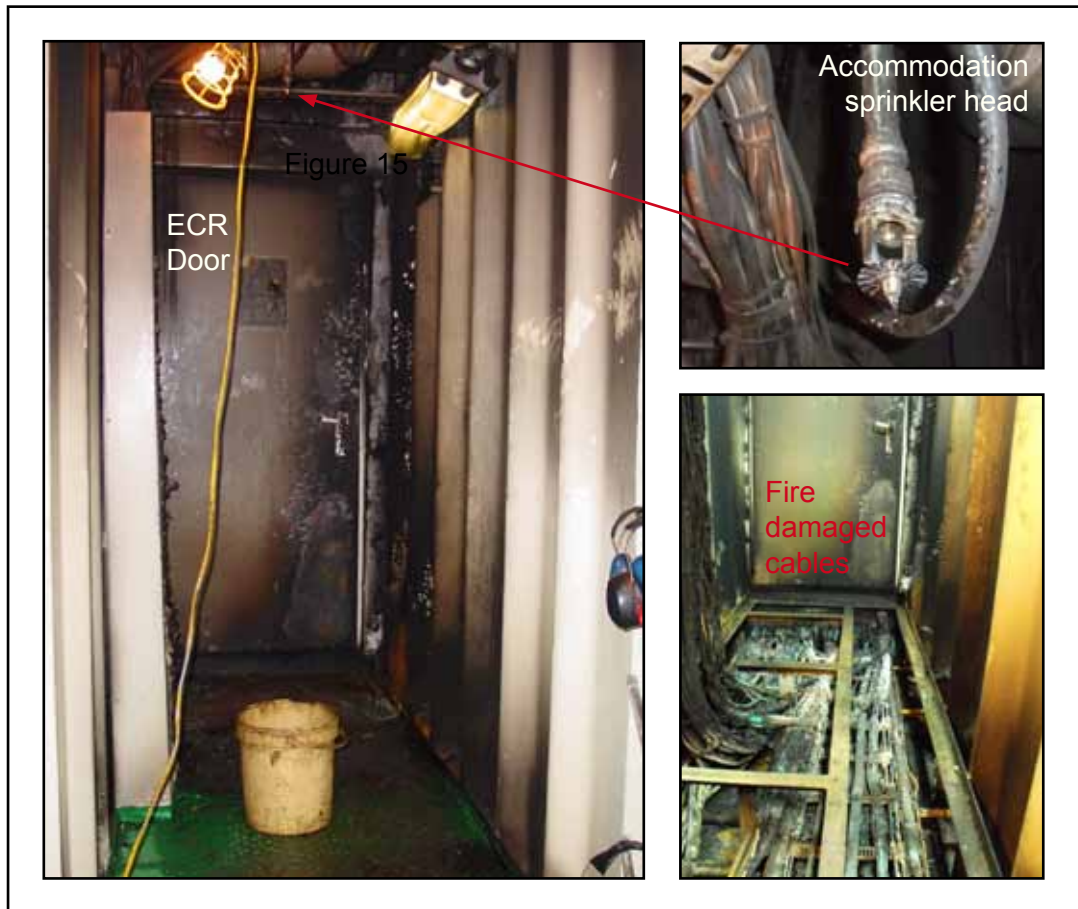
Fire damage on deck 2 outside the engine control room

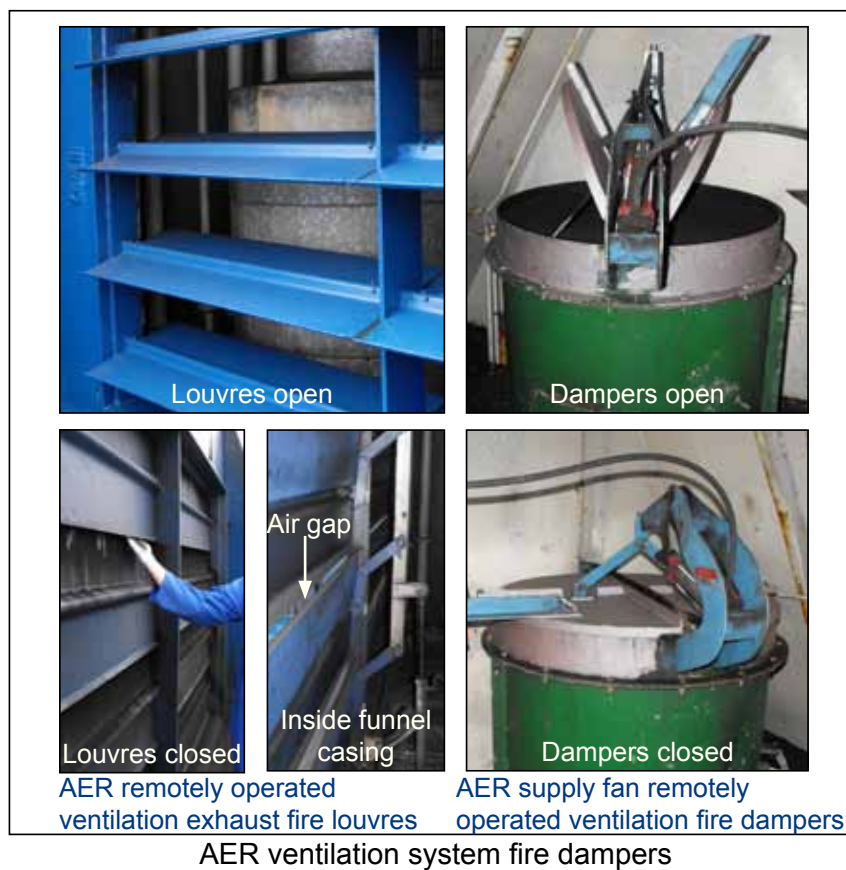
Figure 15

The AER ventilation dampers were found to be in the closed position (**Figure 15**). However, the exhaust louvres on the back of the funnel did not form a gas-tight seal when closed.

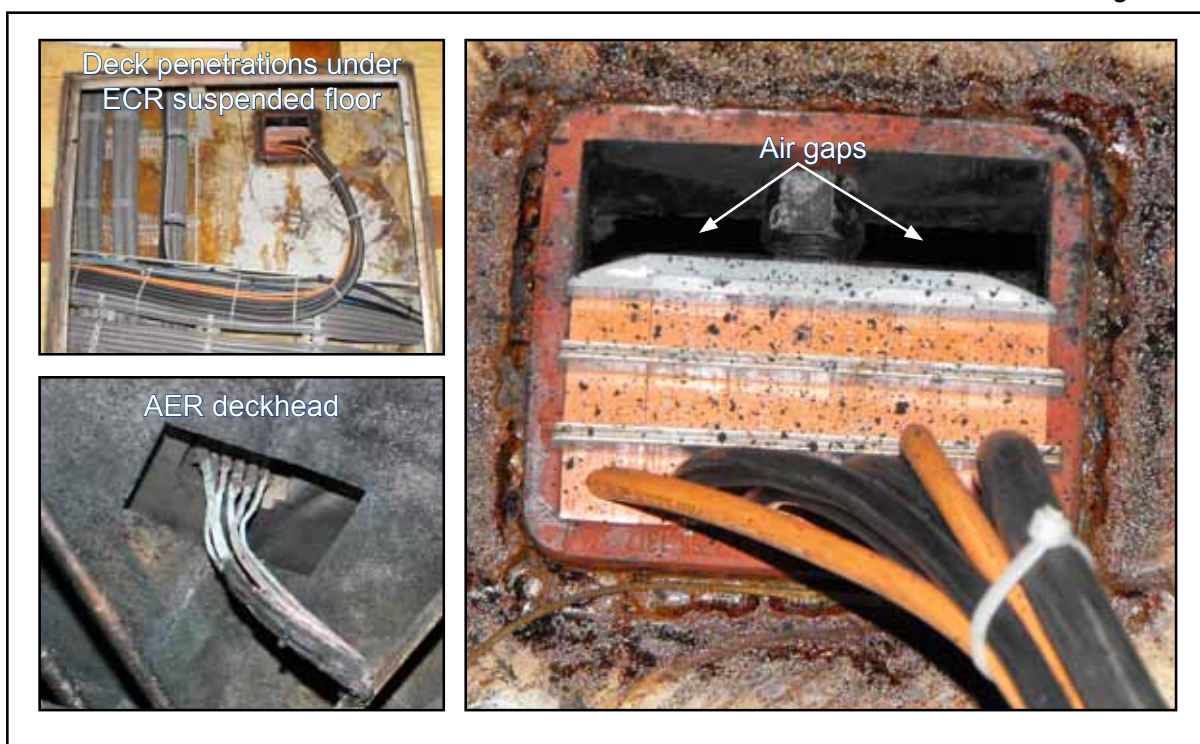
Several deck penetrations between the AER and ECR had not been properly packed and did not provide a gas-tight seal (**Figure 16**). The ventilation supply and exhaust system for the ECR and adjacent compartments was common to the zone 2 passenger accommodation spaces on deck 8. The crew was unfamiliar with the ventilation system, and the vent trunk fire dampers between these areas had not been closed. The doors to the switchboard rooms and other compartments on deck 2 were secured in the open position.

Engine control room deck penetrations

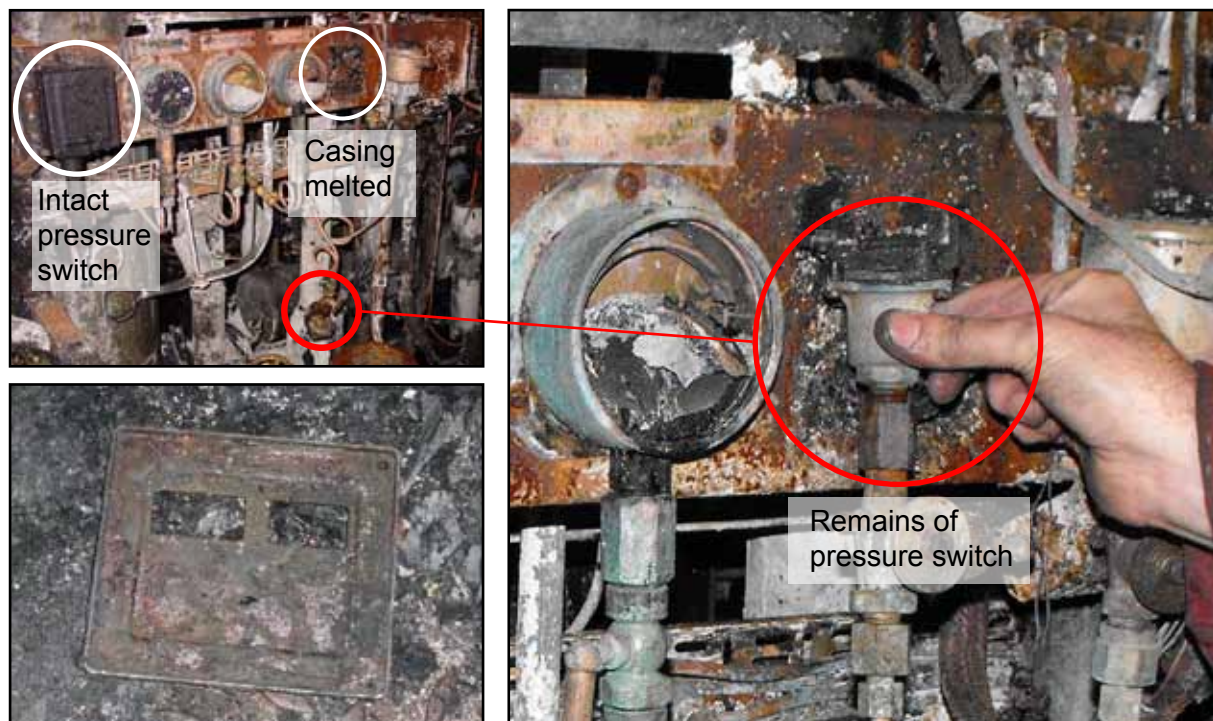
One of the module's pressure switches had been exposed to intense localised heat. Its metal alloy casing had completely melted and its steel casing cover was found on the deck plates close to No.3 auxiliary engine (**Figure 19**). The remains of the pressure switch were removed and closer examination revealed its pressure bellows to be intact.

Pressure switch casing cover found on deck plates

Fire damaged pressure switch

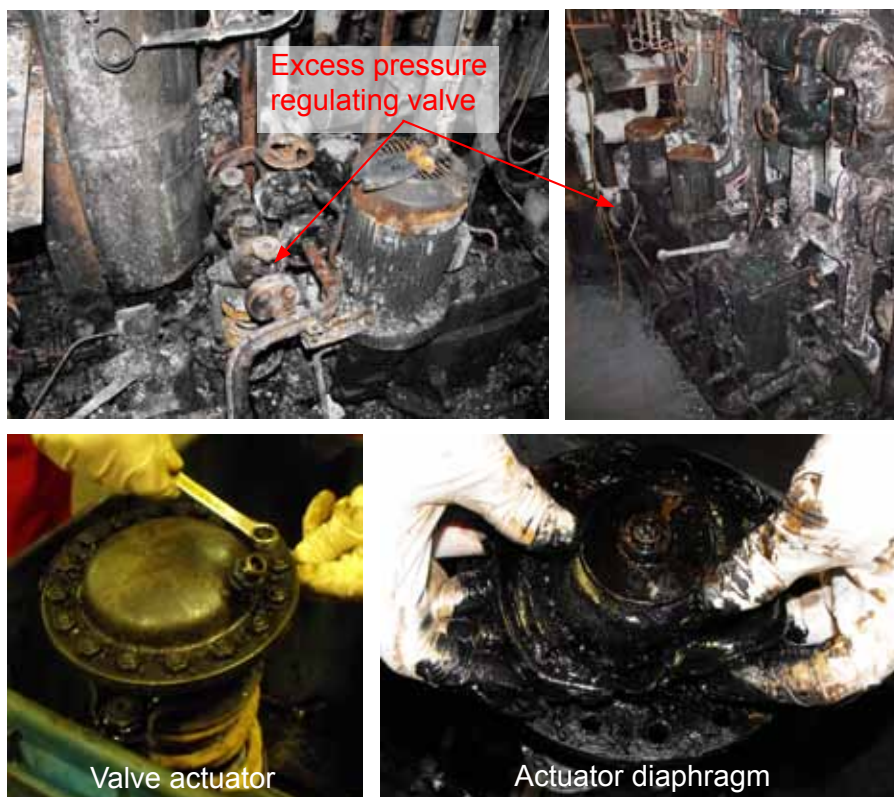
Figure 20

The excess pressure regulating valve's actuator was positioned close to the seat of the fire. The valve was removed and its actuator inspected (**Figure 20**). The rubber diaphragm was in poor condition and had suffered heat damage.

Location of the fuel system's excess pressure regulating valve

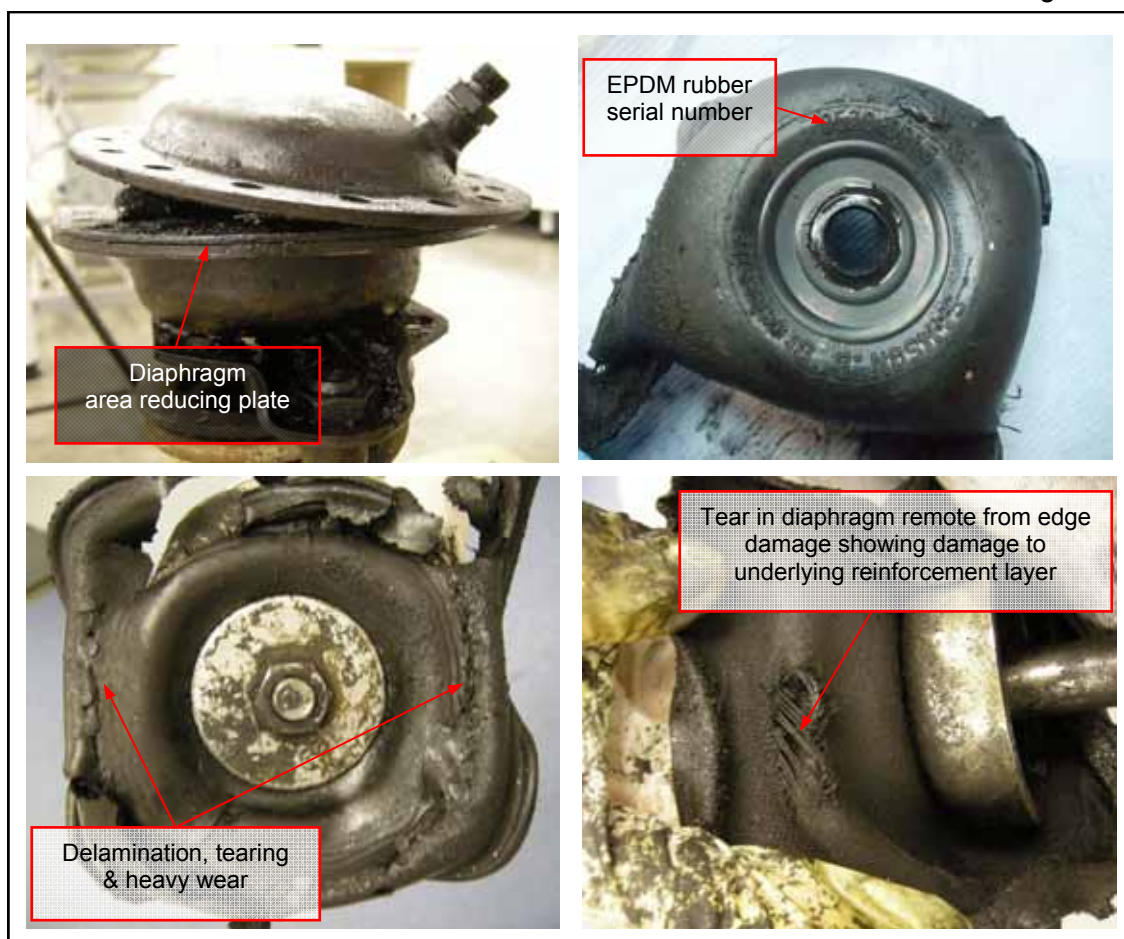
Figure 23

The test report on the diaphragm removed from the valve actuator identified deterioration of the rubber and a tear in its main flex region (**Annex B**). This damage was remote from the fire damage evident at its outer edge. The diaphragm was made from EPDM rubber and was therefore not suitable for use in fuel oil systems. The actuator had a diaphragm area reducing plate which increased the valves' operating pressure range to 4.5 to 10bar (**Figure 23**). The actuators fitted to the fuel modules on board *Oscar Wilde* were not fitted with any optional safety features.

Condition of the auxiliary engines' excess fuel pressure regulating valve diaphragm

Following the examination of damage to the diaphragm from the excess pressure regulating valve, similar valves fitted to the vessel's two main engine fuel modules were replaced. The diaphragms in the main engine valves were also made from EPDM rubber and found to be severely degraded in the main flex area (**Figure 24**). The replacement valves were fitted with FPM diaphragms, diaphragm leakage glands and rupture indicators.

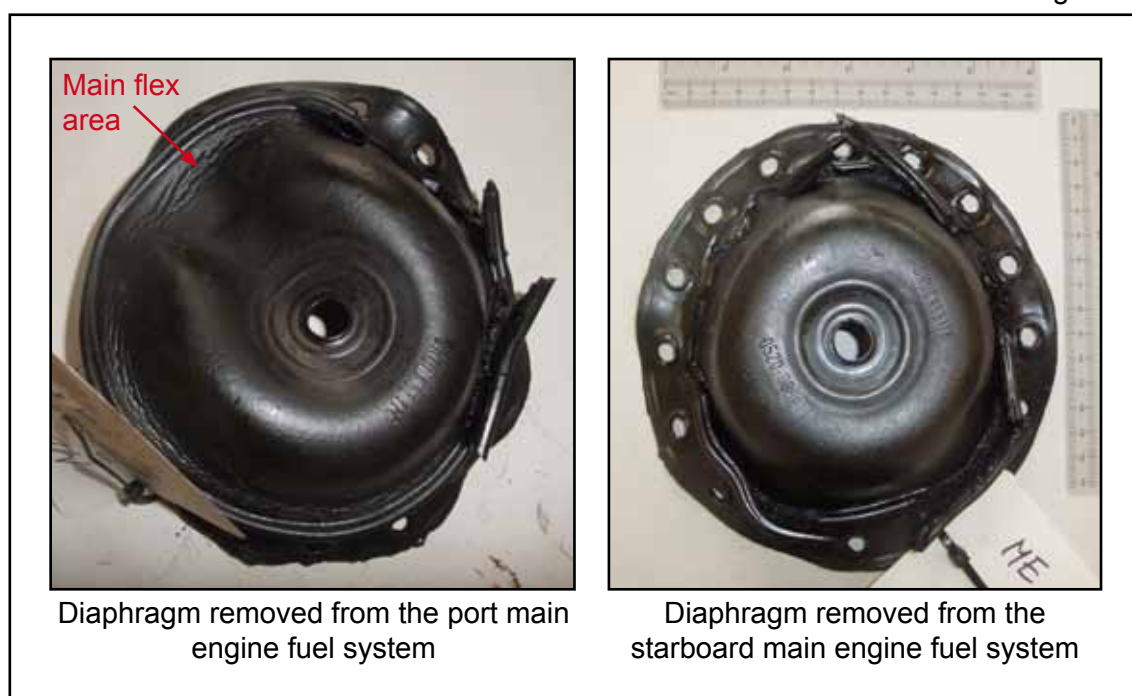
Figure 24

Main engine actuator diaphragms

The information on the actuator tally plates corresponded with that given for EPDM diaphragms and, in the case of the auxiliary engine system, the higher pressure range. No date stamps were found on any of the diaphragms. Neither Irish Ferries, nor the vessel's previous owners, had any record of the actuators being replaced or overhauled. Samson advised that the absence of date stamps on the diaphragms indicated that they were likely to be about 10 years old.

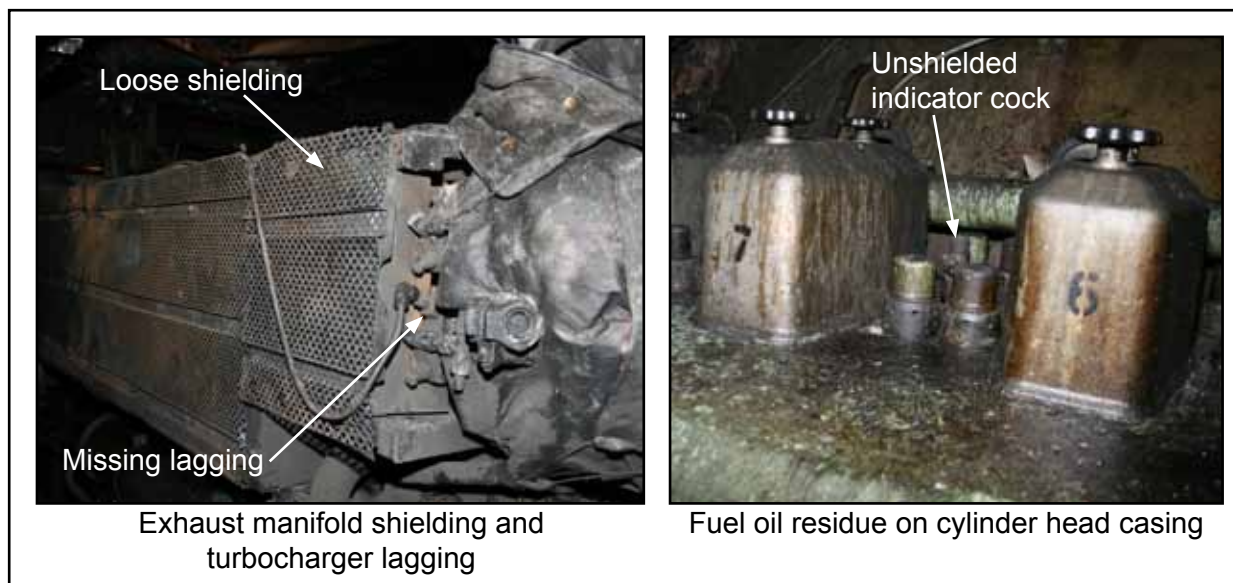
Fuel oil residue on number three auxiliary engine

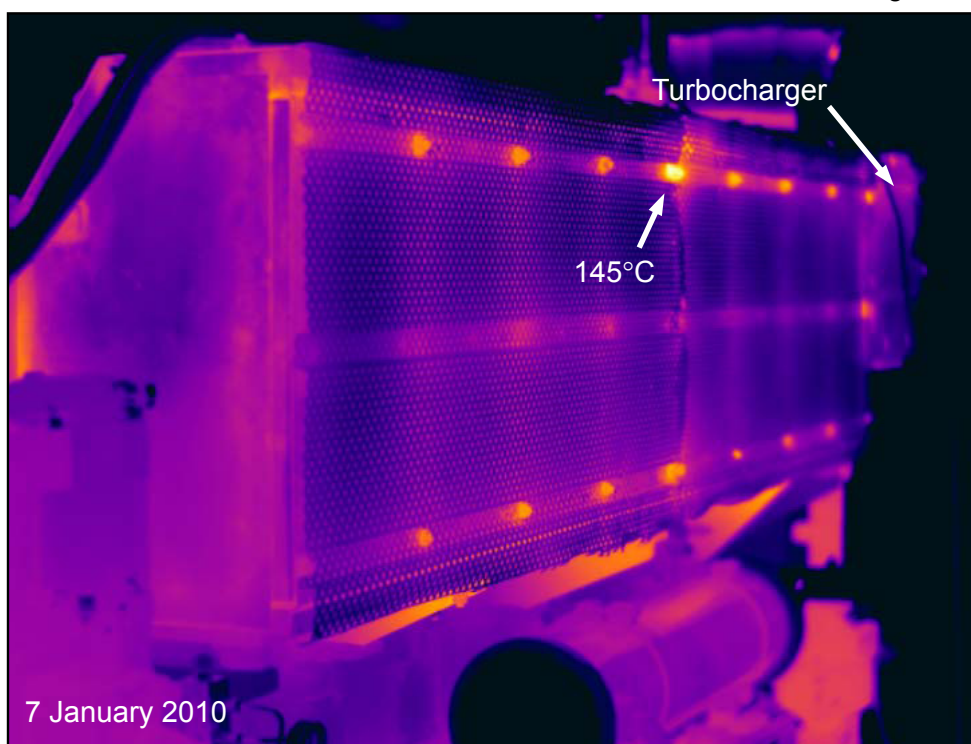
Figure 27

A thermal survey of the ship's electrical distribution system was carried out by a specialist contractor prior to the docking period. The main and auxiliary engines were not included in the work package but, at the request of the chief engineer, thermal images were taken of the auxiliary engine exhaust shields (**Figure 27**). These images identified hot spots, but information relating to the loading on the engines at the time of the survey was not available and no images were taken of the turbocharger or the outboard side of the engine. Work was carried out on the main and auxiliary engines during the docking period that would have required the removal of lagging and heat shields. However, a thermal survey was not carried out prior to the ship returning into service.

Thermal image taken of number three auxiliary engine exhaust manifold shielding prior to docking period

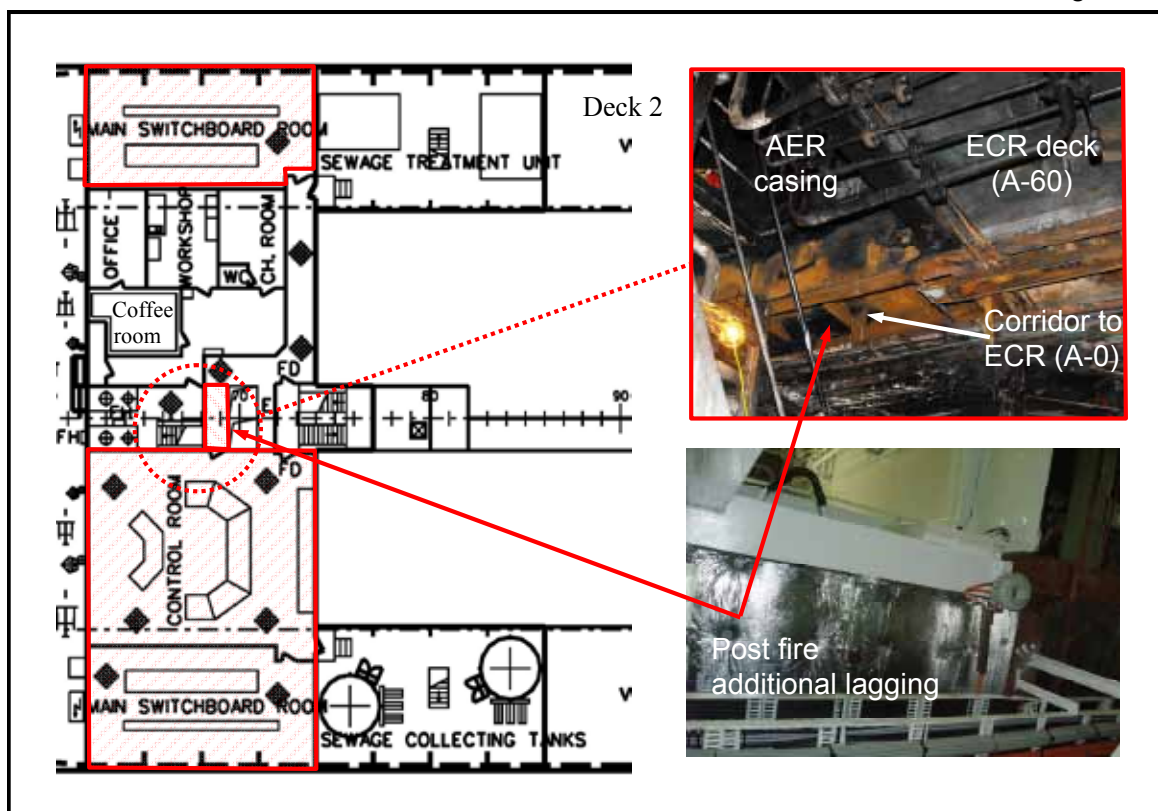
The lobby and corridor area on the port side of the ECR was classified as a *tank, void or auxiliary machinery space having little or no fire risk*. As such, the deck and bulkhead boundaries between it and the AER required A-0 structural fire protection. Therefore, no thermal insulation was provided. Some of the compartments had changed use over time; an electrical store had been converted to an office and a coffee room had been provided for the engineers (**Figure 29**). The deck between these areas and the AER also had no thermal insulation. Following the fire, and prior to *Oscar Wilde* returning into service, Irish Ferries fitted an additional section of A60 insulation to the deck between the AER and the corridor area next to the ECR (**Figure 30**). This additional insulation has subsequently been extended to cover the whole of the AER boundary.

Additional thermal protection fitted prior to the vessel returning to service

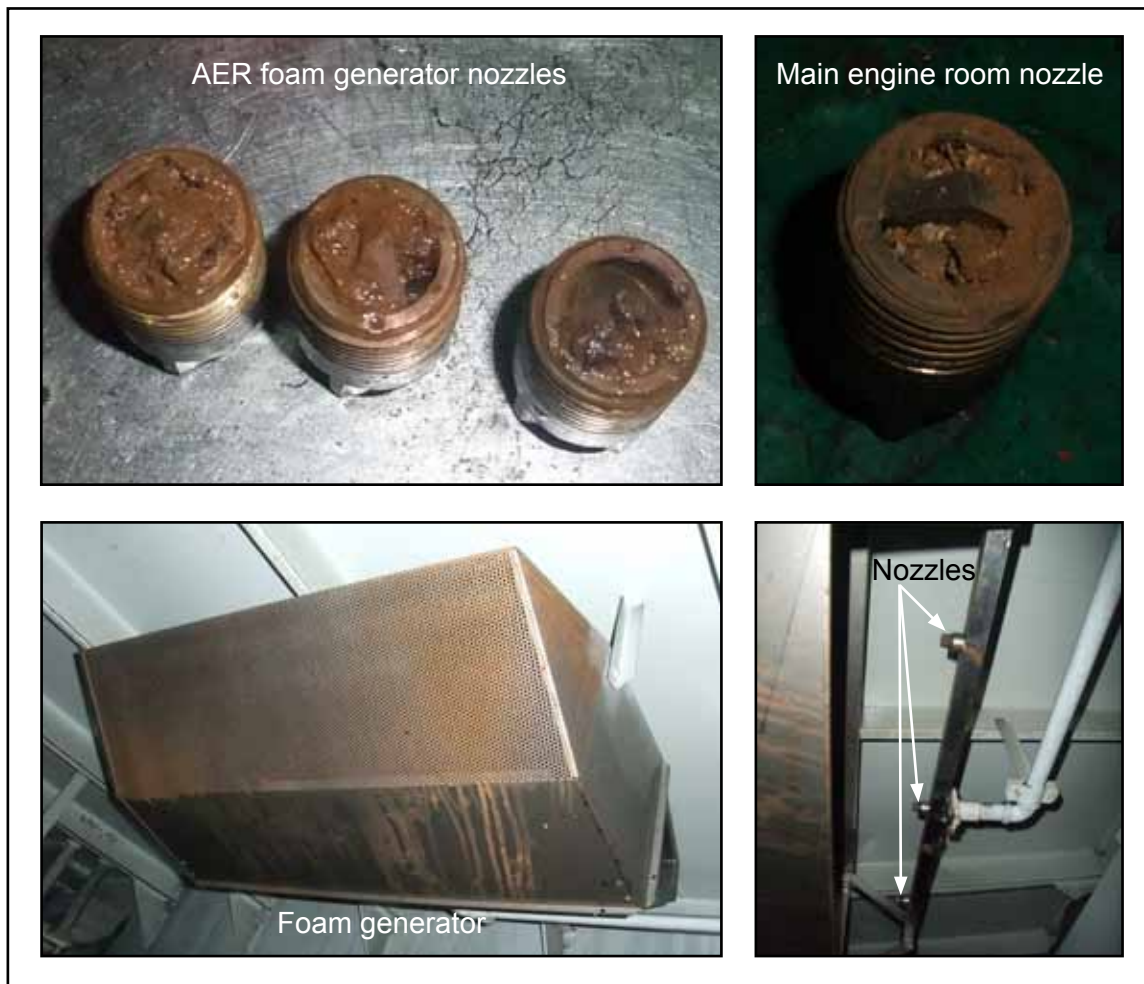
Figure 36

On 5 March 2010, manufacturer's representatives conducted a thorough examination of the system. The foam concentrate pump was found to be fully operational and the sea water strainer was clear. The foam proportioner was in good condition, set at the required 2%, and was functioning correctly. Thirty-one of the 39 AER foam generator nozzles were found to be completely blocked with rust and scale (**Figure 36**). The nozzles from the other protected spaces were removed for inspection, and approximately 50% were found to be blocked.

Blocked *Hotfoam* generator nozzles

The distribution pipework was chemically cleaned and was proved clear of debris before being tested to the satisfaction of the class and flag surveyor. The manufacturer's investigation report included the following recommendations:

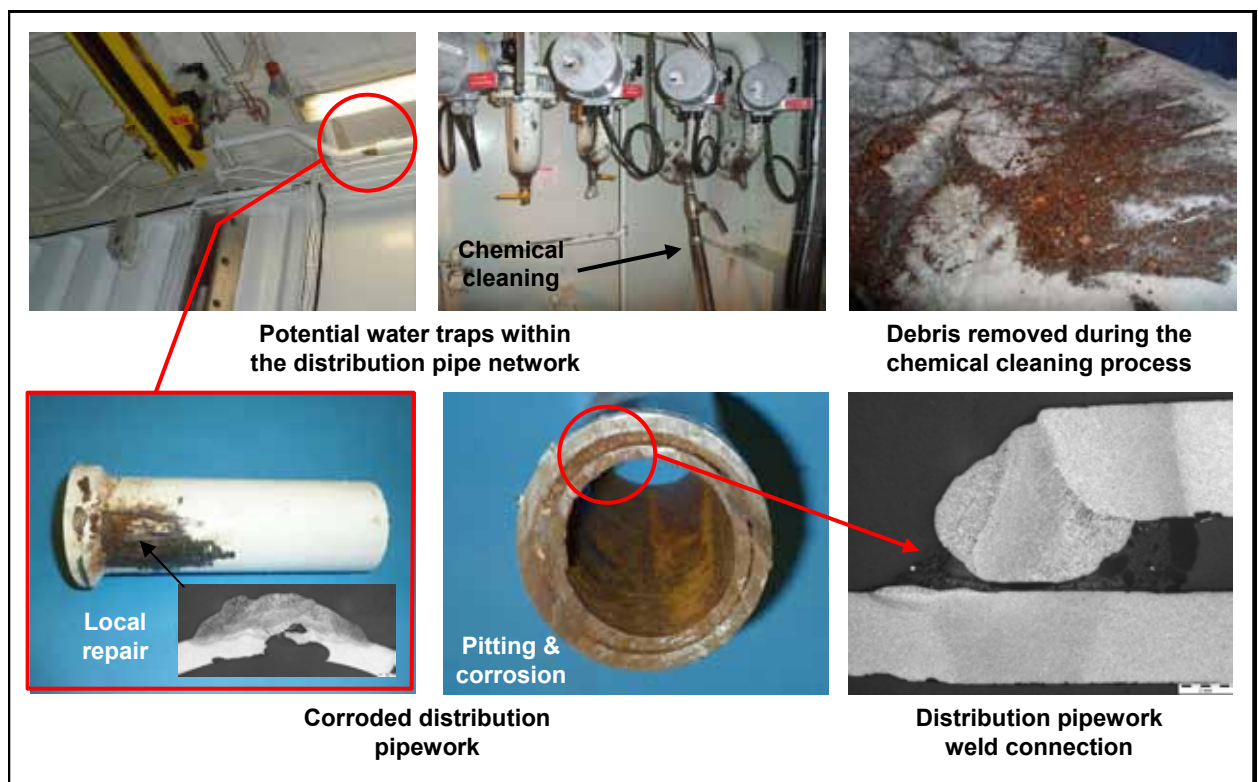
Figure 37

Hotfoam system distribution pipework
