**M.V STENA SPIRIT**

**Report of the marine safety investigation into a fire on the  
vehicle deck in the outer approaches to Gdynia, Poland on  
31 August 2016**

# FINAL REPORT

truck fire on a car deck  
at the approach to the port of Gdynia  
on 31 August 2016

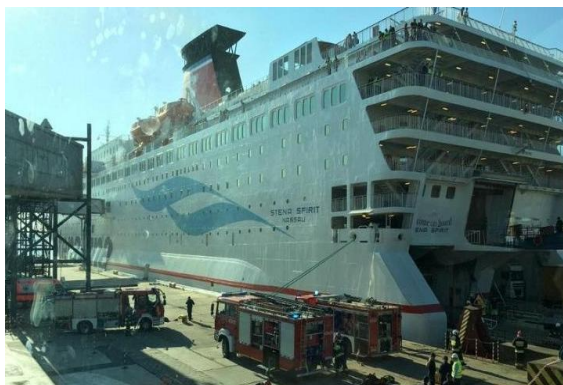
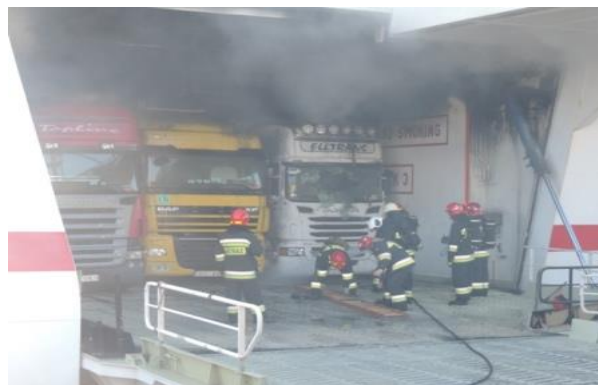
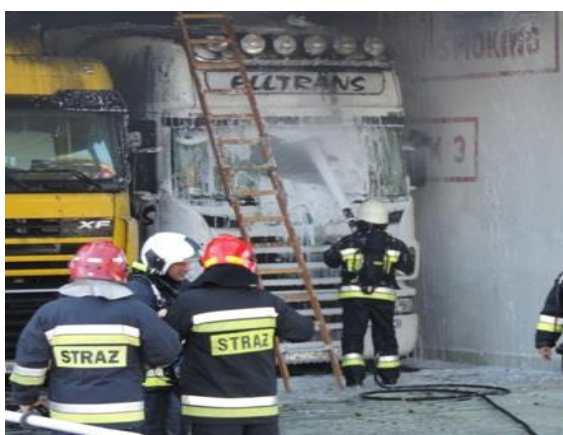
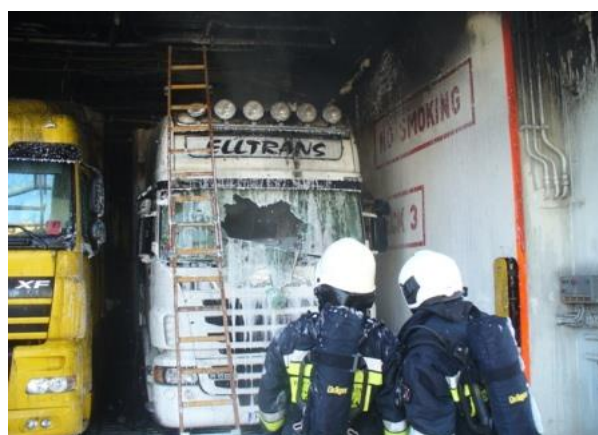
After the crew opened the ship's stern ramp, the shore-side firefighters finished extinguishing the truck fire to ensure the fire was extinguished and no remnants of smoldering material remained inside the cab of the truck and secured the fire location against re-ignition.

Photograph No. 2. Extinguishing the fire of a refrigerator truck onboard of "Stena Spirit"

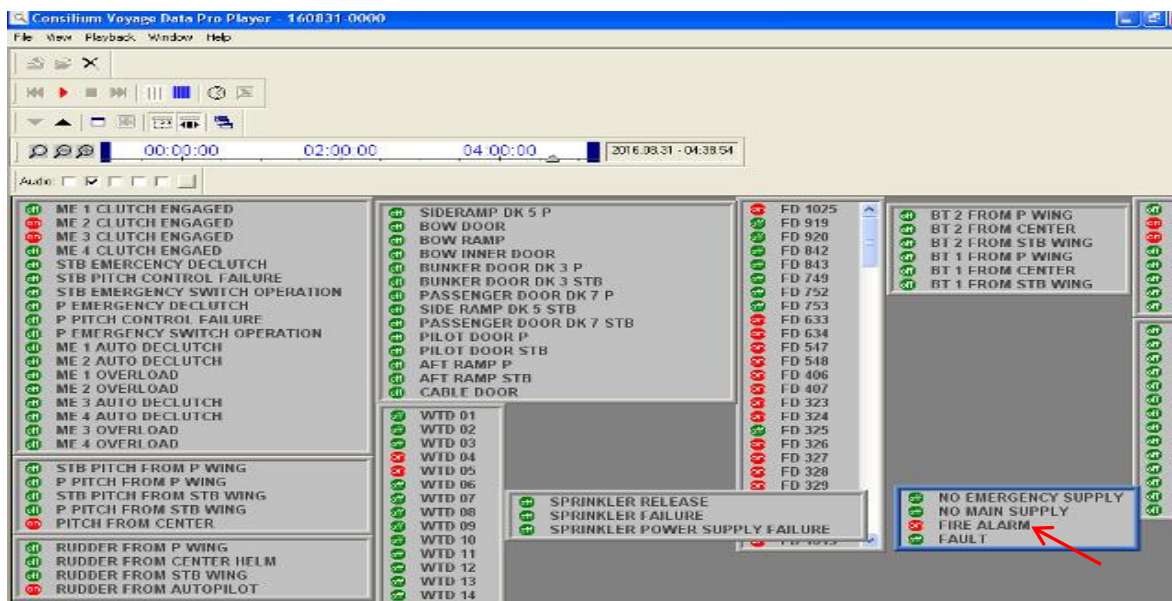
Photograph No. 3. Fire alarm recorded by the VDR

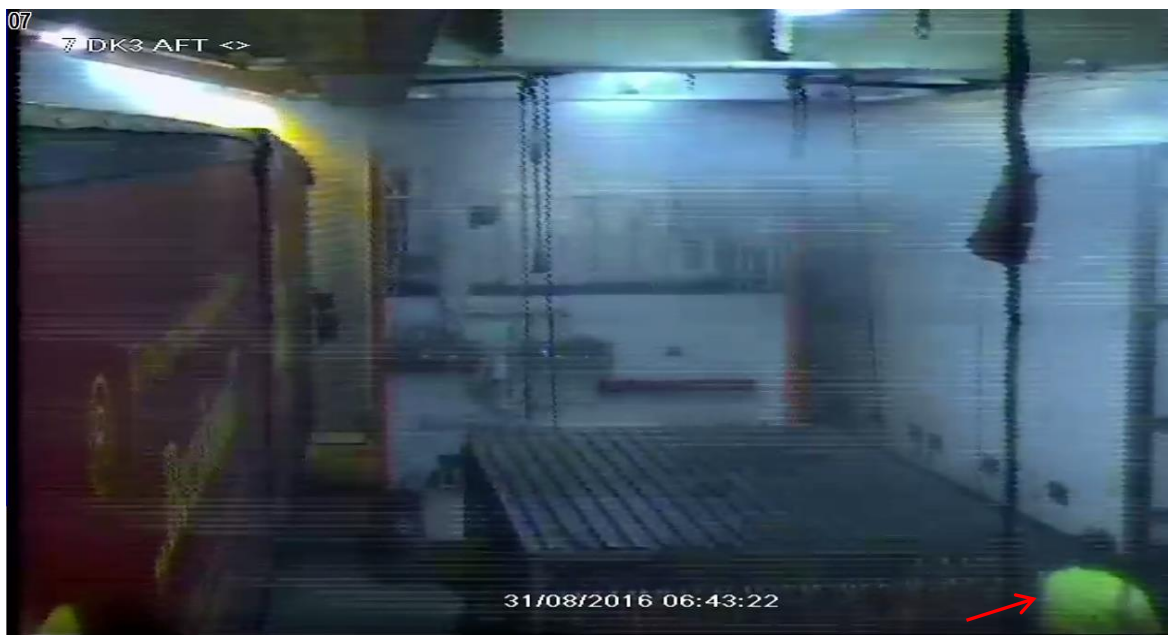
Instructed by the officer of the watch, the watchman disconnected power supply of the truck's refrigerator unit from the ship's electrical system in the distribution cubicle located on the wall of the companionway to the steering room.

*Photograph No. 4. Watchman next to the refrigerator truck in smoke fumes*

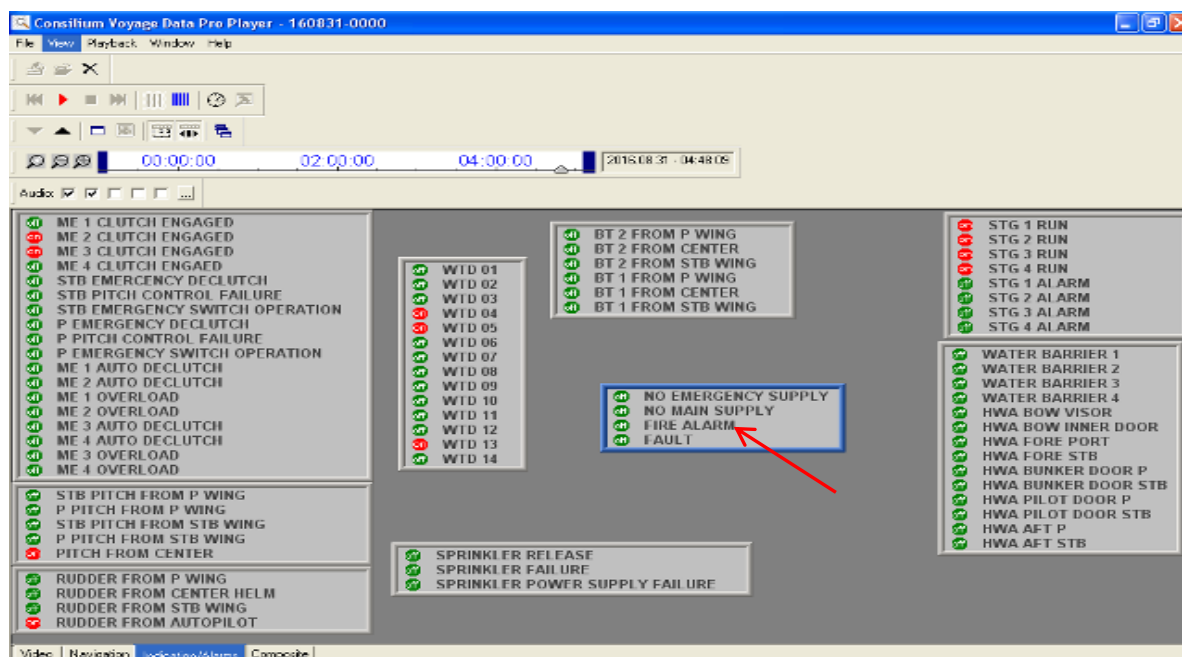
At 06:48:09 the officer of the watch managed to separate the fire zone 110 in the fire alarm control panel on the bridge and, thus, to deactivate the fire alarm (photograph No. 5).

Photograph No. 5. Deactivated fire alarm recorded by the VDR

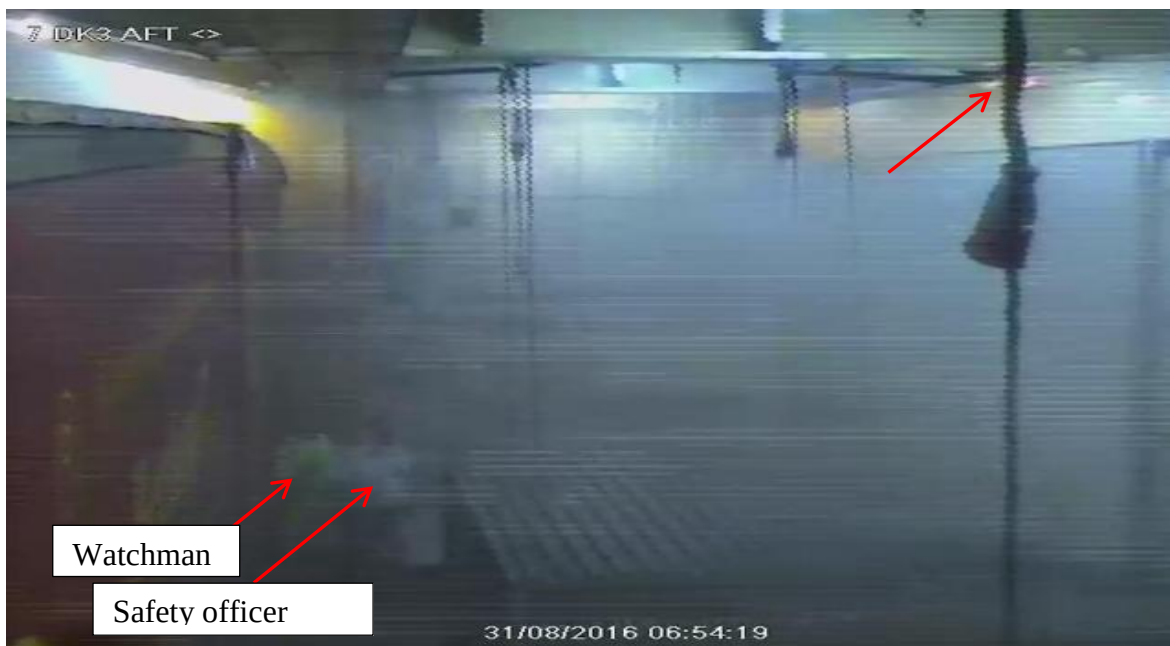
When the crew members were checking the deck in the area of the refrigerator truck, the smoke grew thicker and flames could be seen on the image recorded by CCTV camera No. 07 which were reflected by the ceiling on the right side of the truck (photograph No. 6).

*Photograph No. 6. Flames recorded by the monitoring camera*

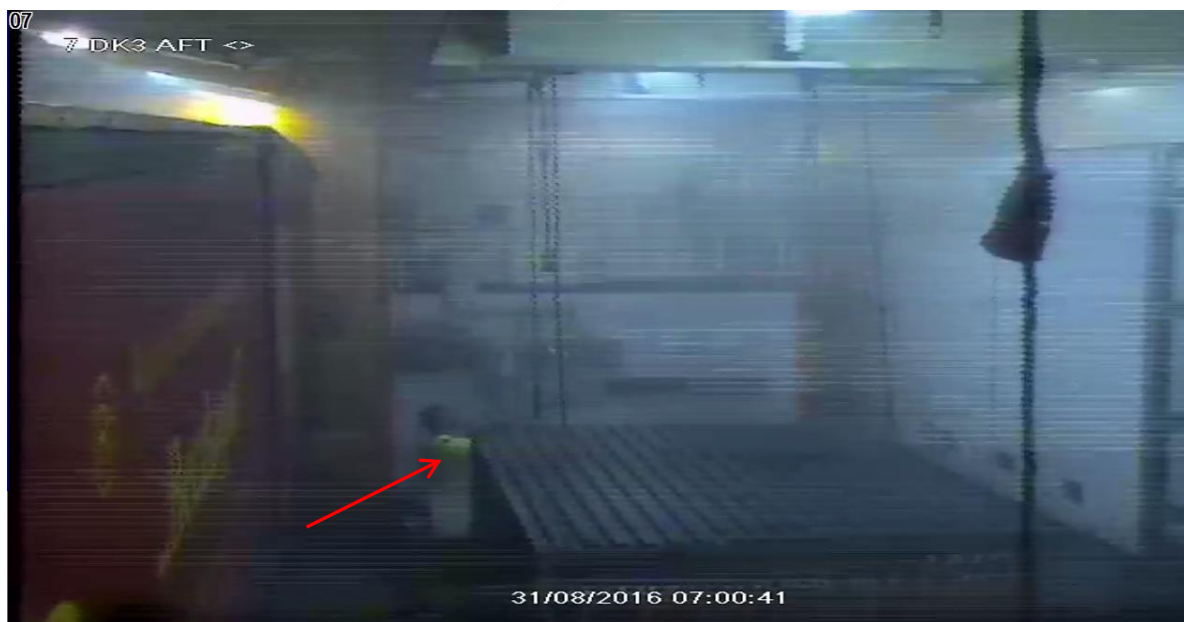
At 07:00:41 when the ship was entering breakwater heads of the port of Gdynia (photo No. 48), the watchman noticed flames on the truck roof (photograph No. 7). He tried to call

*Photograph No. 7. Watchman notices flames on the truck roof*

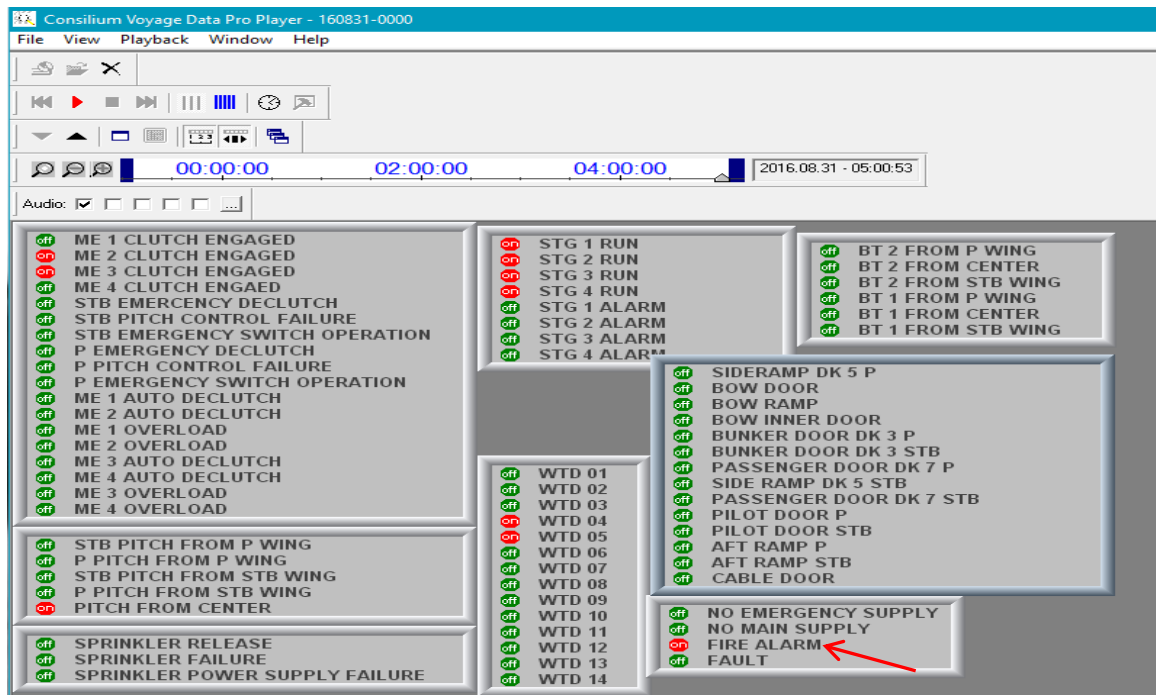
Photograph No. 8. Another activation of the fire alarm recorded by the VDR

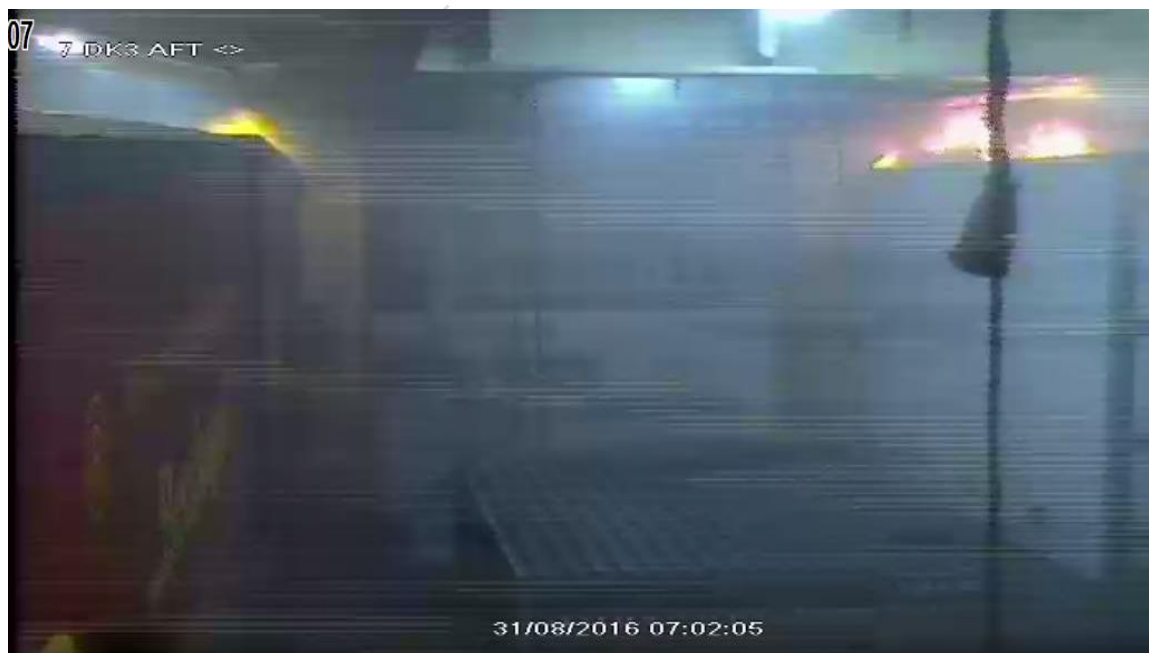
Meanwhile, the officer of the watch and the senior officer attempted to switch on the ventilation on deck no. 3. Furthermore, the officer of the watch tried for almost 2 minutes to contact the watchman in the cargo hold, but he did not succeed. The fire developed considerably and covered the entire width of the truck's roof (photograph No. 9).

Photograph No. 9. Flames on the truck roof

Monitoring the images from camera No. 07 was probably not too frequent, because since around 07:00 the refrigerator truck roof was burning with full flame (which can be clearly seen in photograph No. 9) and the fire was not noticed by the crew on the bridge.

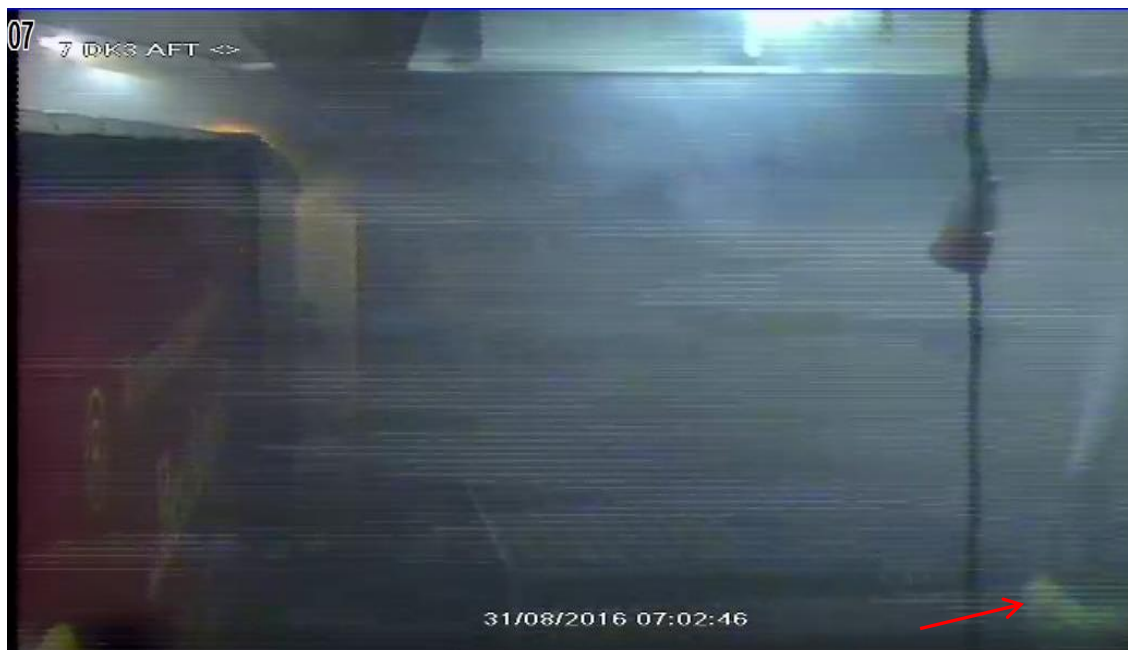
The watchman, not being able to contact the bridge via radio (VHF), started to extinguish the fire with a 50 kg transportable powder extinguisher. He attempted to put out the fire approaching from the rear, left side of the truck, but powder jets did not reach the area of the flames.

*Photograph No. 10. Watchman attempting to suppress the fire using a powder fire extinguisher*

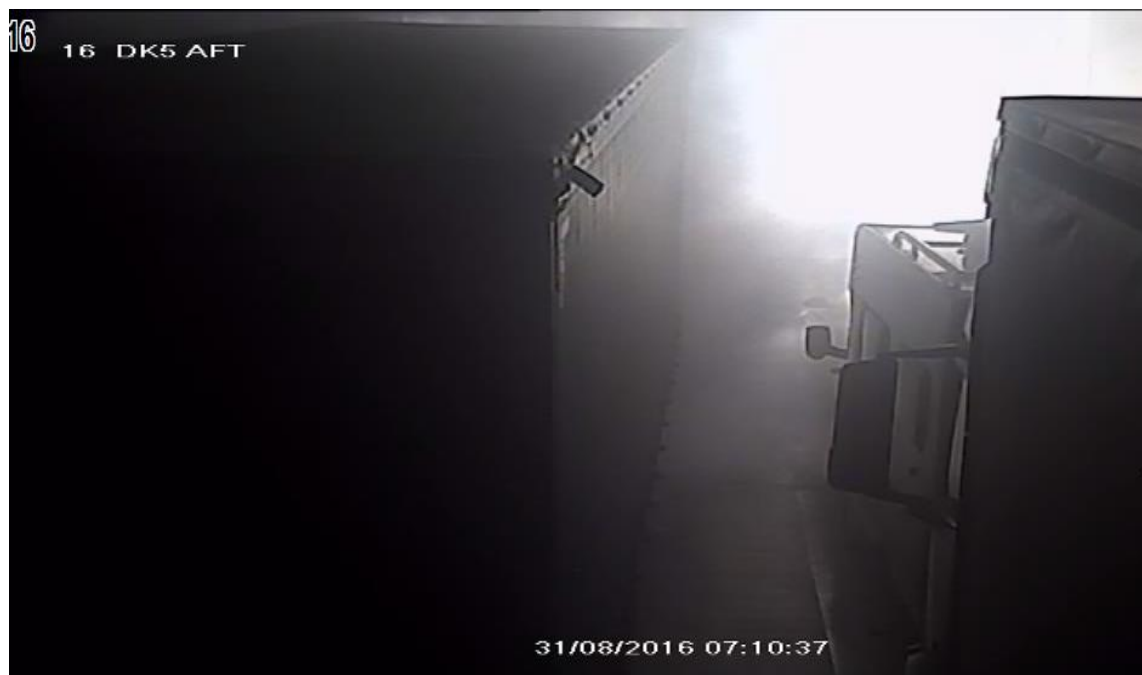
At around 07:10 dense smoke started to enter the car deck no. 5 in the aft part on the port side, via the ventilation inlets (photograph No. 11).

*Photograph No. 11. Smoke on the car deck no. 5 recorded by camera No. 16*

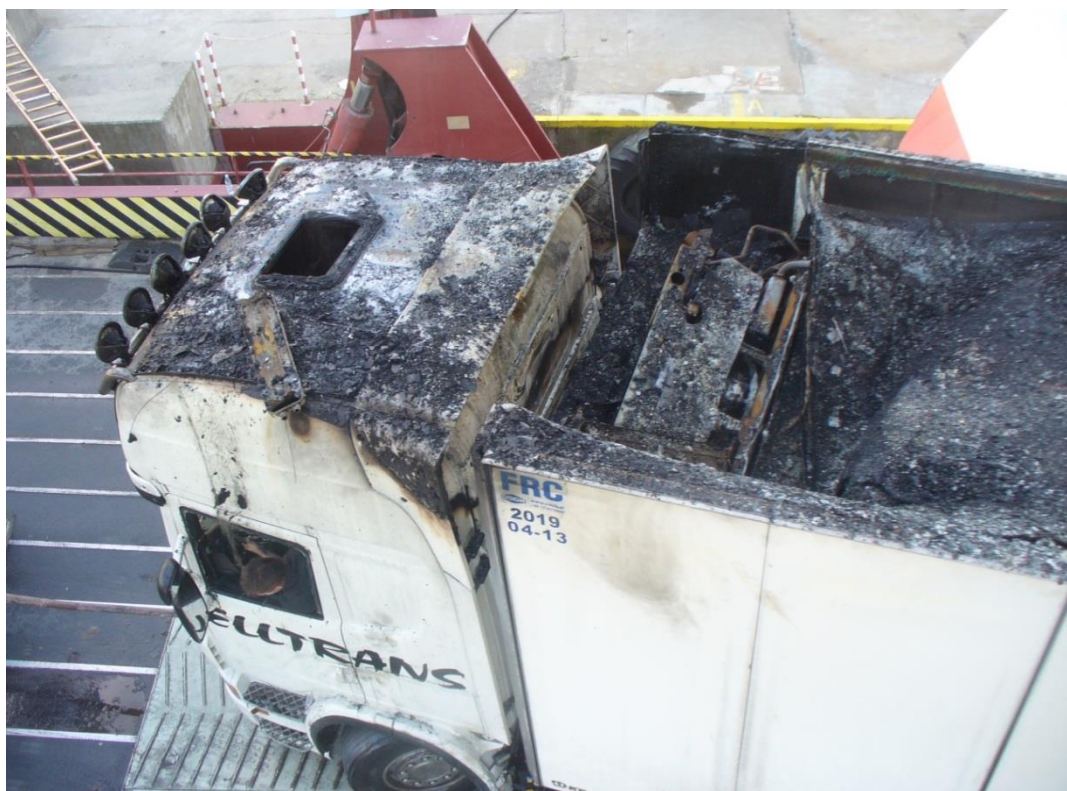
The fire covered the roof and top part of the rear wall of the refrigeration chamber of the refrigerator truck. The refrigeration chamber was covered with polyurethane insulation and laminate (photograph No. 13). The trailer of the refrigerator truck, the refrigeration trailer with an independent refrigeration unit suffered virtually no damages due to the fire.

*Photograph No. 13. Burnt vehicle roof with damaged refrigeration unit*

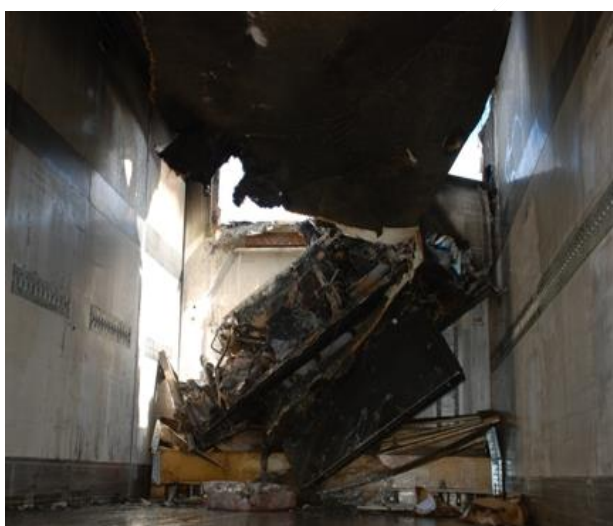
The damage included the fastening of the refrigeration unit installed on the vehicle roof. The burnt unit fell on the cargo<sup>1</sup> loaded into the vehicle (photograph No. 14).

*Photograph No. 14. Burnt refrigeration unit on the truck trailer floor*

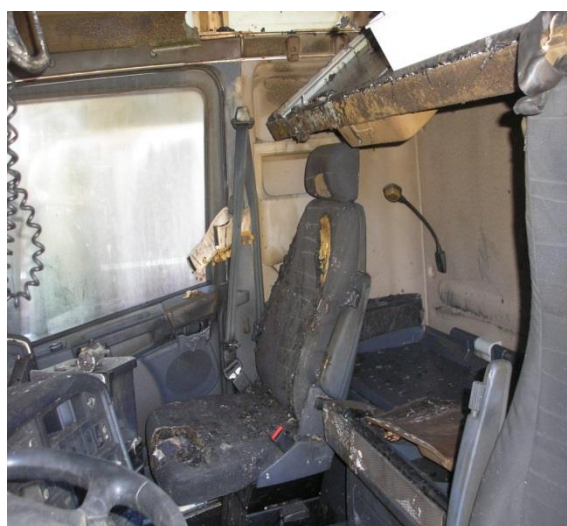
*Photograph No. 15. Burnt driver's cabin of the refrigerator truck*

The interior of the driver's cabin was burnt. The fire spread to the cabin via the sunroof which was damaged by flammable material leaking from the vehicle cargo compartment's ceiling. The cabin ceiling and wall insulation was burnt. Two rows of seats were present in the driver's cabin (photograph No. 15). In the second row, a bunk bed with a mattress was installed. On a second row seat, the driver's computer (laptop) with a connected charger and an electric kettle were found. The computer and charging devices have been completely damaged (photographs Nos. 35 and 36). In the front of the cabin on the driver's side, the refrigerator temperature recorder was installed. It also has been destroyed by the fire.

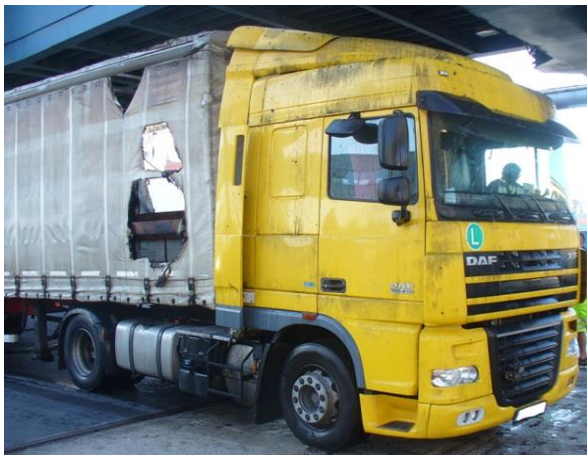
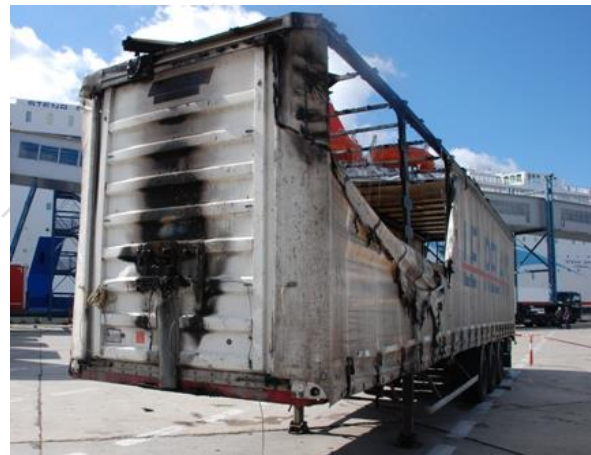
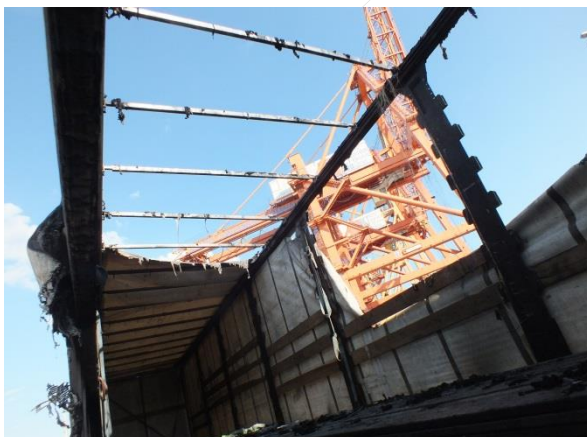
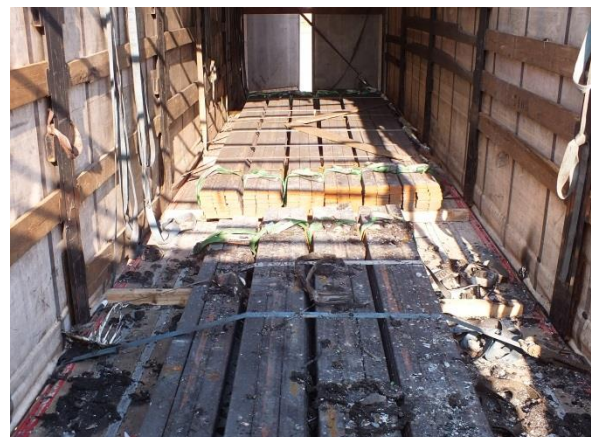
The damages to the second truck that stood next to the truck from which the fire originated were limited to burnt tarpaulin covering the walls and roof of the trailer and partially burnt front wall (photograph No. 16). The cargo transported by this truck – steel rods and plates - was not damaged by the fire.

*Photograph No. 16. Burnt tarpaulin of the truck parked next to the refrigerator truck and its cargo*

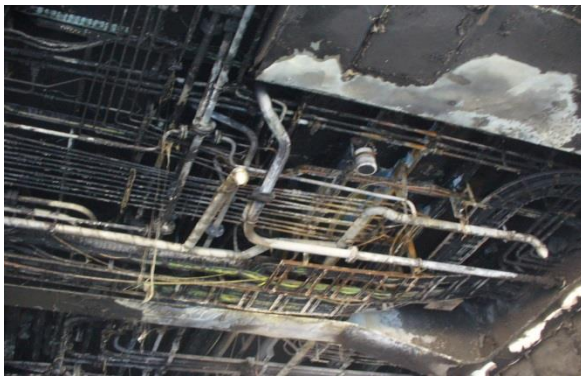
The fire caused damages to the vehicle room (cargo hold) on deck no. 3 and on deck no. 5. Under deck no. 5 which constitutes the ceiling of the cargo hold on deck No. 3, apart from extensive charring and deck paint scaling in the port side stern area over the place where the refrigerator truck stood, electric cables, ventilation ducts and hydraulic system pipelines have been charred and damaged (photograph No. 17).

*Photograph No. 17. Ceiling of the car deck No. 3; ship systems damaged by fire*

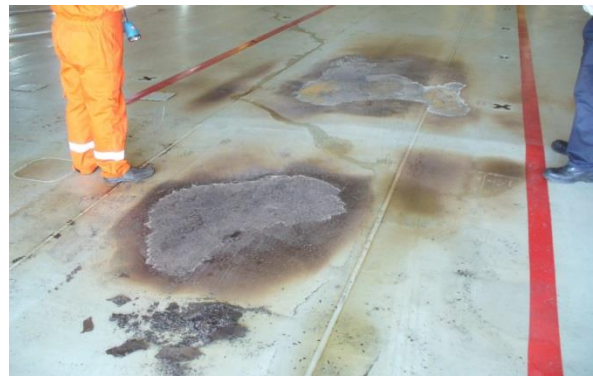
*Photograph No. 18. Car deck no. 5; burnt paint spots and deformed deck plate*

Two spots of burnt paint located around 2 meters away from each other were visible on deck no. 5, indicating the location of fire and high temperature sources that caused the deck deformation (photograph No. 18).

The "explosion" was probably caused by hydraulic oil pipeline eruption above the fire location, with the leaking oil feeding the fire that spanned the entire width of the vehicle's roof. The fire temperature was high enough to cause the paint to burn and the deck steel plate to deform directly above the fire source (photograph No. 18).

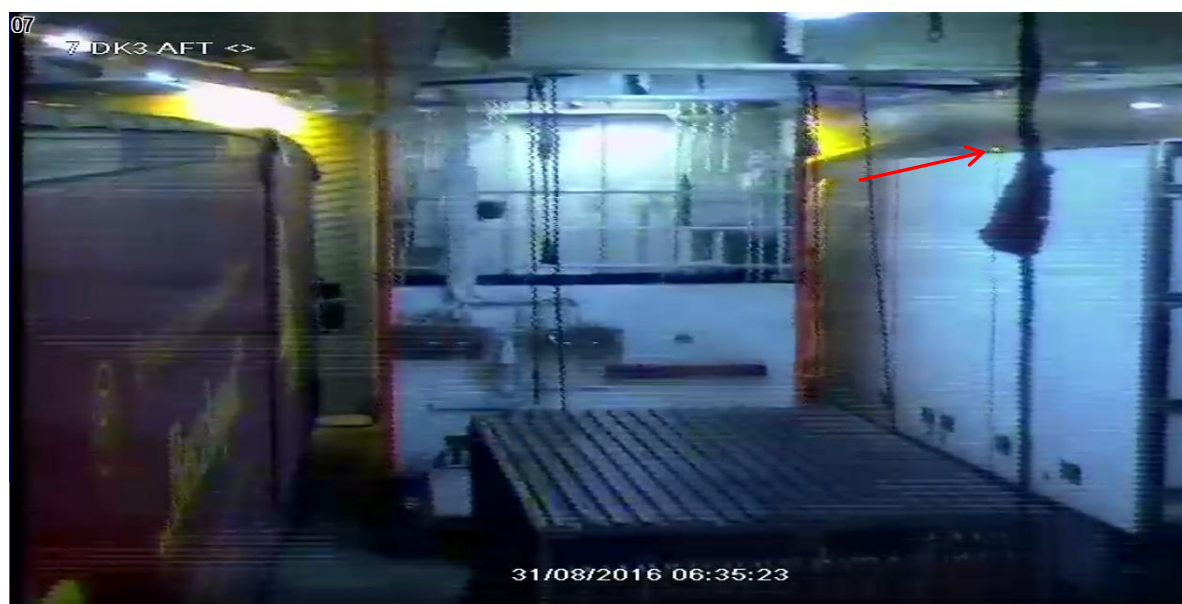
At around 06:34, the camera No. 07 of the ship's CCTV system recorded an image of smoke and at 06:35:23 of the first flames above the truck standing on the car deck no. 3,

*Photograph No. 21. Flames above the refrigerator unit on the truck roof*

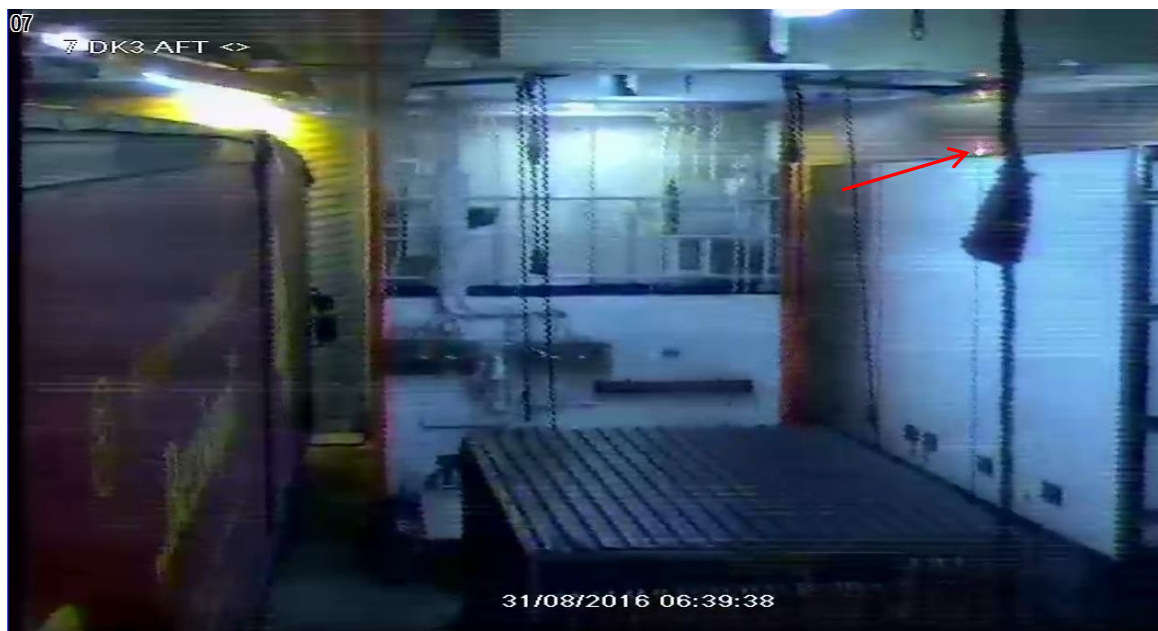
The flames above the truck were visible for a certain period of time and, at 06:38:54 when the smoke detection alarm was activated at the bridge, the fire on the image captured by camera No. 7 was already visible clearly enough that it could not have been overlooked and disregarded by the person checking the ship CCTV images.

*Photograph No. 22. Flames above the truck recorded by camera No. 07 immediately after activation of the fire alarm*

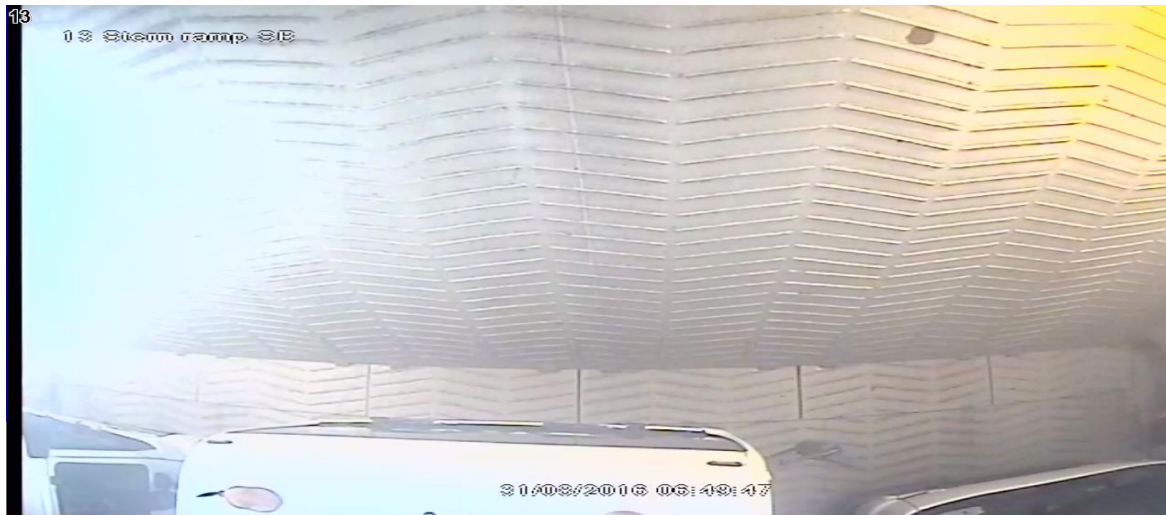
relatively minor), they would have noticed smoke with rotating scales of paint which fell off the ceiling and other items carried by hot smoke, recorded by camera No. 14 located next to the port side stern door, as well as showing the smoke already in front of the trucks standing at the stern next to the starboard side door, recorded by camera No. 13 on the starboard side.

*Photograph No. 25. Smoke entering the space in front of the vehicles standing next to the starboard side stern door*

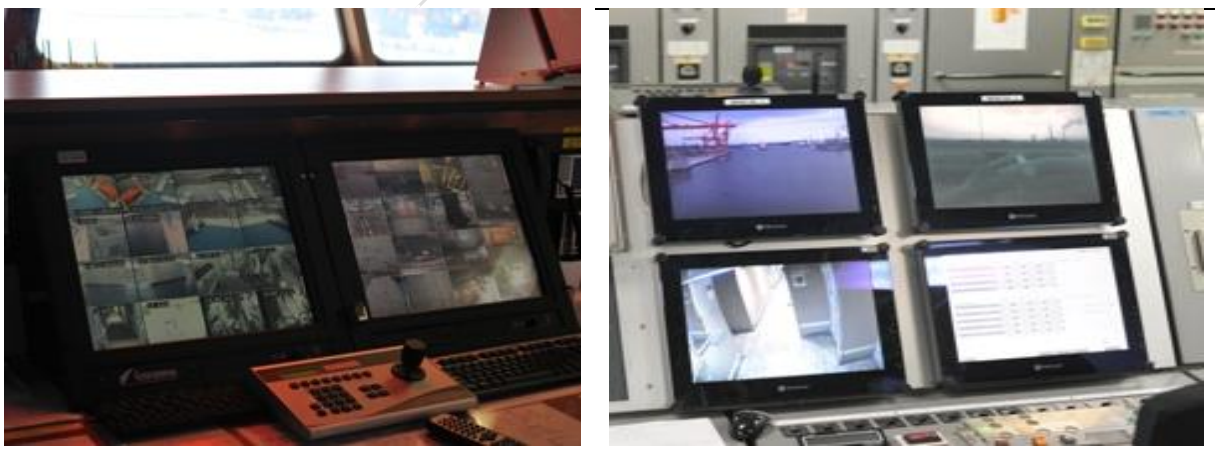
For more than 15 minutes, from the master's arrival at the bridge until 07:03:15 when the officer of the watch approached the display screen and noticed major smoke presence recorded by camera No. 07, nobody either at the bridge or in the engine control room analyzed the images captured by the other CCTV cameras.

*Photograph No. 26. CCTV images on the screens on the bridge (left) and in the engine control room (right)*

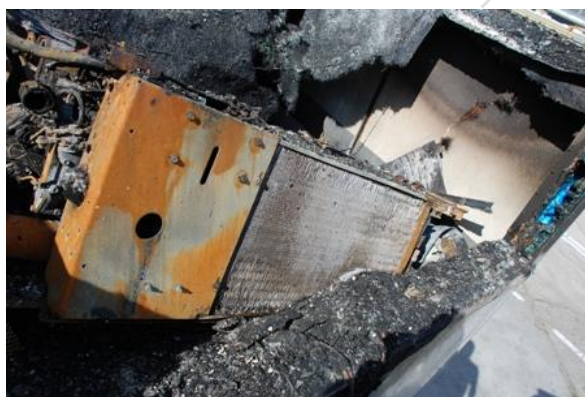
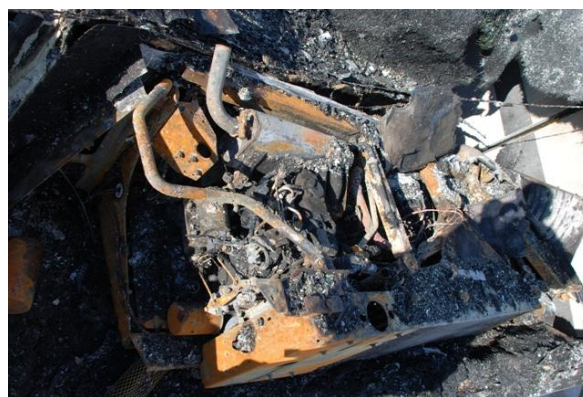
Refrigeration unit of the SCANIA truck (maker: Carrier Supra 850 Nordic – its main components are shown in photograph No. 28) suffered considerable damage during the fire (photograph No. 29) and, after the fire, was taken away from the refrigeration chamber.

*Photograph No. 29. Burnt refrigeration unit and truck's cargo space*

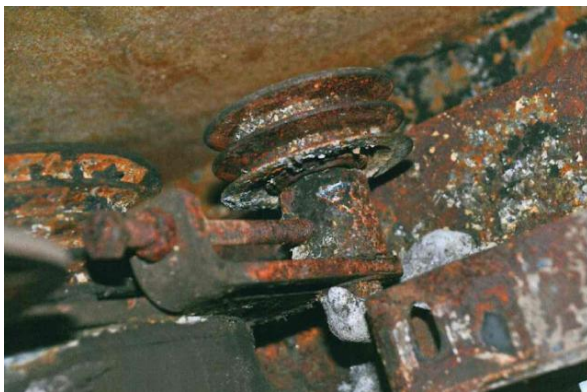
Blocking of the belt wheel of the V-belt tensioner could cause friction generating large amount of heat that resulted in the ignition of the belt's rubber material and occurrence of open fire, causing the ignition of the unit's plastic components. This caused the fire to propagate to refrigeration chamber's insulation and entailed damage to vessel system components installed under the cargo space ceiling. The rubber V-belts were fully completely burnt, with only a small remnant of a charred V-belt surviving the fire (photograph No. 31).

*Photograph No. 30. Blocked belt wheel of the V-belt tensioner*

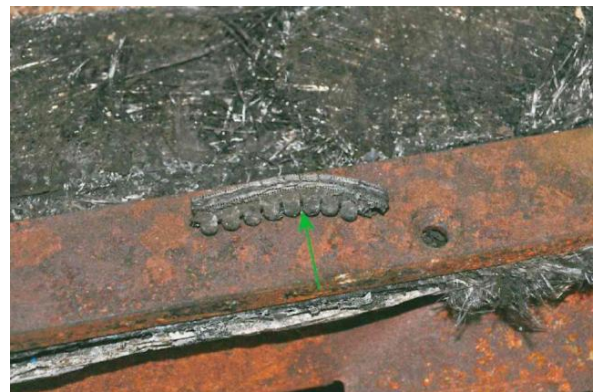
*Photograph No. 31. Charred portion of the V-belt*

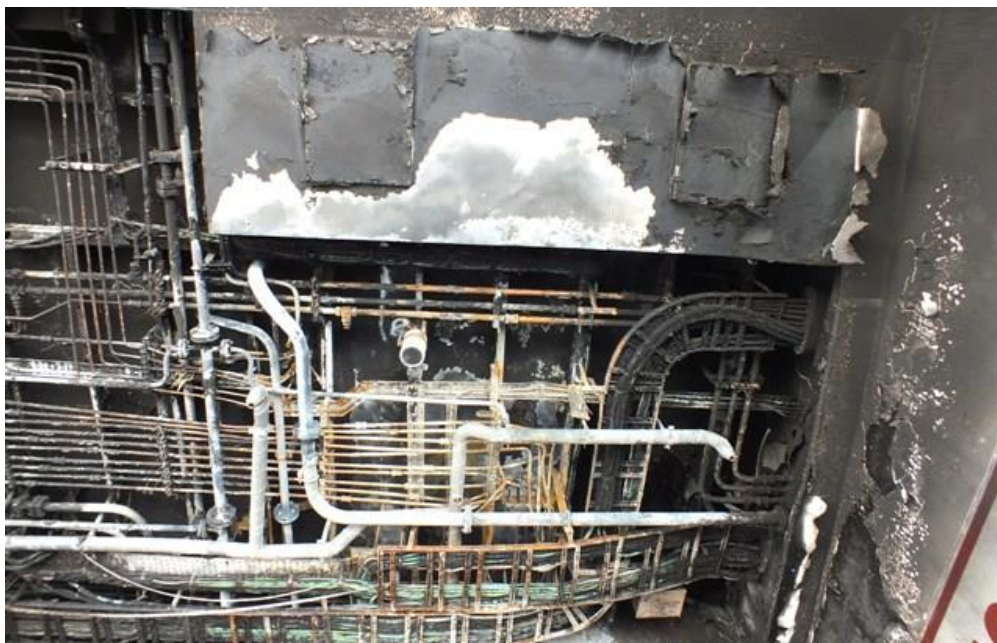
As a result of the fire, the electric cables suspended under the ceiling were burnt and part of the hydraulic pipelines were damaged (photographs Nos. 32 and 33).

The damage to the pipelines consisted of their deformation, loosening of fasteners as well as mechanical circumferential rupture which caused them to be unsealed.

*Photograph No. 32. Damaged hydraulic system pipelines*

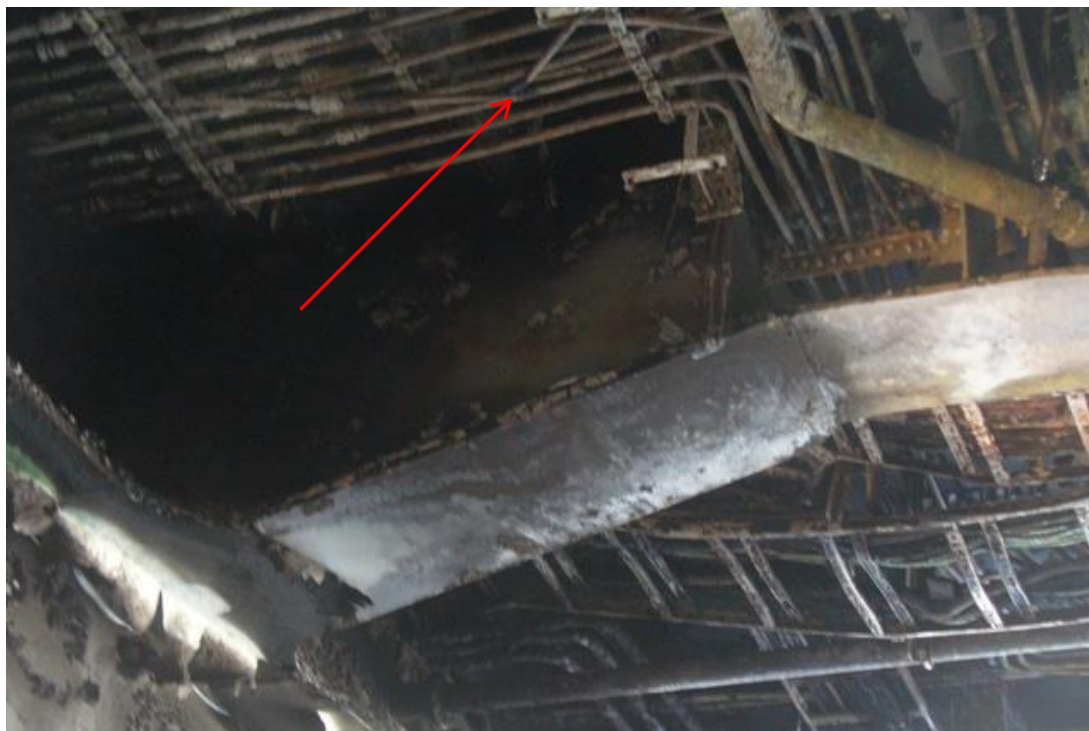
*Photograph No. 33. Hydraulic pipeline cracked and deformed as a result of the fire*

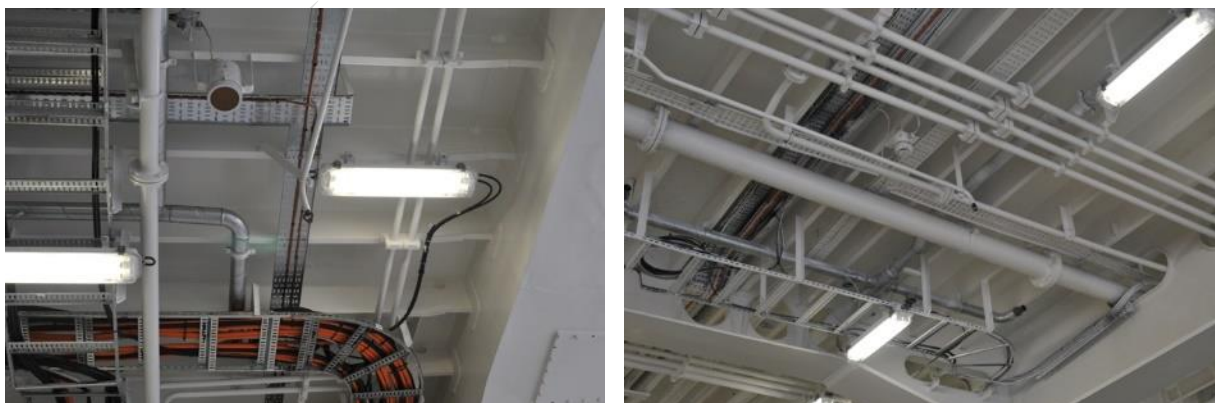
*Photograph No. 34. Ceiling of the car deck no. 3 in the place of the fire*

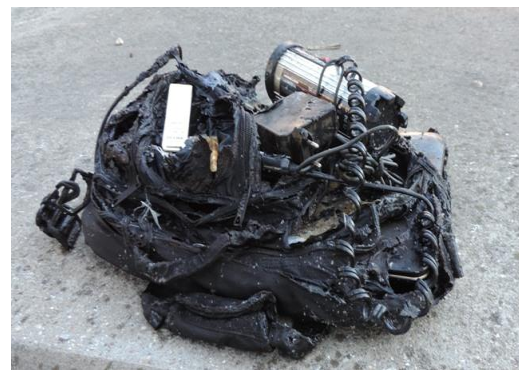
*Photograph No. 36. Burnt computer (laptop)*

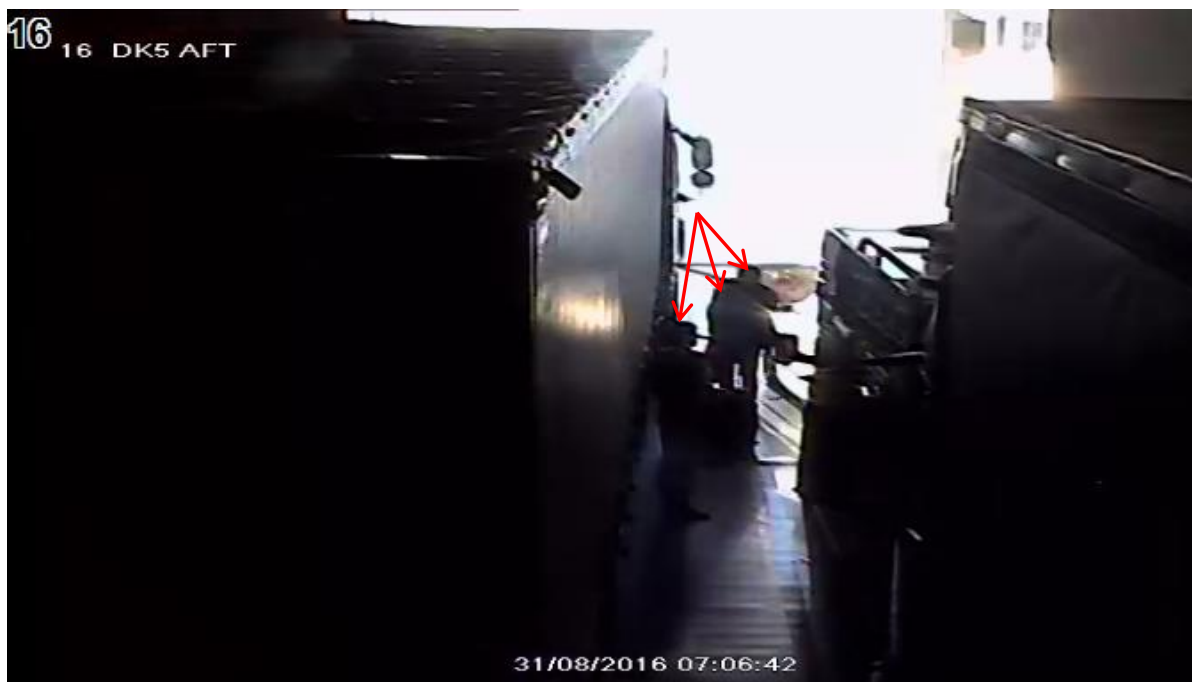
*Photograph No. 38. Passengers in the vehicle space on deck no. 5 during the firefighting operation, in the place where smoke was appearing*

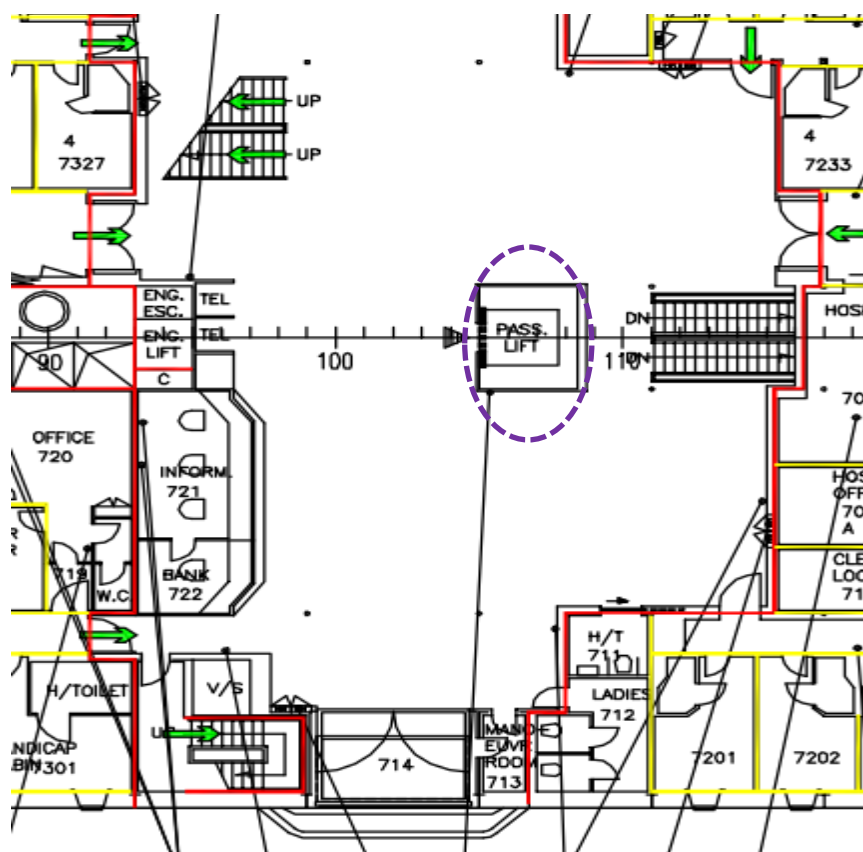
Figure 4. Deck no. 7: Passenger lift shaft (frames 105-109) in the reception hall is not marked as the class "A" division

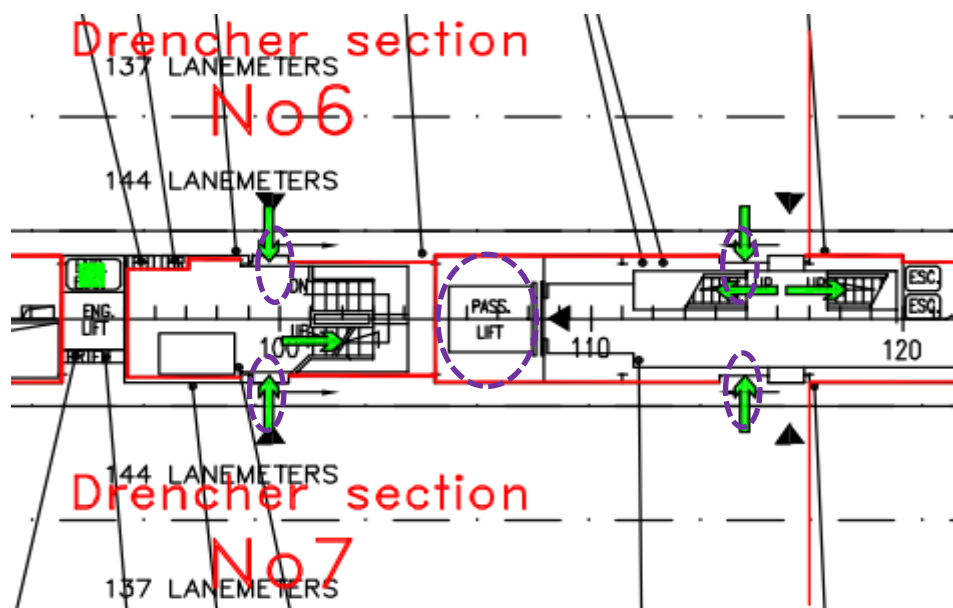
Figure 5. Deck no. 3: doors to staircases and passenger lift shaft are not marked as the class "A" divisions

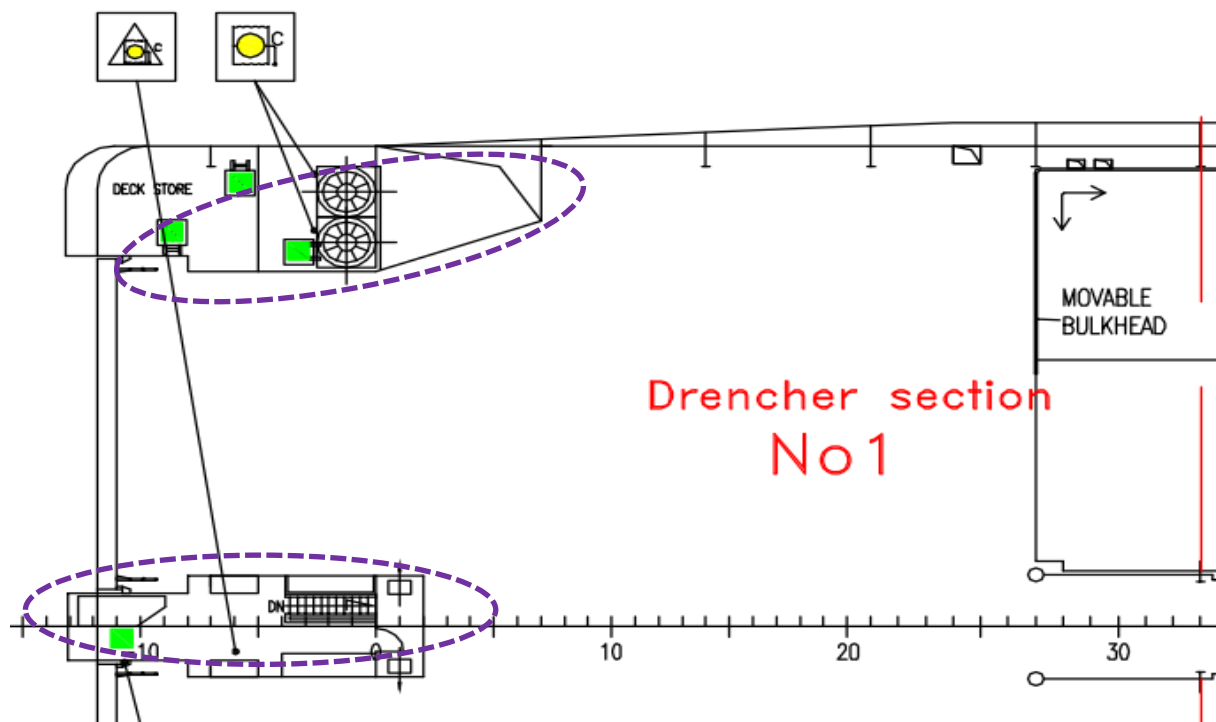
Figure 6. Deck no. 4: walls of spaces (under the cargo space ceiling) with fire dampers in vehicle space ventilation ducts are not separated with the class "A" divisions

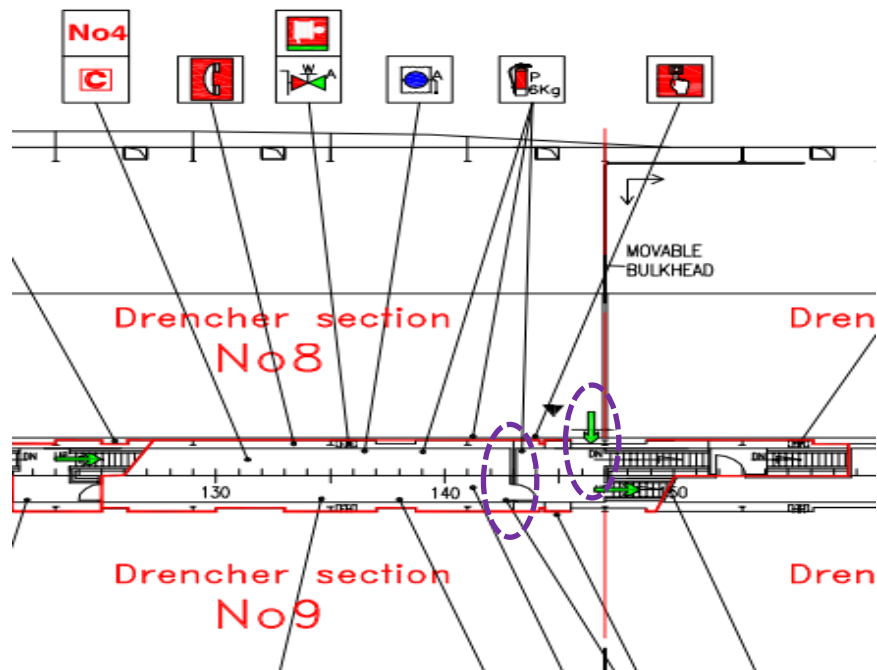
Both the entrance doors to the staircase from the car deck and the door separating the station and staircase are not marked as class "A" which may lead to a conclusion that the staircase and drencher station does not meet the requirements of the SOLAS Convention.

Figure 9. Deck no. 4: entrance door to the staircase from the car deck and wall with doors at frame No. 143 separating the drencher station from the staircase are not marked as the class "A" divisions
