**M.V STENA SPIRIT**

**Report of the marine safety investigation into a fire on the  
vehicle deck in the outer approaches to Gdynia, Poland on  
31 August 2016**

# FINAL REPORT

truck fire on a car deck  
at the approach to the port of Gdynia  
on 31 August 2016

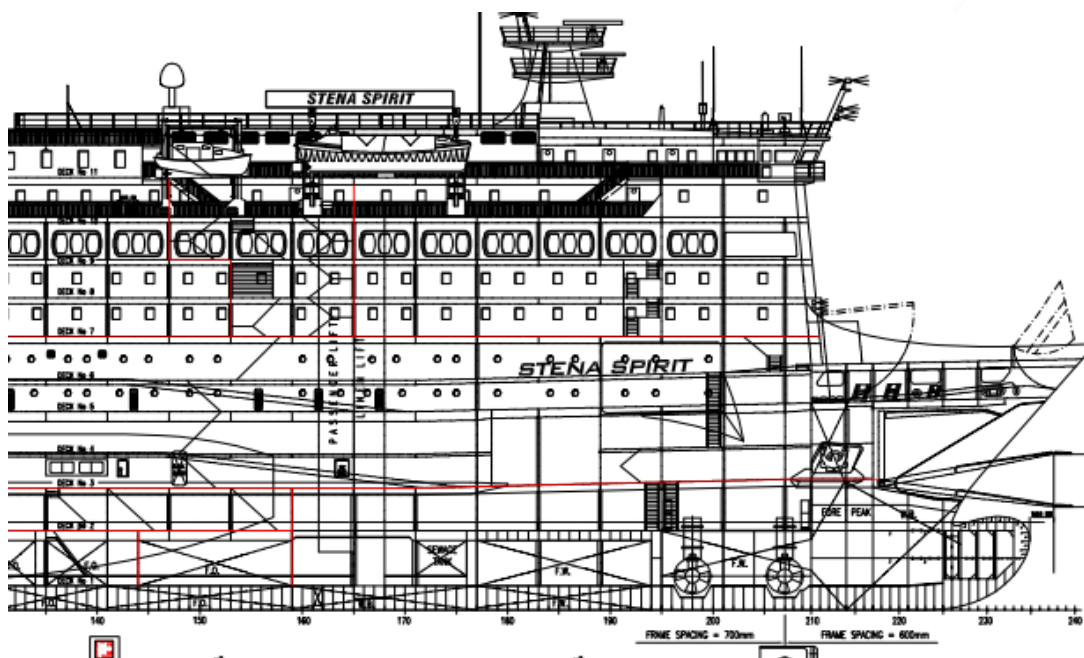
Figure 10. Longitudinal section of the ship "Stena Spirit": main vertical zones are not shown

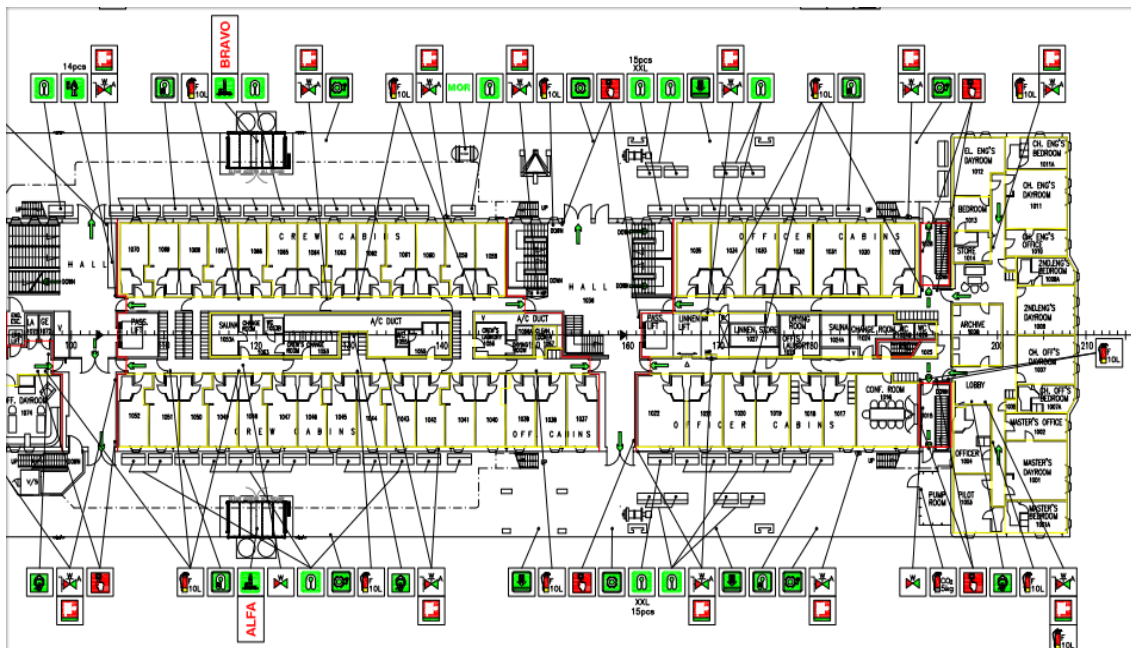
Figure 11. Deck no. 10: no marking of main vertical zones

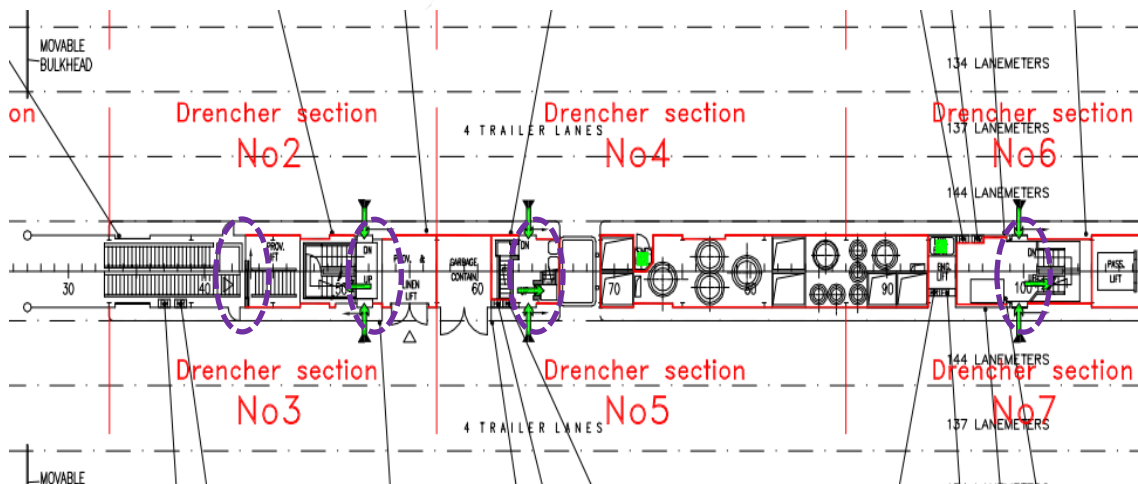
Figure 12. Deck no. 3: no marking of walls and stairways door as the "A" class division

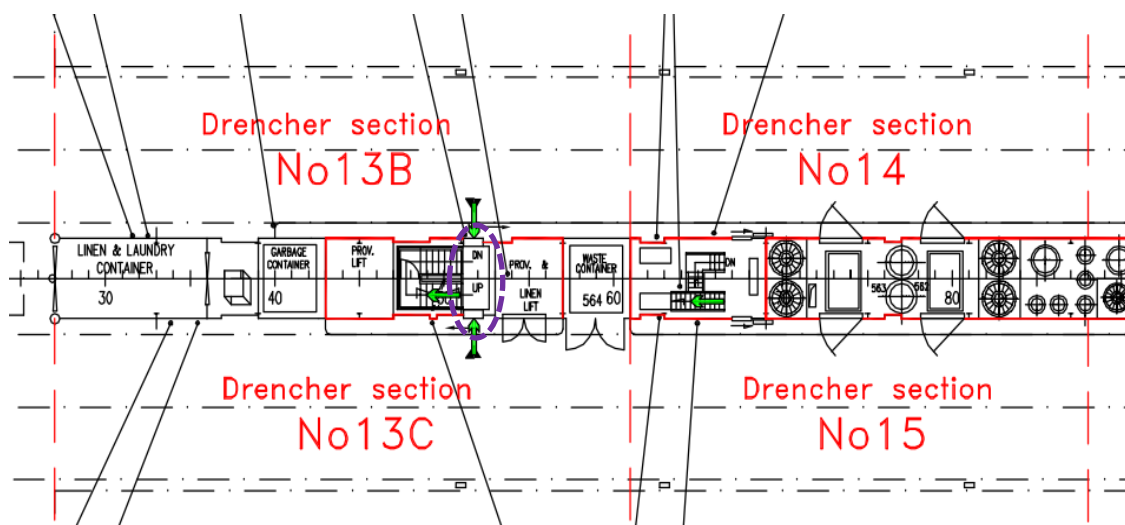
Figure 13. Deck no. 5: no marking of walls and stairways door as the "A" class division

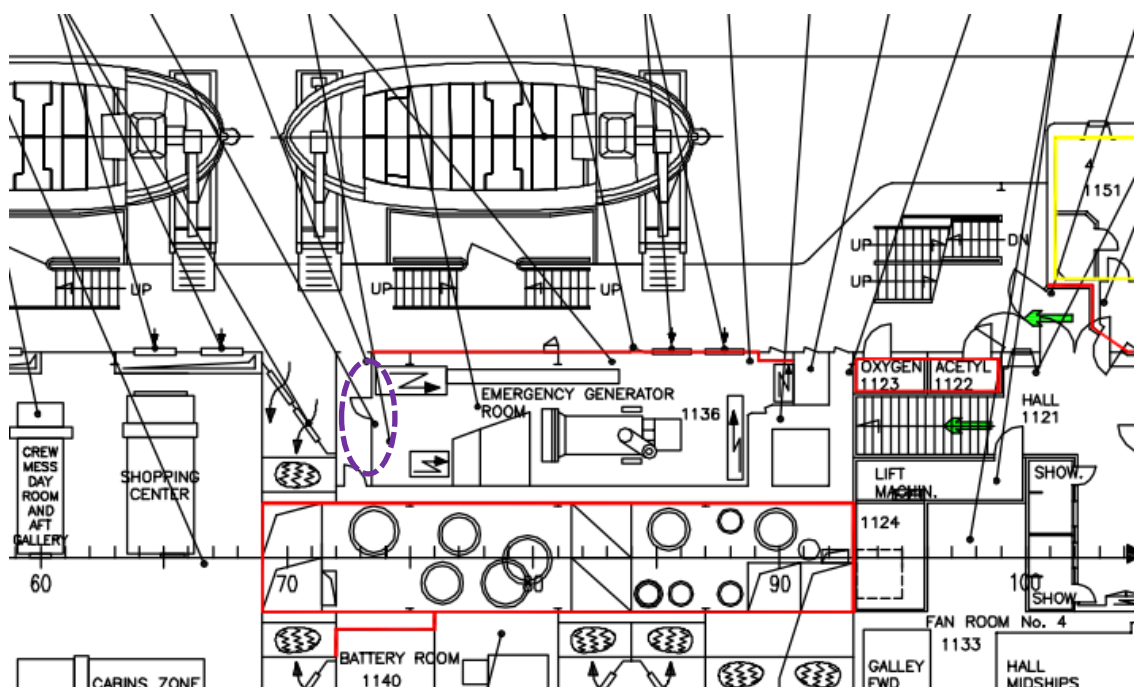
Figure 15. Deck no. 11: no marking of the walls and doors of the emergency generator room as the "A" class division

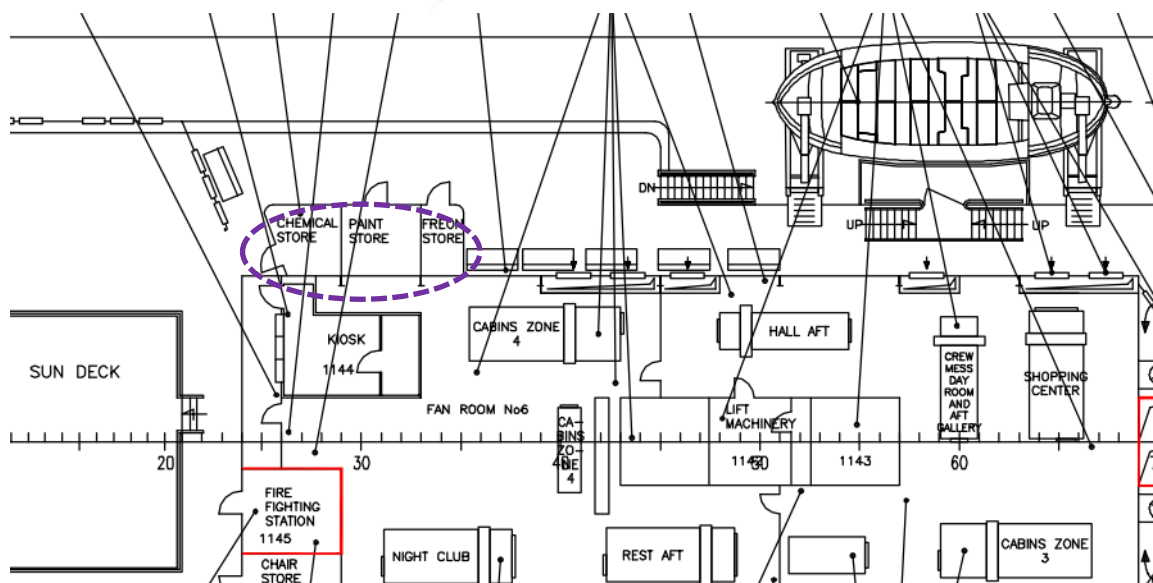
Figure 16. Deck no. 11: no marking of the walls and doors of the paint store and a fan room as the "A" class division

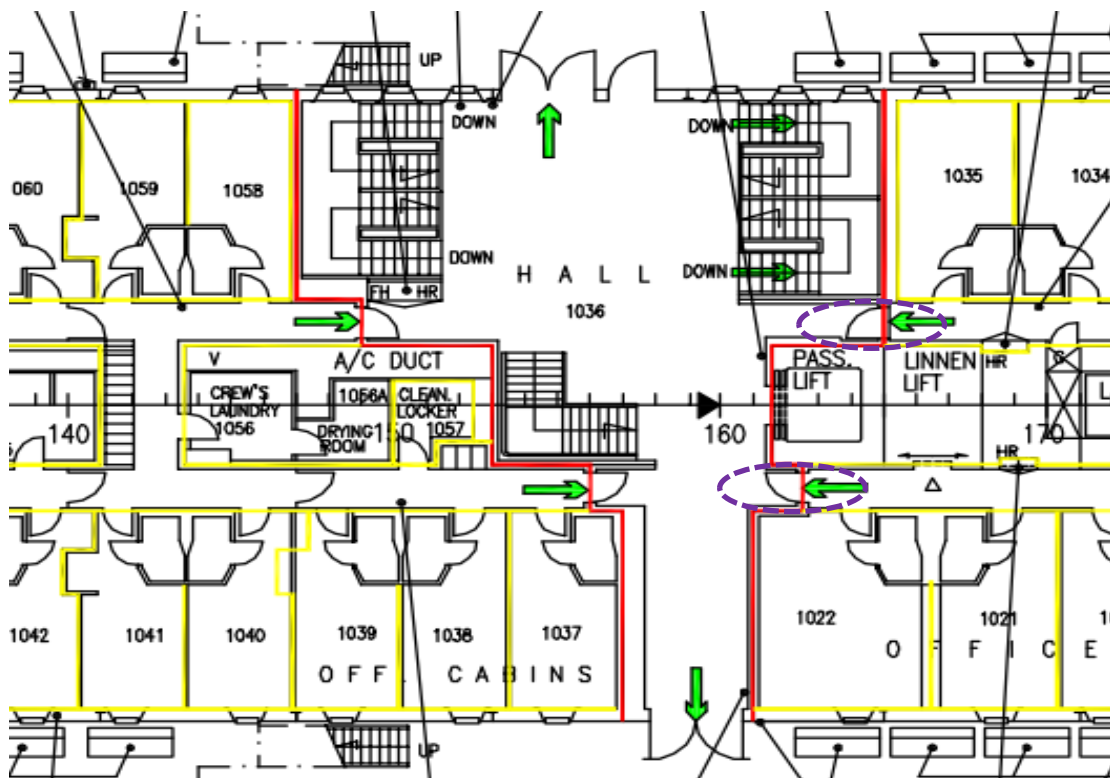
Figure 19. Deck no. 10: no marking of the door as being of self-closing type in the walls and in the division which should be marked as the separation of the main vertical zones

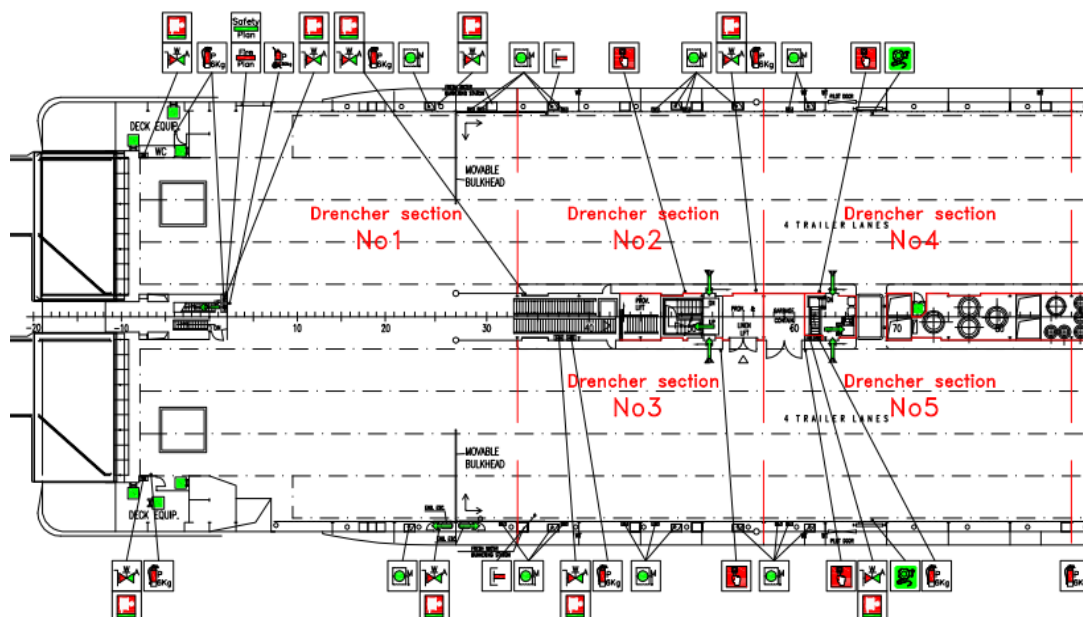
Figure 20. Car deck no. 3: lack of designated escape routes leading along the space between rows of vehicles
