# **Isle of Man Ship Registry**

Casualty Investigation  
Report No. CA103

## **Isle of Man Registered "FICUS"**

Grounding

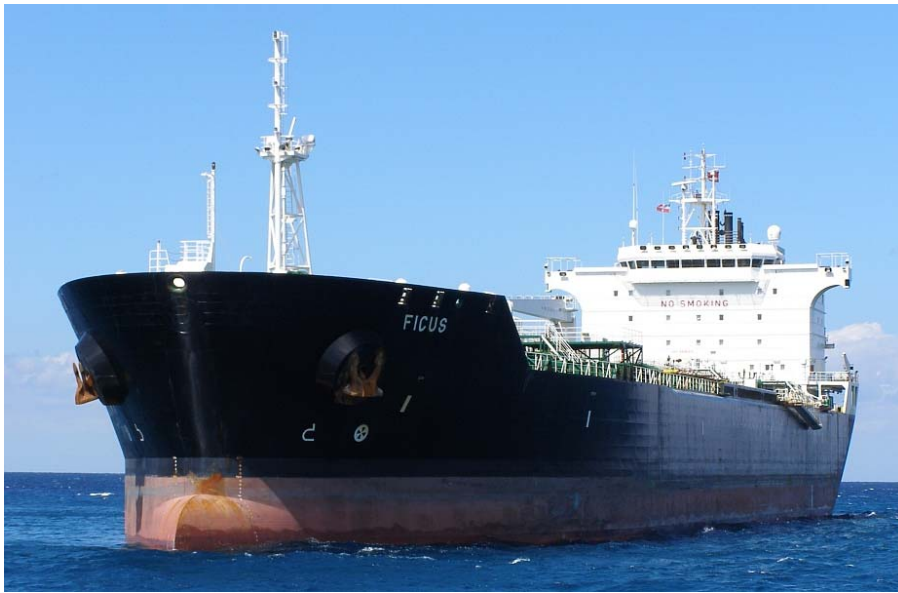
*Photo taken whilst the vessel was aground*

The vessel was loaded with approximately 25600t of non-persistent Oil Cargo. Fortunately all of the oil cargo was contained on board and there were no injuries to any ship personnel and no pollution to the marine environment. The vessel sustained significant structural damage to the ship’s bottom. The limestone shelf seabed was damaged as a result of the vessel making contact whilst making way and when the vessel became firmly aground.

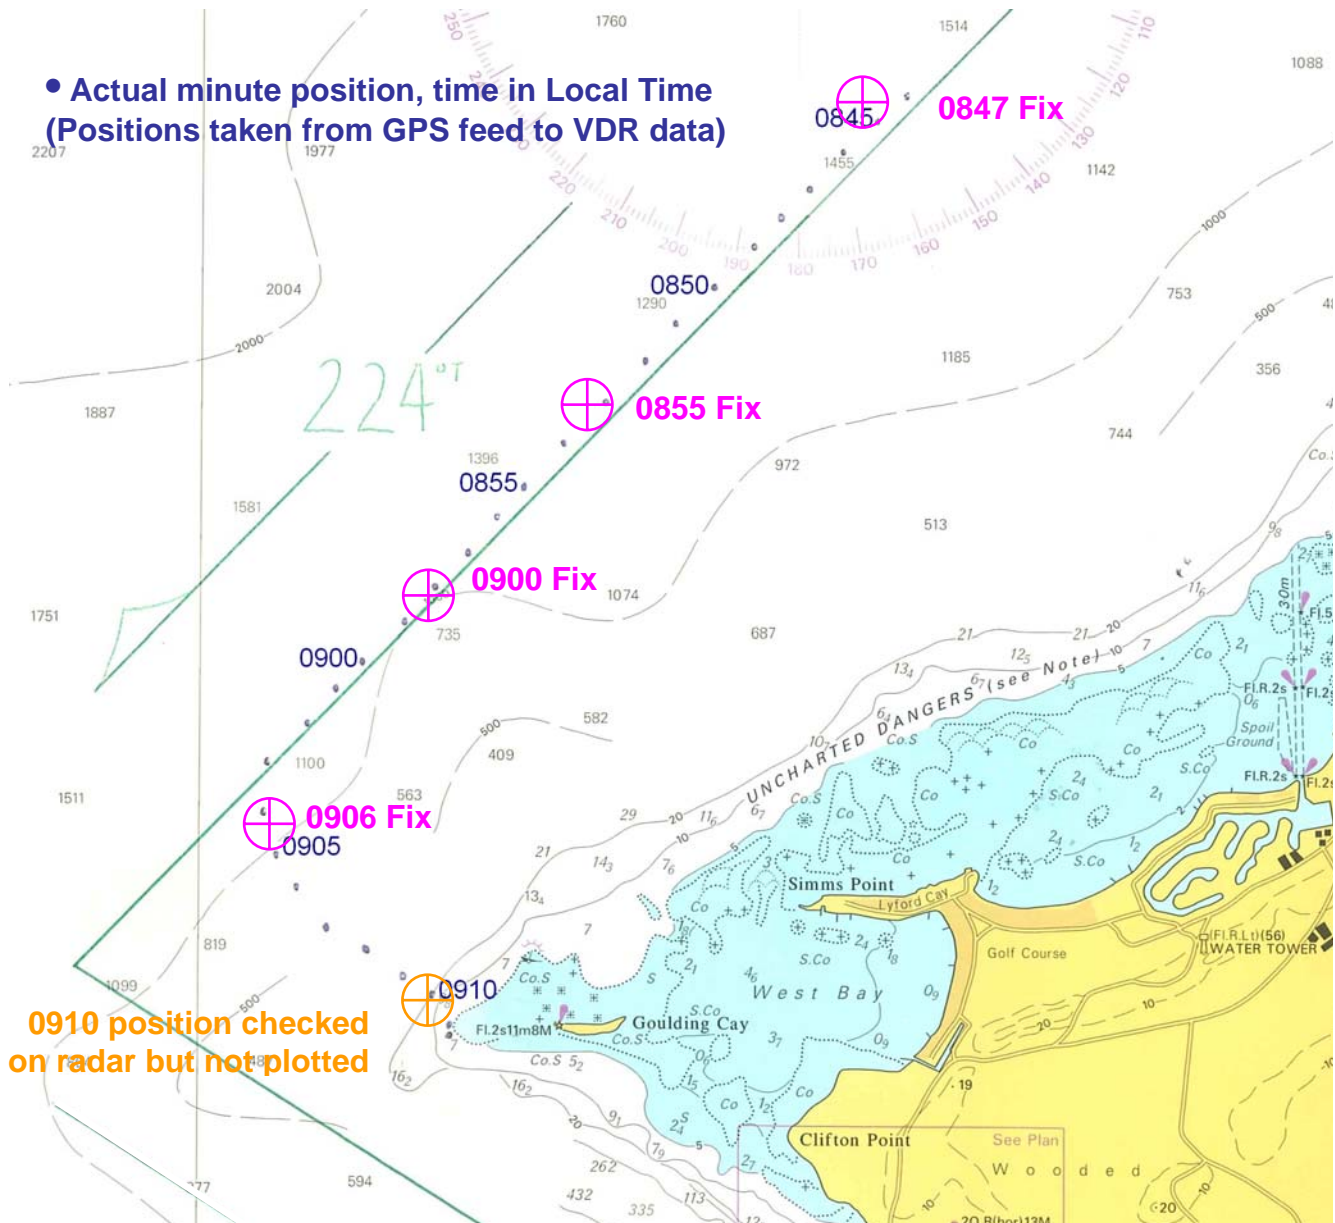
## 1.5 Vessel Tracks Leading Up To The Grounding

The chart extract below shows a minute by minute account of the vessel's actual track starting at 0844LT and ending at 0912LT. The chart extract also shows the positional fixes taken by the OOW(8-12) that were plotted on the chart.

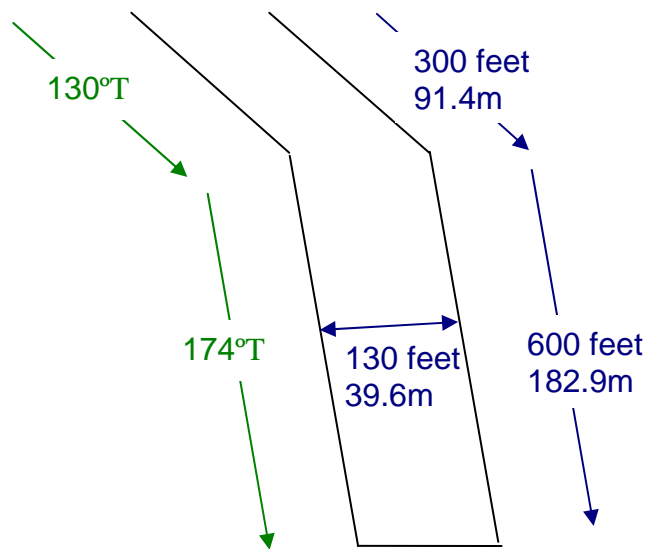
### Damage to the Seabed

The nature of the seabed where the Ficus grounded was predominantly a "limestone shelf" with some coral growth. A divers assessment of the affected area showed the line of grounding to be approximately:-

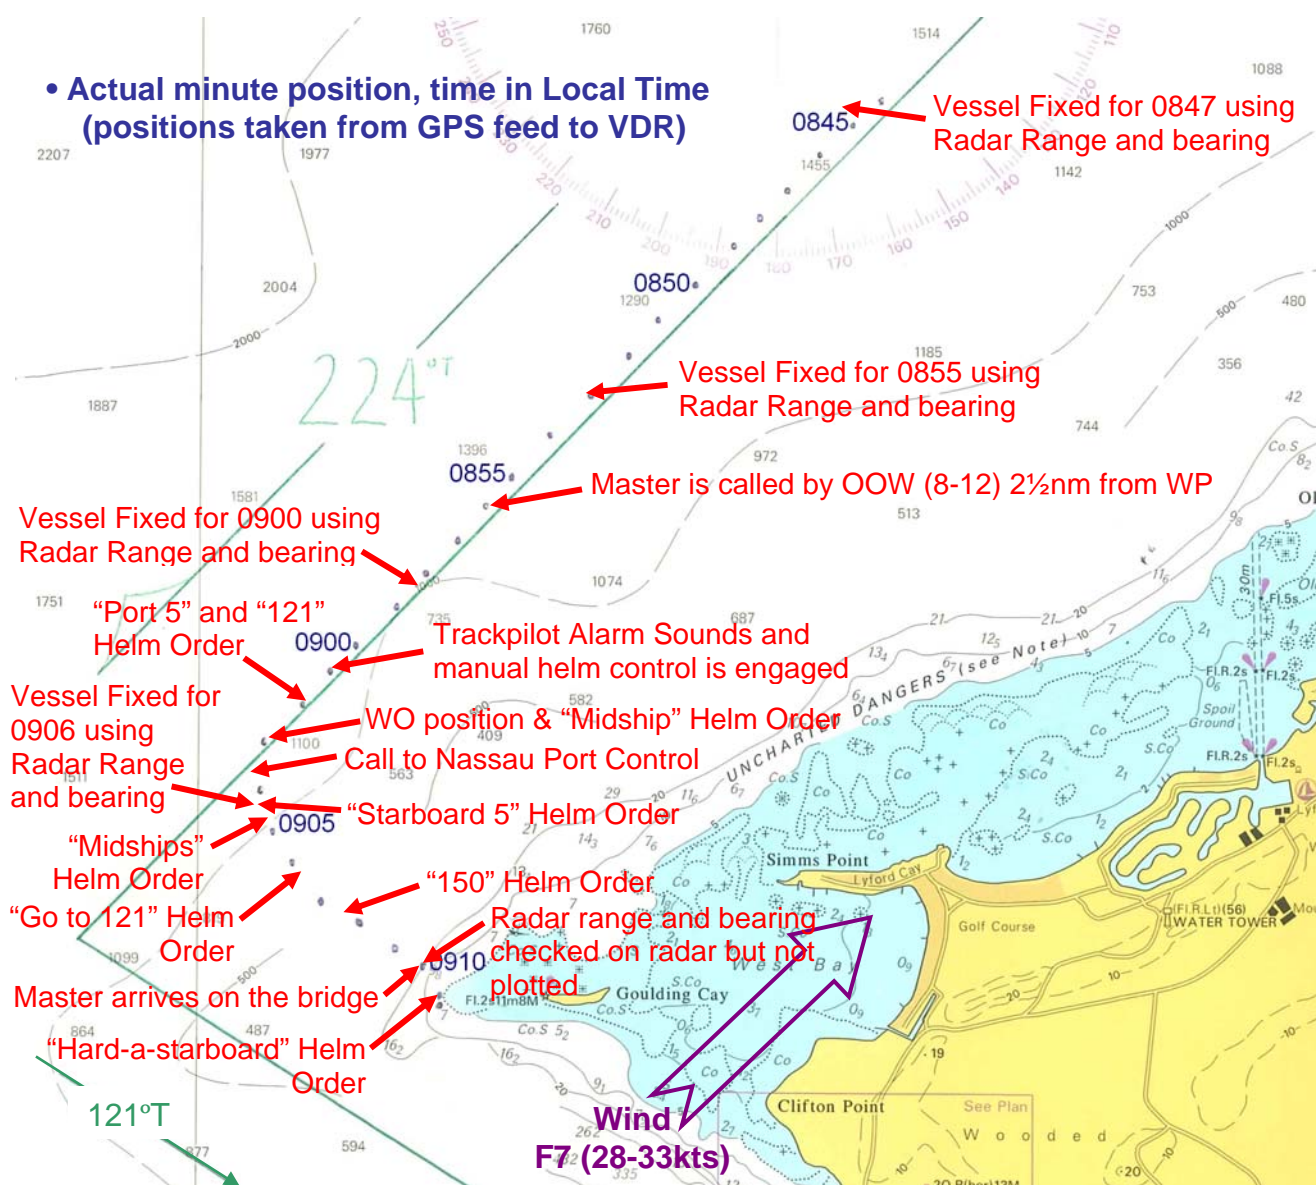
## 2.8 The Course Alteration

The chart extract of BA1489 below shows the significant events immediately prior to and during the course alteration leading up to the grounding of the vessel.

At 0901LT the ECDIS alarm sounded which indicated to the OOW that the vessel was 2 minutes away from the Wheel Over position as calculated by the ECDIS for alteration to the next course. On the basis of this alarm the OOW (8-12) decides he will alter course using manual helm control. The OOW(8-12) immediately instructs the Lookout(8-12) to take the wheel and be the helmsman. The helmsman's role is to carry out helm or course orders as directed by the OOW. The vessel's position was last checked at 0858LT and marked on the chart as "0900".

The OOW(8-12) switches the helm control from track control mode to manual helm control (as shown in Annex 2A) and immediately orders "Port 5" rudder to be applied by the helmsman. The following diagram shows the track information displayed to the OOW(8-12) on the radar and ECDIS screens for the alteration of

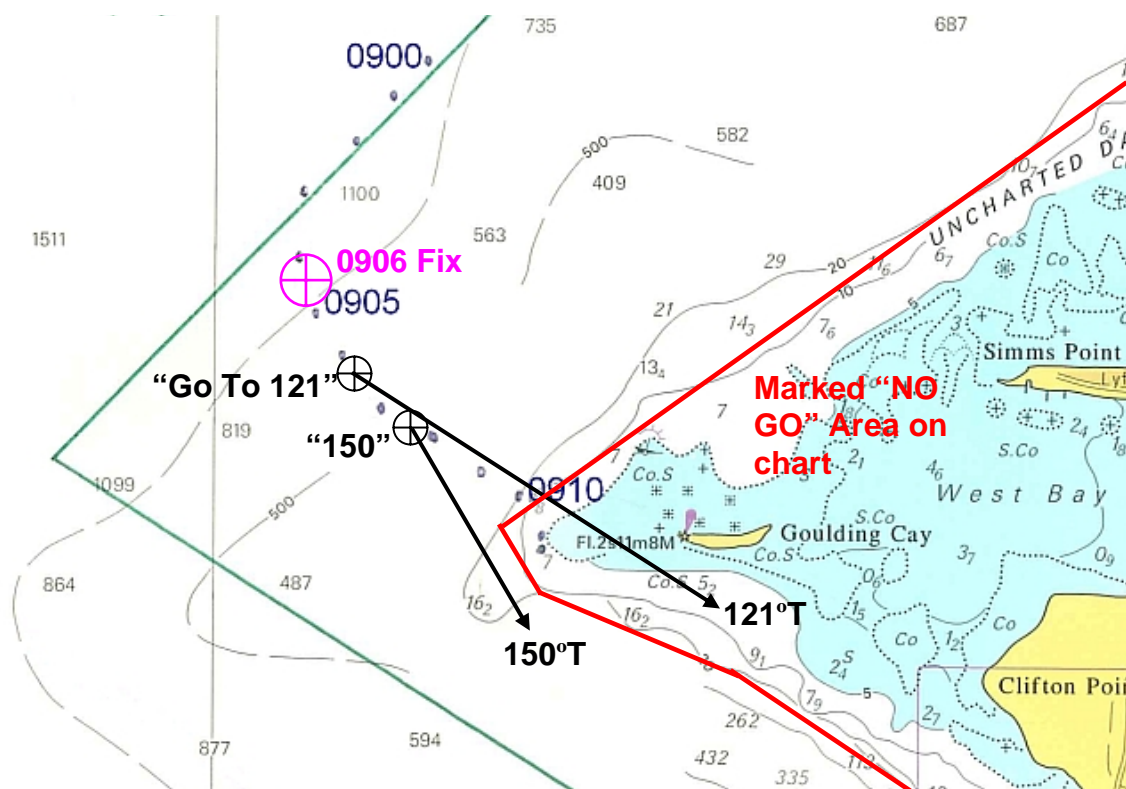
The following chart extract of BA1489 shows the implications of steering a course of 121°G. It is clear the OOW(8-12) has lost his situational awareness at this point with respect to the safe navigation of the vessel and in particular the position of the vessel. By steering a course of 121°G the vessel's track will be taken directly through the "No Go" areas marked on the chart and the shallow waters that would lead to the vessel grounding.

After approximately 46 seconds the vessel's heading reaches 123°G and Goulding Cay is approximately 1 point off the port bow. The OOW(8-12) then states to the helmsman "I think we will alter course, steady 150". The helmsman asks him to repeat by saying "Ay?", the OOW(8-12) then orders "150". The helmsman acknowledges this by stating "150" and steers the ship accordingly.

The chart extract of BA1489 above shows the implications of steering a course of 150G. The "150" order indicates that the OOW(8-12) is attempting to steer clear of the "No Go" area by a narrow margin. The "150" order was not based on a plotted position and it is likely that the course decision was arbitrary based on looking at either the radar, 'zoomed' in ECDIS chart or out of the bridge window. A more decisive and significant alteration of course was needed at this point in order to steer the vessel to safe waters and to counteract any effects of the South Westerly Force 7 wind.

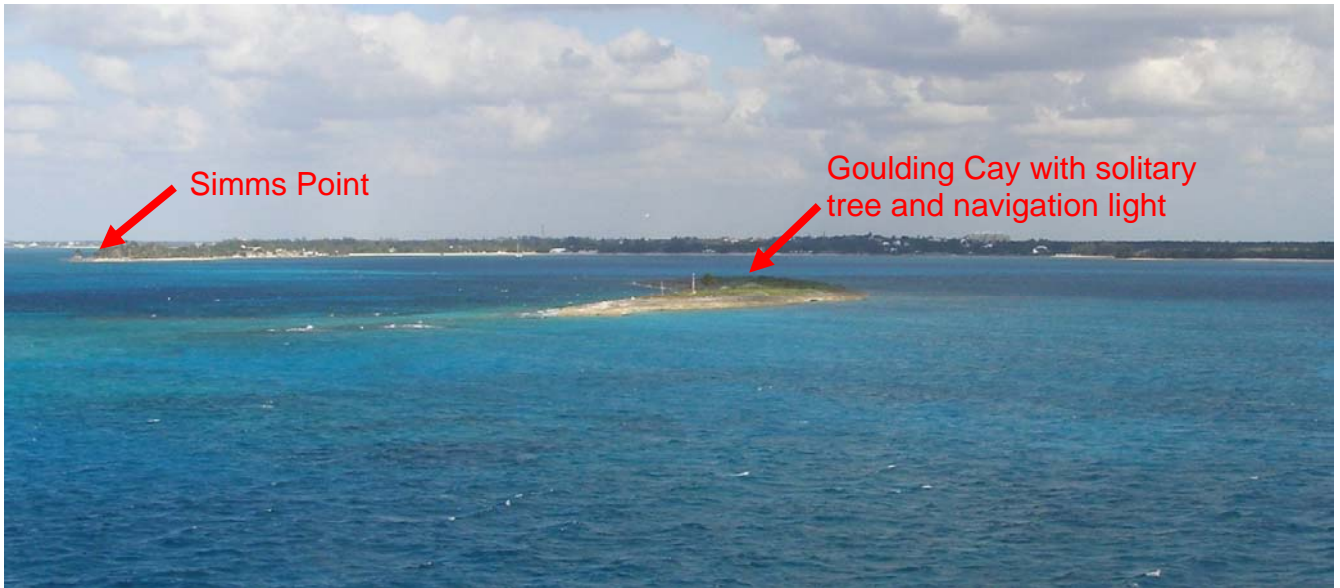
**Goulding Cay and Simms Point Looking approx East by North**

*Picture taken from vessel whilst aground.*

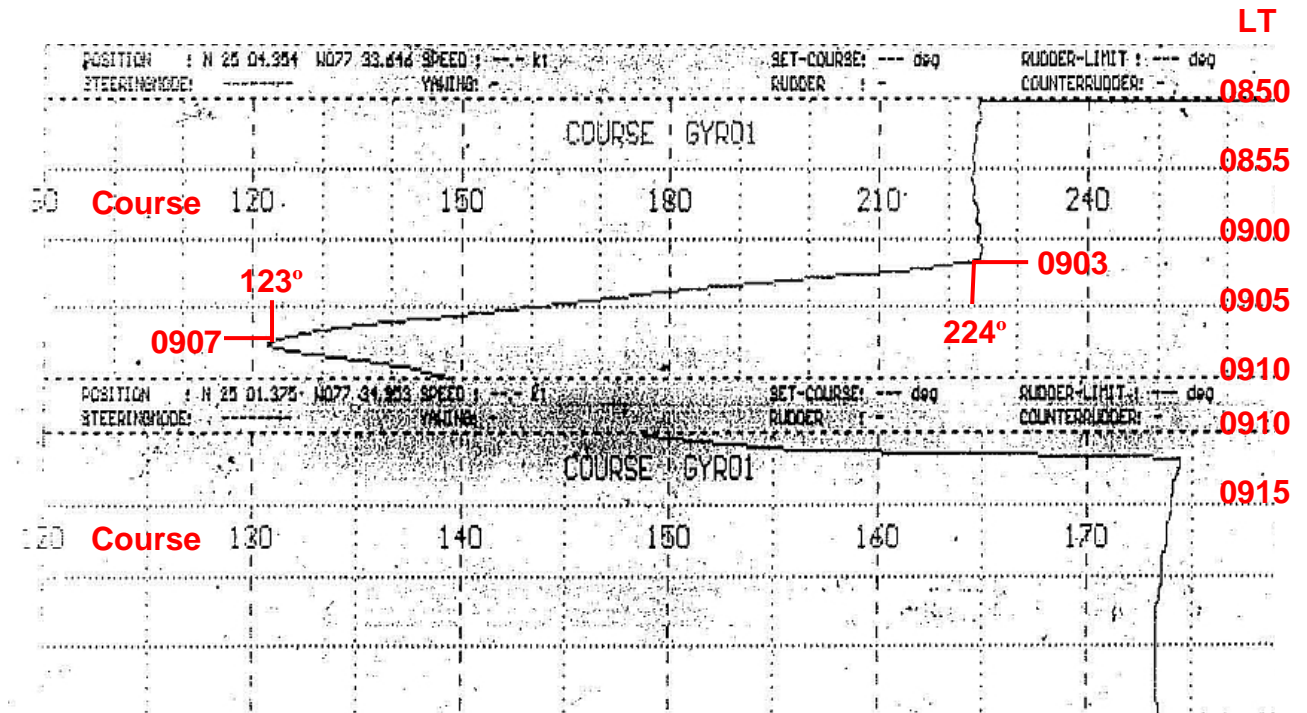
### The Course Recorder

The line representing the change of heading between 0903 and 0907 is approximately a straight line. During this period the change of heading is approximately 101° (224°-123°). Therefore the average rate of turn can be calculated as approximately 25°/min.

Please note that rate of turn at any one point may be higher or lower than 25°/min.
