**The Bahamas
Maritime Authority**

M.V HARMONY OF THE SEAS

**Report of the marine safety investigation into a lifeboat
fall during an abandon ship drill on the 13th September
2016 in Marseille, France**

HARMONY OF THE SEAS

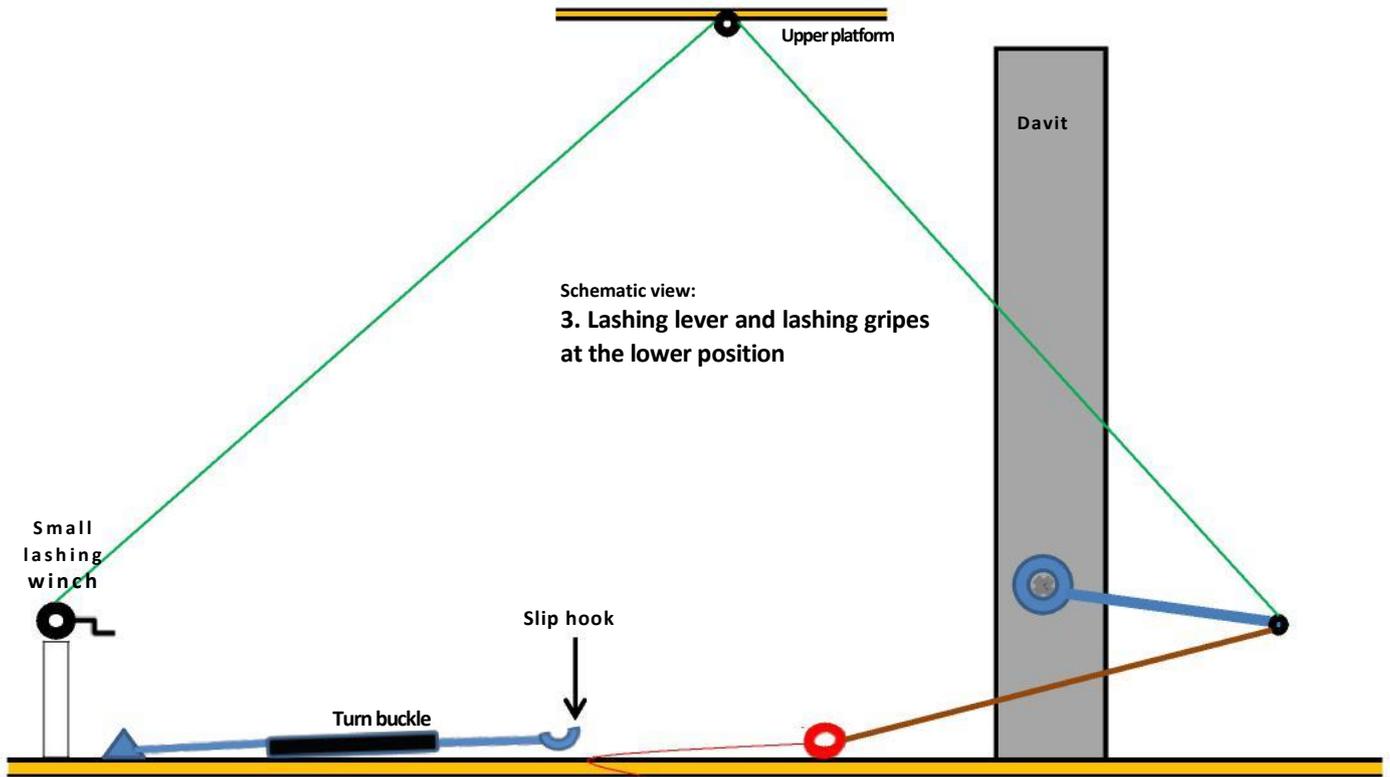
Davit, lashing gripe and limit switch

Contrary to the aft lashing gripe, the lifeboat's securing forward lashing gripe remained in raised position. Thus its limit switch was not activated; in these conditions, it's only the descent of the lifeboat with the electric winch that is prevented. A contrario, gravity launching is possible.

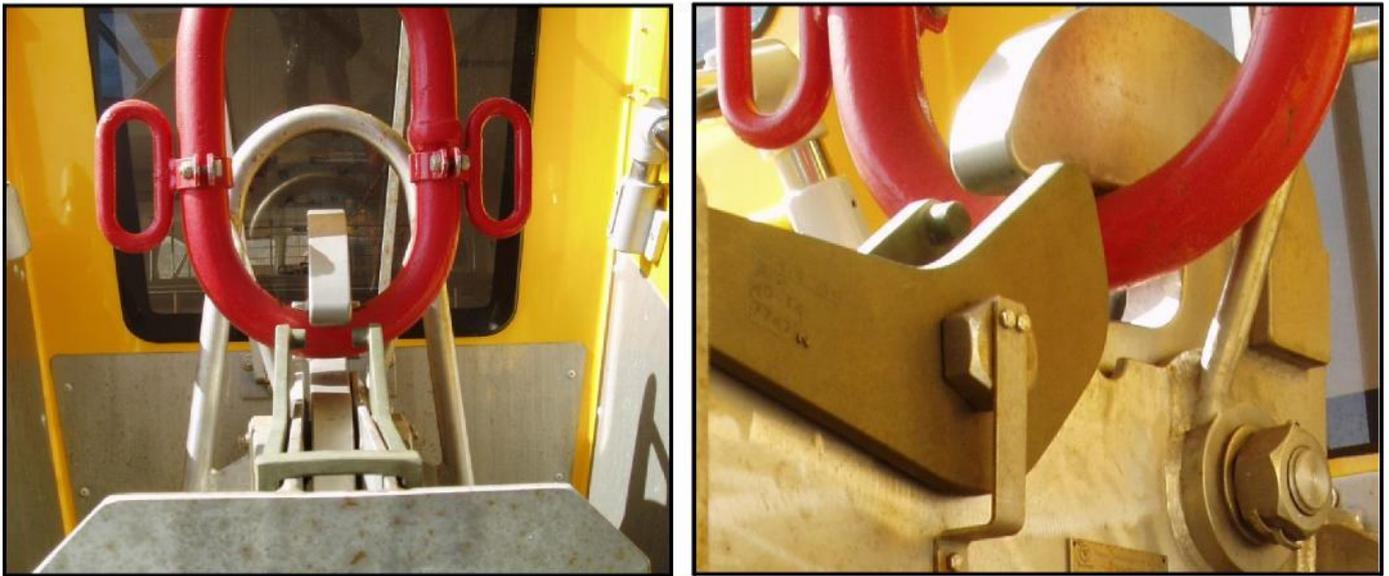
Hook, aft long link and stop pawl - the forward mechanism is the same

From the first metres of descent, the lifeboat tilted heavily backward, which resulted in the (red) long link catch point being moved to the end of the hook, the curve of which is low (in order not to hamper the release when the lifeboat is upright).

secured by the forward long link tumbled then forward. The brutal movement caused the release of the long link from the aft hook with kinematics similar to the release of the fore part (moving of the catch hold as a result of the heavy tilt angle, shape of the hook end and lightness of the stop pawl). Releasing itself, the long link tore off the aft stop pawl (cf. appendix C1).

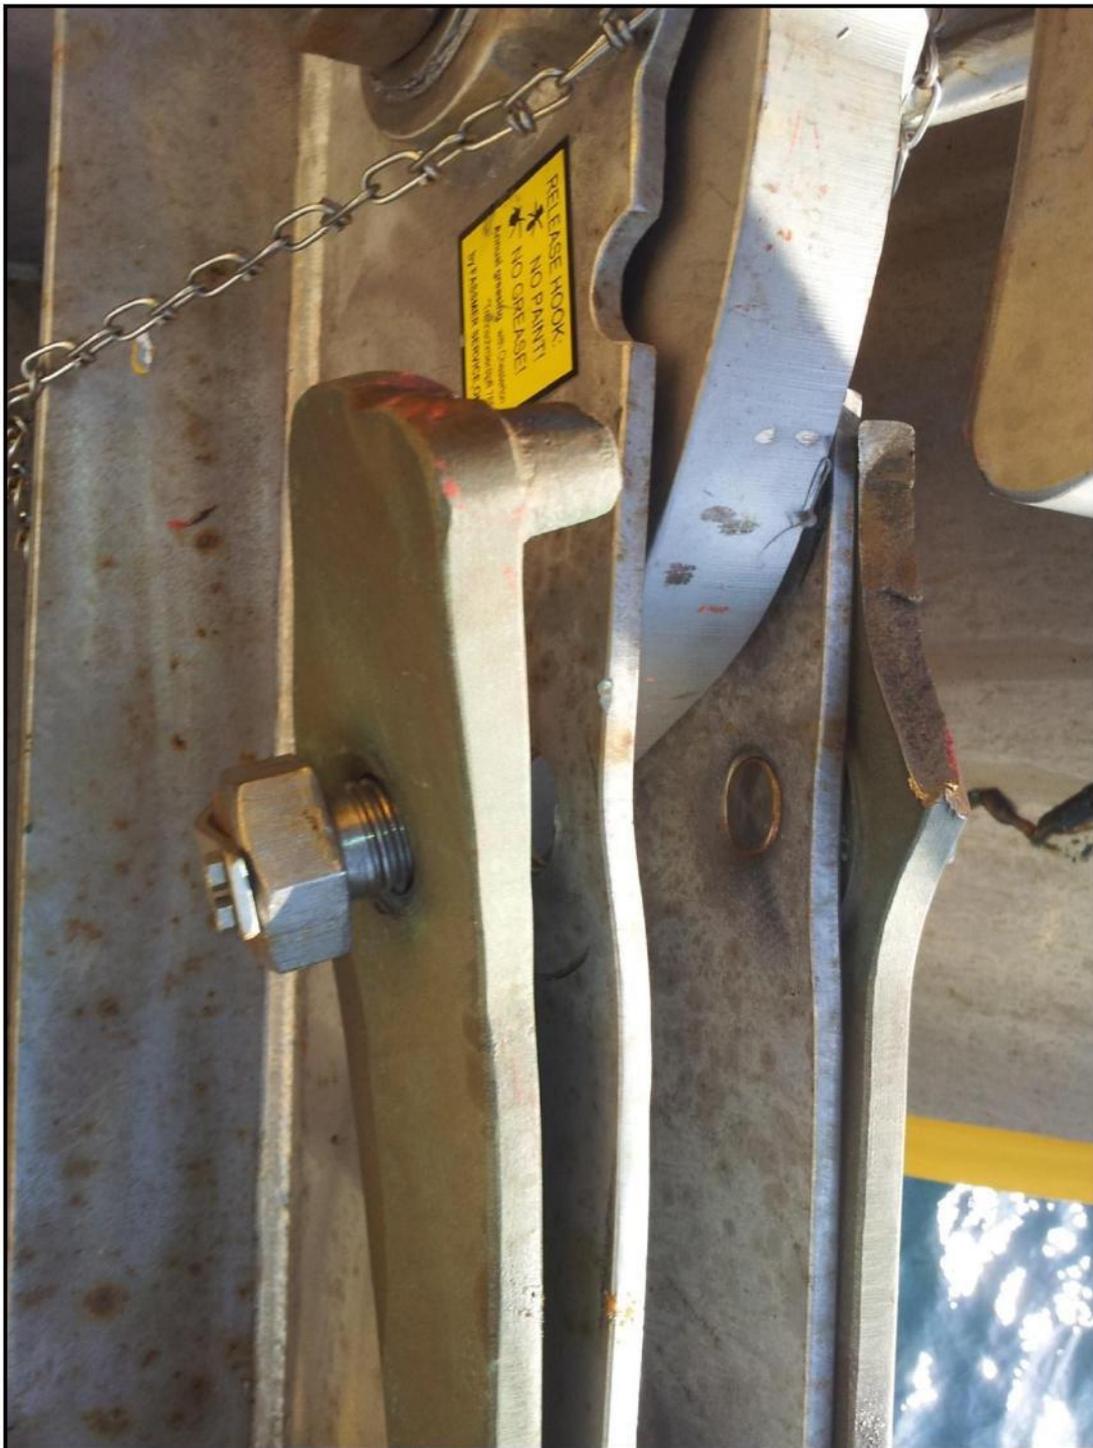
Appendix C4

As soon as the deck-hand actuated the control releasing the winch brake, the stern of the boat started to descend, while the bow was locked in the guide by the davit forward lashing gripe. The lifeboat was destabilized and tilted heavily backwards. Under the combined effects of the excessive inclination and the weight, the bow of the boat freed itself from the guide and the forward long-link « slipped out » from its release hook. The lifeboat tilted heavily forward and a new unbalance was created; the aft long-link was in turn « slipped out » from its hook, tearing its stop pawl (cf. appendix C4).

Linguet / Stop pawl

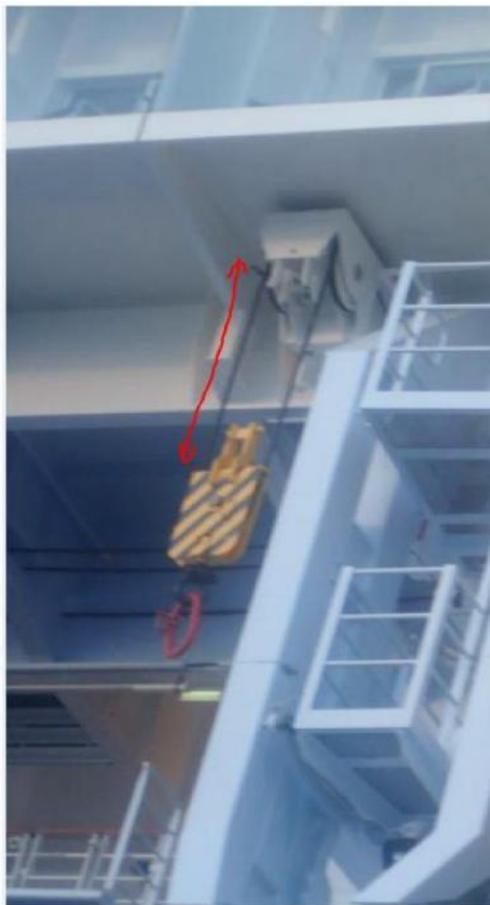
AFT SUSPENSION BLOCK

The fact that the Suspension Blocks are not heavy enough to pull the Fall Wires down (this has been proven during previous lifeboat drills, when recovering the lifeboats, it is necessary to pay out the fall wires via the electric winch in order for the long links to be lowered) means that the Forward Suspension Block remained very closed to its original position, while the Forward Fall Wire was getting slacked between the sheaves. This explains the different positions of the Suspension Blocks (see pics below).

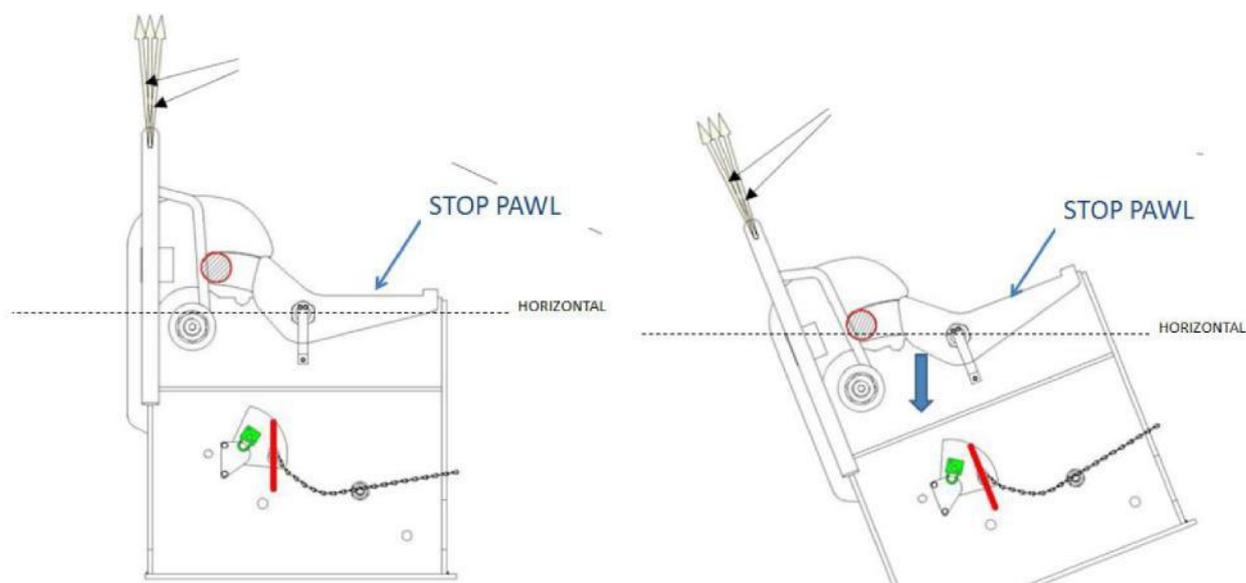
LIFEBOAT IN NORMAL STOWED POSITION

WITH A SMALL INCLINATION, THE STOP PAWL
WOULD OPEN DUE TO LACK OF COUNTERWEIGHT.
