**The Bahamas
Maritime Authority**

FRI DOLPHIN

**Report on cargo fumigant poisoning leading to a fatality on
13 February 2020**

Fri Dolphin – Marine Safety Investigation Report

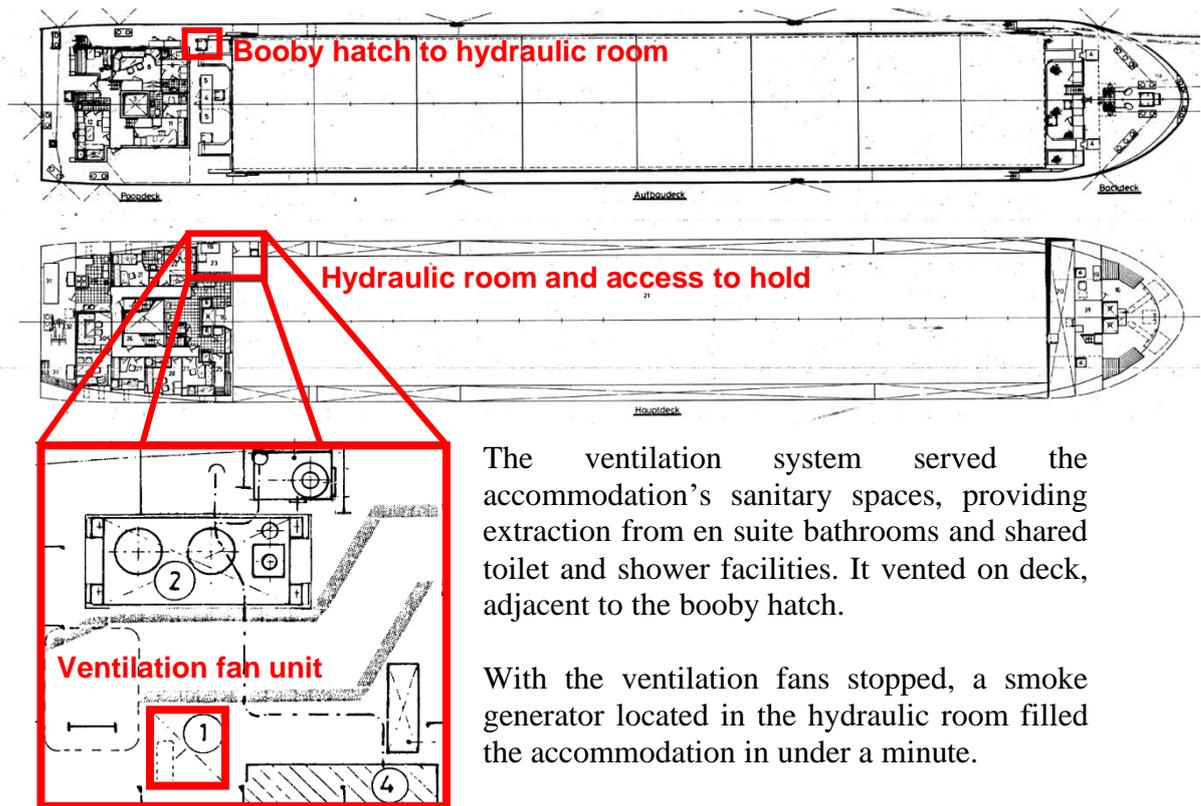
Figure 2: Fri Dolphin general and specific arrangement

Three issues were identified in the hydraulic room:

- i. The door to the cargo hold was misaligned and could not be made gas tight, even with all dogs adjusted
- ii. There were two stubs of unused and uncapped small diameter pipe running between the hydraulic room and accommodation
- iii. A ventilation fan and the associated trunking running through the room was not airtight

The ventilation system served the accommodation's sanitary spaces, providing extraction from en suite bathrooms and shared toilet and shower facilities. It vented on deck, adjacent to the booby hatch.

With the ventilation fans stopped, a smoke generator located in the hydraulic room filled the accommodation in under a minute.

Whilst the ventilation fan and trunking not being airtight was a hidden defect, the misalignment of the hydraulic room door was visibly noticeable. MSC.1/Circ.1264 section 3.3.2.4 requires cargo holds to be inspected and/or tested for leakage by the fumigator-in-charge and member of the ship's crew prior to loading. The fumigators did not arrive at the vessel until after loading was complete and, as such, this inspection could not be conducted as required. No inspection was made by ship's staff to confirm gas tight integrity of the hold.
