## Port State Control - Recurring Deficiencies

Notice to ship owners, managers, Masters, Approved Nautical Inspectors, Recognised Organisations and surveyors

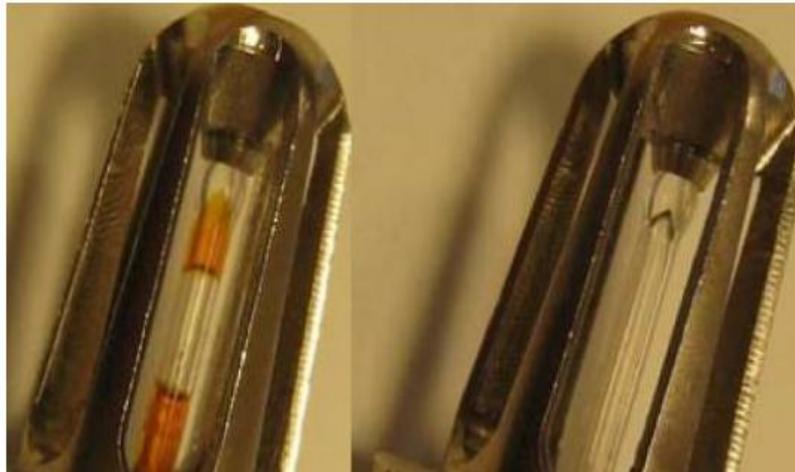
- 4.9.1. In a number of PSC inspections sprinkler heads have been found with empty glass bulbs. Following an investigation with the sprinkler system suppliers, the root cause for the unexpected empty bulbs was identified to be due to “external hits” (i.e. contact damage).

- 4.9.3. It should be noted that external contact damage can happen either prior to installation (e.g. during transport and storage) and whilst fitted in place (e.g. accidental damage during luggage handling, gym, playroom etc.). External contact may cause “micro cracks” in the glass bulb that are not necessarily visible, which could result in the liquid leaking or evaporating from the bulb.

- 4.9.4. When the liquid leaks or evaporates from the bulb, the system may not operate as designed. Sprinkler heads with no liquid in the glass bulb therefore need to be replaced, though a small bubble in the liquid is acceptable. Examples are shown in the following paragraphs.

- i. Sprinkler heads that require immediate replacement:

- 4.9.5. The Company should ensure that spare sprinkler heads are stored and transported carefully to avoid damage and should ensure that they comply with any service bulletins or recommendations issued by suppliers.
- 4.9.6. Suppliers have also highlighted issues related due to external corrosion of sprinkler heads, which can impair sprinkler head performance. During routine inspections, special attention should be given to sprinkler heads subject to aggressive atmospheres (e.g. in galleys and saunas).

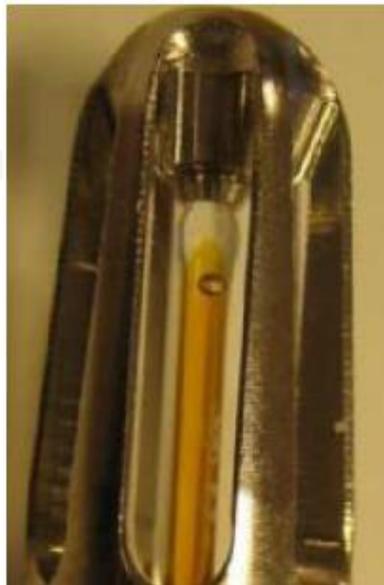
- ii. Sprinkler head with small air bubble that does not require replacement:
