The Bahamas
Maritime Authority

Marine Safety Investigation Report

into a crew fatality on *Irenes Rose* on
08 February 2020

Date of Issue: 19 March 2021
Bahamas Maritime Authority
120 Old Broad Street
LONDON
EC2N 1AR
United Kingdom

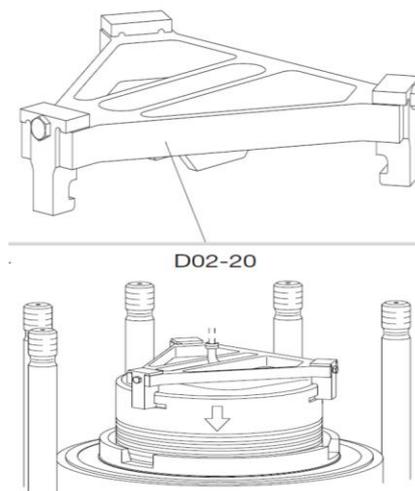
Figure 1: Piston lifting tool

¹ The lifting tool has three claws: two stationary and one adjustable claw. The claws sit in the piston lifting grooves on the top of the piston.

Step 9 of the manual required the piston to be fully turned to TDC to ensure that the piston rod is in full contact with the crosshead. The adjustable claw of the lifting tool then could be unscrewed and the lifting tool pulled free from the lifting groove in the piston ring.

This step was not followed either and the crosshead was not turned to TDC for the piston rod to be in contact with the crosshead. The second engineer unscrewed the lifting tool's adjustable claw using a spanner and hammer to free the lifting tool from the lifting groove, leading the piston to be unsupported.

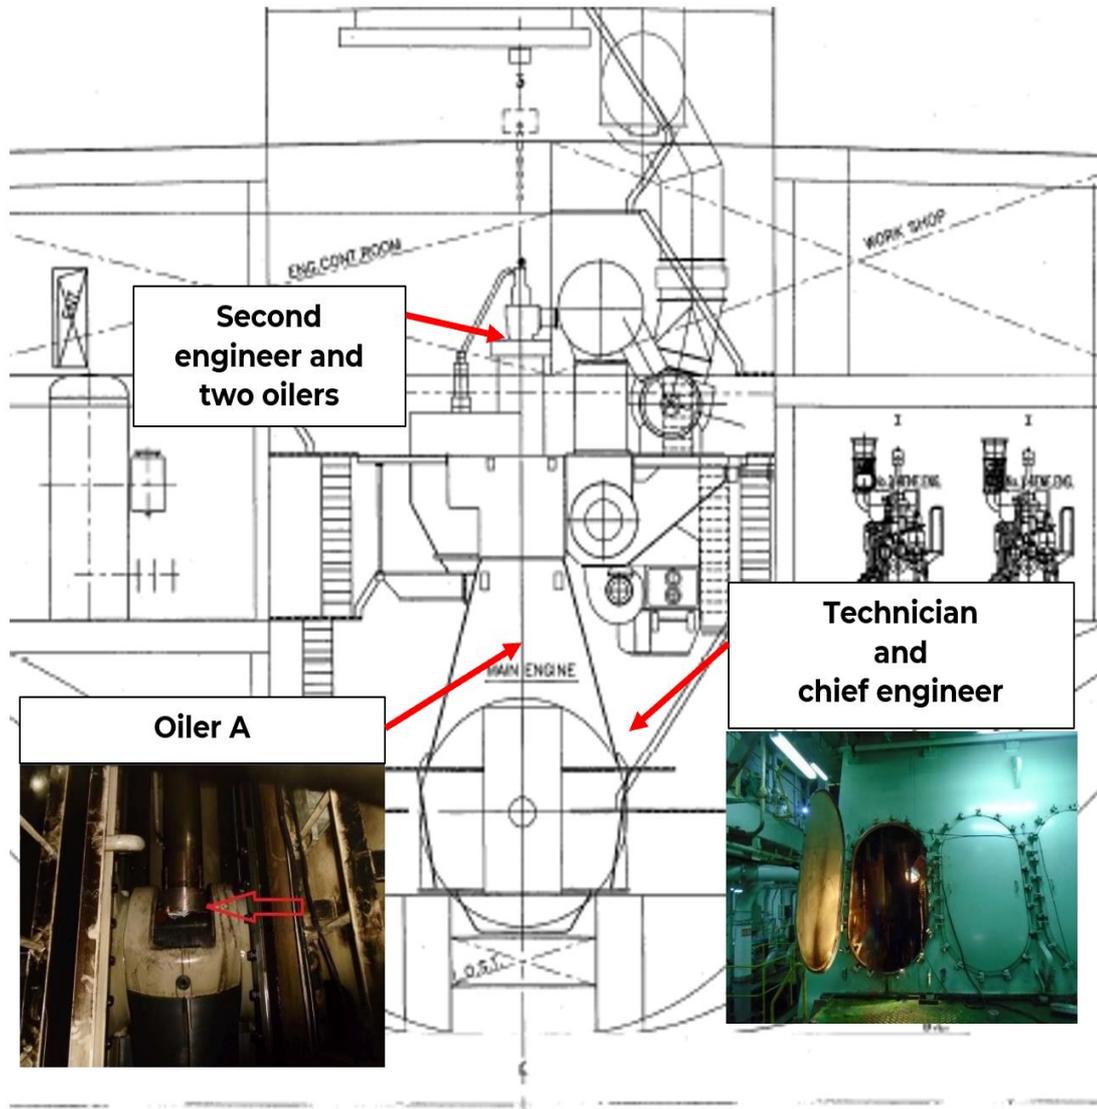
Figure 2: Position of crew members

The second engineer was in charge of lowering the piston using the engine room crane. He was stationed at the upper platform near the cylinder head along with the two oilers assisting him with the operation.

The third engineer was in charge of placing the stuffing box into position and was inside the crankcase along with the technician and oiler A (deceased crew member) assisting him to complete the task.

The chief engineer was standing outside the crankcase at the lower platform supervising the whole operation. The second engineer and third engineer each had a personal portable VHF radio used to communicate the piston rod's position while the second engineer was operating the crane.

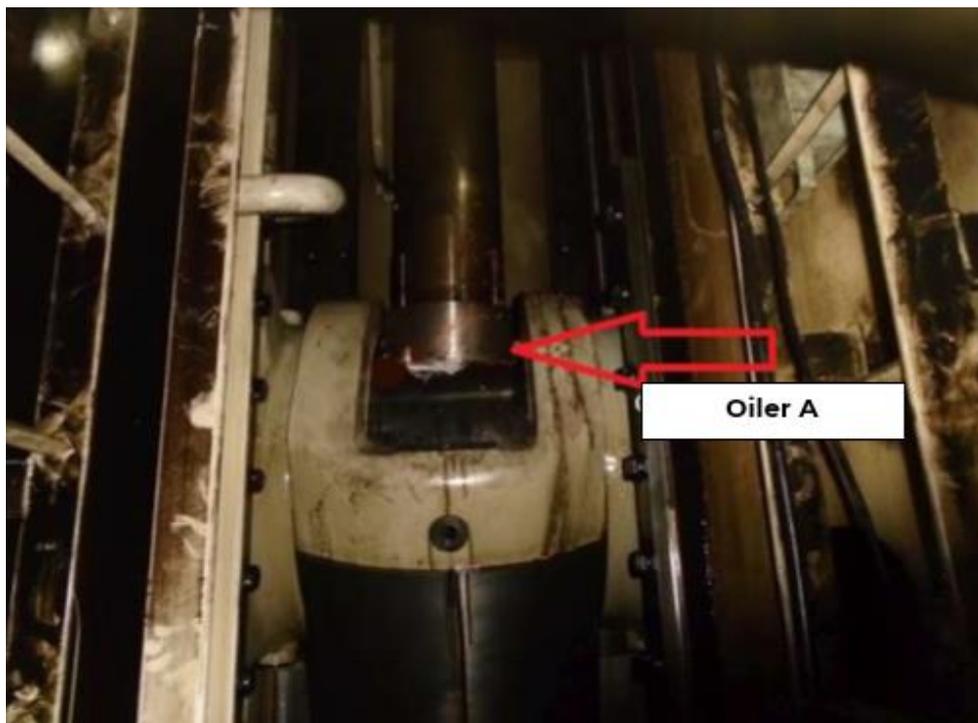
Figure 4: Position of oiler A (deceased crew member)

After tightening the stuffing box, the chief engineer instructed the crew to clear all the tools, clean the surface and exit the crankcase. The third engineer left the crankcase first and went to the engine control room to drink water. The technician came out of the crankcase after removing the tools. Oiler A was still inside the crankcase to clean up the area.

The third engineer returned to the lower platform and the chief engineer instructed him to turn the engine using the turning gear. At this time, the piston lifting tool was released by the second engineer and the engine crew heard a loud noise of the piston dropping inside the crankcase. Subsequently, oiler A was found, injured and unresponsive, in the sump tank of the main engine.

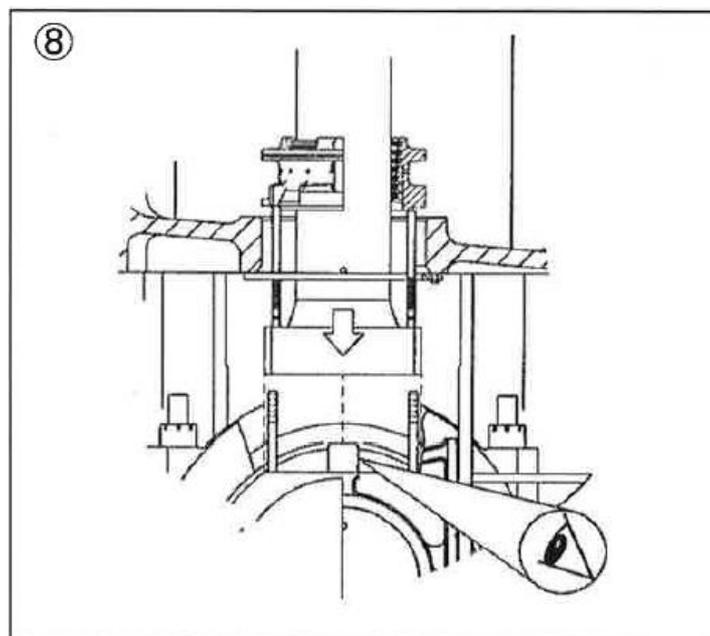
Figure 5: Diagram from the main engine manufacturer's manual for step 8 of piston mounting

Step 8 required the crosshead to be turned nearly to the top dead centre (TDC) while checking that the guide ring of the crosshead enters the centre hole in the piston rod.

The crosshead was not turned to near the TDC position for the mounting process of the piston.
