The Bahamas
Maritime Authority

Marine Safety Investigation Report

into a man overboard from Castillo De
Valverde on 28 May 2020

Date of Issue: 19 April 2021
Bahamas Maritime Authority
120 Old Broad Street
LONDON
EC2N 1AR
United Kingdom

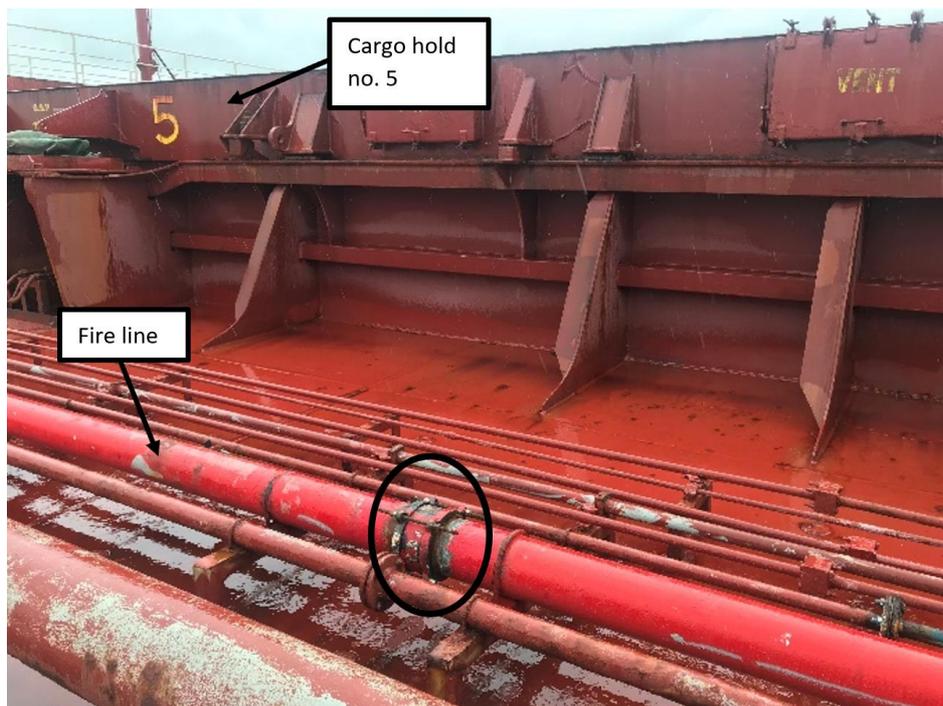
Figure 2: Location of the leaking flange on the fire line

At 13:30, the bosun observed a leak on the fire line flange near the cargo hold no. 5 and informed the chief officer.

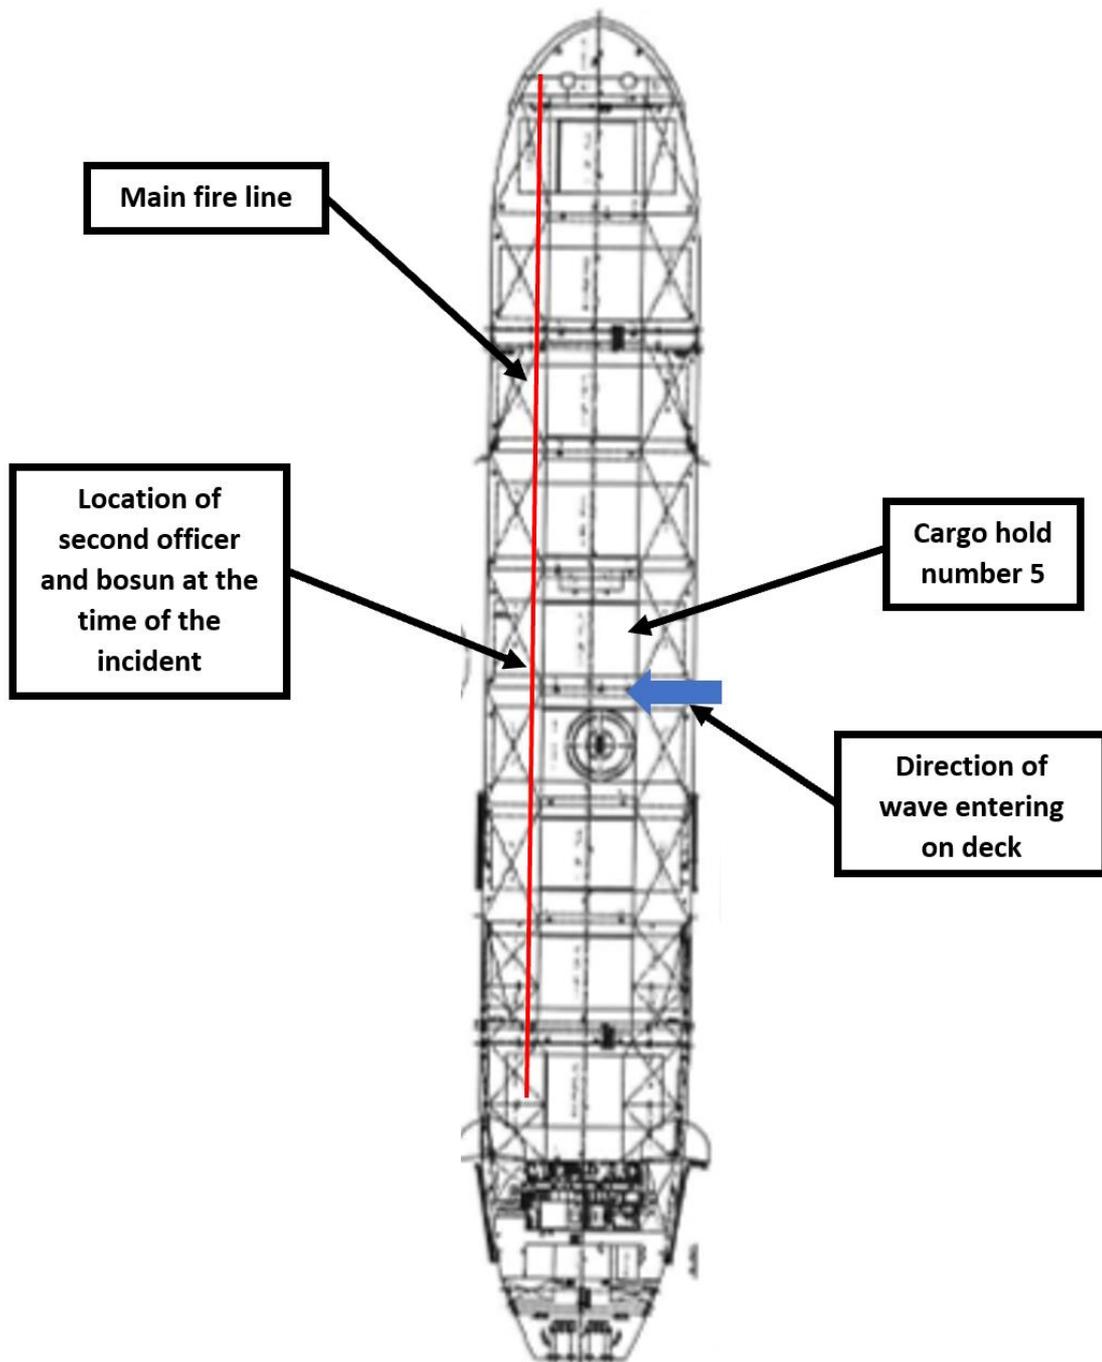
Figure 3: Location of the incident on deck

At 15:40, while the bosun and second officer were collecting the tools, a heavy wave entered the deck from the starboard side, between the cargo hold no. 5 and 6. The second officer held on to the railing, but the bosun was swept overboard with the wave.

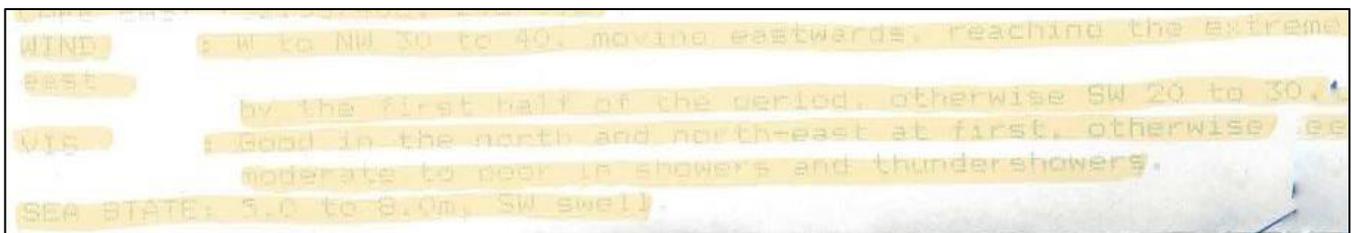
Figure 4: Screenshots¹ of weather bulletin from the South African weather service

The weather was considered good in the morning and the chief officer planned the scheduled jobs on deck for the day. The vessel received a weather bulletin from the South African weather service at 12:34 (09:34 UTC) on 28 May 2020. The bulletin included a weather warning with an expected wind speed of 30-40 knots and a 5-8m wave height. However, the tasks for the day were continued on deck.

Wind: W to NW 30 to 40, moving eastwards, reaching the extreme east by the first half of the period, otherwise SW 20 to 30.
VIS: Good in the north and north-east at first, otherwise moderate to poor LP showers and thunder showers.
SEA STATE: 5.0 to 8.0m, SW swell

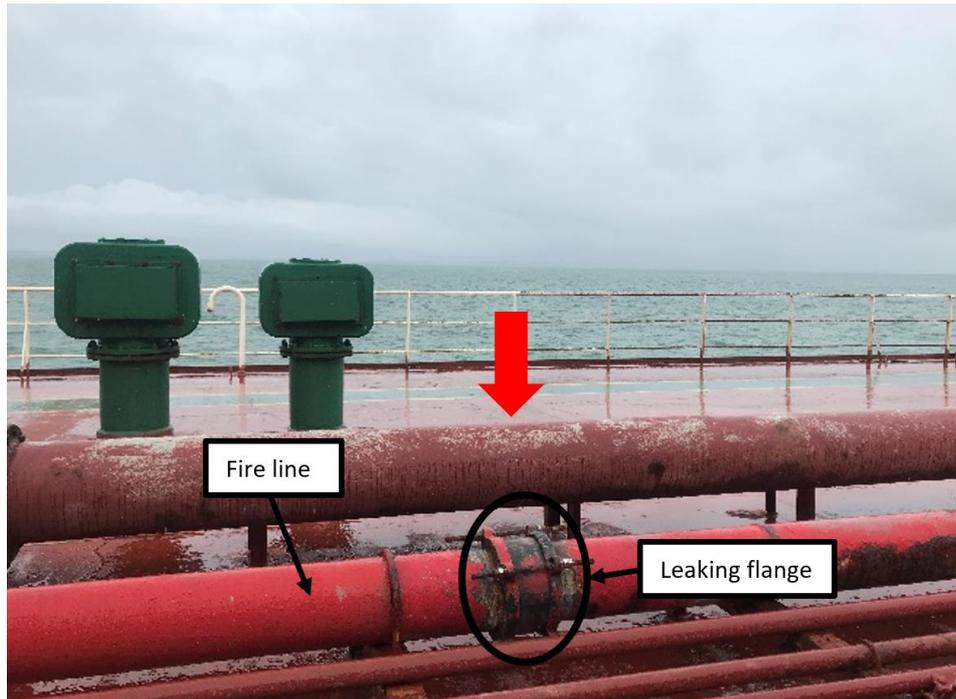
Figure 5: Red arrow indicating the approximate location of the bosun and second officer while collecting the tools on deck, see figure 3 for schematic

After the coffee break, the two crew members went back on the deck to collect the tools when the wave hit, striking the starboard side midships, washing the bosun overboard on the port side. While on deck, the crew members were not wearing any harness, safety line or personal flotation device.

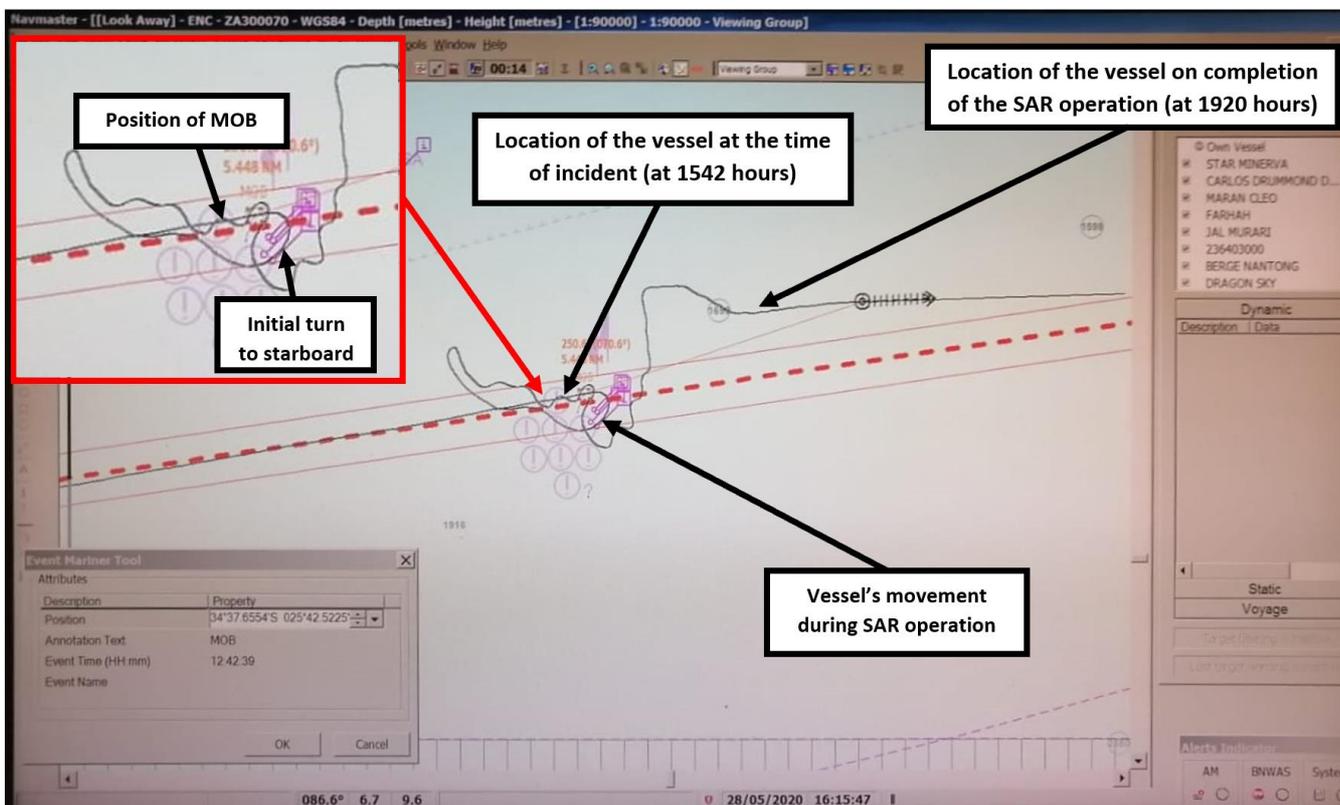
Figure 9: Vessel's movement during the conduct of the SAR operation

There was a significant delay in the vessel regaining the MOB location which may be a result of the significant weather impacting the manoeuvring characteristics coupled with the set and drift experienced during the turn, but a safety helmet, assumed to be the bosun's, was sighted nearby.

The International Aeronautical and Maritime Search and Rescue (IAMSAR) Manual³ includes the guidance on the Williamson turn to be on the side of the casualty. The bosun was washed overboard to port and the vessel had executed the turn to starboard. Further, the IAMSAR manual also provides guidance on planning the search areas and search patterns such as expanding square searches, sector search, track line search and parallel track search. None of the search patterns provided in IAMSAR were used. However, the manoeuvring characteristics of the vessel at the time are not known and therefore the precise reason for the master executing a turn to starboard, into the weather should be taken into consideration.
