Port State Control - Recurring Deficiencies

Notice to ship owners, managers, Masters, Approved Nautical Inspectors, Recognised Organisations and surveyors

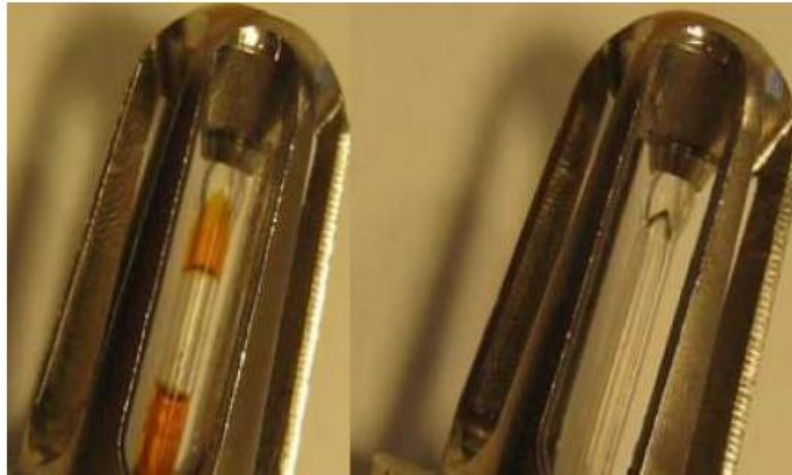
4.9.1. In a number of PSC inspections sprinkler heads have been found with empty glass bulbs. Following an investigation with the sprinkler system suppliers, the root cause for the unexpected empty bulbs was identified to be due to “external hits” (i.e. contact damage).

4.9.3. It should be noted that external contact damage can happen either prior to installation (e.g. during transport and storage) and whilst fitted in place (e.g. accidental damage during luggage handling, gym, playroom etc.). External contact may cause “micro cracks” in the glass bulb that are not necessarily visible, which could result in the liquid leaking or evaporating from the bulb.

4.9.4. When the liquid leaks or evaporates from the bulb, the system may not operate as designed. Sprinkler heads with no liquid in the glass bulb therefore need to be replaced, though a small bubble in the liquid is acceptable. Examples are shown in the following paragraphs.

- i. Sprinkler heads that require immediate replacement:

- 4.9.5. The Company should ensure that spare sprinkler heads are stored and transported carefully to avoid damage and should ensure that they comply with any service bulletins or recommendations issued by suppliers.
- 4.9.6. Suppliers have also highlighted issues related due to external corrosion of sprinkler heads, which can impair sprinkler head performance. During routine inspections, special attention should be given to sprinkler heads subject to aggressive atmospheres (e.g. in galleys and saunas).

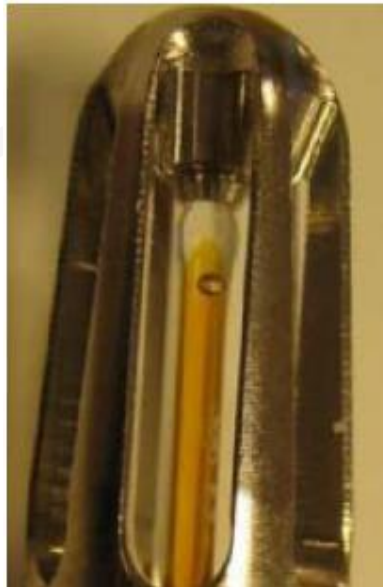
- ii. Sprinkler head with small air bubble that does not require replacement:
