The Bahamas
Maritime Authority

Marine Safety Investigation Report

into an engine room fire onboard Pride of Hull
on 20 October 2020

Date of Issue: 30 November 2021
Bahamas Maritime Authority
120 Old Broad Street
LONDON
EC2N 1AR
United Kingdom

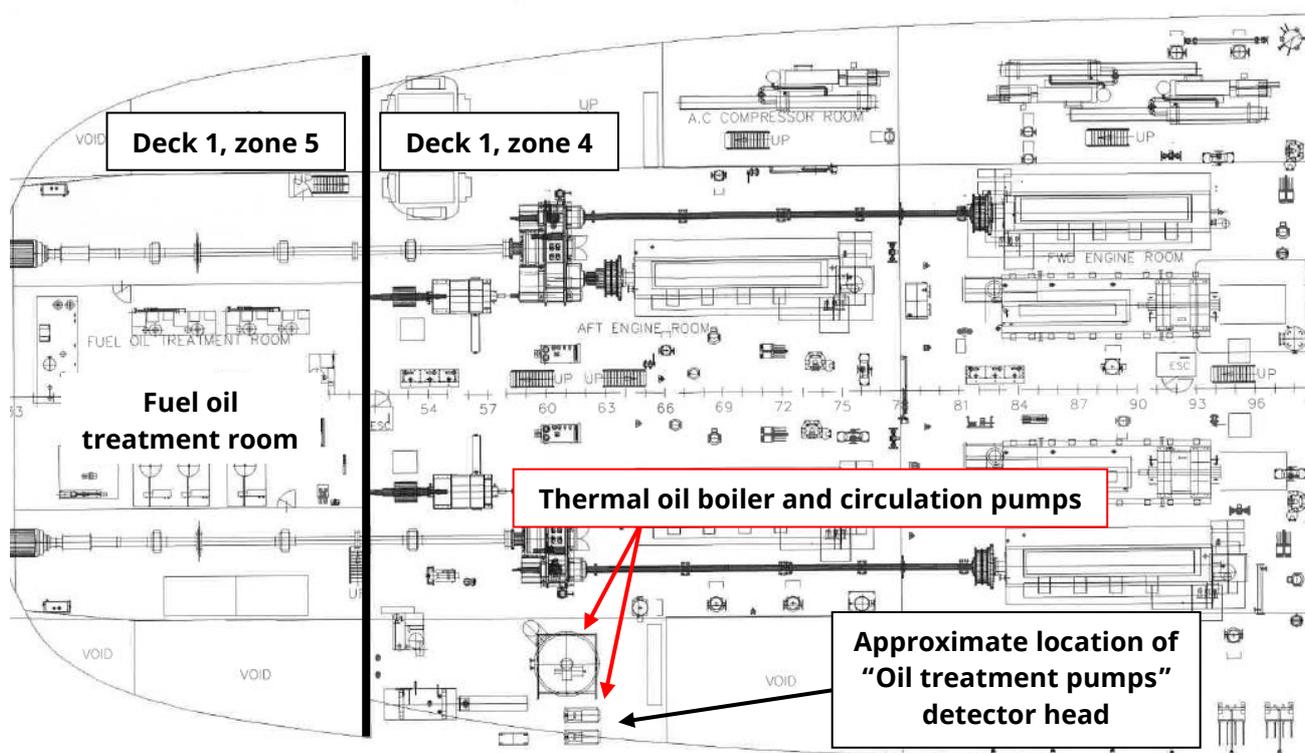
General arrangement plan with “oil treatment pumps” and fuel treatment room identified

The naming of the fire detector section that incorporated the thermal oil circulation pumps as "Oil treatment pumps" created confusion and resulted in a delay in confirming the existence of the fire and its location.

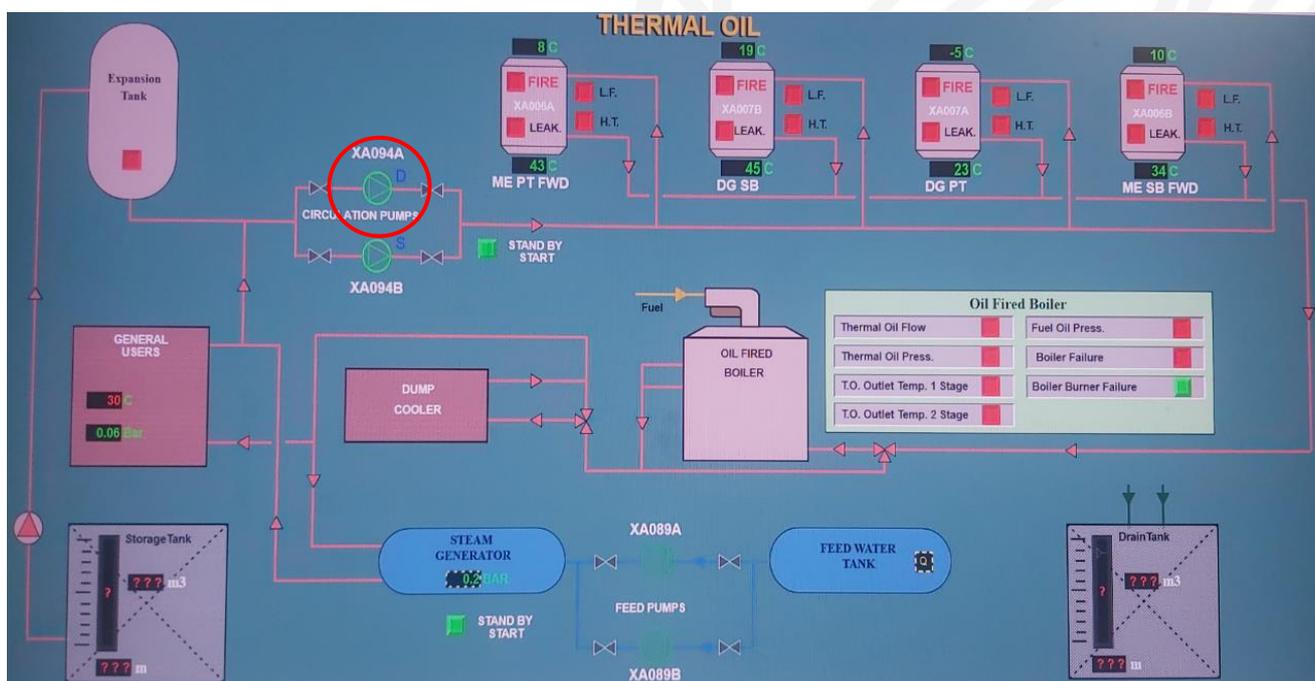
Post-fire scene examination identified that thermal oil circulation pump #1 was the seat of the fire.

Thermal oil system overview. Circulation pump #1 ringed

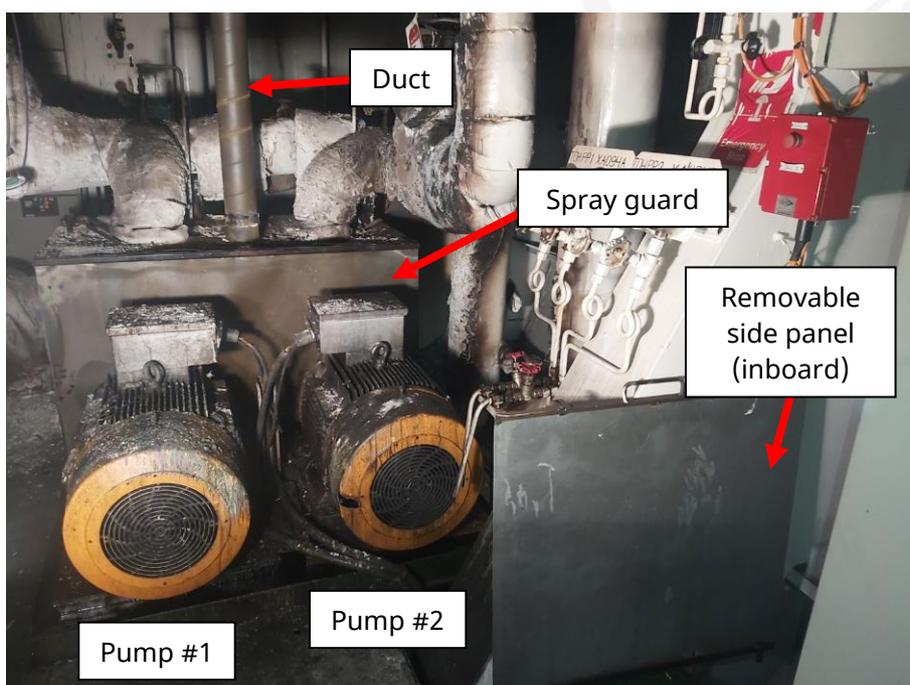
The thermal oil circulation pumps had a spray guard fitted to retain oil in the event of a seal failure. The original spray guard was manufactured onboard and installed by the engineering team in 2001. Removable side panels were added in 2017 and a duct, connected to the engine room ventilation system, was added in July 2018. At the time of the fire, the side panels were not in position.

Thermal oil circulation pumps with spray guard arrangement, seen from aft (post fire)

Considering the identified cause of ignition, the open sides and ventilation duct are not considered to have had an impact on the cause of the fire but may have limited the effectiveness of the spray guard in terms of containment.

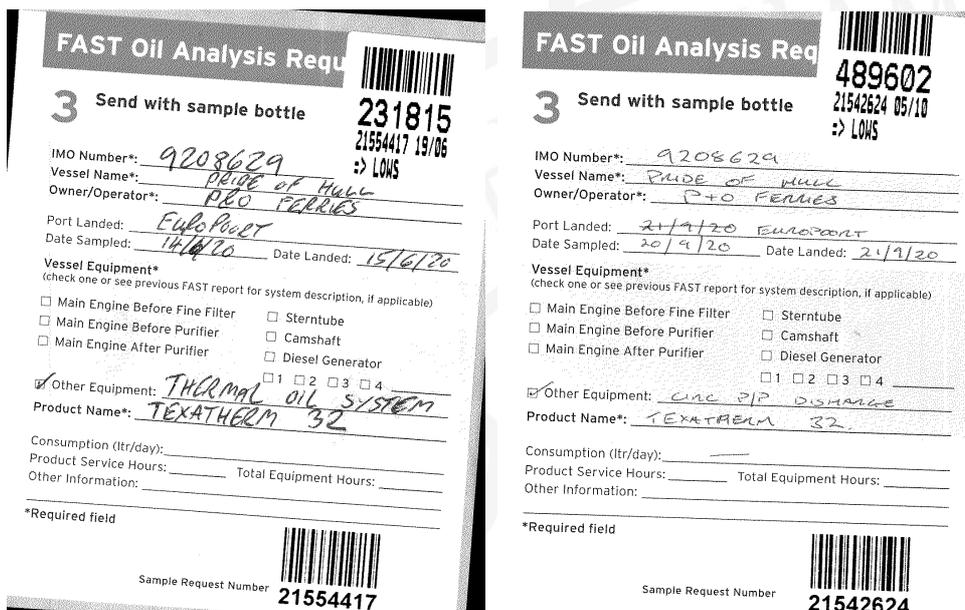
The most recent sample of Texatherm 32 was drawn on 20 September 2020 and tested on 05 October 2020. Tests identified a flash point of 135.5°C. The test results report did not identify a safety limit or highlight that the flash point was lower than the safety limit.

Chevron attributed the absence of safety advice on the test report to the sample label not identifying the equipment it had been drawn from. Texatherm 32 was not used in any other equipment / system onboard Pride of Hull.

Thermal oil sample labels, June and September 2021

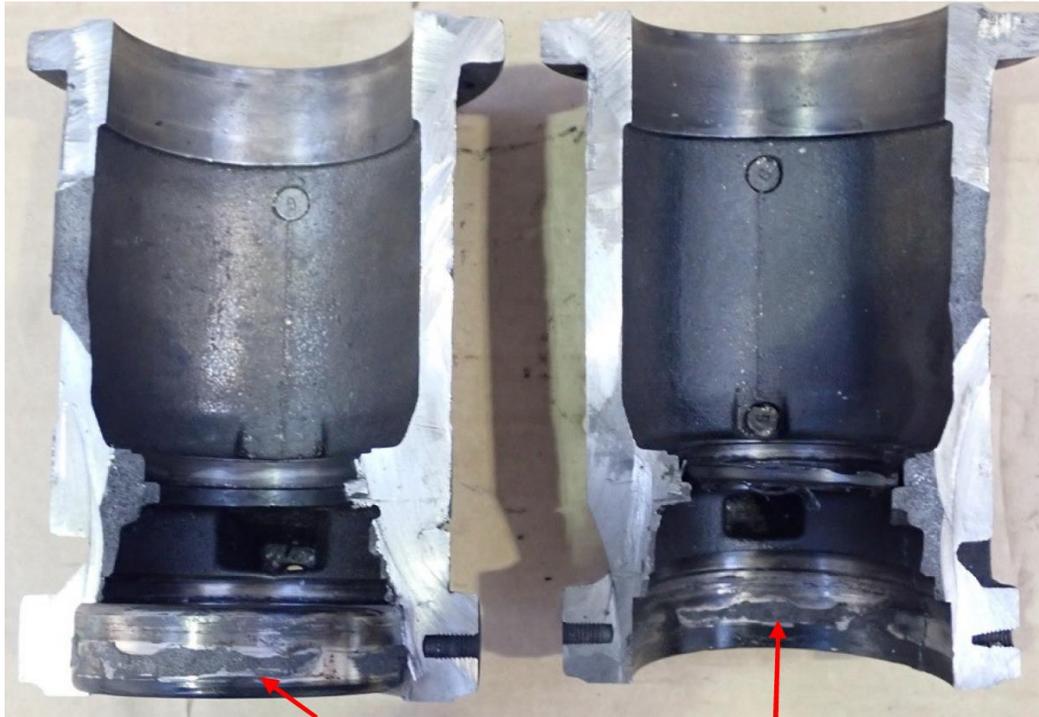
Metallurgical examination identified that the damage to the pumps was consistent with a bearing failure and fire originating at pump #1. The pattern of damage to pump #1 indicates that the impeller end bearing failed first and the drive end bearing collapsed shortly afterward. This collapse led to the drive end bearing's outer race rotating in the bracket housing, which resulted in extreme frictional heating, generating temperatures in the order of 1,200°C - well in excess of the thermal oil's autoignition temperature. Due to the failure of the mechanical seals and circlips, there was a path for the thermal oil to reach the hot spot internally as well as spray to make contact externally.

Thermal oil pump #1's bearing housing, split longitudinally. Arrows show the drive end bearing's outer race fused to the housing (left) and heat affected longitudinal band (right).

The metallurgical examination of the pumps did not conclusively identify the reason for the initial bearing failure. Both the bearings were Allweiler parts, of correct design for application and had failed after a relatively short period of operation. However, it was identified that the surface of the bracket housing in which the impeller end bearing sits was pitted and "possibly slightly" worn. This may have affected the fit of the bearing and potentially led to premature failure.

- The fire was caused by a series of mechanical failures in thermal oil circulation pump #1. A bearing failure created a hotspot of around 1,200°C, this also resulted in failure of the mechanical seals and circlips which created a route for the thermal oil to come into contact with the hotspot, well in excess of its autoignition temperature.

- Replaced Pride of Hull's thermal oil pumps and reviewed the condition monitoring plan within the planned maintenance system.
 - Provided fleetwide guidance on the principals of installation of spray guards.

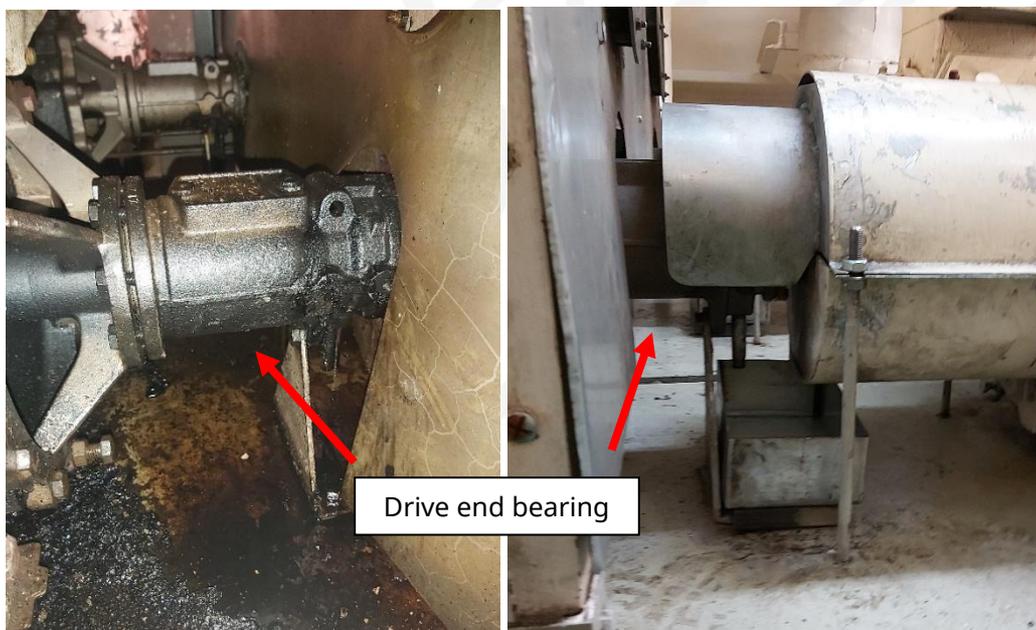
The thermal pumps' spray guard was fitted in response to thermal oil circulation pump seal failures experienced onboard the Pride of Hull and its sister ship, the Pride of Rotterdam, shortly after entering service¹⁰. Both vessels fitted spray guards of a similar design: providing protection forward, above and aft of the circulation pumps. The design differed in their exact placement: on the Pride of Hull the guard's aft end incorporated the drive end bearing whilst on the Pride of Rotterdam's the drive end was covered by a separate, smaller guard.

**Spray guard position in relation to drive end bearing
Pride of Hull (left) and Pride of Rotterdam**

After a bearing failure resulting in pressurised oil release and activation of the Hi-Fog in 2017, the spray guards on both vessels were adapted to “box in” the pumps on all sides. On Pride of Hull, this resulted in the pumps overheating. In response, the engineering team added ducting to provide air from the ventilation system. The forced air did not resolve the overheating and the side panels were subsequently removed.
