HMPE mooring lines - breakaway

- 1.1. This Safety Alert is issued by The Bahamas Maritime Authority to share lessons to be learned on the design, selection and safe use of mooring arrangements that incorporate high modulus polyethylene (HMPE) mooring lines. It is based on the findings of a preliminary investigation into a marine incident.

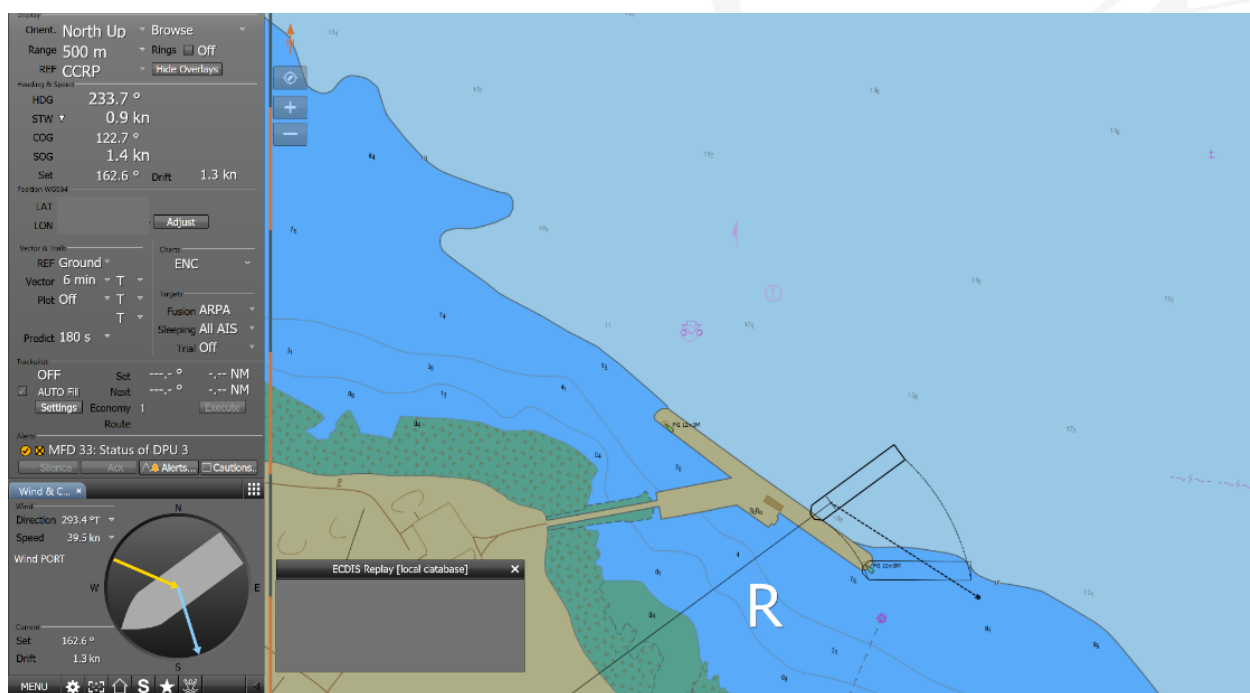
ECDIS screenshot: point of final line failure

- 2.3. As the vessel's stern swung away from the berth, tension was transferred to the forward lines and all lines had parted within four minutes of the initial failure. There was power to the ship's propulsion 13 seconds later and the vessel was manoeuvring to hold station shortly after that.
- 2.4. Damage was limited to the mooring lines and gangway; no one was hurt and there was no pollution. At the time of the incident, the vessel had been in service for six weeks.
