Safe Handling of Condemned Fire Extinguishers

- 1.1. This Safety Alert is issued by the Bahamas Maritime Authority to highlight the risks associated with handling condemned fire extinguishers. It is based on the preliminary findings of a Marine Safety Investigation into a Very Serious Marine Casualty.

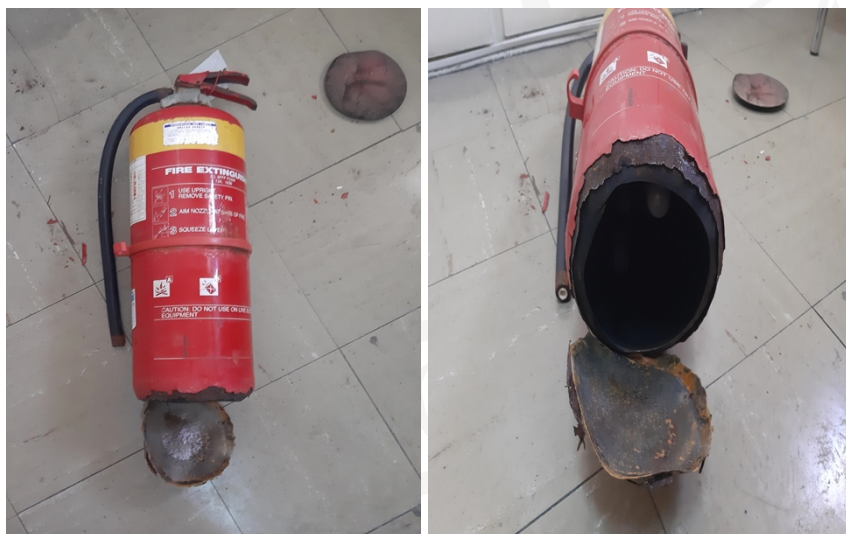
- 2.1. A Bahamas flagged tanker was alongside conducting repairs to the shaft bearing and several scheduled maintenance tasks.
- 2.2. During the late morning, junior officers from the deck department were preparing to dispose of several condemned fire extinguishers to garbage facilities ashore. Preparation of the portable (9 litre) foam extinguishers involved removing the CO₂ charge cartridge.
- 2.3. Having successfully removed the cartridge from one extinguisher, the officers could not remove the valve assembly from the second. The senior of the two officers involved decided to discharge the contents of the extinguisher into some waste rags.
- 2.4. During discharge, the body of the extinguisher ruptured at the base, causing the extinguisher to strike the officer in the chest. Despite immediate first aid from the crew and paramedics the officer died from the injuries sustained.

Ruptured extinguisher

- 3.1. The vessel's fire extinguishers had recently undergone an annual inspection by an approved firefighting equipment service provider. All extinguishers had been passed without comment but, post-inspection, eight fire extinguishers were identified as being in an unacceptable condition during shipboard planned maintenance checks and were removed from service.

- 3.2. The officers were decommissioning the fire extinguishers in order to leave them in a 'safe' condition once disposed of. However, they were not fully aware of the risks associated with handling fire extinguishers where the material integrity was compromised.

- 3.3. The Company's generic risk assessment for shipboard operations highlighted the requirement to follow the guidelines contained within its cold and pressurised systems work permit and onboard work instructions. When the officer could not remove the valve assembly as planned, an opportunity was missed to stop and reassess the plan.

- 4.1. Servicing by shoreside personnel may not be sufficient to control risks.
- 4.2. Pressure vessel failure can be catastrophic. Crew should be made aware of the potentially fatal risks associated with handling compromised pressure vessels and systems.

- 4.3. Fire extinguishers should be mounted on brackets off the deck to reduce the chance of water being trapped under the base. Fire extinguishers that are exposed to the elements require particular attention, where possible they should be rotated with those stored in a controlled atmosphere to reduce the likelihood of corrosion.

- 4.4. Where possible, decommissioning and disposal of fire extinguishers should be conducted by suitably qualified contractors.
- 4.5. When discharging any fire extinguisher, the manufacturer's guidelines on the correct operation should be followed. Where guidelines have not been provided, crew are advised to place the extinguisher on the deck away from the body when operating the trigger.
