# Marine Safety Investigation Report

into a fatal injury sustained during load testing  
of a mooring rope onboard mv Jawor  
on 09 November 2021

Date of Issue: 08 November 2022  
Bahamas Maritime Authority  
120 Old Broad Street  
LONDON  
EC2N 1AR  
United Kingdom

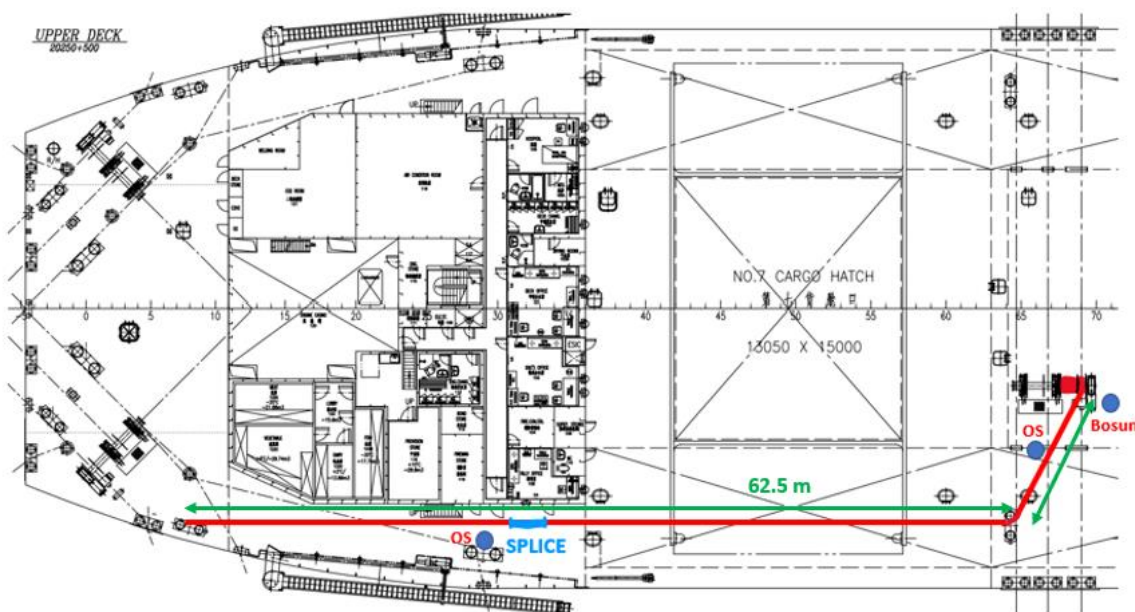
**Figure 1. Planned mooring line arrangement – splice and test of line**

After the meeting, the bosun, OS1 and OS2 made their way to the mooring station located on the starboard side between cargo holds No 6 and 7 (approximately 25m forward of the accommodation), uncoiled the mooring rope from the forward most winch and ran it out through a set of mooring bitts (adjacent to the chocks) and past the accommodation. The area of damage was then positioned under cover outside the entrance to the accommodation block to provide shade whilst work on the rope commenced (figure 1).

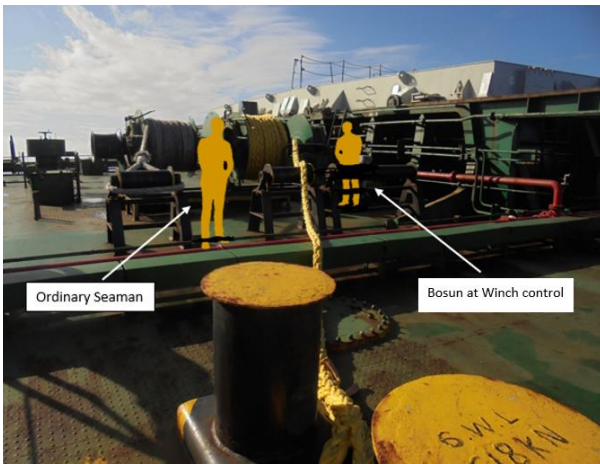
**Figure 2. Mooring station positions**

Shortly after 11:00, the bosun who's back was turned to the winch drum whilst operating the winch control, started heaving on the mooring winch whilst OS1 guided the rope, making sure it transferred to the split drum before it came in to tension (Figure 2).

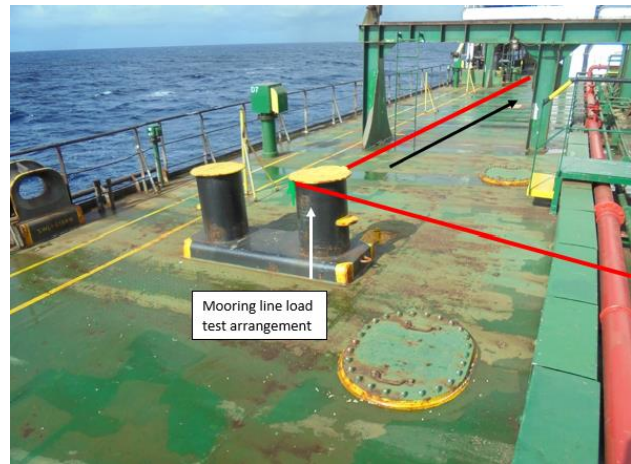
**Figure 3. Mooring line under load**

Once the bosun considered the tension sufficient, he left the control lever in the stop position and walked towards the railing to confirm with OS2 that the splice was holding (Figure 3), whilst making his way to check with OS2, he observed that OS1 was positioned between the roller trestle and the winch drum.

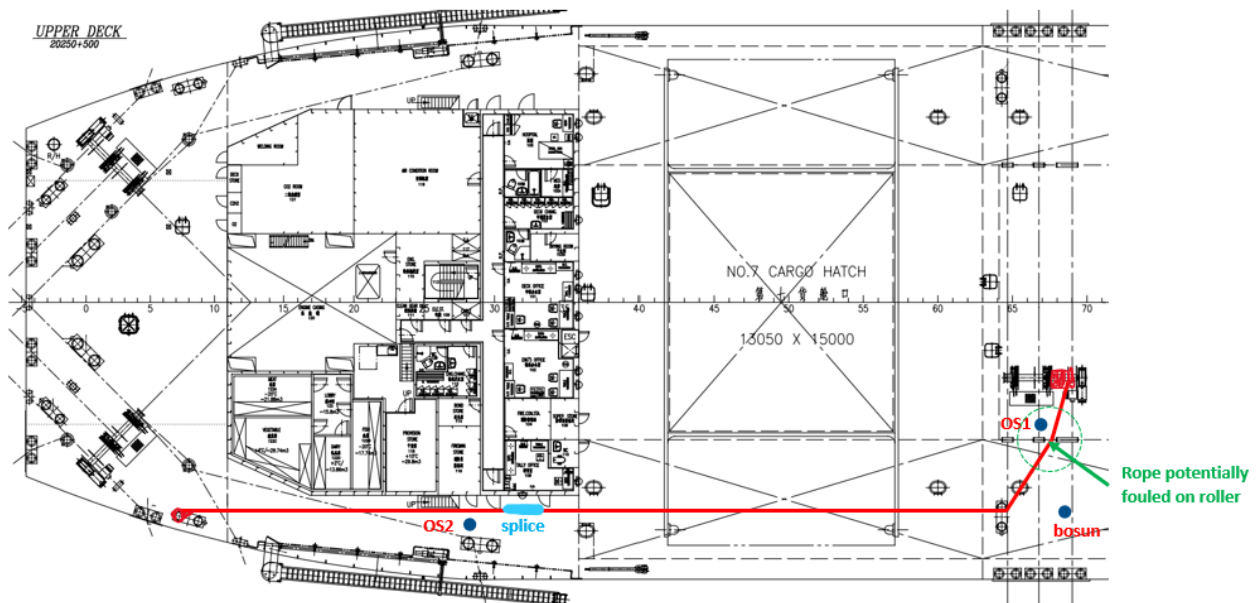
**Figure 4. Mooring line arrangement - Position of Bosun (line under tension)**

OS1's primary role was to ensure that the rope was correctly fed onto the winch's split drum. During normal operations, the mooring line would be paid out and recovered via the chocks with the use of the trestles positioned to assist direct feeding onto the drum. On this occasion the rope was leading aft meaning it needed to be manipulated to ensure it was fed correctly onto the drum without fouling.

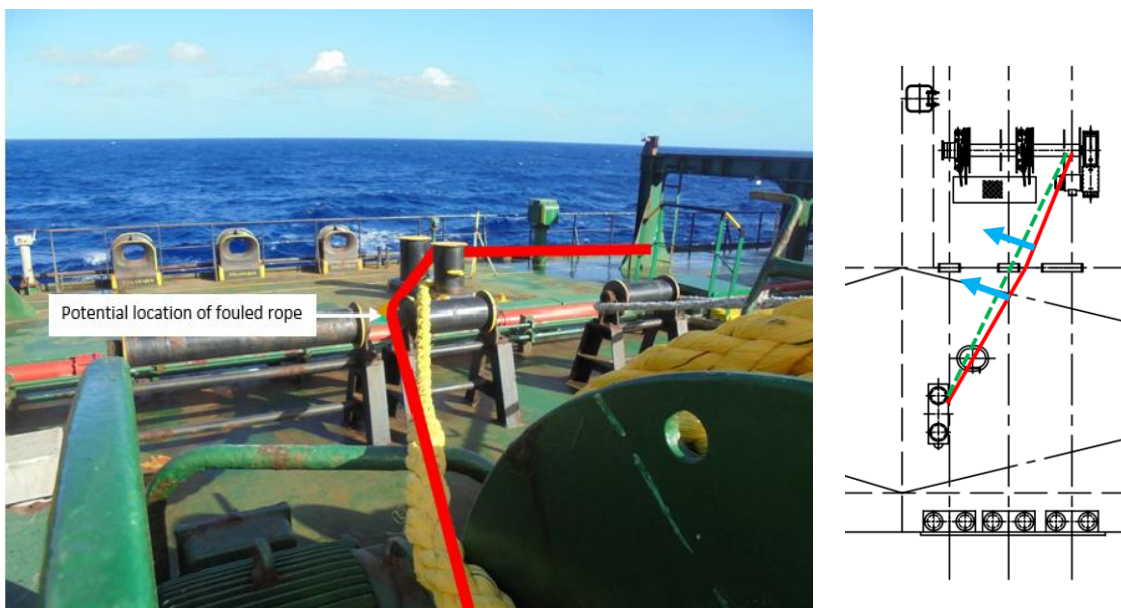
**Figure 5. Illustration of fouled mooring line and directional force when released**

The cause of injury which resulted in the death of OS1 was blunt force trauma to the mid-section, as a result of extreme force brought about by the recoil of the rope when it sprung free from where it had become fouled.

The properties of man-made fibre ropes such as polypropylene mean that they can extend up to one third their original length when tension is applied. Once the maximum permissible tension is applied the rope will recoil back to its static position once freed from its fouled position with the force equivalent to over 250 Newtons (1 Newton = 1 kg • m/s<sup>2</sup> - /Newtons 2<sup>nd</sup> Law) (figure 5).

The OS1 at the time of the recoil would have been unaware that the rope if freed would reach the position where they were stood, or that it placed them in the path of the ropes static position.
