The Bahamas
Maritime Authority

Marine Safety Investigation Report

into a collision between BGP Prospector and
an unnamed fishing boat resulting in the loss
of one life on 5 April 2022

Date of Issue: 08 March 2023
Bahamas Maritime Authority
120 Old Broad Street
LONDON
EC2N 1AR
United Kingdom

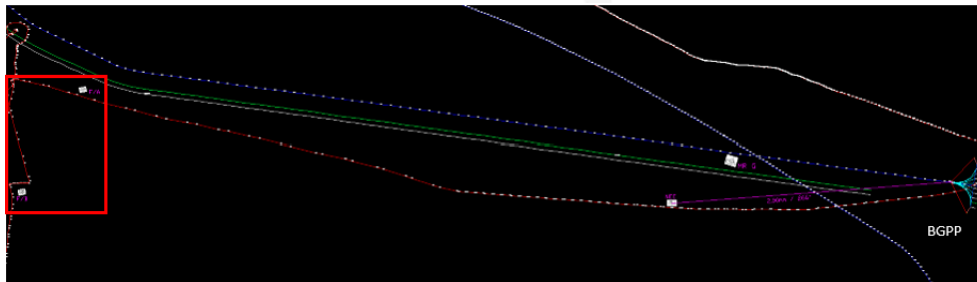
Figure 1. Targets spotted on radar (from BGPP Orca survey system)

At 18:18 the second officer noticed two faint targets on the radar screen, ahead of the vessel at a distance of 8NM, with a CPA significantly less than the 5NM required. On closer inspection, the second officer observed that the vessels were not displaying any vessel automatic identification, nor were any navigation lights or signals visible through the use of binoculars.

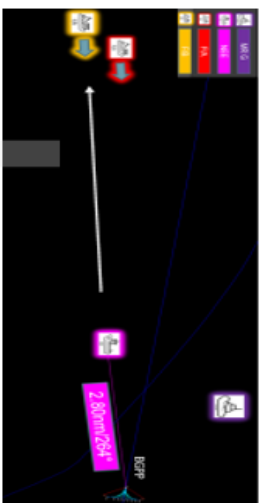
18:20 BGP requests NEE to intercept and move 2 vessels 8NM ahead occupying the path that the BGP is on. Both vessels in path of approaching BGP seismic trawl gear.

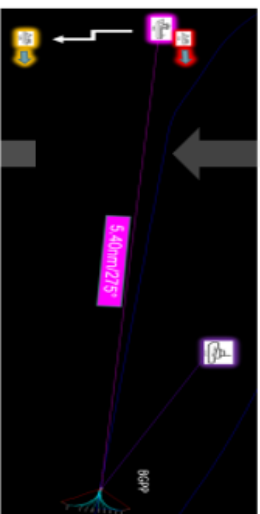
19:00 NEE arrived at FBA. No reply on VHF. Made contact and FBA agreed to recover gear and move South. BGP informed. Moonrise G proceeds North.

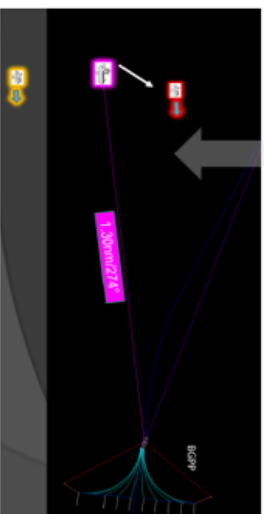
19:41 Navigator instructed by 2nd officer to alter course 30° stbd in seismic track. NEE Proceeds south to FBA. NEE notified that FBA not moving. NEE heads back to FBA

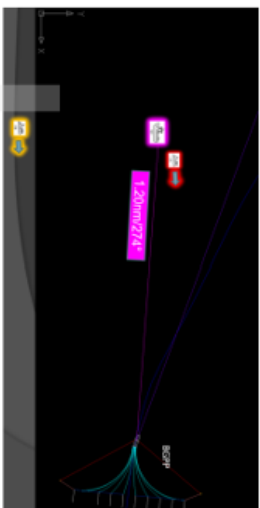
19:44 NEE arrived at FBA again. NEE urged fishermen to increase urgency in retrieving fishing gear and move South of fast approaching BGP

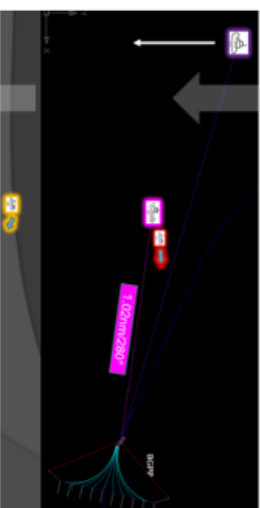
19:47 BGP completes first 30° stbd turn. NEE advised to remain with FBA and assist with moving it South. Moonrise G instructed to head South to make sure FBA is moved on.

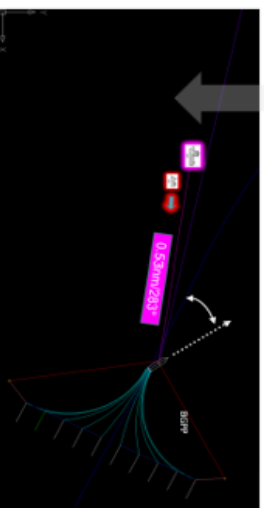
19:52 After assessing situation, BGP Master orders 40° stbd turn and increased turn rate of 5°/min, in order to take evasive action to avoid collision.

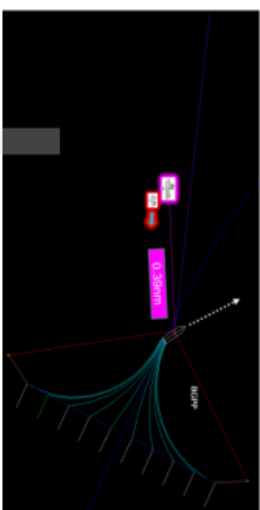
19:56 Heading 314°. NEE instructs crew on bow to tell FBA to cut nets and move away from the area. FBA continued to recover fishing gear

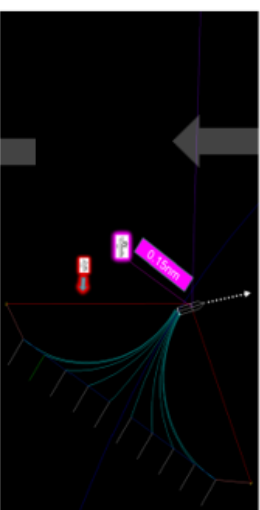
19:59 NEE ordered by BGP to vacate area and avoid entering danger zone. FBA left recovering its fishing gear. BGP continues to turn to stbd.

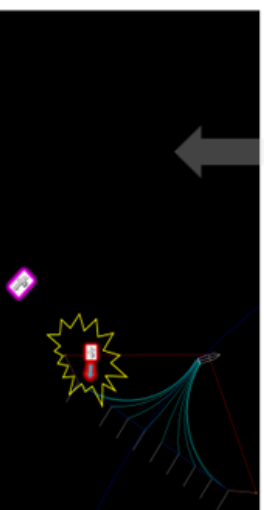
20:02 FBA collides with BGP wide tow rope and capsizes throwing occupants into the water
