The Bahamas
Maritime Authority

Marine Safety Investigation Report

into a fumigant poisoning fatality on board mv
Jupiter on 17 May 2022

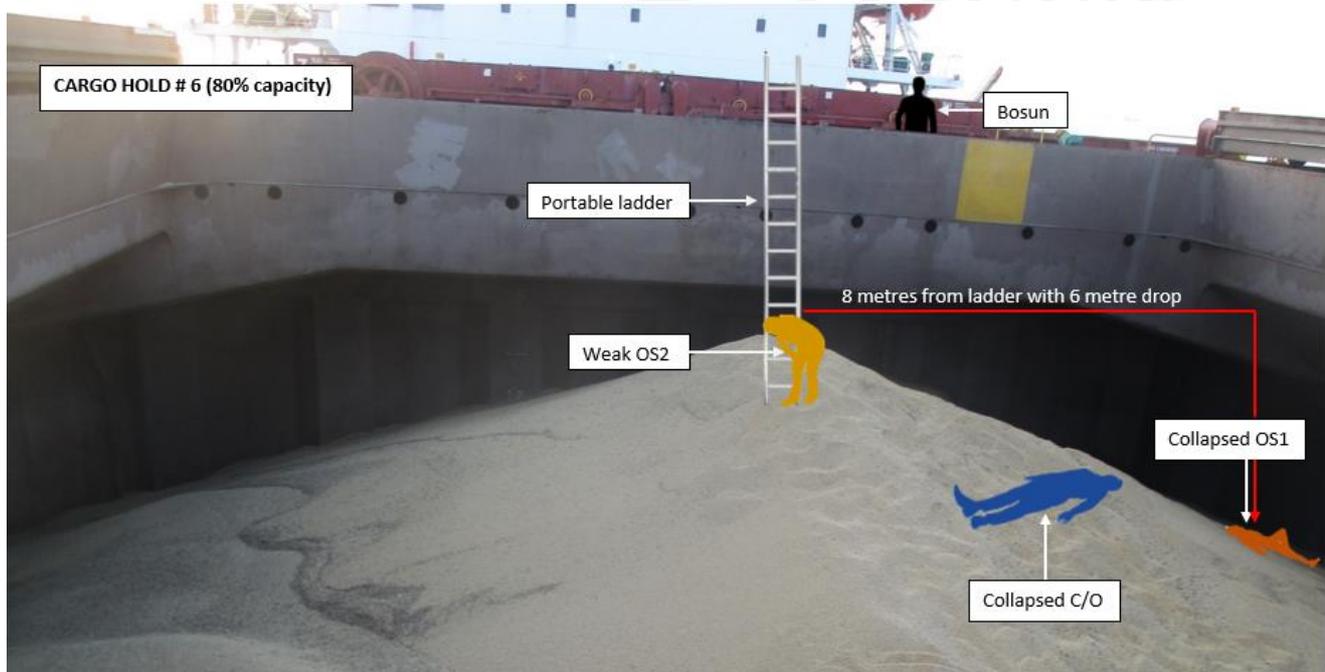
Figure 3. Positioning of crew inside cargo hold 6 at time of casualty

During this time OS1 fetched a portable ladder as hold 6 was only 80% full and therefore access could only be gained with the use of a ladder, when placed inside the hold resting it on the highest point of the soya bean and positioning it against the coaming of the hold (Figure 3).

At 10:45 OS1 made his way into hold 6 and shortly after OS2 arrived at the opening and dropped the two buckets into the hold, one of which rolled down the slope of the soya bean in the hold, before then making his way inside the hold via the ladder to join his colleague. OS1 made his way down to the port side to fetch the bucket that had rolled down and collapsed.

OS2 who had now entered the hold was making his way aft, when he observed that his colleague had collapsed and immediately called for help. OS2 started to feel weak, breathless and nauseous, and made his way back to the base of the ladder. When the chief officer heard OS2's calls for help, he notified the master of the emergency and requested assistance, before then making his way into hold 6, and headed straight to OS1 to help. The master summoned the third officer to gather a rescue team and attend to the emergency.

Shortly after arriving beside OS1, the chief officer struggled to offer assistance or pull OS1 clear to the middle of the cargo hold, and was struggling to breathe, and called out for help from OS2, before managing to make his way back towards the centre of the hold where he collapsed, complaining of chest pains, struggling to breathe and see clearly.

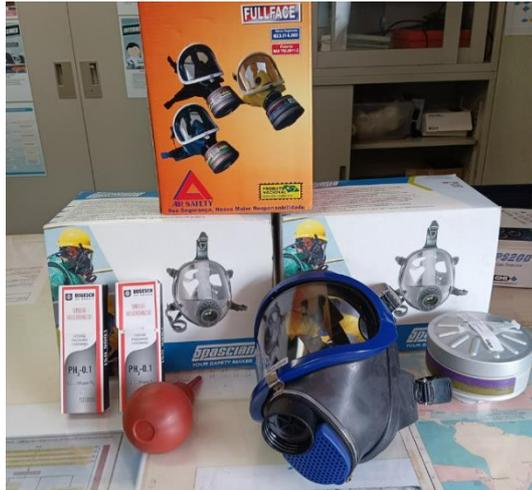
Figure 4. Safety equipment supplied by the fumigation contractors at Paranagua

The fumigation contractors identified a TLV of 0.3 parts per million (ppm) and provided safety equipment for detecting phosphine in the accommodation and gas masks for use when crew might be exposed to phosphine (such as when opening the holds for ventilation). The gas detection equipment provided was of the colorimetric tube type: detection tubes had to be opened and inserted into a pump and the air sampled by manually operating the pump to draw air through the tube. Discoloration of the tube indicates the presence of the gas.

The ship's Marine 4 PS 200 gas detectors were fitted with sensors to measure oxygen (%O₂), lower explosive limits (%LEL), carbon monoxide saturation levels (ppm C) and hydrogen sulphide levels (ppm H₂S). there was no means for continuous monitoring of phosphine.
