The Bahamas
Maritime Authority

Marine Safety Investigation Report

into a fatal man overboard during tender
operations from The World on 19 February 2022

Date of Issue: 29 September 2023
Bahamas Maritime Authority
120 Old Broad Street
LONDON
EC2N 1AR
United Kingdom

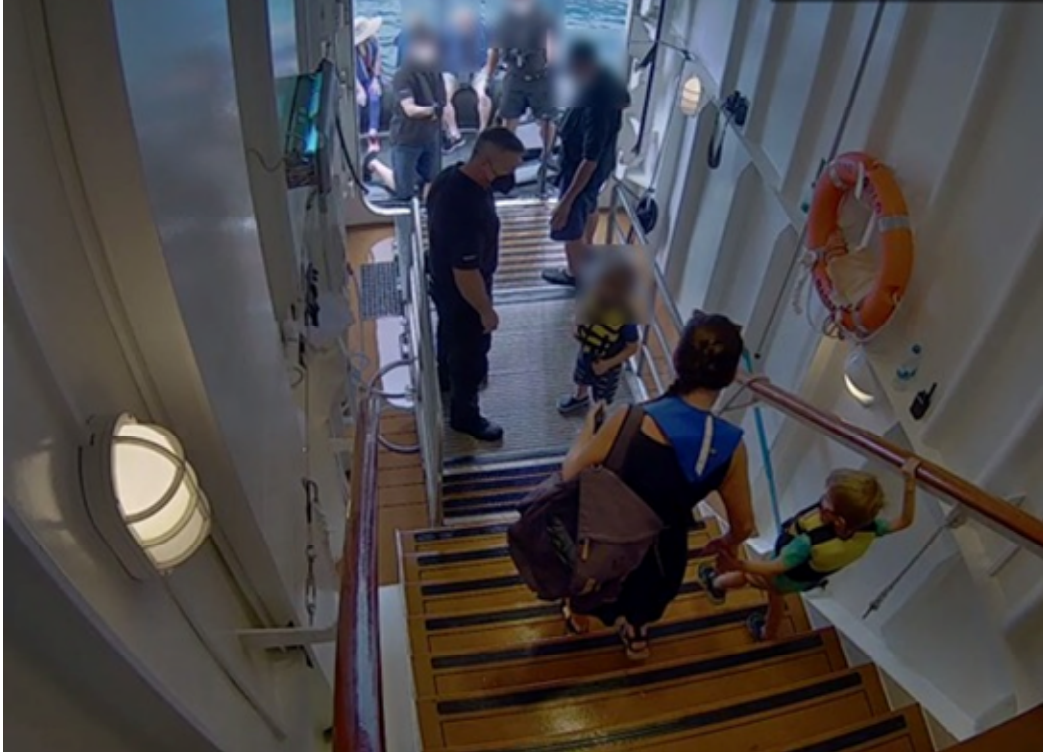
14:33 The last passengers readying to board Zodiac #10 (frame from The World's CCTV)

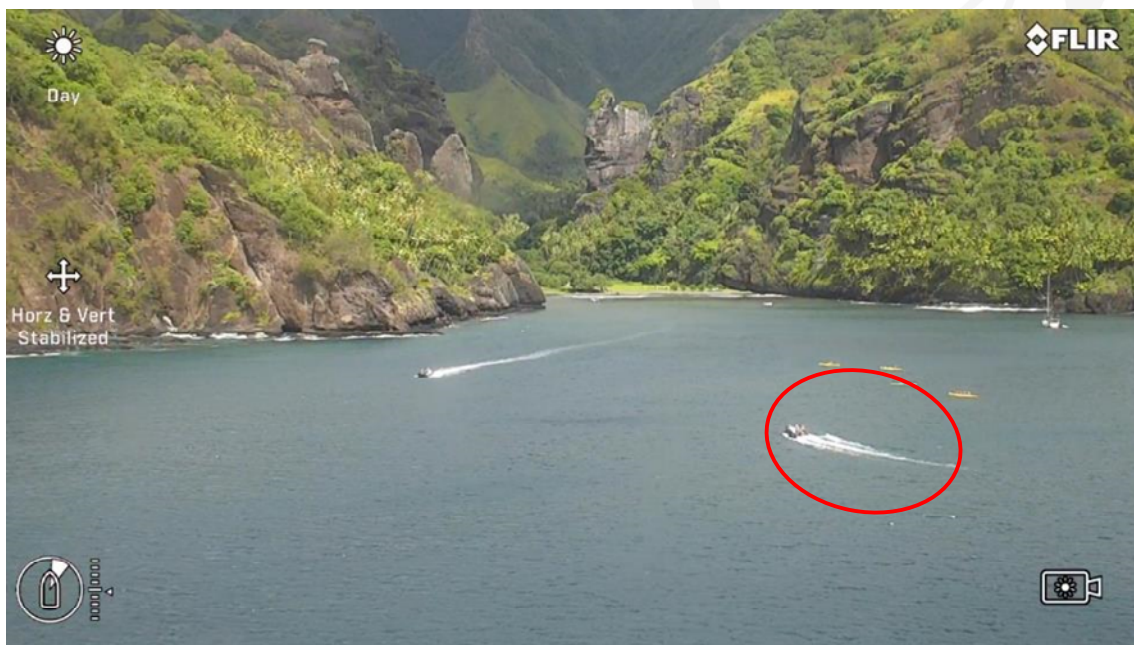
14:38 Zodiac #10 (ringed) inbound to Hanavave (frame from The World's FLIR)

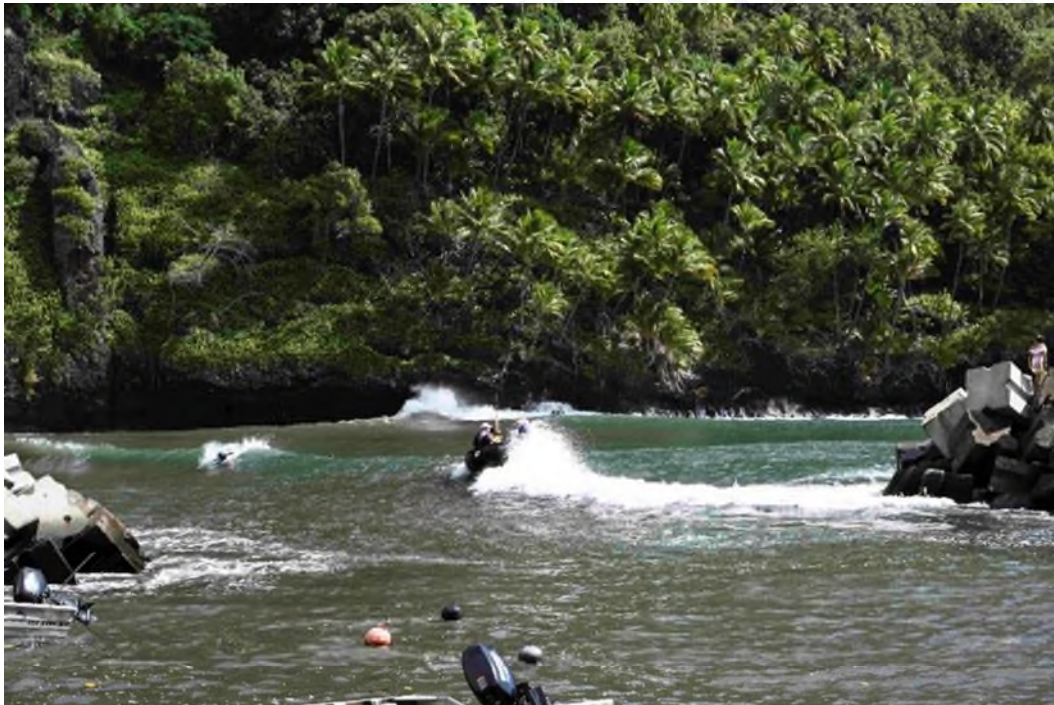
At 14:41, Zodiac #10 was at the entrance to the harbour, the swell was higher than on earlier entries and, whilst the coxswain was positioning for entry, clear of the surfers, the boat was caught in a breaking wave, inflating one passenger's lifejacket and driving the boat sideways.

14:41 Zodiac #10 at harbour entrance (photograph taken by resident)

Due to the breaking wave, Zodiac #10 was unable to make the entry into the harbour and the coxswain took a clear exit towards deeper water. At the trough of the wave, Zodiac #10's propellor touched the seabed, stopping the engine and halting the boat's momentum.

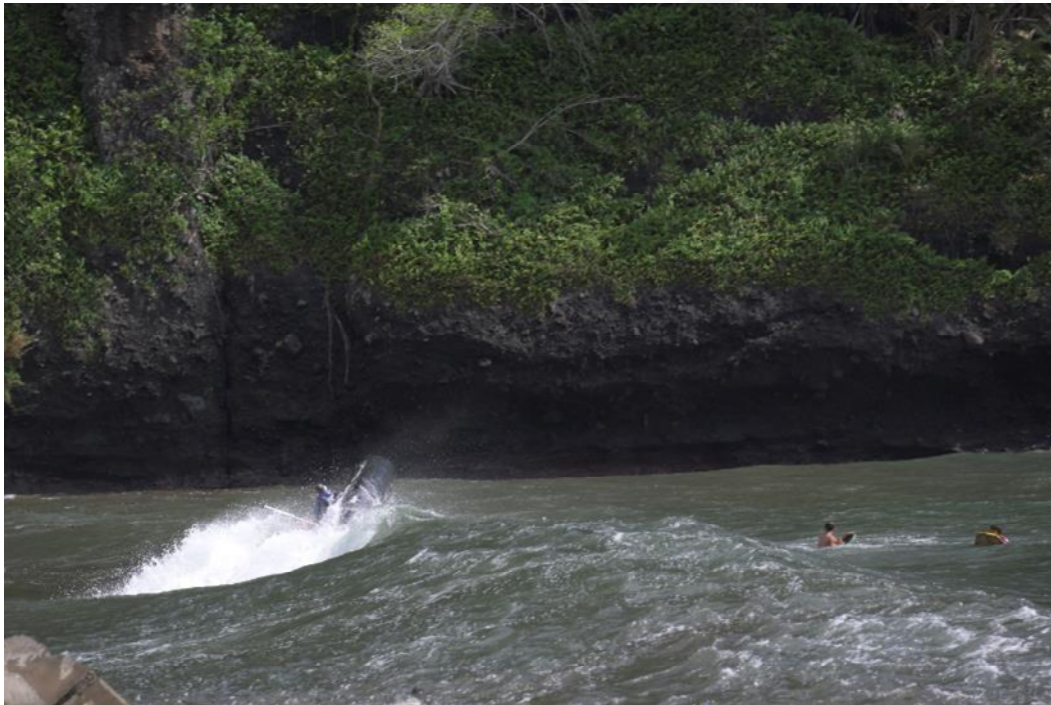
At 14:42, the next wave broke over Zodiac #10, washing out the passenger sat furthest aft (port side) and inflating several lifejackets. The coxswain then managed to restart the engine but the next breaking wave washed out the remaining passengers on the port side and pushed the boat in to shallow water at the beach.

**14:42 Another breaking wave washes more passengers out of Zodiac #10
(photograph taken by staff photographer)**

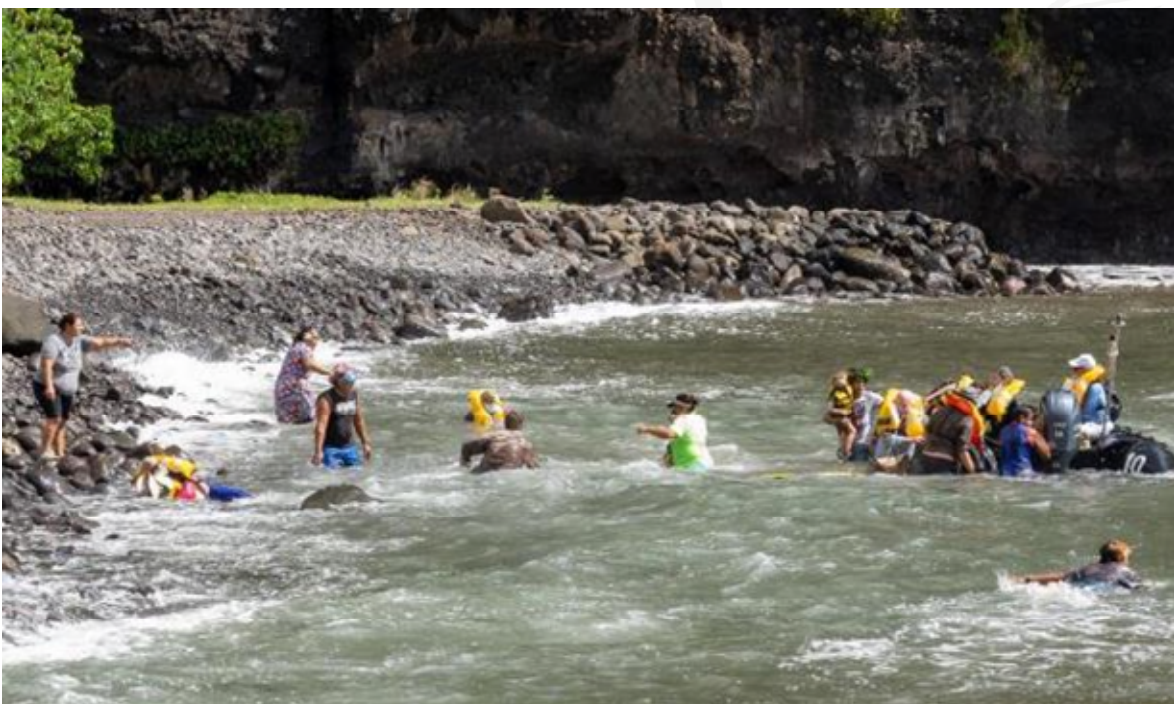
With the water shallow enough to stand, the coxswain stopped the engine and exited the boat, in an attempt to control its movement. People ashore, locals, crew and EYOS staff, identified that they were in difficulties and attempted to help.

At 14:44 the EYOS shore controller contacted The World and informed them that Zodiac#10 had “flipped in the surf” - initiating the shipboard response. At about the same time, passengers were being helped ashore when the coxswain noticed that there was someone trapped under the boat.

**14:44 Zodiac #10 with coxswain stood in shallow water passengers receiving assistance from
locals (photograph taken by resident)**

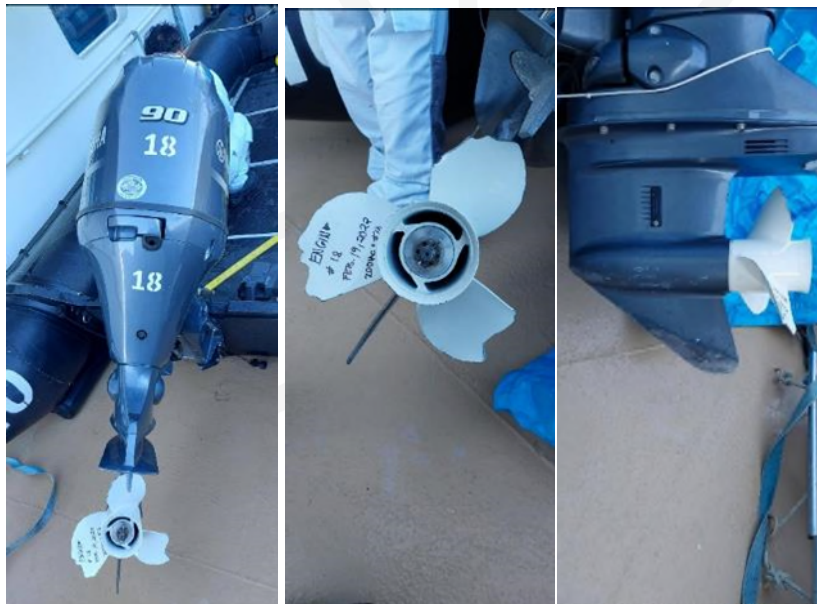
When Zodiac #10's propellor touched the seabed it stopped the engine, leaving the boat vulnerable in an area of breaking waves. Propellor guards may be used on outboard engines to protect people or the propellor but their advantages and disadvantages are subject to fierce debate in the leisure boating industry.

Ultimately the decision on whether they should be fitted to an outboard motor is a matter for risk assessment by the operator; as with all risk assessments though, if the hazard is not identified the risk can't be assessed and controls identified.

Zodiac #10's outboard engine / damage to propellor

- Wearing a crotch strap on a correctly fitted lifejacket improves lifejacket performance.
 - The decision on whether to fit propellor guards on an outboard motor is a matter for risk assessment. Expedition operators may benefit from considering the risk to their operations holistically.
-

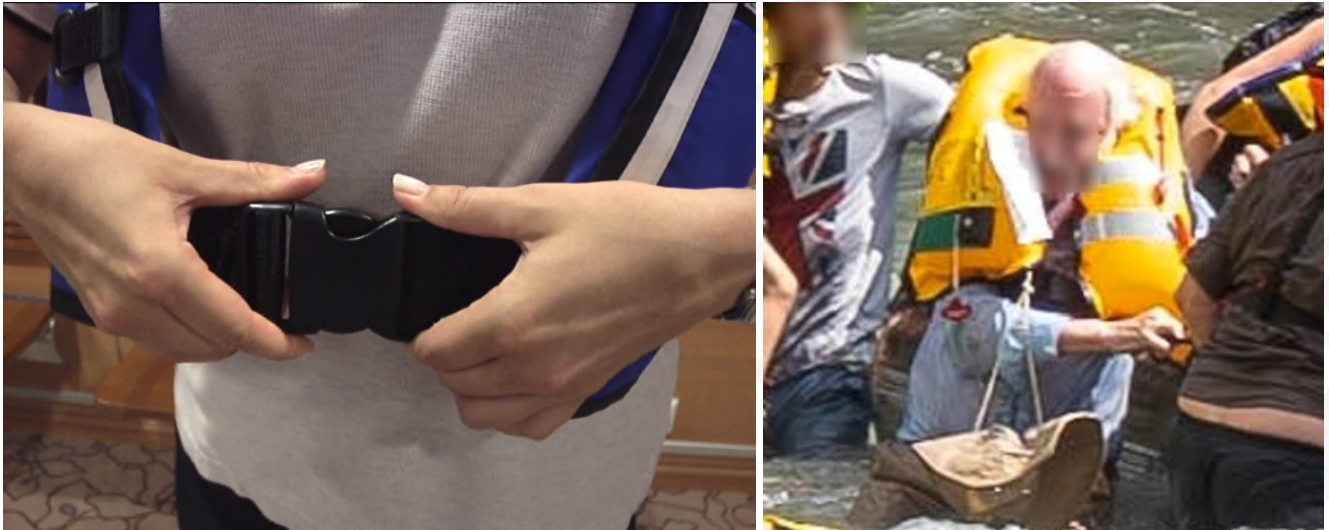
It is unknown how well fitted the victim's lifejacket was as it was removed to facilitate cardio-pulmonary resuscitation, but photographs taken of the other occupants of Zodiac #10, post-casualty, show inflated lifejackets that would not have effectively kept the wearer's face above the water if it had been necessary.

**Still from The World's Zodiac safety video – loose waistbelt in demonstration.
Post-casualty - passenger with ill-fitting lifejacket**

Properly fitted lifejackets with fastened crotch straps help keep an unconscious or incapacitated casualty's airways clear of the water and therefore significantly increase their chances of survival.

- During the casualty, all inflatable lifejackets inflated on immersion as designed but they were not fitted with crotch straps nor were the waistbands appropriately adjusted for every individual, leading to reduced performance.

- Replaced inflatable lifejackets with new twin-chamber lifejackets, fitted with crotch straps
- Updated their in-house *Zodiac Operations* safety video to further focus on small boat safety details.
