Marine Safety Investigation Report

The Bahamas
Maritime Authority

Magic Striker

Dangerous space fatality on 21 December 2021

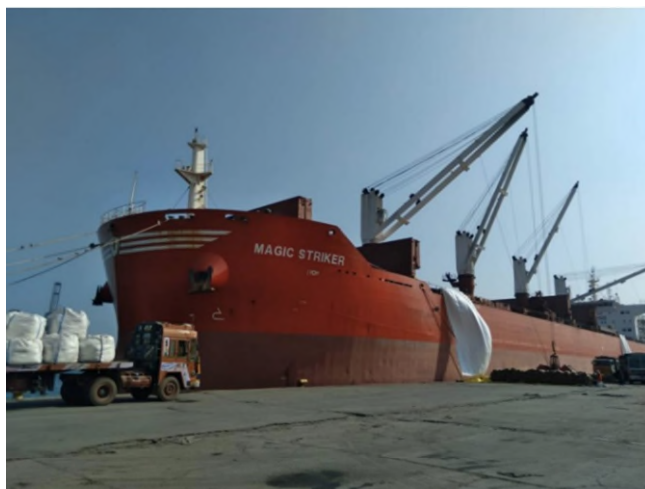
At around 12:12, the team set about arranging the fumigant circulation equipment for cargo hold 4, two workers entered the booby hatch, wearing gas masks and taking with them a phosphine gas detector. Shortly afterwards, worker A climbed back out, feeling breathless. He then noticed worker B had fallen and went back down the ladder to help him.

Having heard the initial call on the radio, the chief officer ran to the booby hatch and saw the two workers motionless at the bottom of the ladder. He then fetched an emergency escape breathing device and at 12:22 the chief officer, wearing the emergency escape breathing device, entered the hold and retrieved worker A.
