Report on the near-miss grounding of The Bahamas flagged passenger vessel Norwegian Prima off Reykjavík on 26 May 2023

Case nr: 2023-036 S 019

Date: 26 May 2023

Description: Near miss grounding

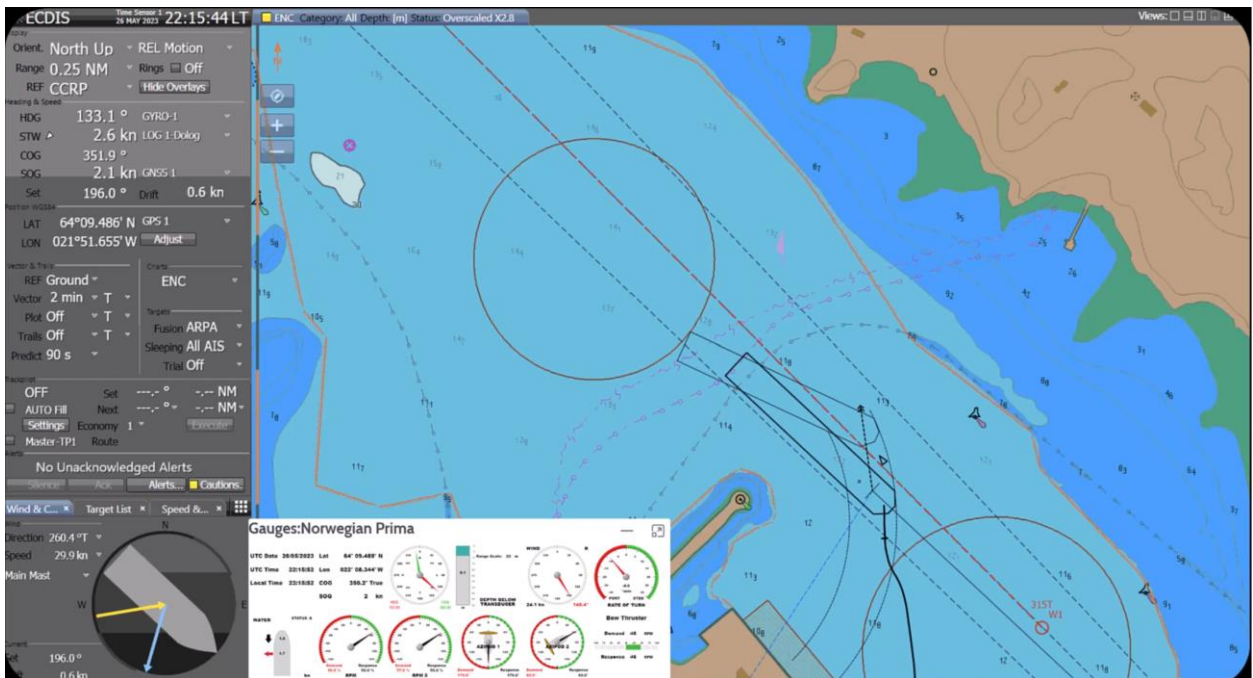
At 22:05 Norwegian Prima was unmoored and manoeuvred off the berth with Magni, on the port side. At 22:15, the breakwater was on Norwegian Prima's starboard beam with the stern approaching the charted swinging area - the master started the swing (bow to port) with Magni still standing by on the port bow.

Fig. 1 Norwegian Prima passing breakwater and starting to swing

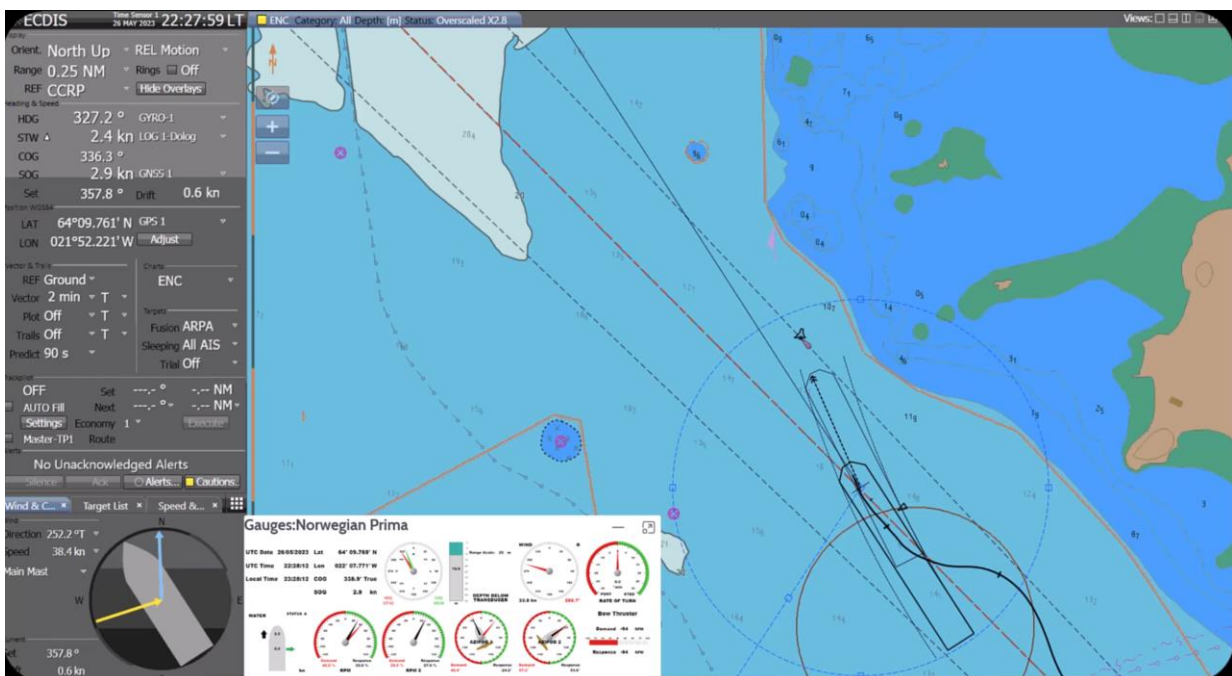
Approximately halfway through the turn, with the wind speed increasing, Magni repositioned from the port bow to the starboard bow. Shortly afterwards, when the turn was almost complete, the master increased speed and, at about the same time, the vessel experienced gusts in excess of 35 knots from the west. The pilot requested¹ that Magni push at full power.

Fig. 2 Norwegian Prima swing almost complete, increased forward momentum

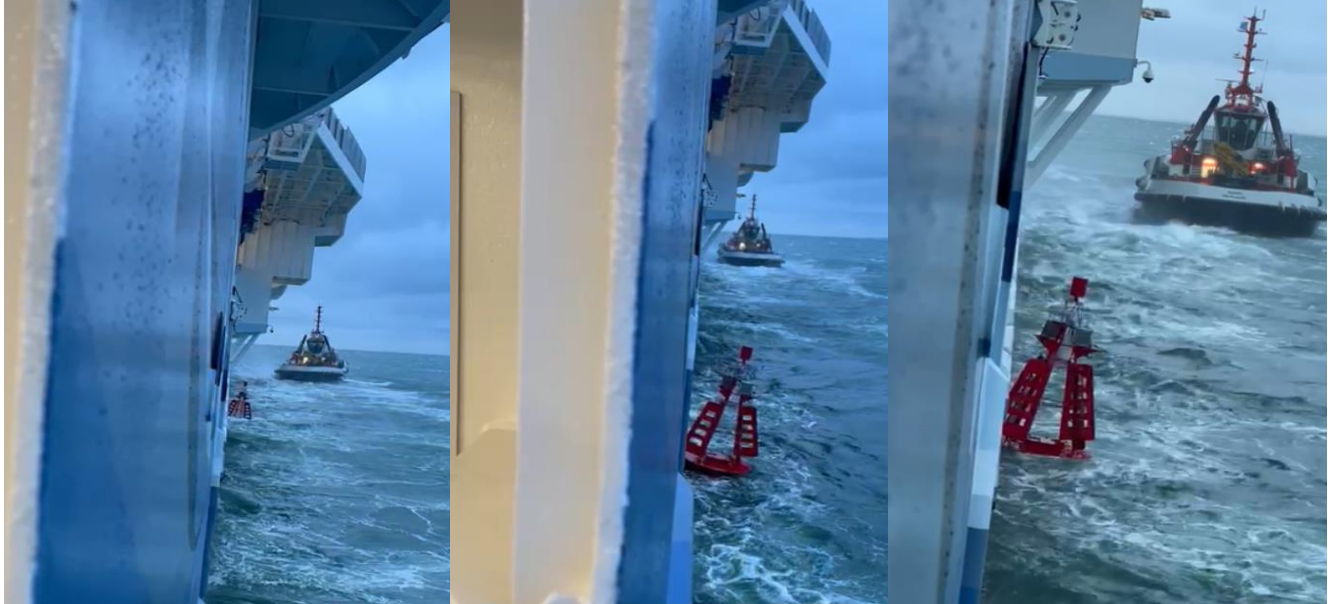
The wind speed continued to increase with gusts in excess of 50 knots. With Magni pushing at full power, the vessel could not achieve its planned track, the master increased power to the azipods, attempting to gain the required heading. At 22:31 the vessel allided with Hjallasker buoy, marking the eastern edge of the navigational channel.

Fig. 3 Stills from mobile phone footage (looking forward): Hjallasker buoy, Magni adjusting position

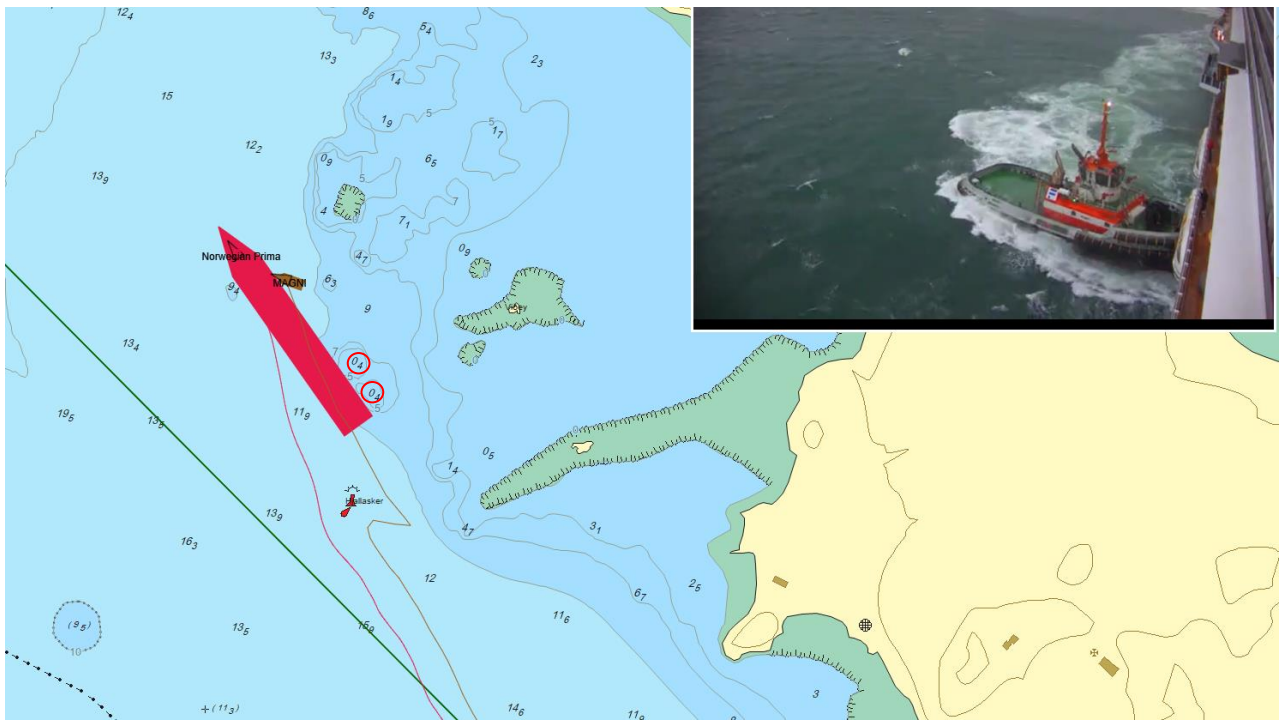
To avoid the risk of entanglement with the buoy, Magni pulled clear and could not reestablish itself to push for two minutes, resulting in Norwegian Prima losing further leeway towards the rocks. The master continued to “walk the ship” – alternating the direction of thrust from the azipods to attempt lift the bow and then to lift the stern.

Fig. 4 Norwegian Prima at closest point to shallow rocks as Magni regains position to push (CCTV inlay)

In any event, the effectiveness of the tug can be seen when it had to stop pushing for two minutes to avoid entanglement with the Hjallasker buoy. Norwegian Prima's leeway increased and its course over the ground (see fig. 4)

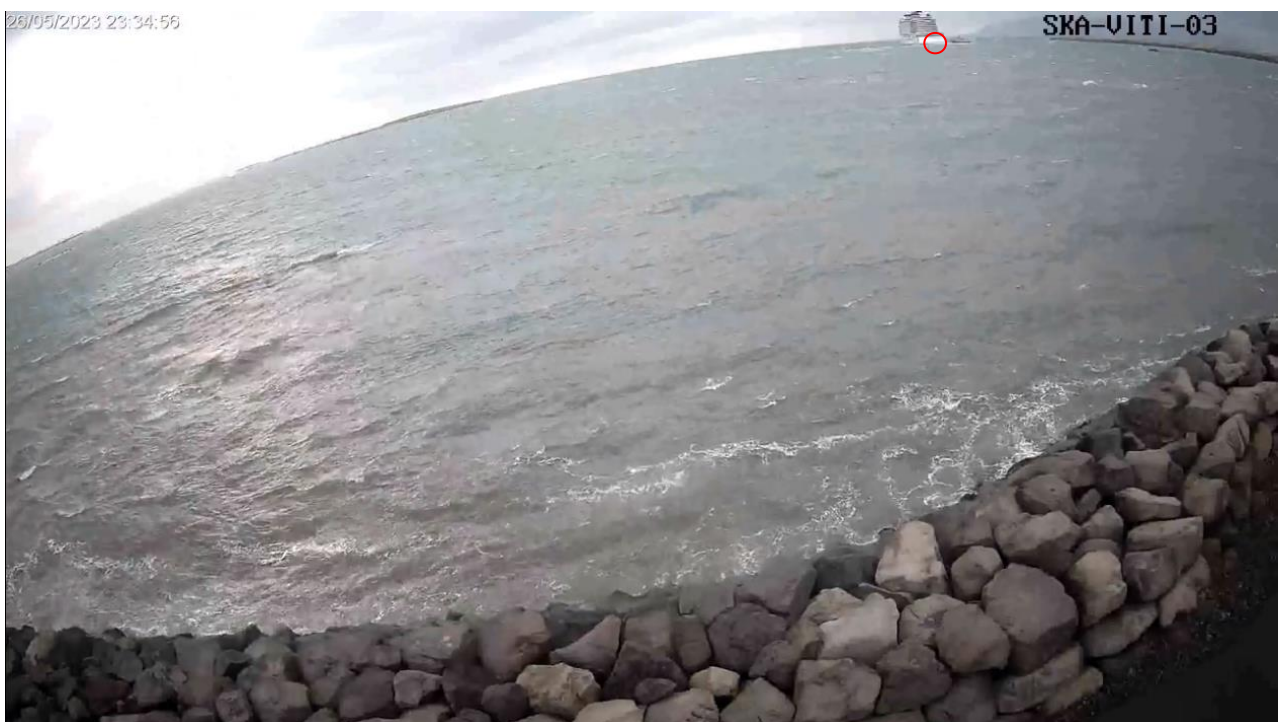
Fig. 5 Stills from breakwater CCTV: Hjallasker buoy (ringed) clears Norwegian Prima's stern

With Norwegian Prima having over-run the buoy and closing on rocks with a charted depth² of 0.4 m, Magni informed the pilot that the tug would sustain damage if it continued

to push. The pilot asks that they continue pushing. Norwegian Prima's stern passed approximately 10 m clear of the rocks.

- Norwegian Prima over ran the Hjallasker buoy (but avoided entanglement with its mooring chain) left the safe navigable channel and passed within 10m of rocks at a charted depth of 0.4m.

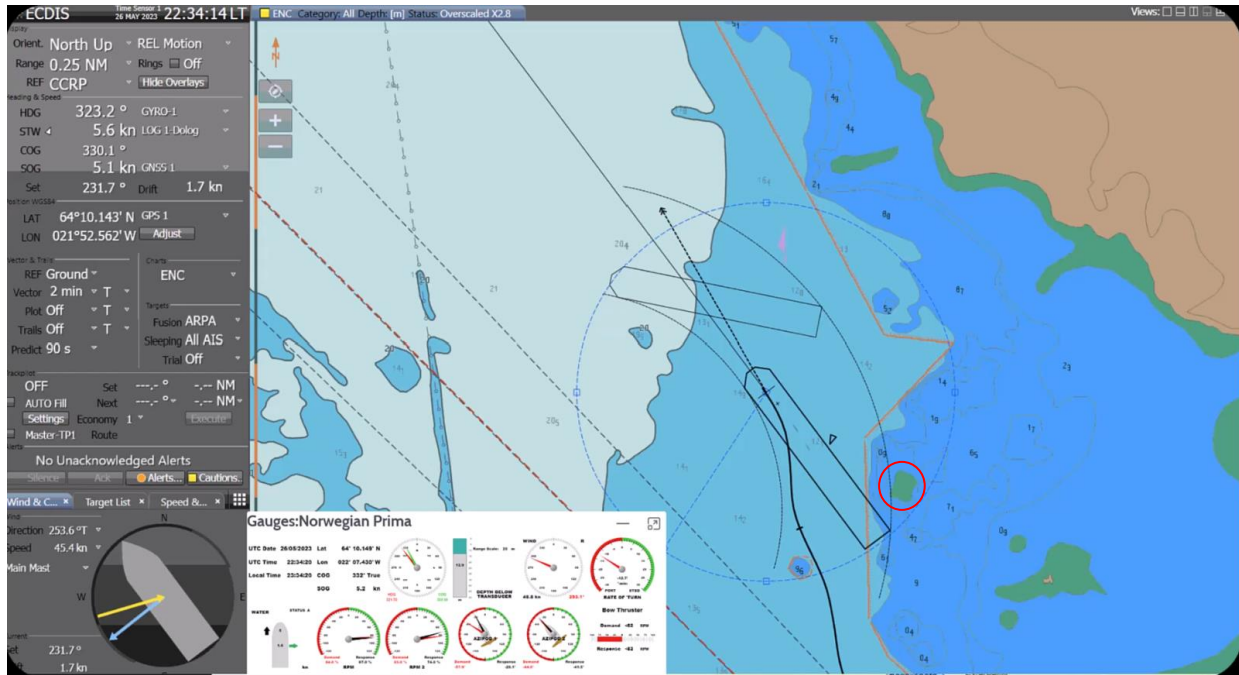
After then passing within 25 m of a shoal with a drying height (above chart datum), the vessel managed to regain the planned track and depart the harbour without further incident.

Fig. 6 Norwegian Prima attempting to clear drying height (ringed)

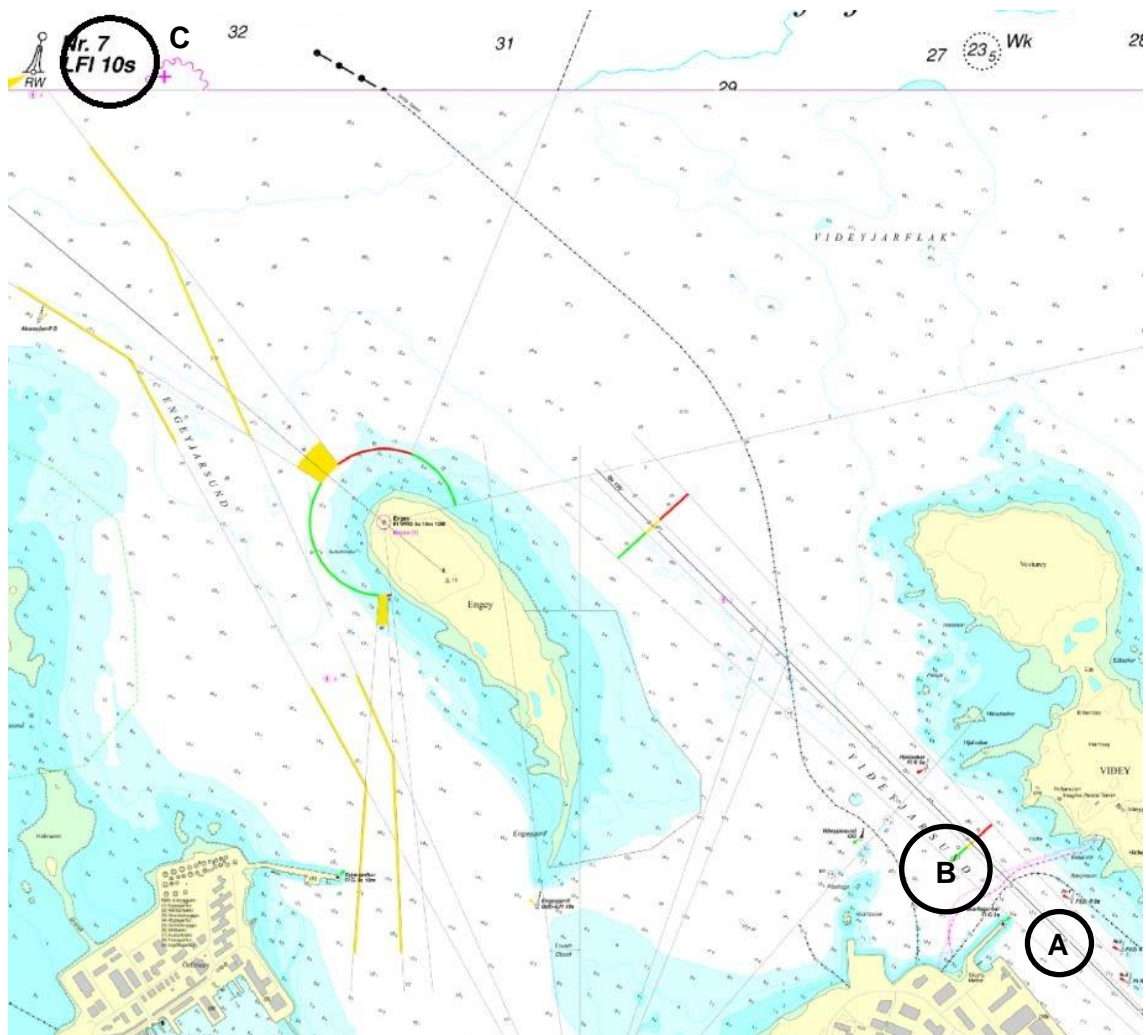
Figure 12 – turning circles at Reykjavik

For departure, Norwegian Prima was considered too large to swing inside the harbour at circle A in the prevailing conditions⁵. The pilot’s preference was to depart stern first and swing near circle C but the master and pilot opted to swing outside the breakwater, at circle B. This position is exposed to westerly winds and bounded by the shallows to the east and west.

When the wind speed increased at a critical point of the manoeuvre – with the vessel almost stopped and beam on to the wind – there was limited navigable water available for the vessel to complete the swing and gain its planned track.
