# Marine Safety Investigation Report

VERY SERIOUS MARINE CASUALTY | 17 June 2024

## **Algoma Integrity**

Mooring line casualty 21 October 2018

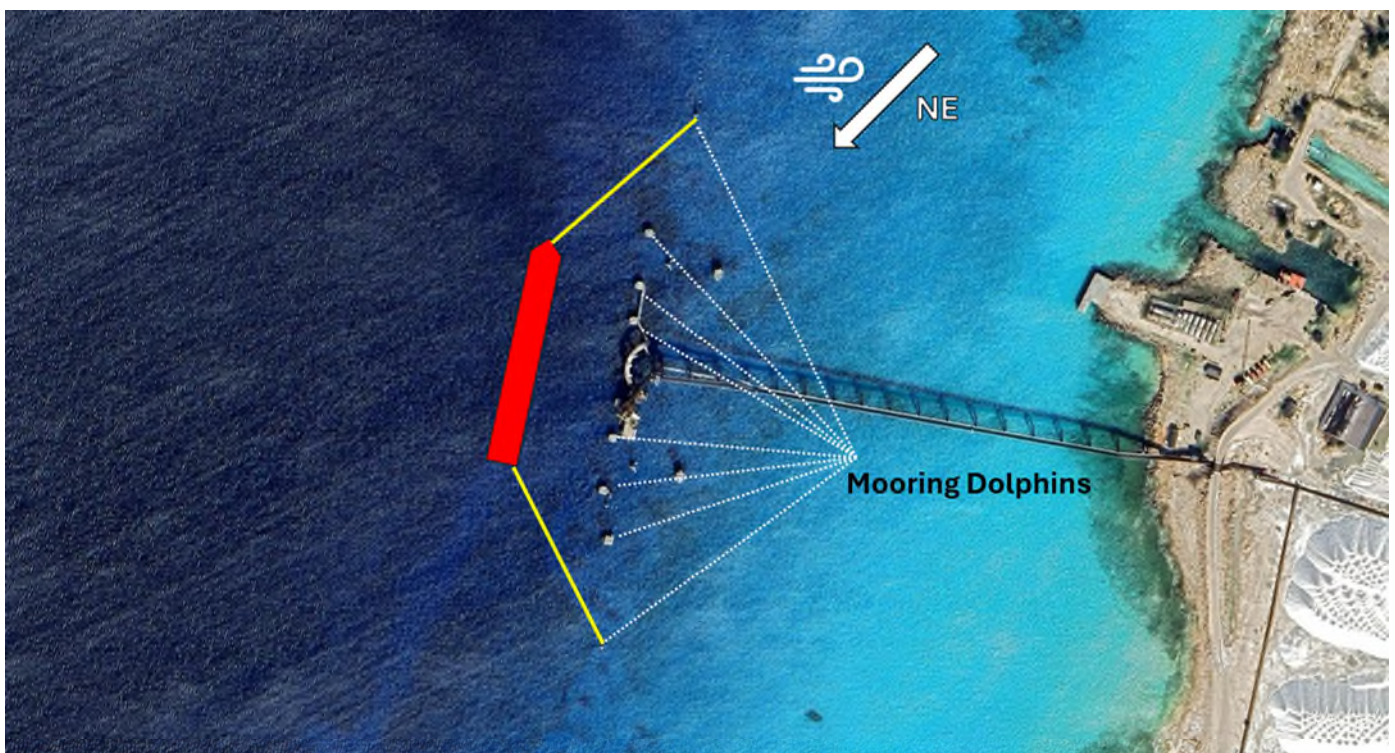
**Figure 1. Mooring plan (aerial view depicting proposed lay of extended lines in yellow)**

Prior to arrival at Inagua at 05:57, the master and pilot briefly discussed the mooring plan where the pilot requested that two sets of lines (one fore and aft) needed to be connected end to end to form a "long line" which would then be passed to the line boats to secure on the mooring dolphins. The plan was to use the lines as a means to get the ship alongside due to the unavailability of tugs at the terminal.

Although a master/pilot exchange form had been completed there was no formal diagram to depict the mooring arrangement plan, the intended number or sequence of lines to be sent ashore, thereby removing any shared mental model for the master, deck officers or those involved with mooring to refer to.

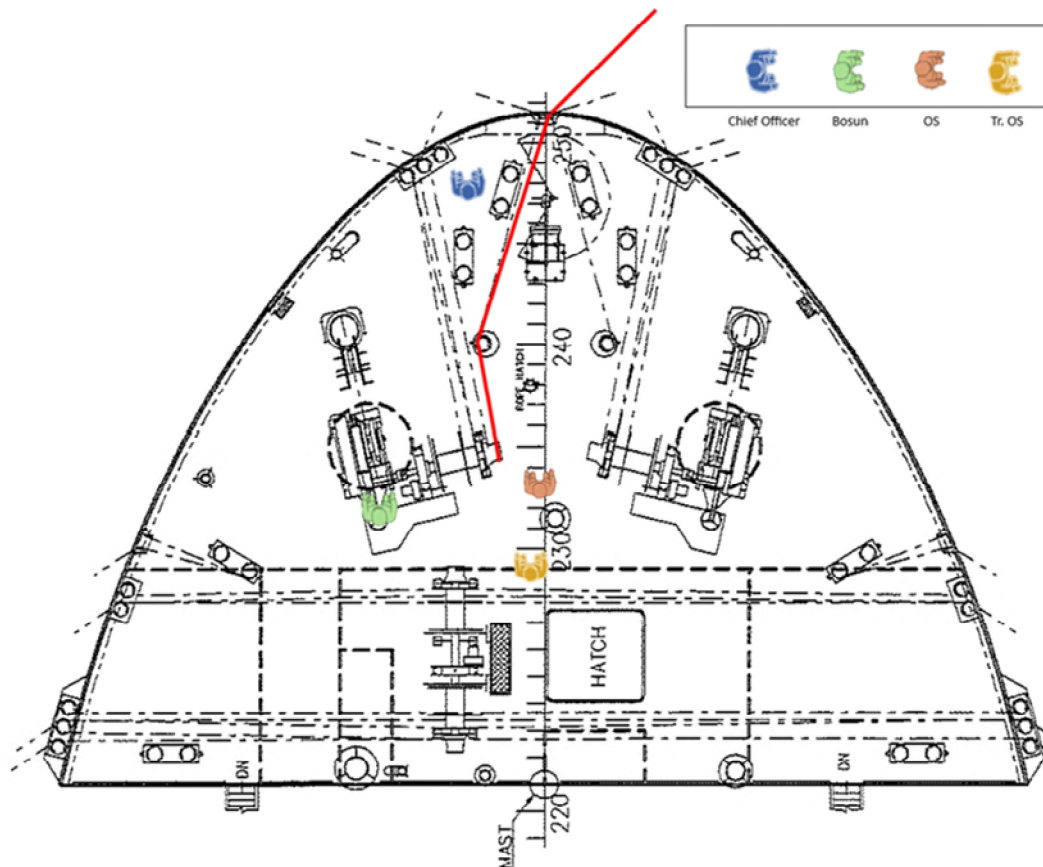
The pilot contacted the line boat crews at 07:23 and requested them to be on standby to collect the stern line first followed by the forward line and to make fast ashore once it was confirmed that the vessel was within proximity to commence mooring. The line boats would then proceed to secure the remaining lines ashore. During this period the chief officer, bosun, ordinary seafarer (OS) and trainee OS shackled together two 200m long mooring lines and set the line up to be passed down in preparation of mooring. (Figure 2)

**Figure 2. Pre-incident personnel positioning**

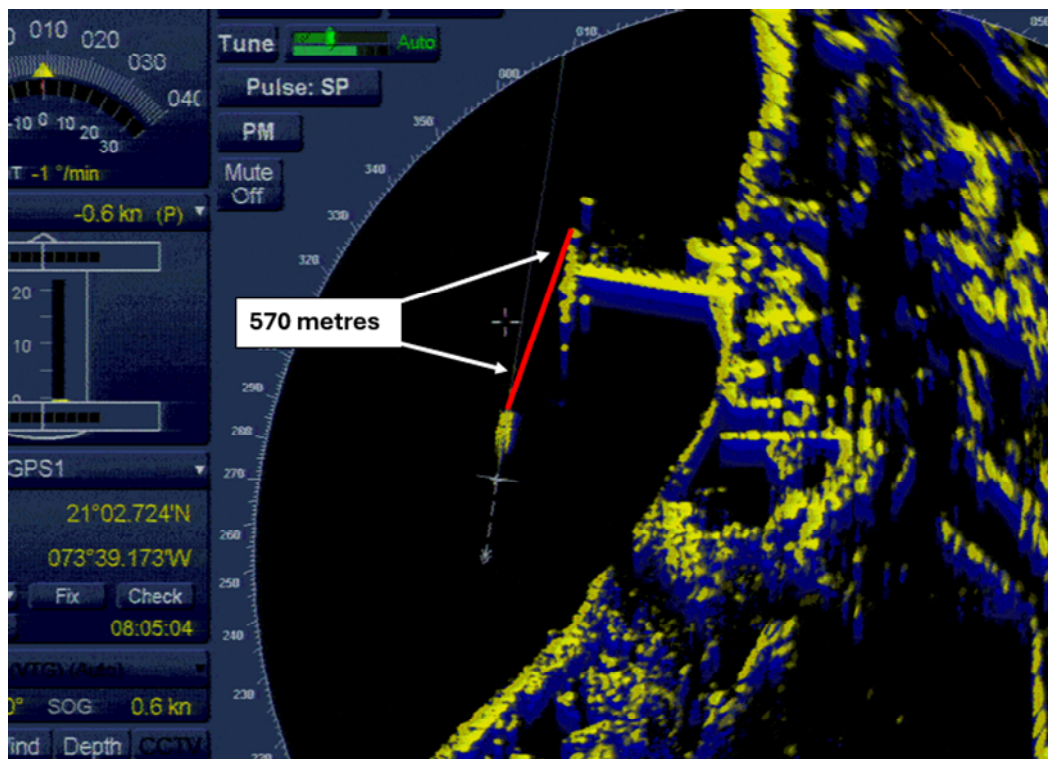
A decision was taken at 08:05 to stop the engines so that the line could be freed and recovered onboard, at which point the master instructed the forward mooring party to "Hold on" to the forward line. (Figure 3)

Figure 3. Distance and position from berth when propulsion stopped

When it became apparent that the aft lines had potentially fouled the propellor, no consideration was given by either the pilot or master to deploy the ships anchor in order to reduce the tension on the solitary long line forward. The need to hold the vessel in position whilst crew aft worked to free the line, resulted in rushed and hurried operations.

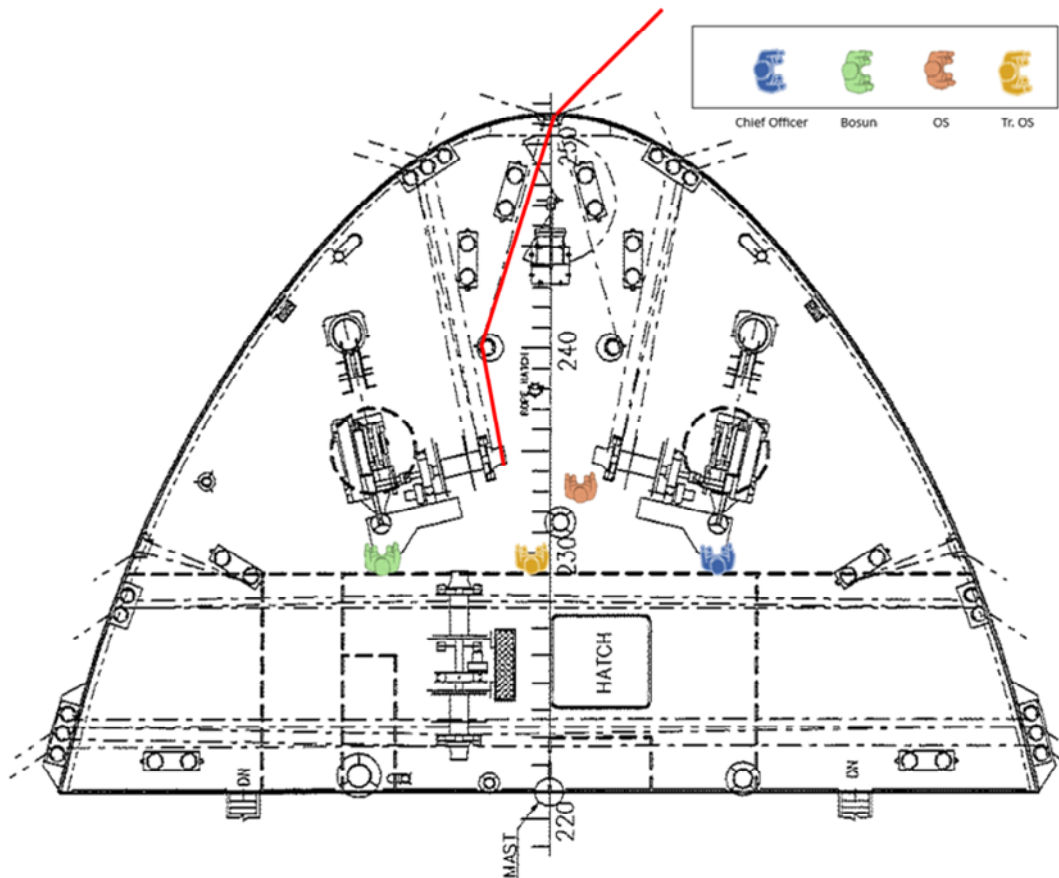
At the time of the casualty, the ordinary seafarer thought he had moved to a safe position but was most likely unaware he was standing in a bight of the coiled rope aft of the warping drum.

Whilst this was taking place, and with the attentions of the pilot and master focused on the aft line and ship's position, the bosun was becoming concerned with the increasing tension on the forward line and instructed the chief officer to vacate his position forward and proceed to a safe area adjacent to the starboard winch, at which point the chief officer instructed the OS and trainee OS to stand aft of his position adjacent to the ventilation cowl<sup>2</sup> and keep clear. (Figure 3)

**Figure 3. Positions of personnel when requested to stand clear**

At around 08:08 the chief officer had just taken up his position at the starboard side winch, when a loud noise alerted him and the crew towards the tensioned line on the warping drum which had sprung free, running out and the OS who was standing closest to the warping drum was dragged and ended up 3 metres forward of the winch suffering severe injuries to his left leg.

All personnel working with mooring lines under tension should be aware of the associated risks and ensure they maintain a safe position, free from bights and away from the dangers of snap back.
