Marine Safety Investigation Report

VERY SERIOUS MARINE CASUALTY | October 2024

Fri Sea

Man overboard on 28 March 2024

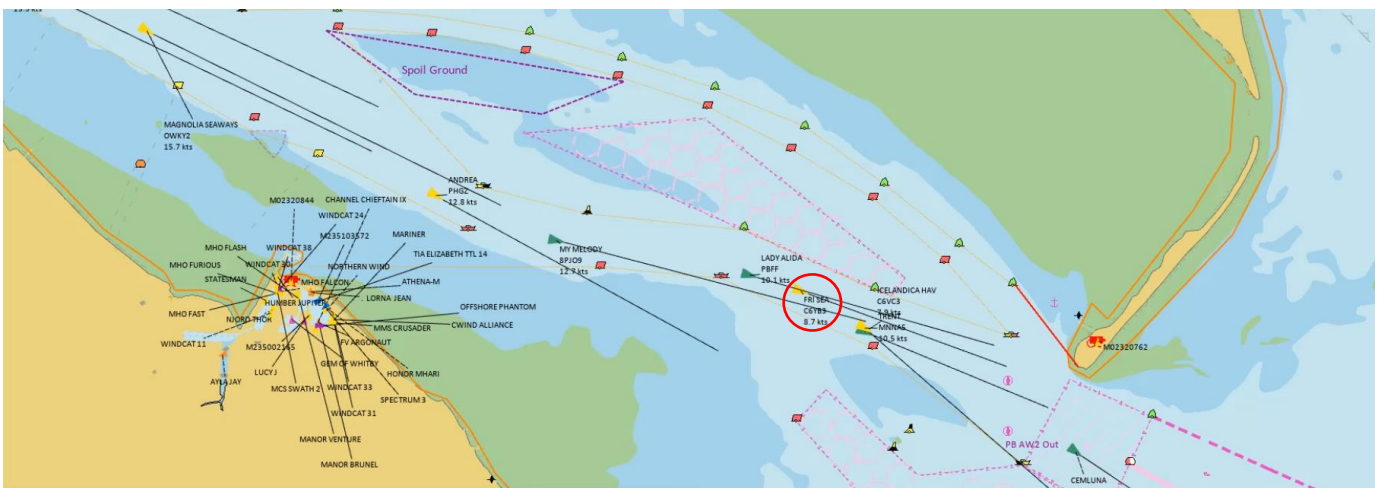
Traffic situation at the time the man overboard was reported. Fri Sea ringed. (Source: Humber VTS)

After the pilot's initial report of a man overboard, Humber Vessel Traffic Services (VTS) relayed the distress call and tasked search and rescue assets to assist, based on Fri Sea's position at the time of the initial report. 55 minutes later (at 23:45), the pilot contacted VTS to inform them that 5-10 minutes had elapsed before the crewman was noticed to have been missing.

Whilst it would not have had an impact on the outcome of the casualty, the initial search plan was based on an incorrect starting location (datum). The drift pattern was also based on incorrect information, hindering the effectiveness of the search.

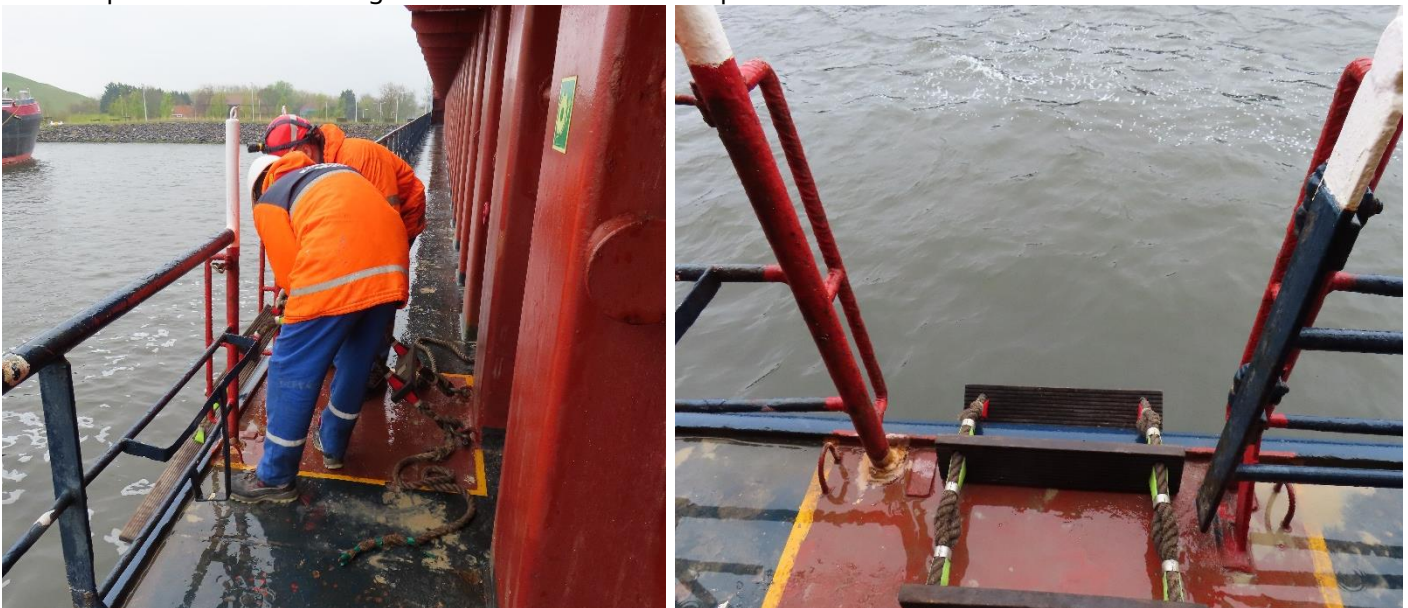
Fri Sea carried two pilot ladders – one of a length suitable for the vessel's loaded condition and one for its ballast condition. When it was required to be rigged 1.5m above the sea, the ladder could be shackled directly onto two purpose fitted lugs on the deck. The pilot ladder then passed through an inward-opening gate in the ship's rail. This task could only be completed with two crew working together. Due to the design of the gate, it was not possible to close the gate once the ladder was in position.

Rigging the ladder, ladder in position (gate opens to the right of picture)

The design of the pilot transfer arrangement meant that when the pilot ladder was rigged, there was a gap in the ship's rails that could not be closed, adjacent to a potential trip hazard (the ladder). As the hazard of falling overboard was not recognised, there were no control measures in place to reduce the risk of falling over the side (such as a temporary barrier/chain) and no appropriate personal protective equipment available to the crew to mitigate the outcome of a fall.

In line with requirements, the gate in the ship’s rails opened inwards but its design meant that it had to remain open when the pilot ladder was in place – increasing exposure to risk.

- Provided vessels in its fleet with inflatable lifejackets.
- Reviewed the design of openings in ship’s rails throughout its fleet. The gate on Fri Sea has been altered to allow it to be closed when the pilot ladder is rigged.
- Added anti-slip coating to the decks between pilot ladder and accommodation.
- Revised its procedure for rigging of the pilot ladder (including mandatory use of inflatable lifejackets) and issued a fleet circular explaining the changes.

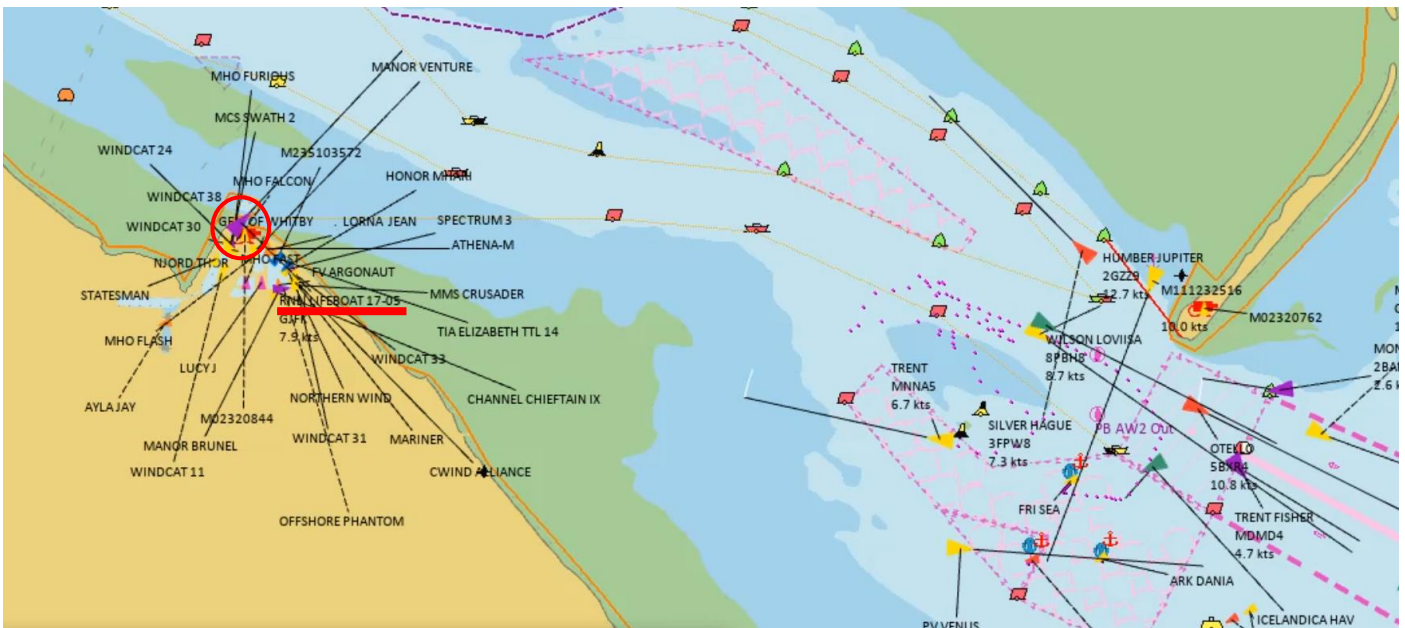
Pride of Humber (RNLi Lifeboat 17-05) leaving Royal Dock lock at 23:57 (Source: Humber VTS)

Whilst it would not have had an impact on the outcome of the casualty, Humber lifeboat was waiting in the lock for over an hour after mobilising due to an issue with the outer sluice gate which reduced ability to remove lock water to match the falling tide outside the gates. Further delay would have resulted in insufficient depth of water for the lifeboat to safely cross the sill.

Whilst it would not have had an impact on the outcome of the casualty, Humber lifeboat was waiting in the lock at Grimsby for over an hour after mobilising. Humber lifeboat’s availability may be more restricted than identified on the basis of tidal predictions alone.
