Marine Safety Investigation Report

VERY SERIOUS MARINE CASUALTY | May 2025

Sophia Z

Electrocution on 30 August 2024

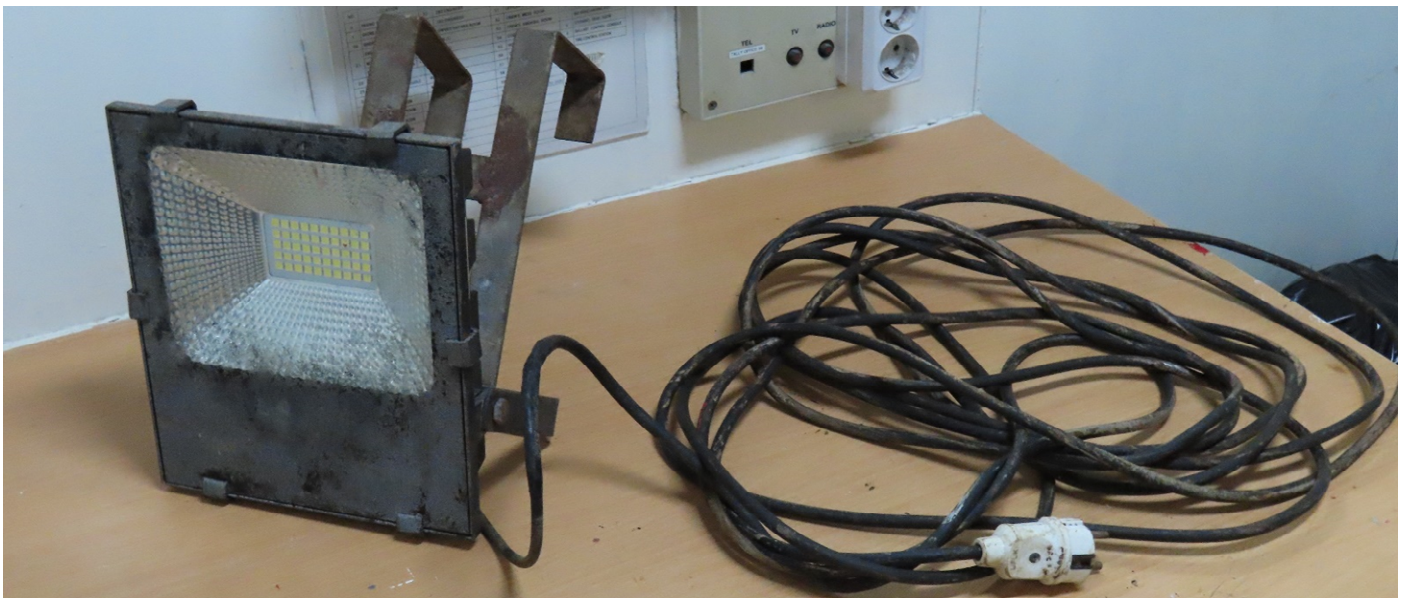
Portable lamp and cable

The portable lamp the victim was carrying was a 50 Watt light emitting diode (LED) floodlight that was labelled to have accepted an alternating current of 85-265 Volts at 50-60 Hertz. Its internal LED driver was rated IP67². No records were available to indicate the origin of the lamp.

The lamp had a power supply cable that was approximately five meters long and was fitted with a two pin plug, (which was not compatible with the vessel's power sockets). The lamp had been adapted with a double steel hook to enable it to be hung from the hatch coaming, rung or railing. The burns on the victim's left wrist/forearm matched the position of the lamp's hook when the victim was found by the deck rating.

- Replaced portable floodlights with low voltage equivalent (36V AC)
- Conducted a fleet-wide inspection of all portable electrical lighting systems
- Incorporated inspection of electrical cables and insulation resistance tests into their Planned Maintenance System
- Provided safety training on electrical hazards and the use of portable electric tools

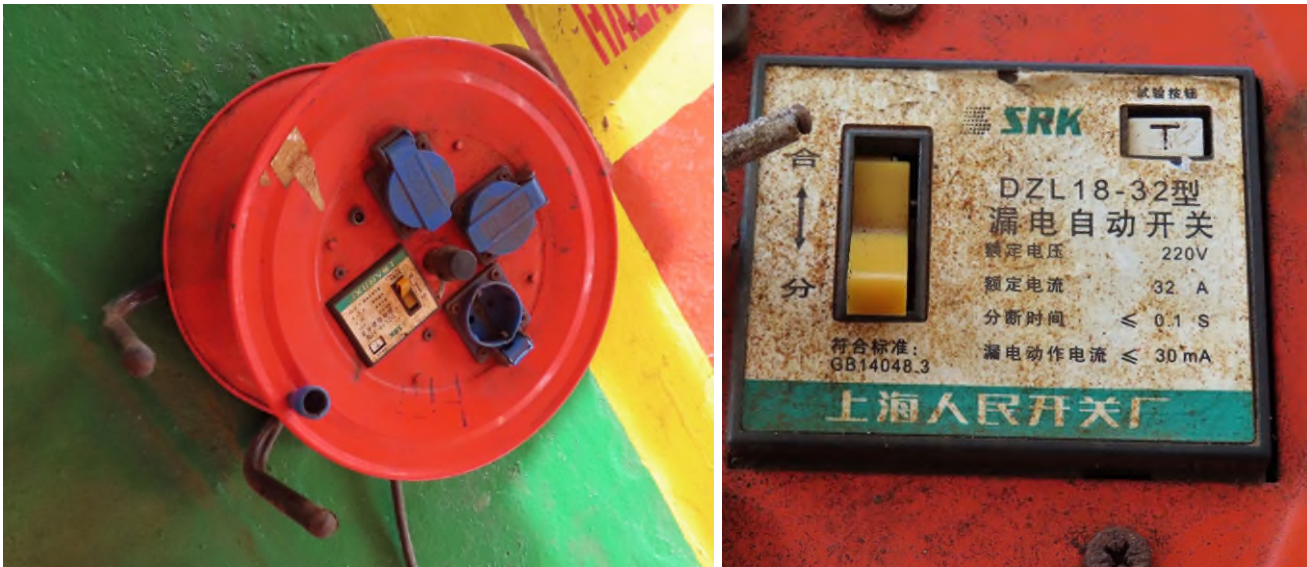
Extension cable reel. Detail of residual current device

At the time of the casualty, the portable lamp was plugged into an extension cable reel that was fitted with a residual current device³, designed to trip with a current leakage of 30 milliamps. The extension cable reel was designed to accept two pin plugs. It in turn was plugged into a power supply in the bosun's store using a three pin plug (that was compatible with the vessel's power sockets).

The deck rating received an electric shock when he touched the victim - neither the residual current device nor any circuit breaker tripped during the casualty. There was no record of an alarm on the vessel's earth system.

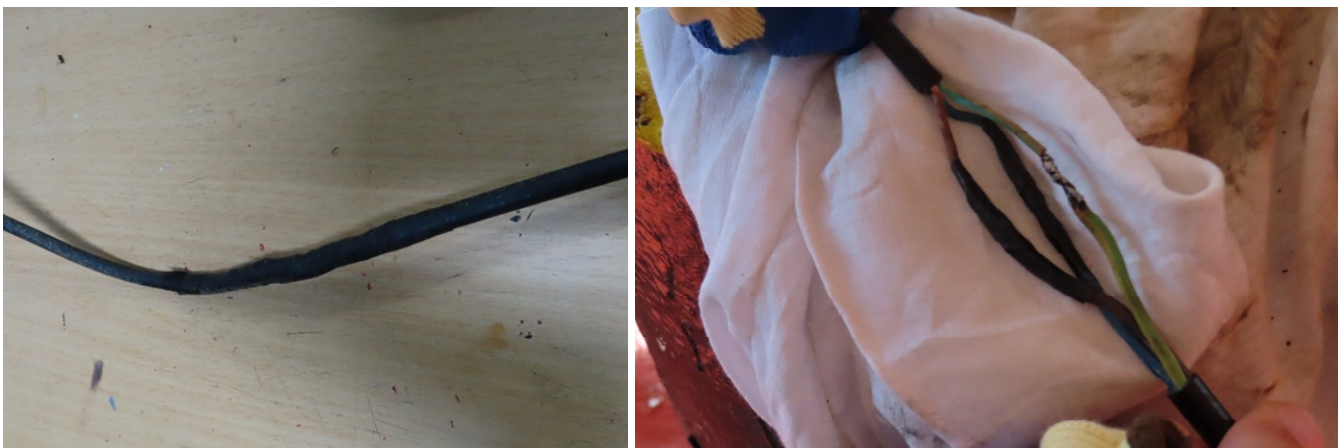
Cable joint wrapped in tape. Same joint, exposed

The cables that were joined together were of differing diameters. The joint was a simple soldered connection.

Without testing in a controlled environment, the source of current leakage cannot be confirmed. If the earth connection was lost there was a possibility of the exterior of the equipment becoming live. In any event, the joining of a larger diameter cable (at the supply end) to a smaller diameter cable would increase resistance at the joint. The method of jointing would have significantly reduced the effectiveness of the cable insulation.
