# Marine Safety Investigation Report

VERY SERIOUS MARINE CASUALTY | June 2025

**Margaritaville at Sea Islander**

Fall from height on 10 October 2024

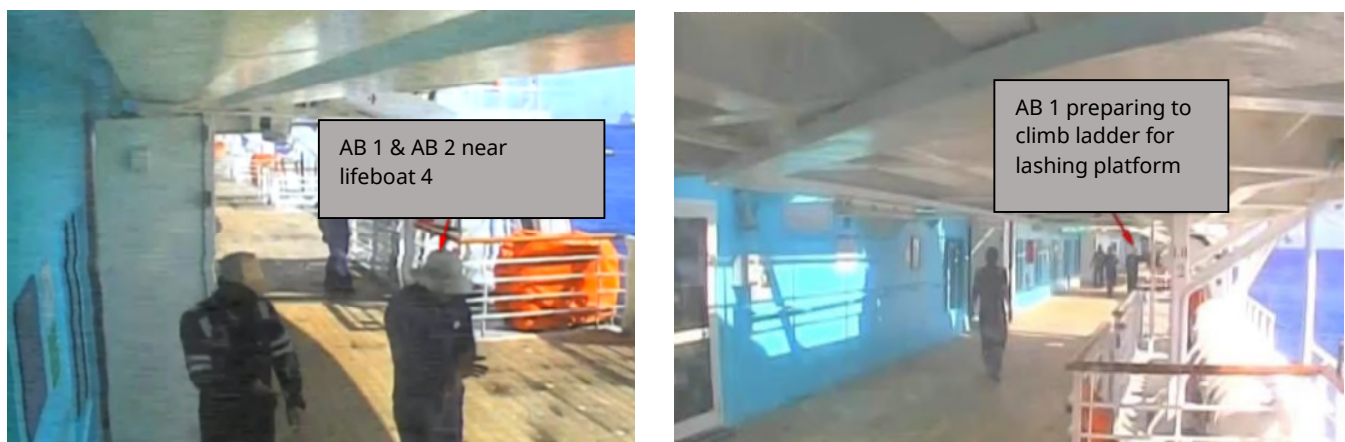
At 10:45, AB 1 spoke with AB 2, and other nearby crew members. He was wearing a company issued coverall, work boots and his own sun hat. AB 1 then prepared to climb the ladder leading to the lashing platform of lifeboats 2 and 4.

### AB 1 preparing to go up ladder leading to lashing platform between lifeboat 2 and 4

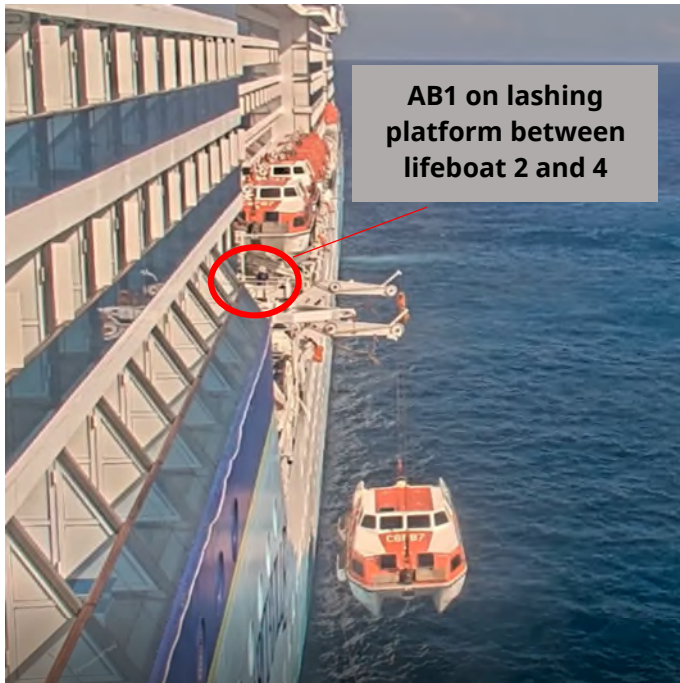
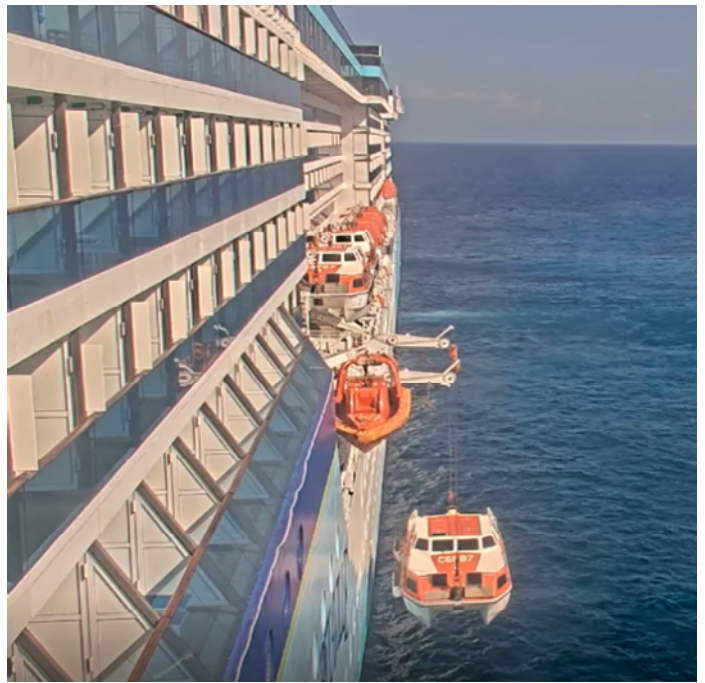
**AB 1 on lashing platform (left) immediately followed by rescue boat being recovered (right)**

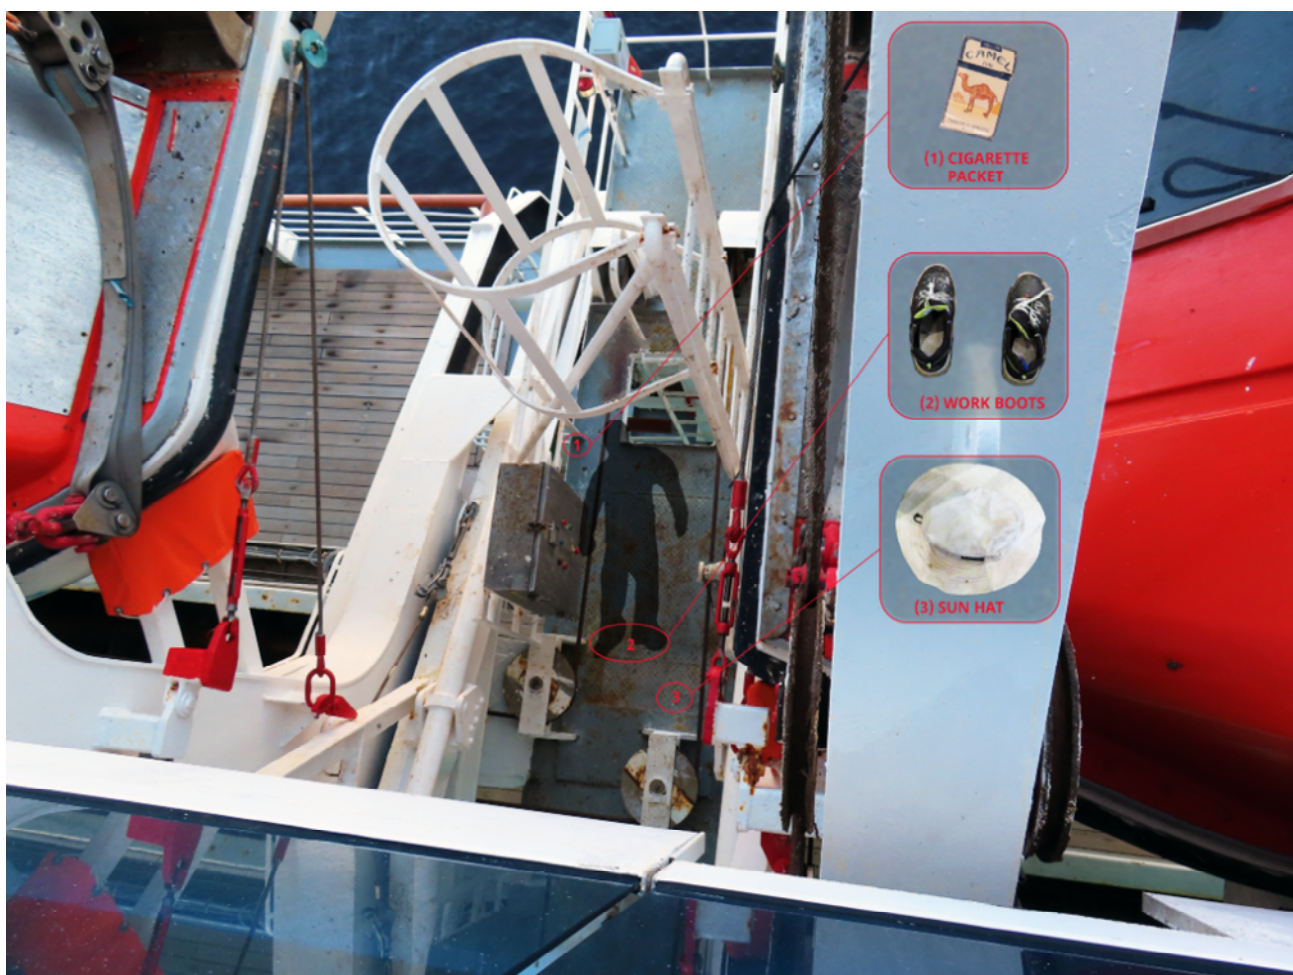
**Position of victim (face up) on the lashing platform between lifeboat 2 and 4**

- ① A pack of cigarettes was found, in line with his head near a railing. The cigarette packet was partially opened, with seven cigarettes inside. No lighter was recovered from the scene.
- ② The victim's work boots were found in fair condition. His coveralls remained on his body during transport to the hospital and therefore were not available for inspection.

- ③ The sun hat the victim was wearing was found near his feet, having fallen off during his fall. The hat was used specifically for the weather that day (31°C) and was not appropriate personal protective equipment (PPE) for working on the lashing platform and the preceding drill.

With numerous points of elevation on the platform and the position his body was found, it could not be determined from which specific point on the platform the victim fell. Once lifeboat 2 was stowed, the bridge wing's CCTV camera no longer had a line of sight to the lashing platform.

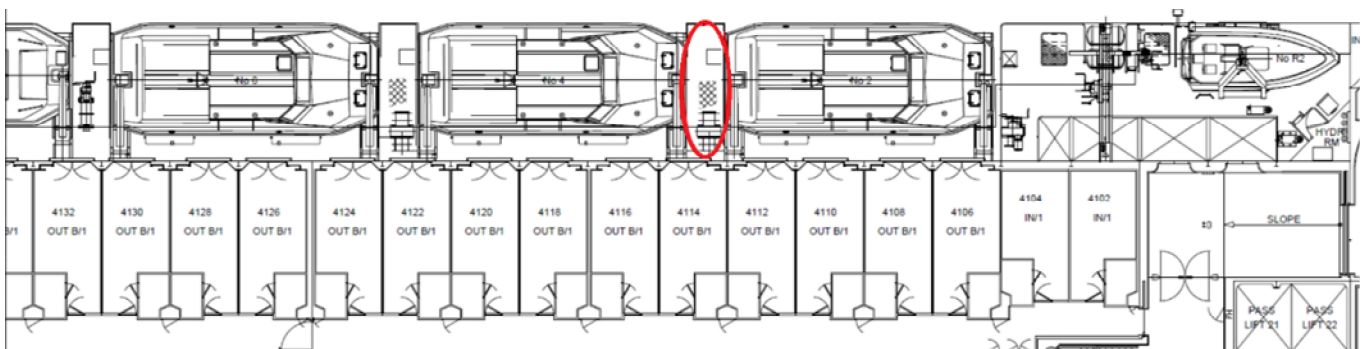
The lashing platforms are used to lash and secure two separate ends of different lifeboats. A team on a lashing platform will cover the aft end of one lifeboat, and the bow of another lifeboat.

**Circled in red, lashing platform between lifeboats 2 and 4 where the casualty occurred**

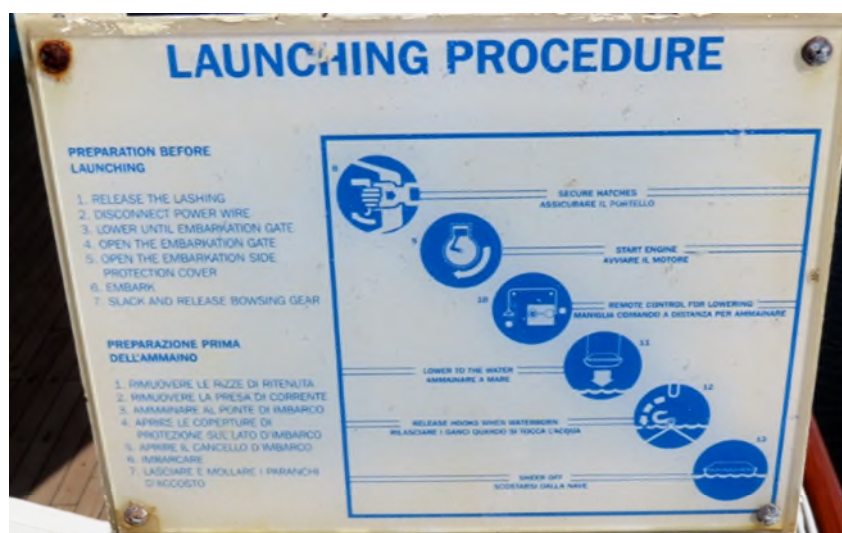
All crew members involved in the launching and recovery of lifeboats complete and sign a safety familiarisation, that is overseen by the deck safety officer. The company also has lifeboat procedures readily available in document form on the vessel, and generic placards placed on bulkheads and lashing platforms in between lifeboats. The written procedures and placards illustrate the launching of lifeboats, but do not address recovery.

**Example of lifeboat launching procedure on lashing platforms and bulkheads**

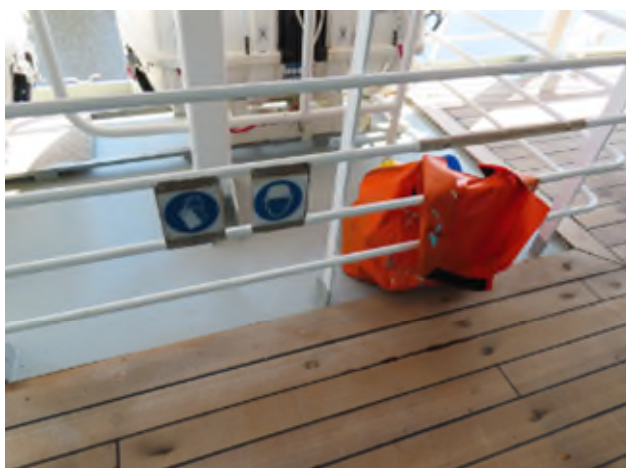
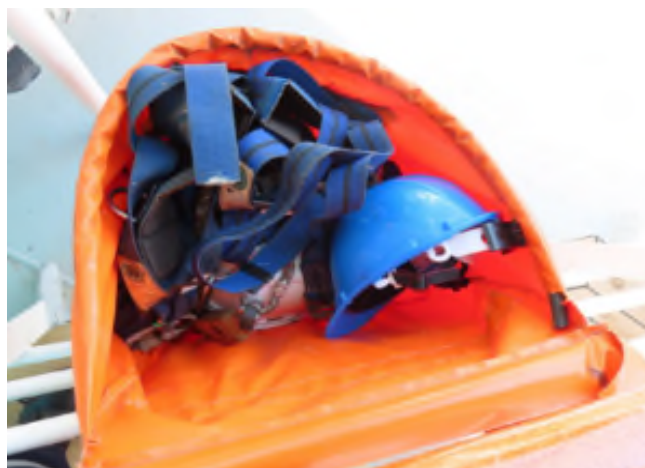
**Example of signage and PPE by lifeboat and rescue boats stations**

Signage near the stations indicated the areas guarded by rail required hard hats and safety gloves. The ladder leading to the lashing platform above the stations is between the railings. However, on the lashing platform where the casualty occurred, there were no PPE symbols present. The placement of PPE signs, or lack thereof, allows for interpretation the gear may only be required for work on the rescue boat, within the life raft area, or over the side. The signs do not clearly indicate PPE gear is required on the lashing platform located aloft.

Review of CCTV footage identified that a majority of the crew were not wearing hard hats during the drill – opting instead to wear head gear that would mitigate the heat and humidity as the temperature was 31°C. The review also identified that wearing of harnesses for accessing the platforms was not in practice at the time. The bosun who had on scene oversight of the drill, was the only crew member seen with a hard hat on.

- Take action to ensure safeguards in place for crew are effective and appropriate across varying conditions they are required to work in
- Ensure supervisors have robust support systems to enforce appropriate gear requirements

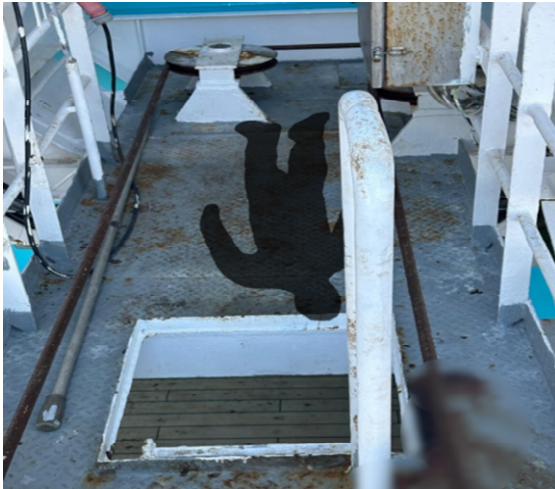
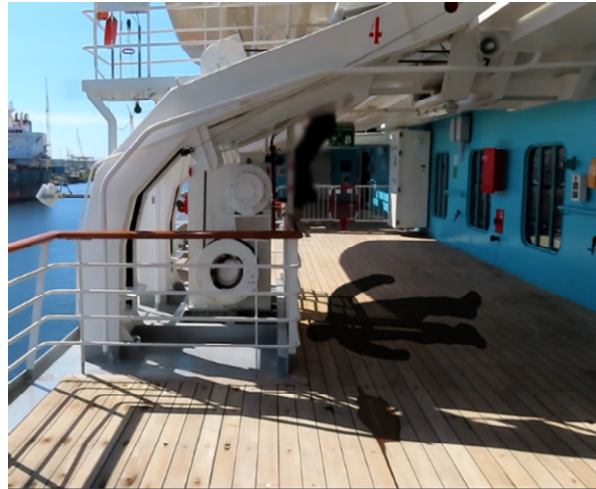
Some of the communication language throughout the medical response included phrases such as “Deck 3 port side” and “near lifeboat number 4”. There is a significant difference in useable space and ability to transport a casualty between a relatively larger deck area, and a confined lashing platform.

**Work area on lashing platform (left) and Deck 3 (right) where the casualty was lowered**

Communication around a medical response should be as precise as possible and updated as more information becomes available for medical emergency responders.
