Marine Safety Investigation Report

VERY SERIOUS MARINE CASUALTY | June 2025

Master Ru

Capsize of vessel on 11 July 2024

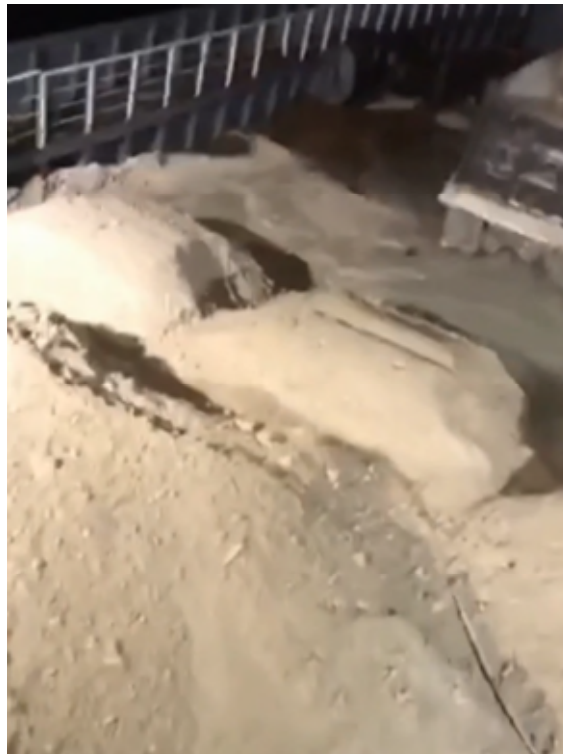
The wet cargo clogged scuppers and drains, reducing the vessel's ability to free excess water from deck. As well as the shifting cargo and excess weight from the trapped water, free surface effect adversely impacted stability and Master Ru began to develop a significant list to starboard.

The mate went outside to assist three other crewmembers who were setting up portable pumps in order to dewater the deck. However, the pumps were not sufficient and consistently became clogged with sand from the cargo.

State of cargo on deck during attempts to pump

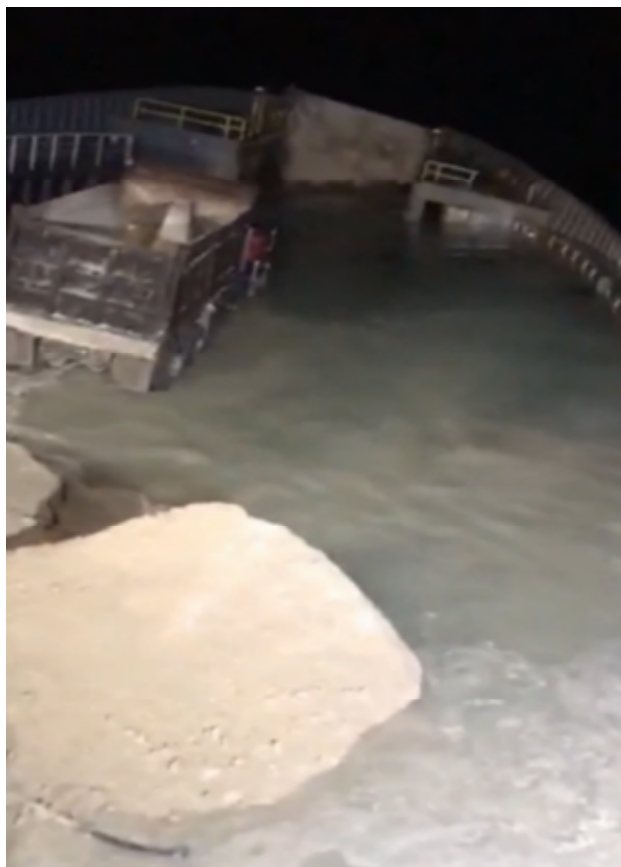
There was at least one metre of water accumulated on the starboard side of the vessel, increasing the list and bringing the Master Ru close to a state of deck edge immersion.

Water on deck, increasing starboard list

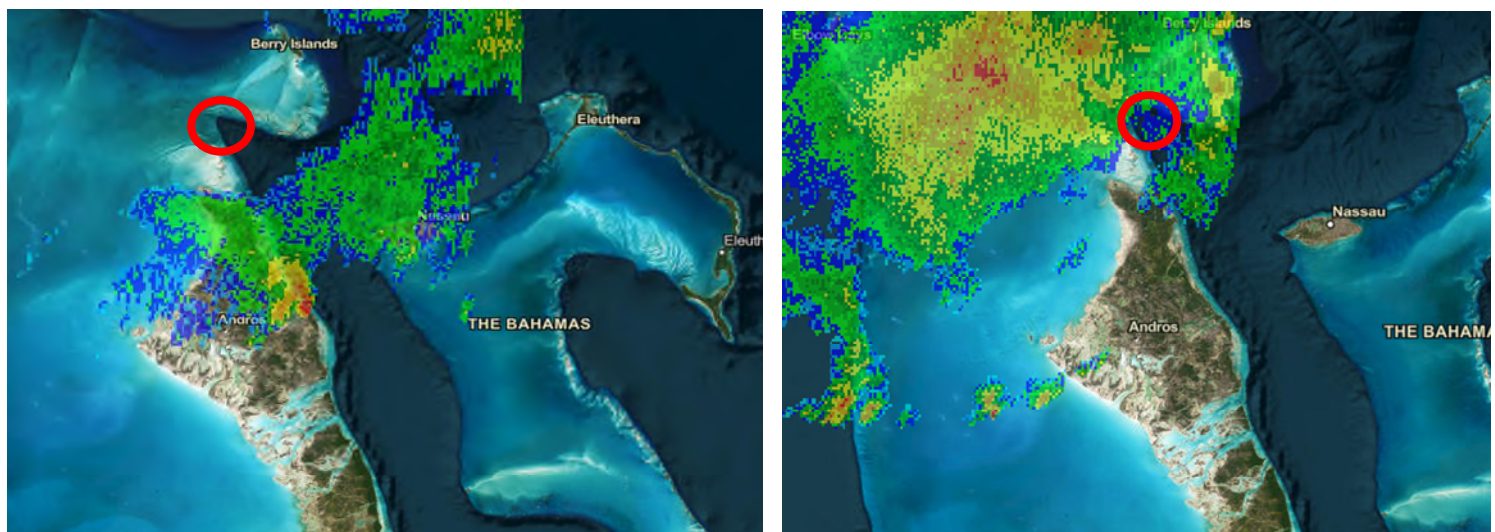
When handing over his watch at around 20:00, the mate stated the weather was clear and calm but an intense storm had developed on their planned route and was moving towards them.

Approximate position of Master Ru at 20:00 and at the time of the casualty

As they were not aware of the weather warnings, Master Ru did not attempt to seek shelter or deviate to avoid the worst of the weather. Regardless, the effectiveness of any attempt at deviation would have been minimal due to the limited manoeuvrability of the vessel.

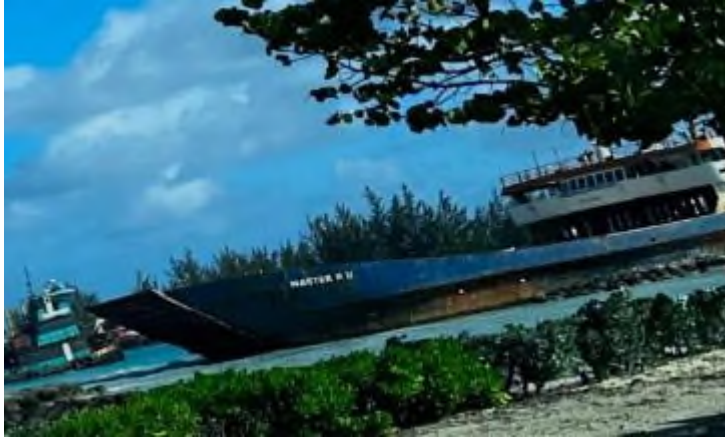
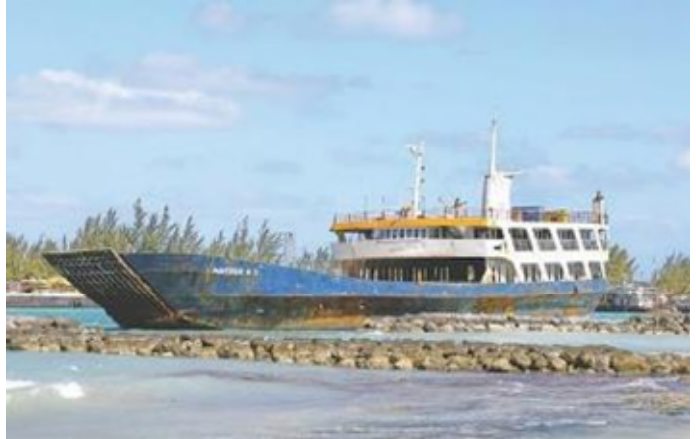
Master Ru had at least one other recent casualty in The Bahamas. On 07 February 2024, while moored at Curling Dock, Nassau when its mooring arrangements broke during adverse weather, causing it to drift and ground.

Master Ru aground on 07 February 2024 at 0942, preparing to be towed by tug

The vessel was successfully salvaged but suffered significant damage to the underwater hull, propellor(s) and shaft. A series of repairs were completed by Sands Marine & Salvage Services as shown in [Appendix 2](#).

The repairs were not verified by a Classification Society or flag surveyor, nor was Master Ru resubmitted for inspection to The Bahamas Port Department in accordance with Part II Paragraph 6 (2) of the Boat Registration Act. Verification was limited to a “sea trial” with oversight by the chief engineer and shoreside support from members of Incredible Bulk Ltd, to which they concluded the vessel was safe to operate.

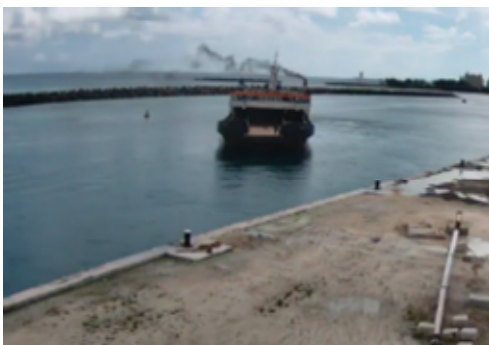
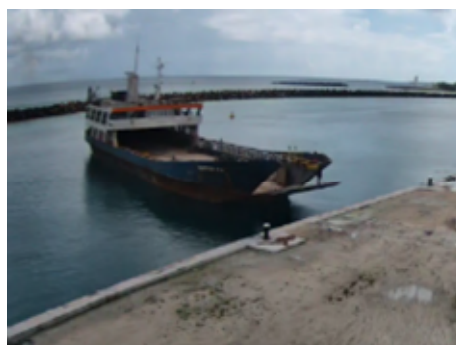
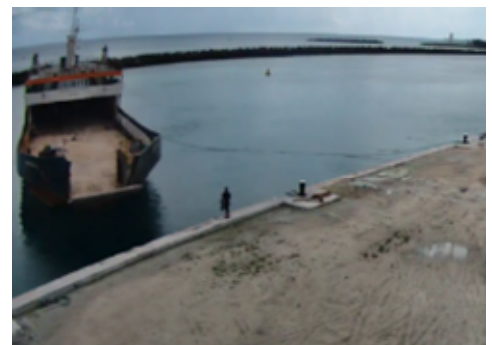
Shortly after repairs were affected to the underwater hull , propellor(s) and shaft, Master Ru starboard main engine developed a fault and became non-operational. The engine remained unavailable for the five months preceding the casualty, an issue known to Incredible Bulk Ltd and Mosko Group Ltd. The unavailability of the engine restricted the speed of the vessel to 1-4 knots depending on sea state and cargo loaded. A spare turbocharger and additional main engine components had been ordered for the starboard main engine (see [Appendix 3](#)). However, the casualty occurred before the starboard main engine could be repaired.

Due to the lack of power, Master Ru experienced difficulties in manoeuvring. CCTV footage shows the vessel, in sheltered waters, unable to safely berth or hold position and had to be towed into position for mooring.

Master Ru attempting to come alongside (bow to dock)

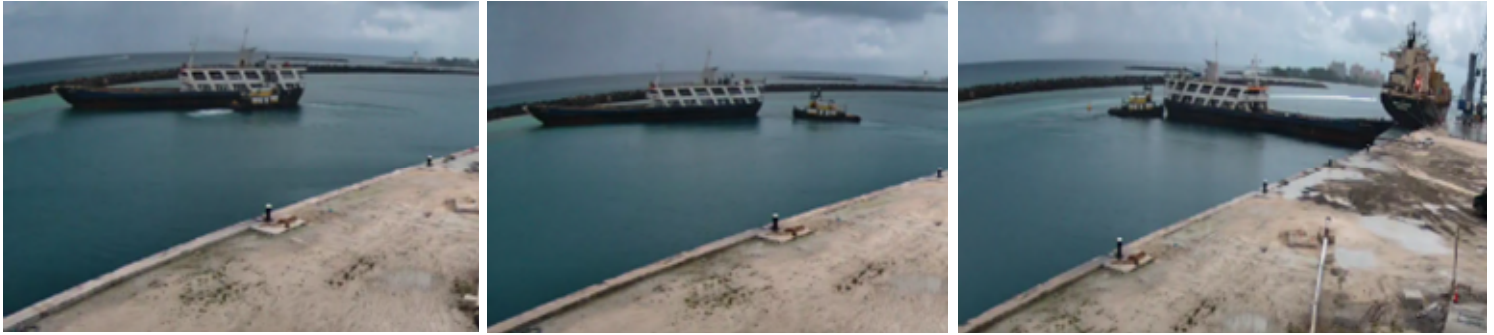
Master Ru being towed into position after crossing channel buoy under its own power

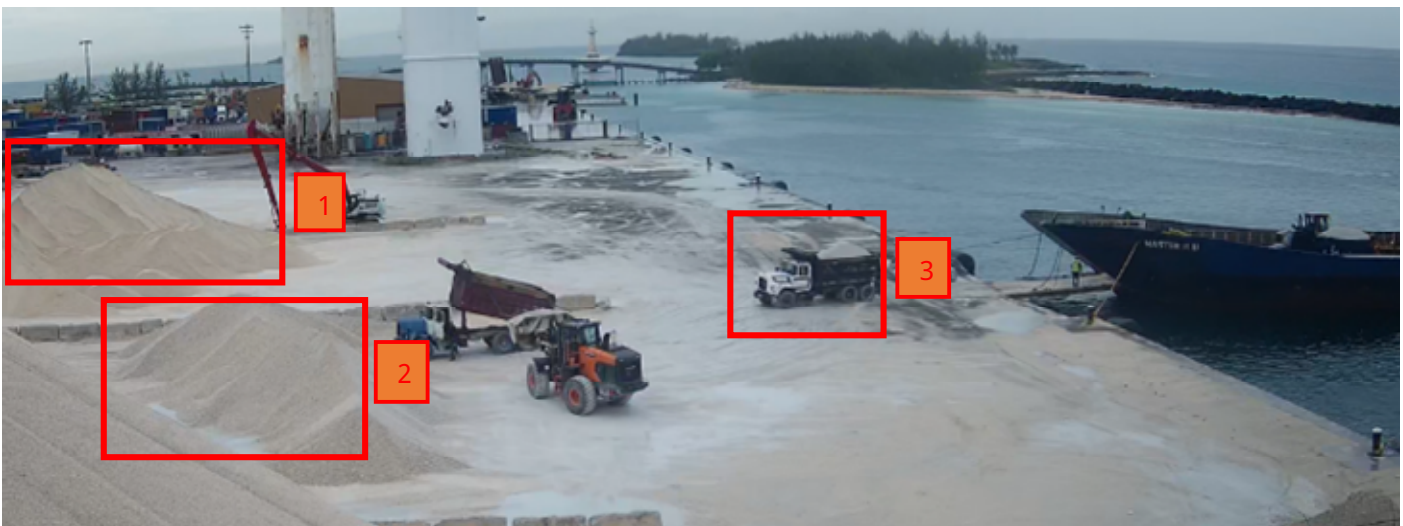
At the time of the casualty Master Ru was being used to transport solid bulk aggregate cargo and construction equipment on deck. While some of the equipment and cargo was placed underneath the vessel's superstructure, this did not mitigate the risks associated with carriage of these cargoes.

CCTV Footage showing loading operations at Curling Dock on 01 July 2024

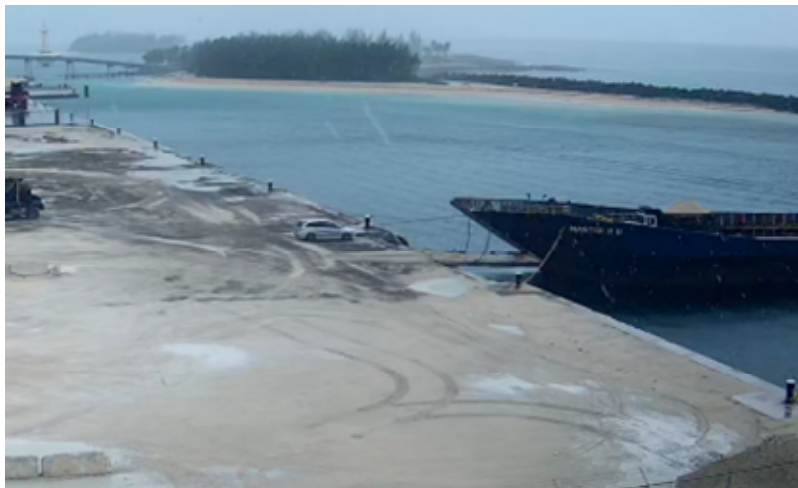
This cargo shall be kept as dry as practicable before loading, during loading and during voyage. This cargo shall not be loaded during precipitation. During loading of this cargo all non-working hatches of the cargo spaces to which this cargo is loaded, or to be loaded, shall be closed.

Master Ru loaded bulk aggregate cargo regardless of weather conditions, and had no measures to contain the cargo or protect it from water ingress once on deck.

Master Ru continuing to be loaded while raining

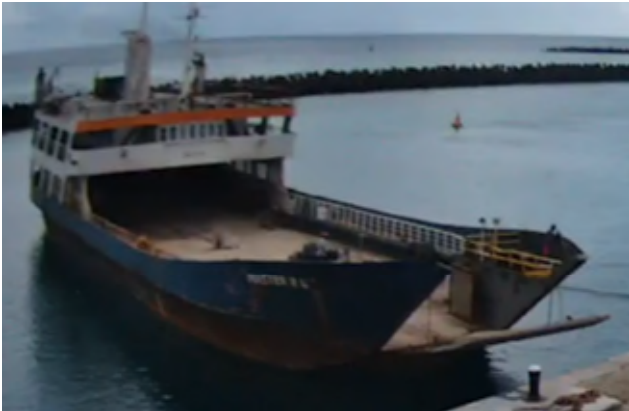
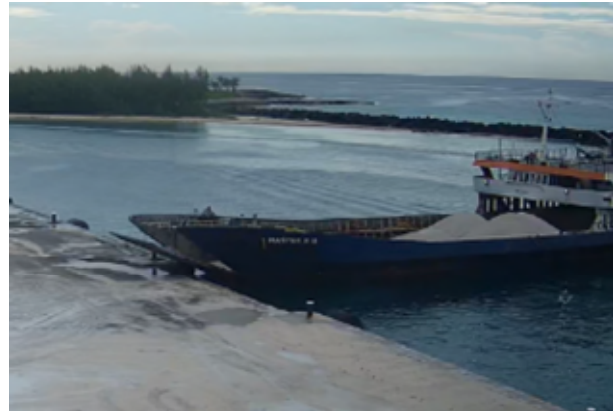
Master Ru also did not have adequately marked Load Lines or draught marks. The crew made estimations based on the waterline level to the hull to determine when the vessel was sufficiently loaded. There were no means to assess the vessel's stability available to the crew and, as such, no assessment of stability was conducted.

Port and Starboard side of Master RU with no prominent Load Line or draught marks

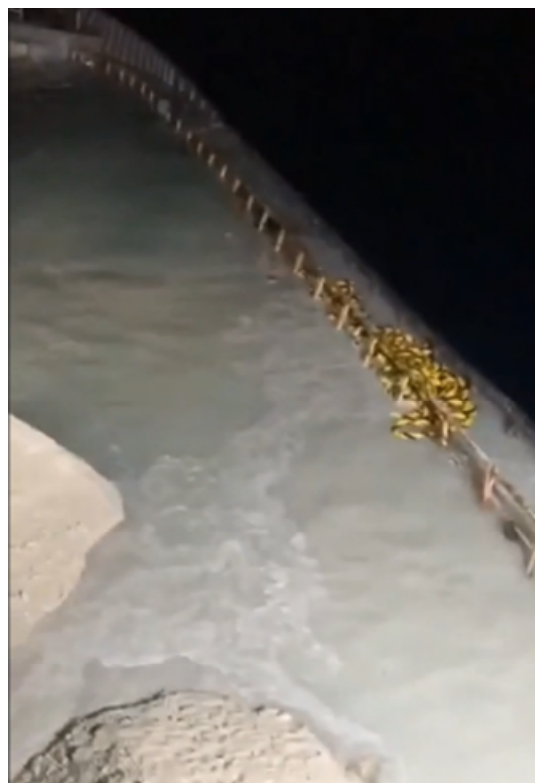
Video footage recorded during the casualty shows sand and limestone rocks had shifted. Aside from also blocking the scuppers and drains on deck, the shifted cargo added additional weight with the accumulating rainfall to the starboard side of the vessel.

Eventually – with shifted cargo and accumulated water on deck, the vessel's freeboard reduced and the list resulted in the main deck meeting the waterline, resulting in deck edge immersion and the vessel ultimately capsizing.

Master Ru starboard side, moments before capsizing – approaching a state of deck edge immersion
