## Failure of fall arrest equipment

- 1.1. This Safety Alert is issued by the Bahamas Maritime Authority (BMA) to share lessons to be learned on the failure of fall arrest equipment that resulted in a man overboard. It is based on the findings of a preliminary investigation.

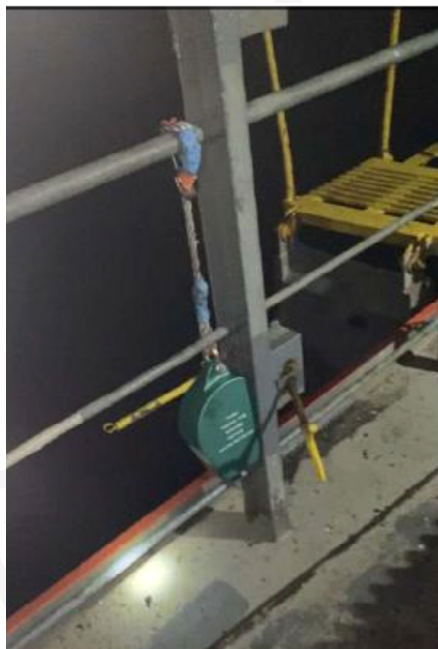
Dropped gangway and failed fall arrestor after casualty

- 3.1. The failed hoist wire was subject to electromagnetic inspection to detect damage, metallic area loss, broken wires and corrosion. The wire showed significant degradation. Tests indicated a reduction in breaking load across the entire length of the wire. A loss of up to 87.6% of its residual breaking load was recorded where the electromagnetic inspection showed a metallic area loss of 31.2%.

- 3.2. The wire had been in service for 27 months. Whilst fitted, it was subject to inspection and lubrication as part of the vessel's planned maintenance system. The location at which the wire parted was on the outboard side when the ladder was secured for sea. As well as being exposed to weather and sea spray, this length of the wire was incredibly difficult for the crew to access. The wire's condition and shipboard records of work suggest that the section of wire had not received the required lubrication during service. There was inadequate instruction for lubrication of this wire and the difficulties in effectively completing the task were not recognised.

- 4.2. Safety starts with design. The ladder's hoist wire was exposed to harsh conditions and was difficult to effectively inspect or maintain. These factors were not effectively considered in the design of the arrangement or material choice, leaving the end users to solve a difficult problem.

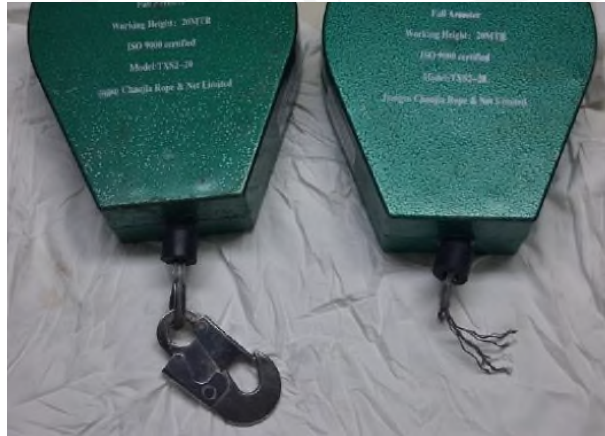
- 3.4. The ordinary seafarer was not aware that this type of fall arrester should be connected directly to a safety harness and there was no suitable anchoring point above the working area. Securing it on the same plane and the addition of the shock absorbing lanyard meant that he fell approximately 5 meters before load was applied to the fall arrester - creating a significant shock load.

- 3.5. The failed fall arrester had been provided to the vessel three months before the casualty. It was certificated<sup>1</sup> to have been tested to local (Chinese) standards rather than an international standard. Due to the limited number available, the fall arrester was not

subject to testing to determine compliance with either standard. As a precaution, the operator of the vessel has removed *Jiangsu Chaojia Rope & Net & Belt Co. Ltd* equipment from its fleet.

Undamaged sample with the failed fall arrestor

- 4.5. Self retracting fall arresters are most effective when attached to an overhead anchor. Anchor points need to have sufficient strength - railings may not provide this strength.
- 4.6. Seafarers are problem solvers and previous investigations have shown they may put themselves at risk to get the job done. When time is of the essence and there are multiple things to achieve, a missing safety barrier (such as a lack of lifejackets) might be overlooked to enable work to be completed. Helping seafarers see risk is an industry-wide problem.
