# Marine Safety Investigation Report

VERY SERIOUS MARINE CASUALTY | November 2025

## Heroic I

Grounding and subsequent sinking on 27 March 2024

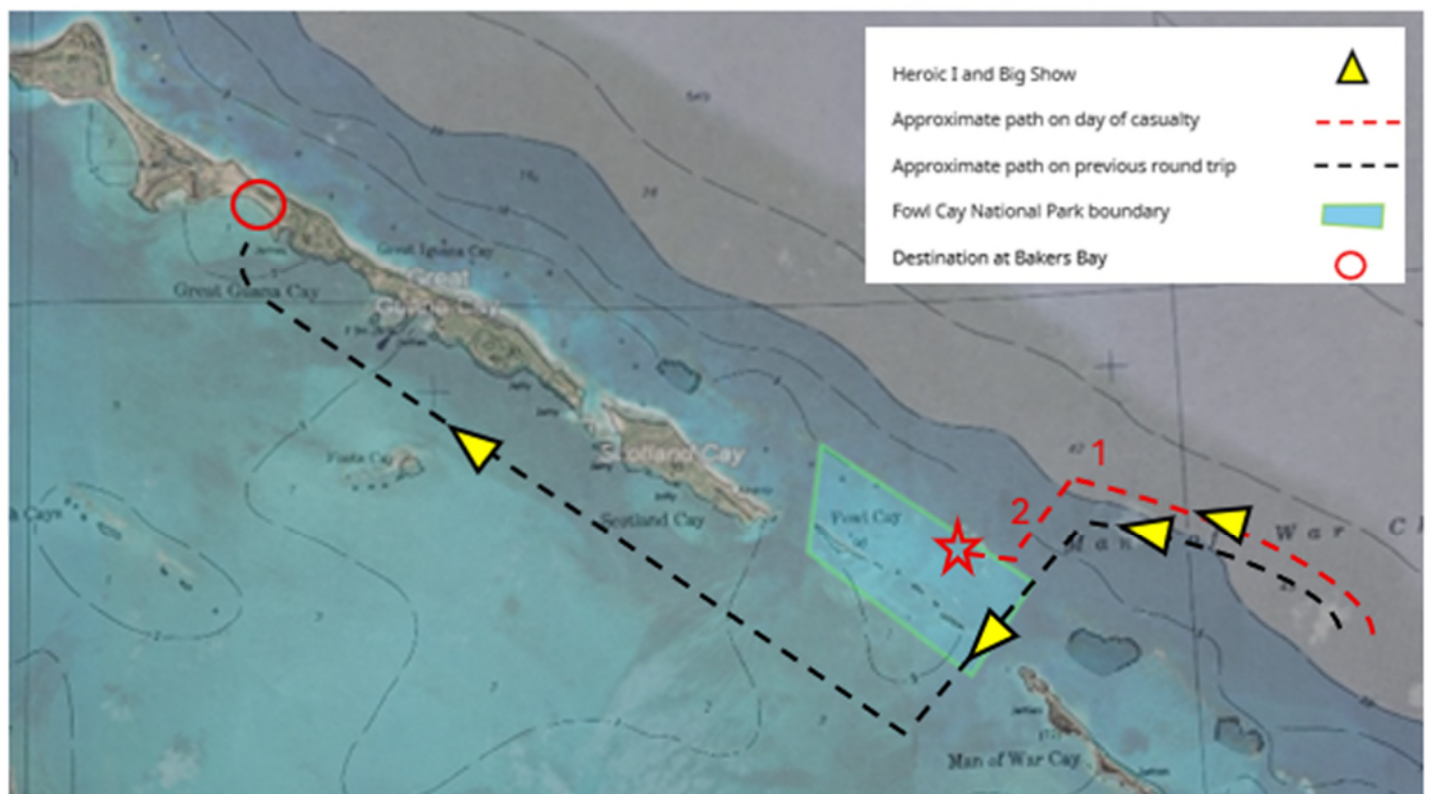
### Extract from US NGA Chart 26321 with satellite image overlay

In position **1** at approximately 07:30 on 27 March, Heroic I was approaching position 26°38.9'N 77°0.6'W proceeding at 4 knots. The tug prepared to make the turn into the channel between Man-O-War Cay and Fowl Cay, which serves as the entrance to Marsh Harbour, Abaco, and the subsequent destination of Bakers Bay.

At position **2** after 07:40, the tug and tow were around position 26°37.8'N 77°01.5'W proceeding at 1.6 knots. The weather was deteriorating and the master found it hard to navigate the tug and tow towards the channel. The waves continued to increase in size, increasing the difficulty in maintaining course and increasing tension in the tow.

At around 08:35 the main tow line parted. The barge drifted towards Fowl Cays National Park's boundaries and the crew began preparing the emergency towing arrangements.

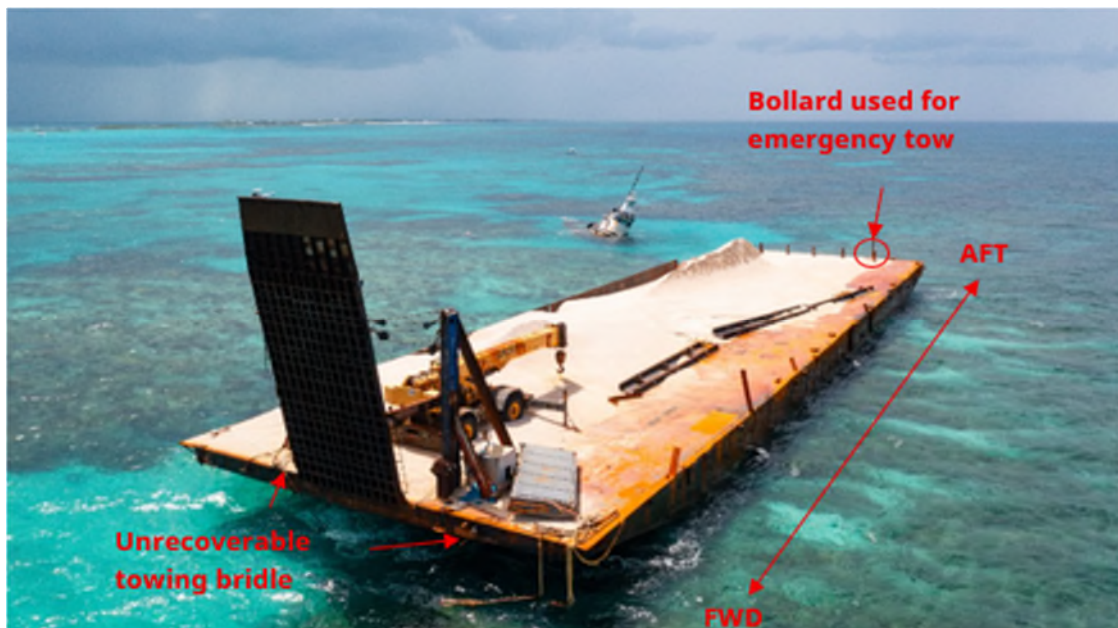
**Heroic I and Big Show grounded at Fowl Cays National Park  
(Photo from Bahamas National Trust)**

Both tug and barge were now well outside the channel and amongst the coral reefs of the Fowl Cays National Park. On board Heroic I, the chief engineer assessed the engine room and reported to the captain that the engines were immobilised, but there was no evidence of water ingress.

A few minutes later, the engine room bilge alarm sounded and the chief engineer activated the remote emergency shutdowns for the main and auxiliary engines. The tug list then increased to 35-40° while the barge remained undisturbed.

Another succession of waves swamped the tug; two crew members were on deck with donned lifejackets and were nearly swept overboard. Two AB's and the chief engineer were able to make it from the tug to the barge with some essential equipment: portable GMDSS radios, the EPIRB and logbook from the bridge. A final series of waves resulted in the tug sinking and grounding onto a reef.

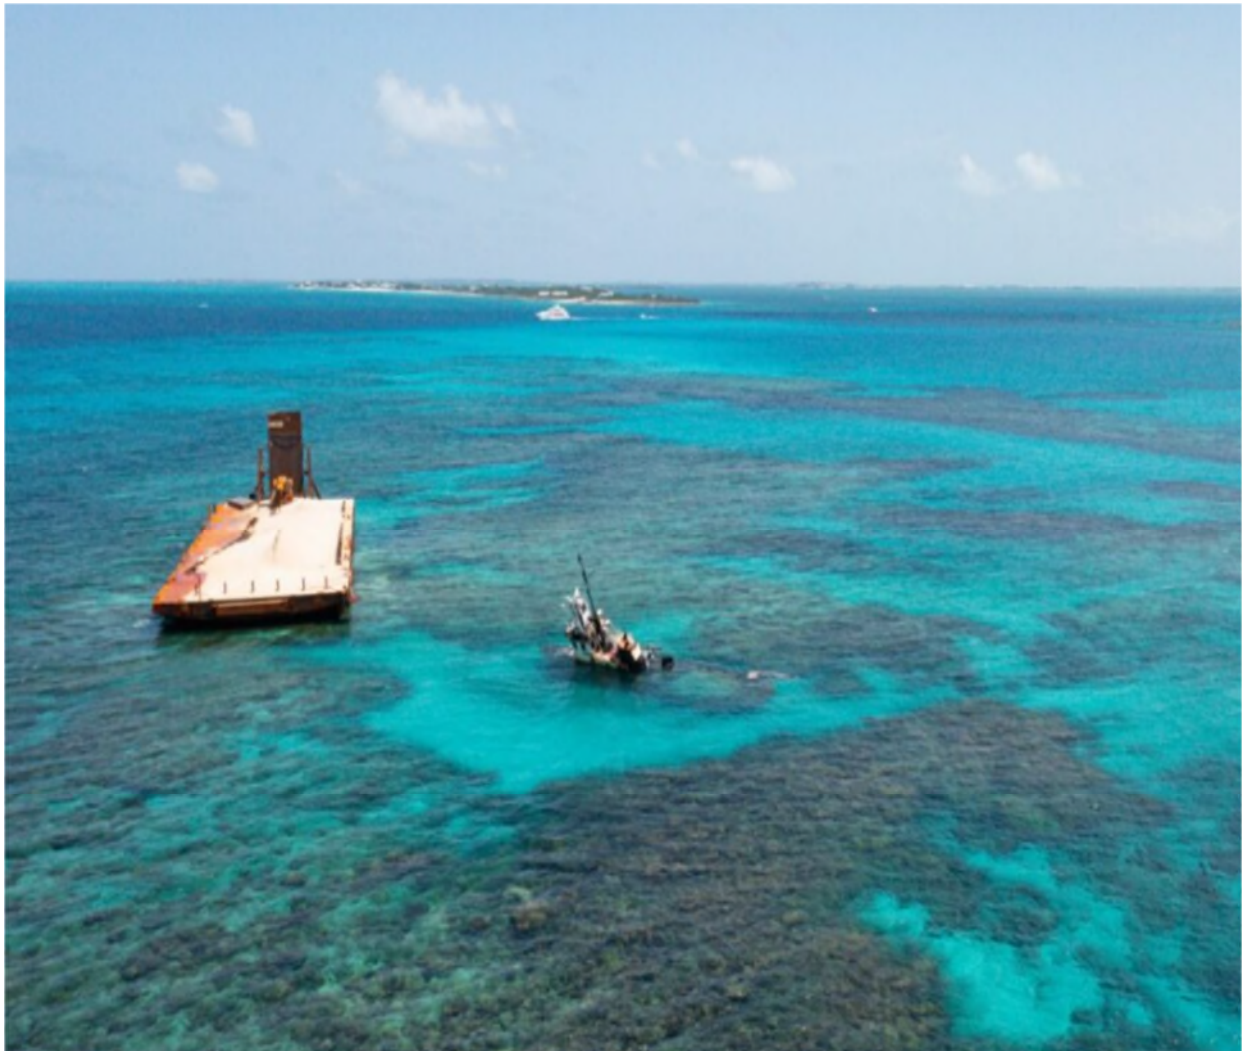
At the time of publishing, Heroic I and Big Show remain stranded within the Fowl Cay National Park boundary in position 26°38'N 77°01.8'W.

**Heroic I and Big Show grounded at Fowl Cays National Park  
(Photo from Bahamas National Trust)**

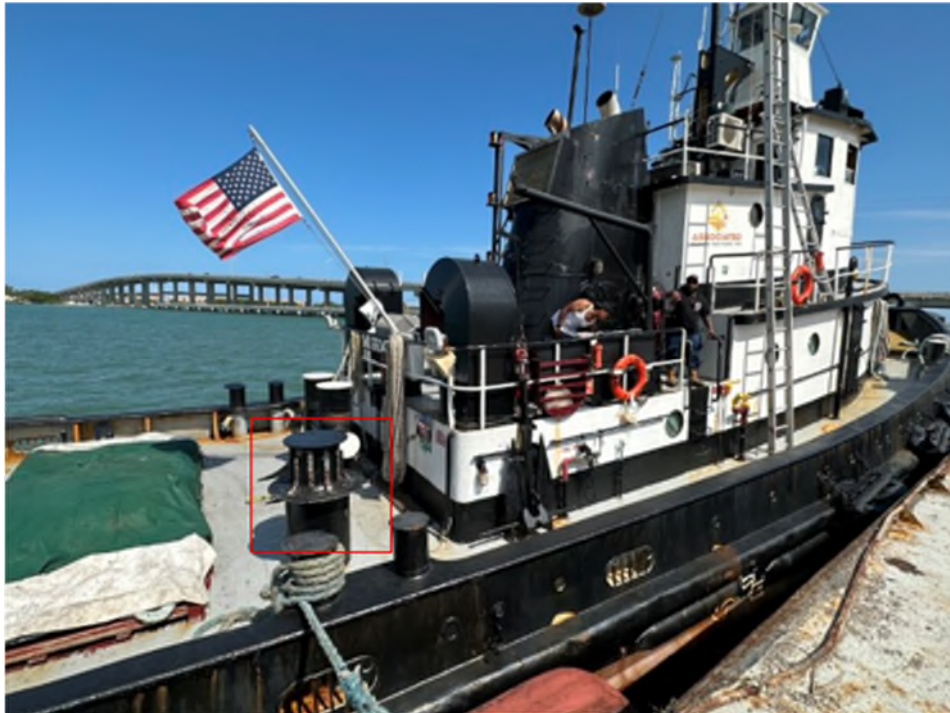
The crew referred to adjustment of "the winch" when reducing the towing length. However, the vessel did not have an equipped towing winch, but a mechanical capstan.

**Heroic I during initial inspection with capstan in red square**
