# Marine Safety Investigation Report

into a fatality on **Grandeur of the Seas** on  
**21 January 2025**

Date of Issue: 23 January 2026  
Bahamas Maritime Authority  
120 Old Broad Street  
LONDON  
EC2N 1AR  
United Kingdom

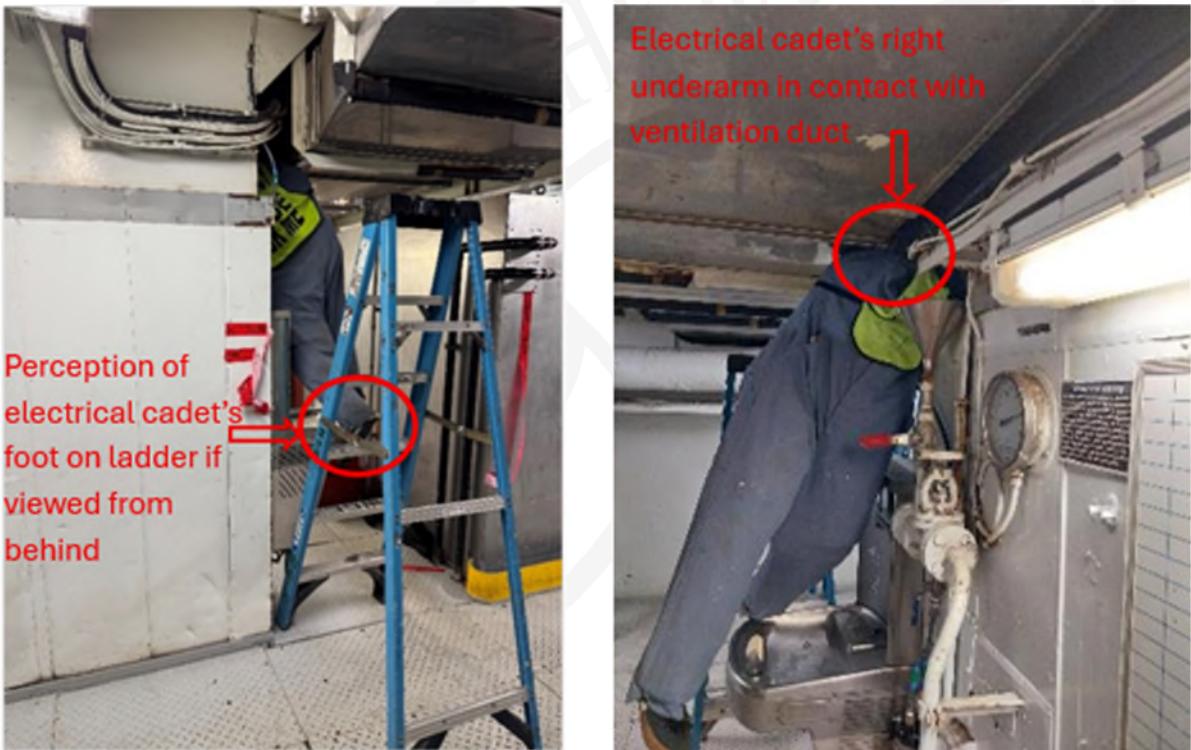
The 1/E and 2/E tried to pull the electrical cadet out, but his right underarm was coming into contact with a ventilation duct immediately outside the access space. They pushed him inside slightly and turned his body, enabling them to remove him from the space and place him on the deck.

**Recreation of victim's body position on ladder with back and front view (with use of dummy)**

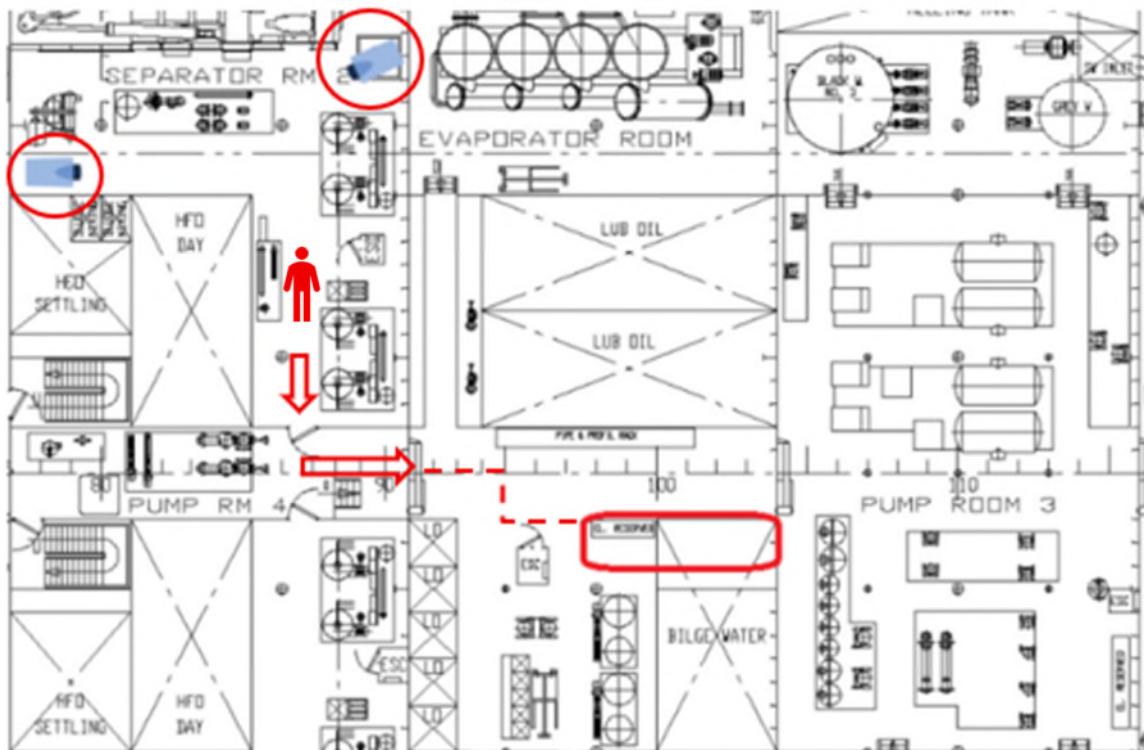
The casualty occurred on the tank top deck, in the access space on top of the bilge water settling tank M4. The electrical cadet was last seen on the port side separator room CCTV cameras collecting his tool bag, exiting the room, and walking in the forward direction. Afterwards, he climbed into the access space above tank M4 using the ladder he previously rigged.

**Tank top deck arrangement showing CCTV cameras and personnel movements**

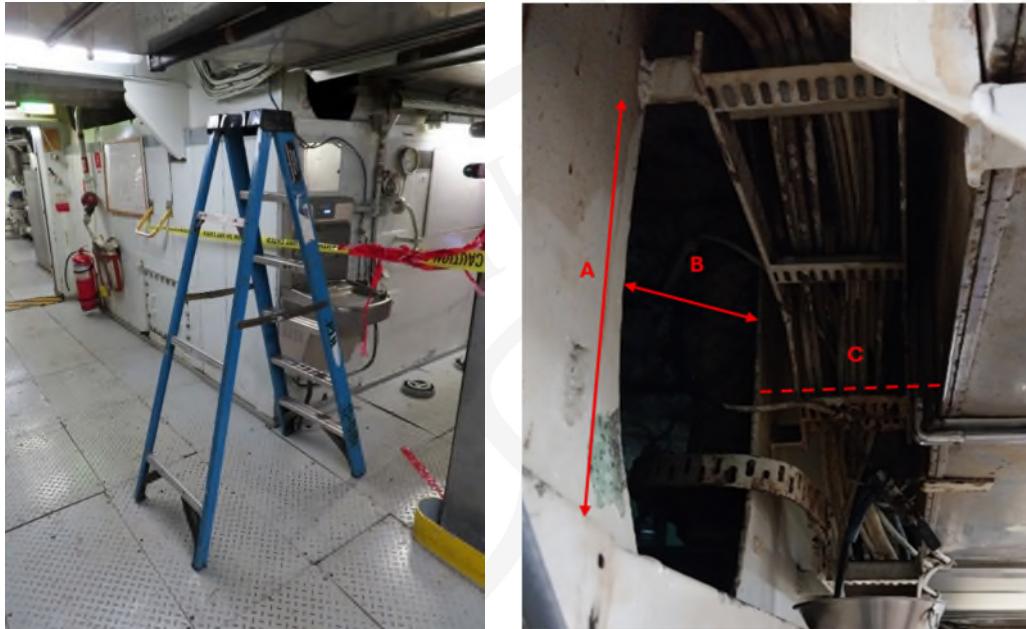
The height of the entrance to the access space was approximately 180cm from the floor plates, hence the rigging of a 183cm (6ft) ladder. Immediately beneath the space is a water fountain, so the ladder was rigged slightly to the port side of its entrance. There is also a ventilation duct running outside of the space.

**Ladder outside of access space and dimensions of entrance**

- A-** Available overhead clearance for access space entry (cable duct to base of entrance): 35cm
- B-** Width of entrance: 41cm
- C-** Distance from bulkhead to ventilation duct running outside of the space: 23cm

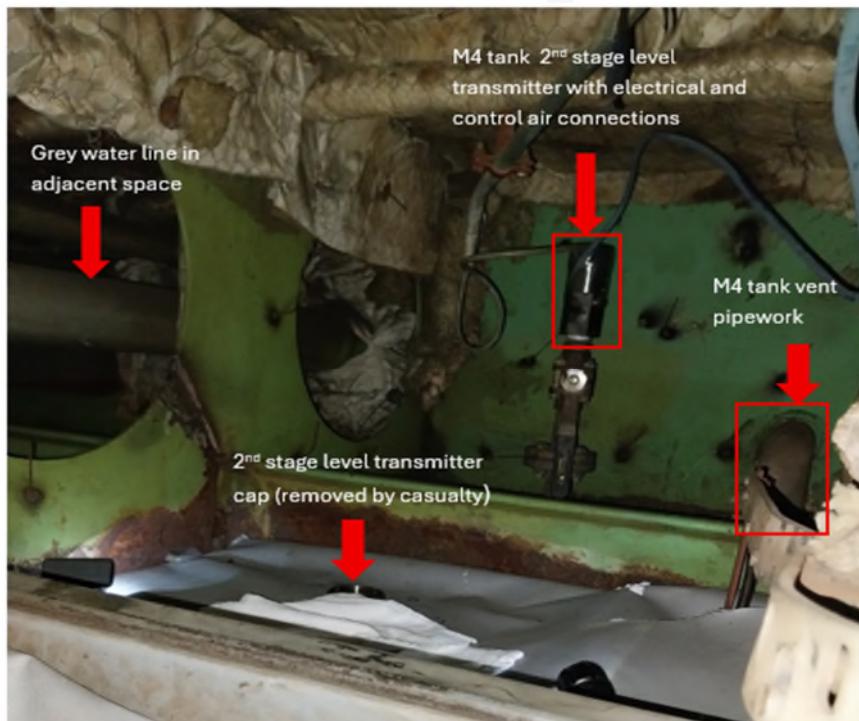
The interior of the access space consists of bulkhead insulation and for tank M4: the tank top covers for both stages, the level transmitter for the second stage, and the ventilation pipework exiting the space leading to atmosphere. The space is not entirely enclosed, as there is accessibility to an adjacent area containing a grey water line.

**Interior of access space (top of tank M4)**

The dimension of the space on the tank top is approximately 188cm long (port to starboard) and 90cm wide (fore to aft). The M4 tank vent pipework is located 20cm aft of the second stage level transmitter.

The access space above bilge settling tank M4 satisfies the criteria to be designated as an enclosed/confined space.

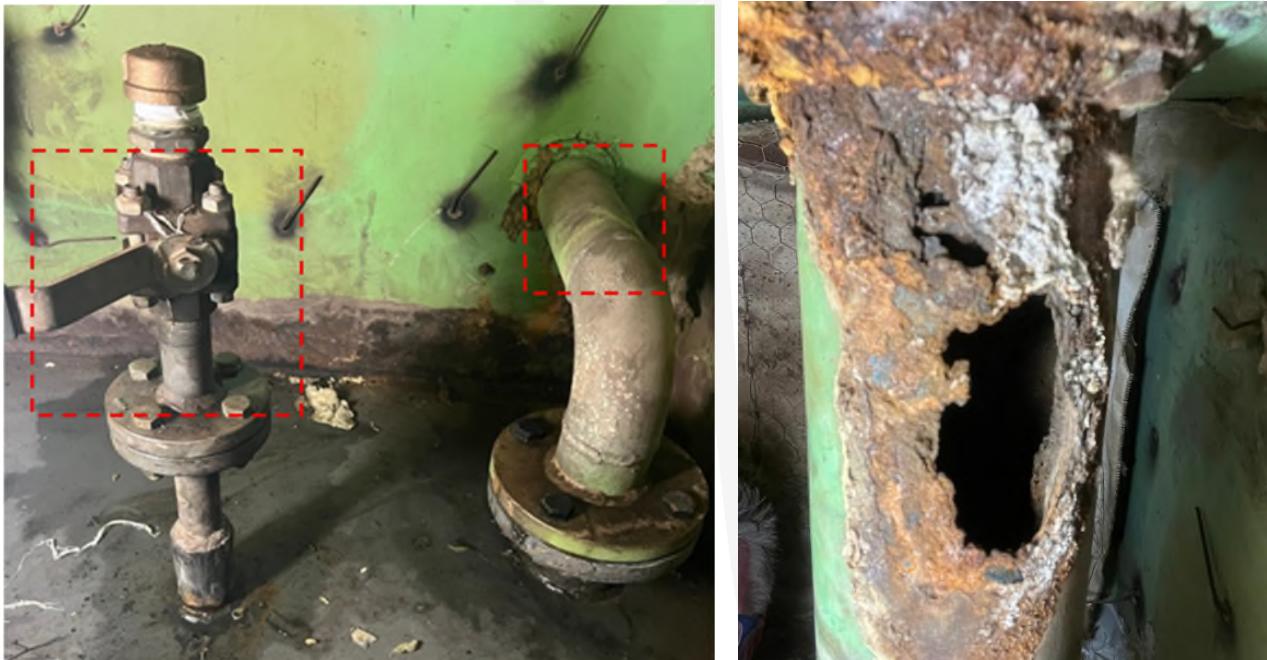
Post-casualty tests conducted by the crew lead to the discovery of a corroded section of the ventilation pipe to atmosphere for tank M4's second stage. This was later confirmed to be the source of Hydrogen Sulphide (H<sub>2</sub>S) ingress into the space.

area and the access space had readings of H<sub>2</sub>S exceeding 100ppm, which later lead to the discovery of the corroded ventilation pipe.

The corroded vent pipe for tank M4 was 20 cm away from the sensor the electrical cadet was checking, and served as the ingress point for H<sub>2</sub>S. The same is shown below:

**Flanged connection for level transmitter near corroded M4 ventilation pipe (to atmosphere)**

- Addressed the immediate cause of hydrogen sulphide generation.
- Removed and replaced the corroded ventilation pipe for tank M4, conducted pressure tests and painted the tank ceiling with corrosion-resistant paint.
- Replaced and relocated both 1<sup>st</sup> and 2<sup>nd</sup> stage sensors for tank M4 external to the access space.
- Created a fleet wide plan to address gaps in knowledge for confined space operations.

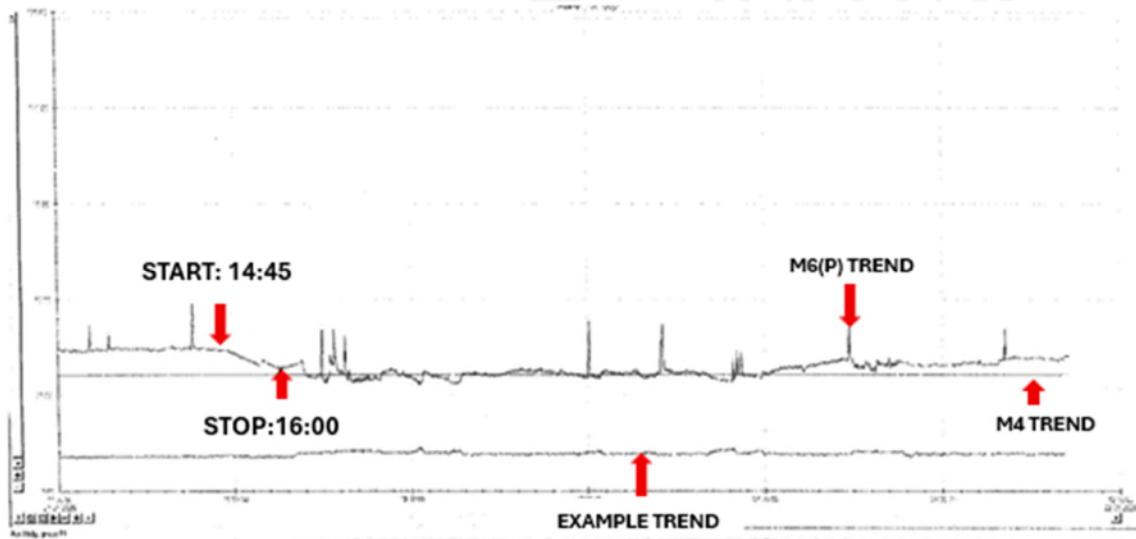
The trend analysis below is for M6P and M4 tank, labelling the points for when the transfer started and stopped. The victim and 2/E observed the same trend for tank M4 (a flat line) in the ECR. A flat line on the

trend indicates either a sensor error or disrupted airflow. An example of an unrelated tank trend is also shown as an example of a tank which is static and has a functioning level transmitter.

**Printout of trend analysis for tanks M6(P) and M4 around the time of casualty (21 Jan 2025)**

Review of the trend analysis history indicates the level transmitter for M4 began failing around 13:00 on 19 January 2025, two days prior to the casualty.

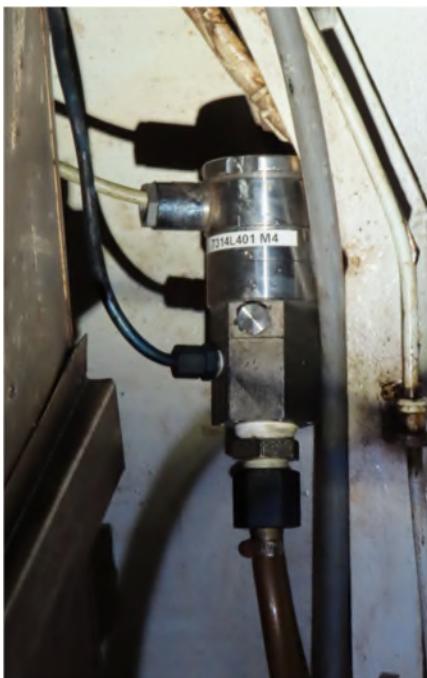
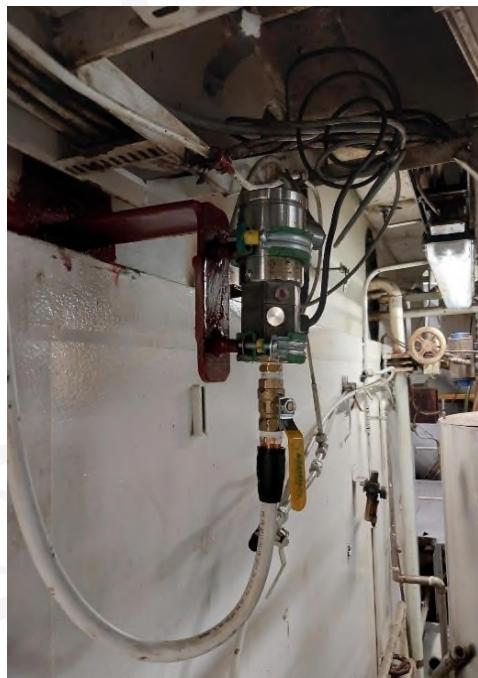
At some point in the vessel's history, the first stage level transmitter for tank M4 had been relocated outside of the access space. No record was available of when this alteration occurred. It is likely this was completed by a member of the electrical team as a matter of convenience: to avoid having to enter the access space to troubleshoot. Post-casualty, the second stage level transmitter was also relocated outside of the access space, thus ensuring ease of access for any future maintenance required.

**First stage (left) and second stage (right) level transmitter for tank M4, relocated outside of access space**
