**The Bahamas**  
Maritime Authority

# Marine Safety Investigation Report

into a collision between Commodore Goodwill  
and L'Ecume II resulting in the loss of three  
lives on 8 December 2022

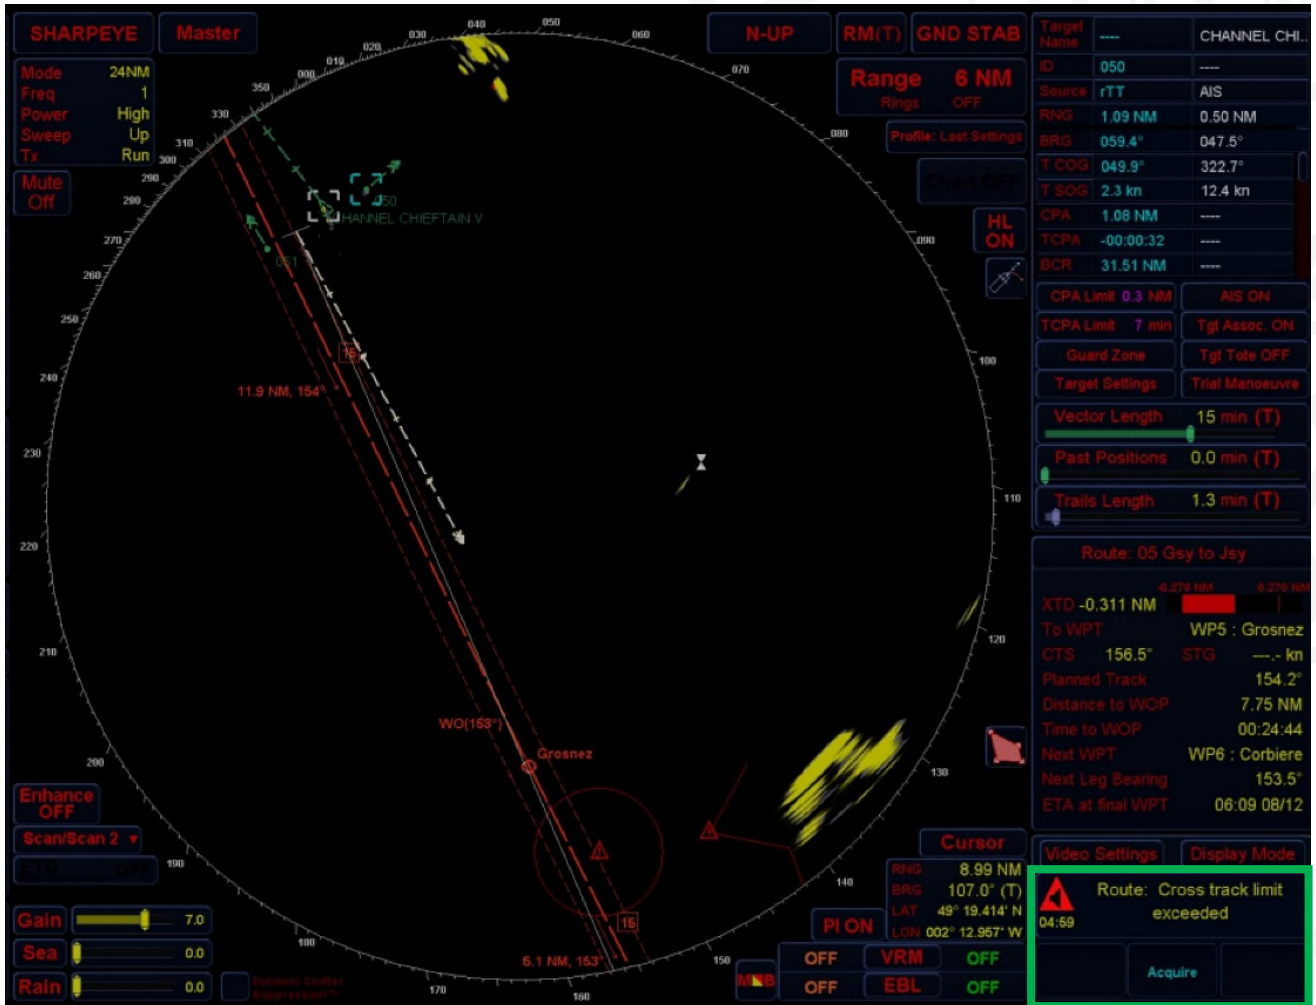
Twelve minutes later, having passed between two vessels heading in the opposite direction, the officer of the watch asked the lookout if he would like to go to breakfast. The lookout then went down, leaving the OOW alone on the bridge taking but a handheld VHF radio.

Screenshot from Commodore Goodwill VDR: Radar at 05:03 passing between Channel Chieftain and fishing vessel (Cross track error alarm in green box)

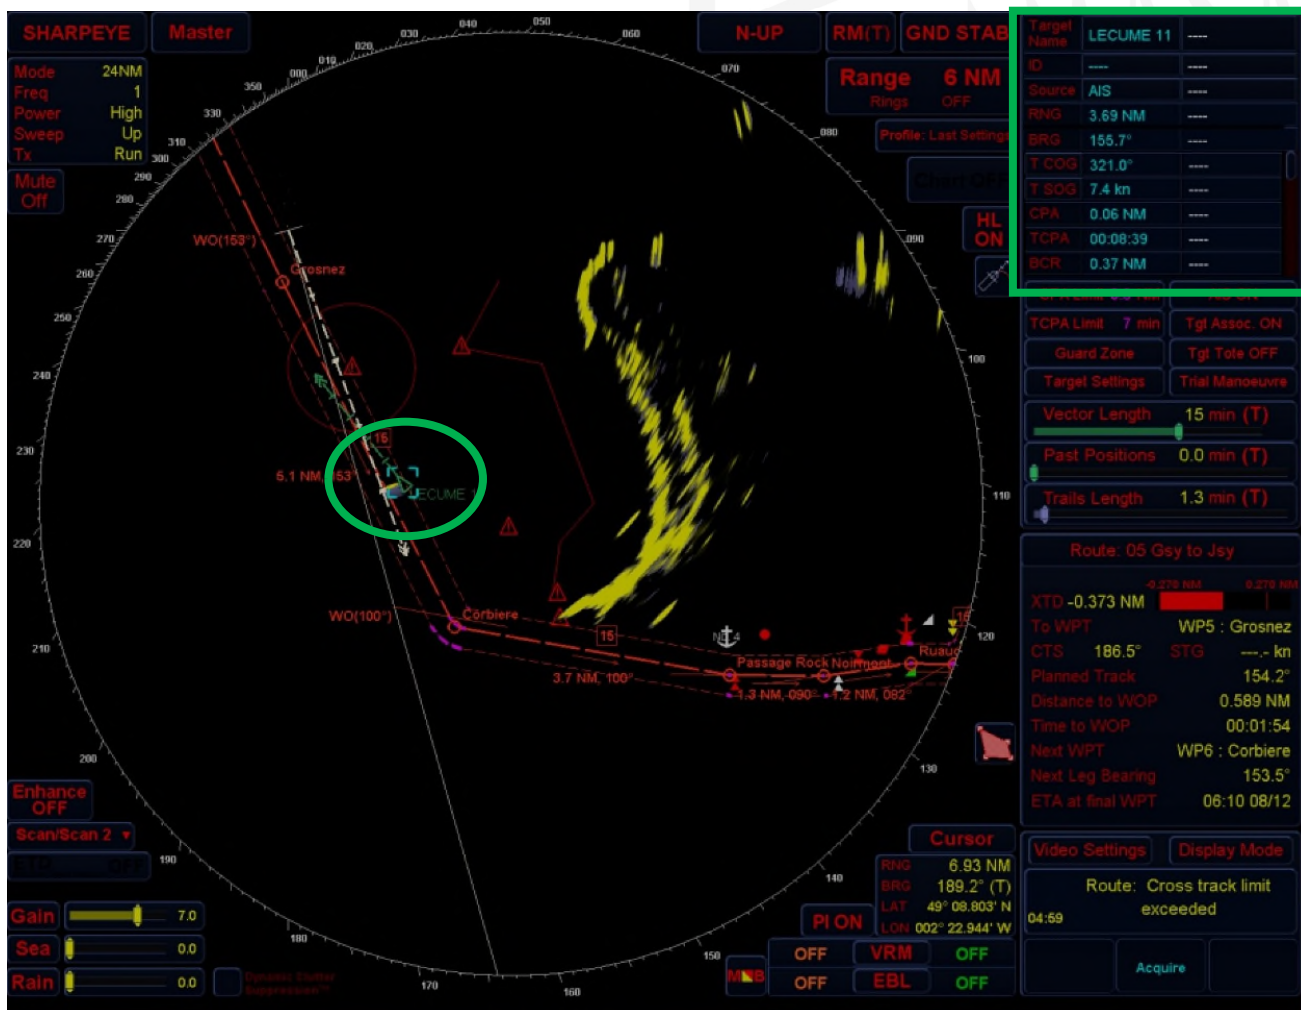
Screenshot from Commodore Goodwill VDR: Radar at 05:26 with L'Ecume II selected as an AIS target (radar return and AIS overlay in green ring, AIS data in green box)

At about the same time, the lookout selected L'Ecume II on the X-band radar. Noting its closest point of approach (CPA) was 0 nautical miles (NM), he tried to discuss this with the OOW but, as the OOW was now on a telephone call to the engine room, the lookout did not interrupt. The call completed, the OOW instructed the lookout to prepare the bridgewing manoeuvring controls for arrival. The OOW then telephoned the master to give 15 minutes notice to Corbiere Light, the point where the master would normally come to the bridge.

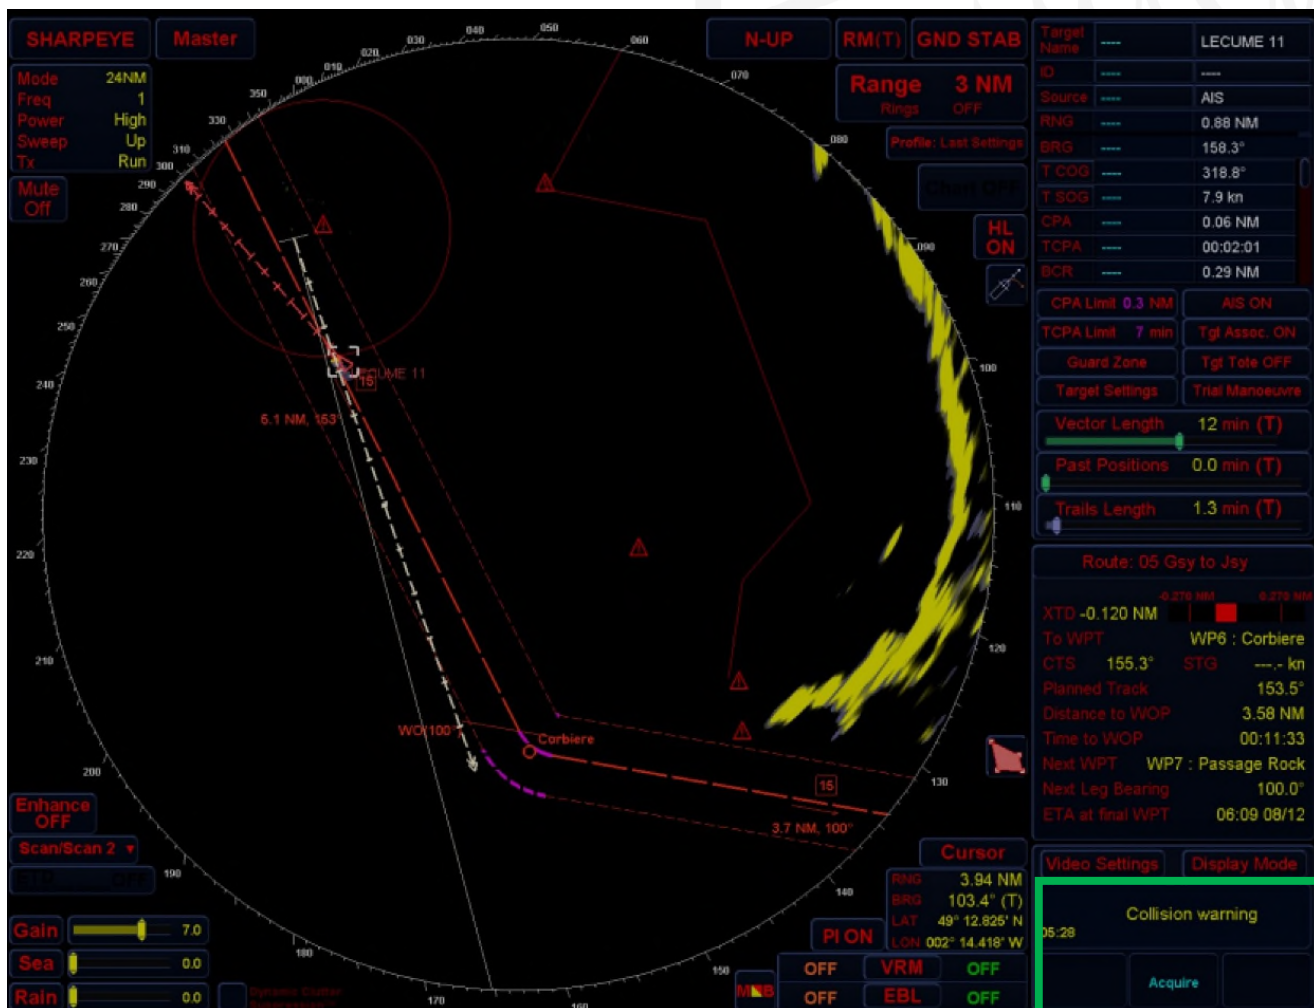
With the lookout on the bridge wing, the OOW made progress through the pre-arrival checklist but was also monitoring L'Ecume II visually. At 05:33:19, with a range of 0.88NM and the radar displaying a closest point of approach of 0.06NM he judged that they were passing too close and altered course further to starboard using the autopilot. L'Ecume II altered course approximately 10° to port, 36 seconds later<sup>1</sup> at 05:33:55.

**Screenshot from Commodore Goodwill VDR: Radar at 0533 - L'Ecume II at 0.88NM (collision warning in green box). Note: AIS vector is ground stabilised**

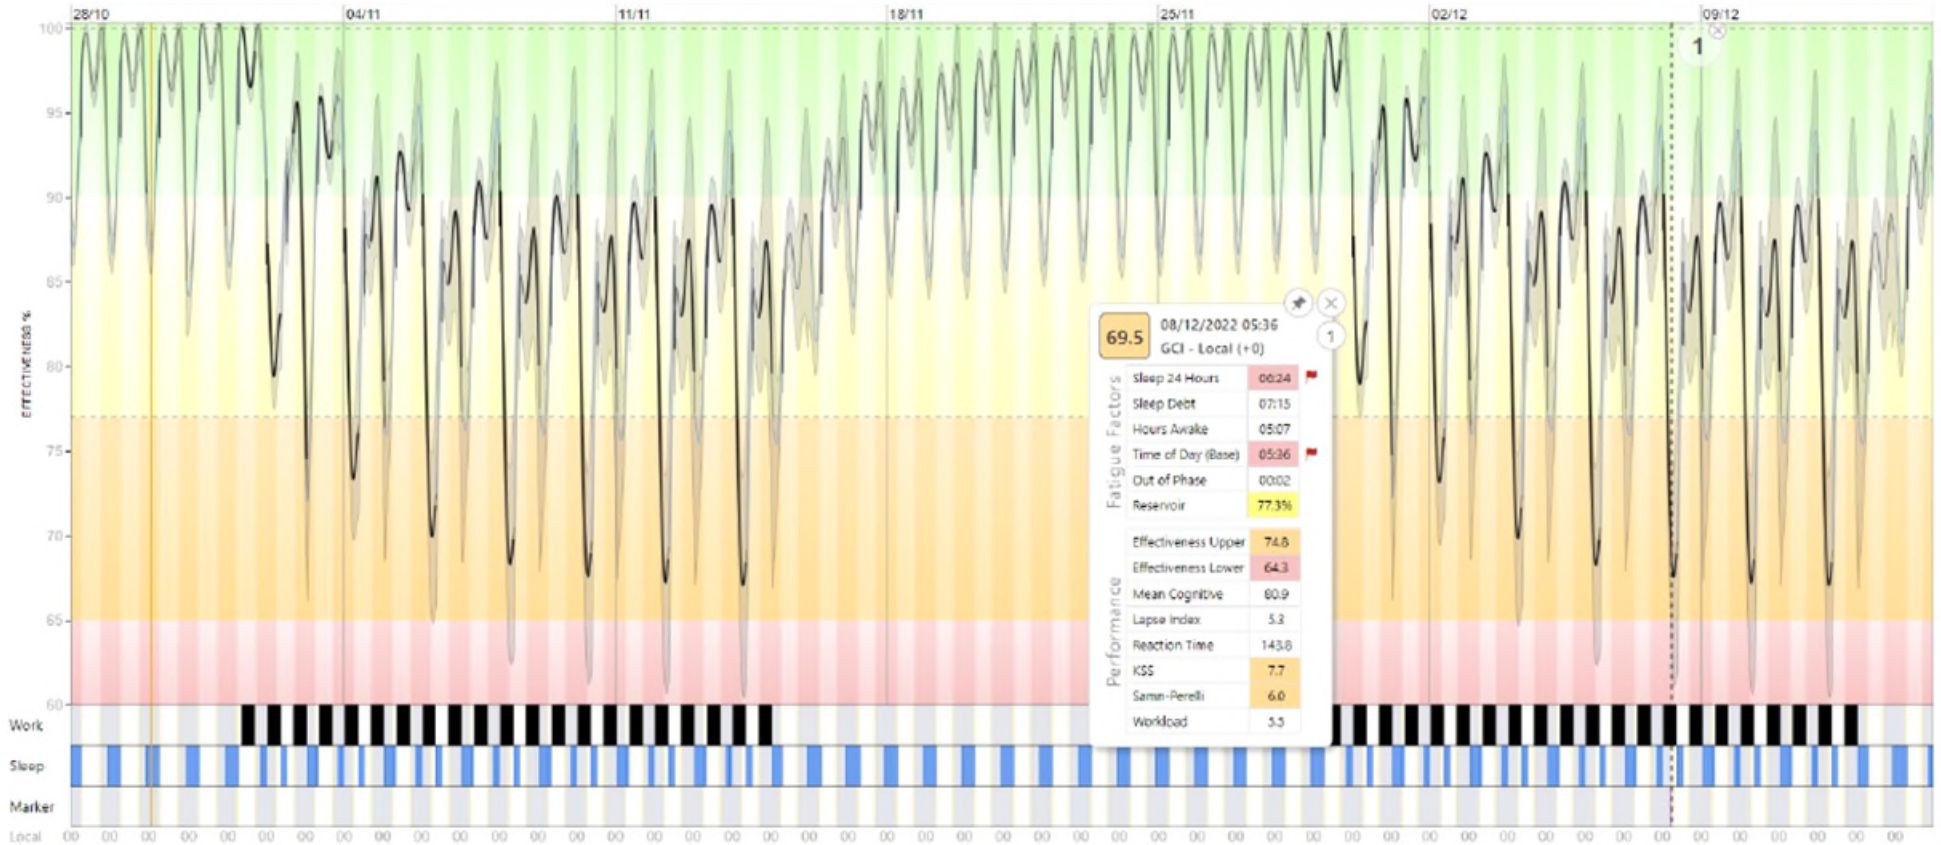
**Rolling 8s\_2 (GCI)**  
Standard Shift Template

**SAFTE-FAST analysis of a 6-week period of the “rolling eights” watchkeeping pattern. Point in the cycle that collision occurred indicated with the dashed line and associated dashboard**

The ‘dashboard’ shows the factors predicted by SAFTE-FAST to have contributed to elevated fatigue levels (those shaded red), and performance measures which are discussed below. Within the SAFTE-FAST graph, thick black lines, and the black blocks at the bottom of the graph show work periods, blue lines and blocks show sleep periods, and thin black lines show time spent awake but not working. The grey ‘shading’ shows the range covered by 1 standard deviation either side of the mean.

When considering the results of the fatigue study, the OOW’s performance in the lead up to and after the collision correlates with these symptoms. His focus on completing the pre-arrival checklist, misjudgement of the effectiveness of the alteration of course and subsequent passing distance, along with the general failure to appreciate the seriousness of the developing close-quarters situation indicate that fatigue was a likely a significant contributing factor in the collision.

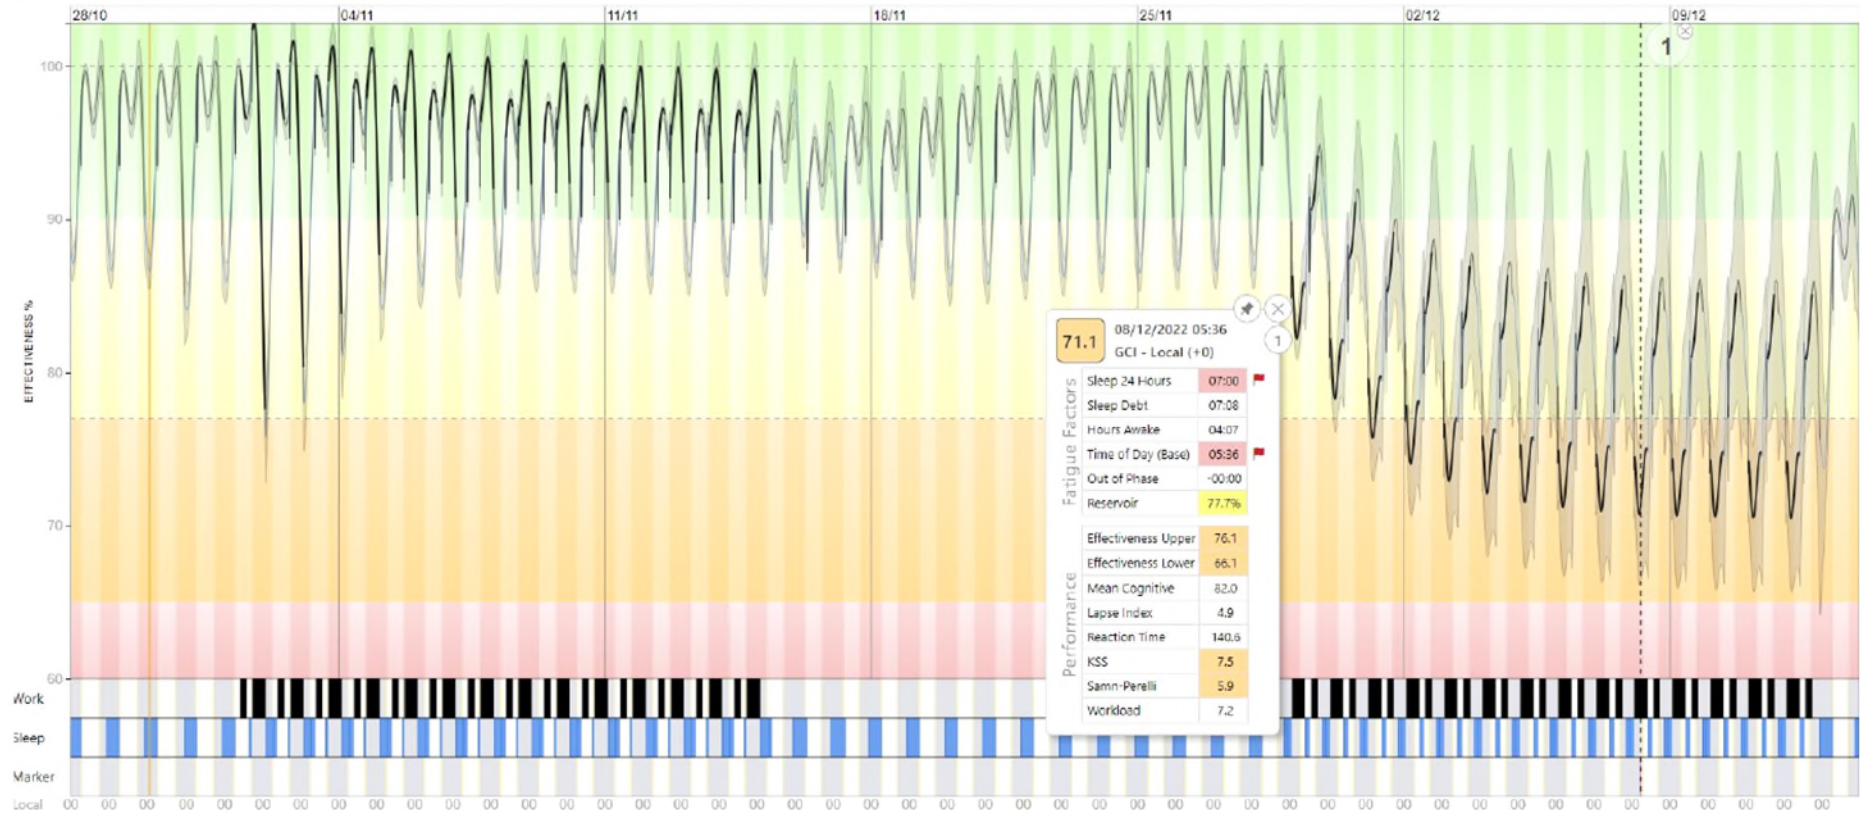
## Alternative pattern 1 (GCI) Standard Shift Template

**SAFTE-FAST analysis of a 6-week period of the “alternative” pattern covering the same period. Point in the cycle that collision would have occurred indicated with the dashed line and associated dashboard**

For the "alternative" pattern, the model predicted a slightly lower level of fatigue for the average individual at the time of the collision (a score of 71.1% predicted performance effectiveness vs a score of 69.5% predicted performance effectiveness in the rolling-8s pattern). The predicted causes of fatigue in this pattern are the same as for the rolling-8s.

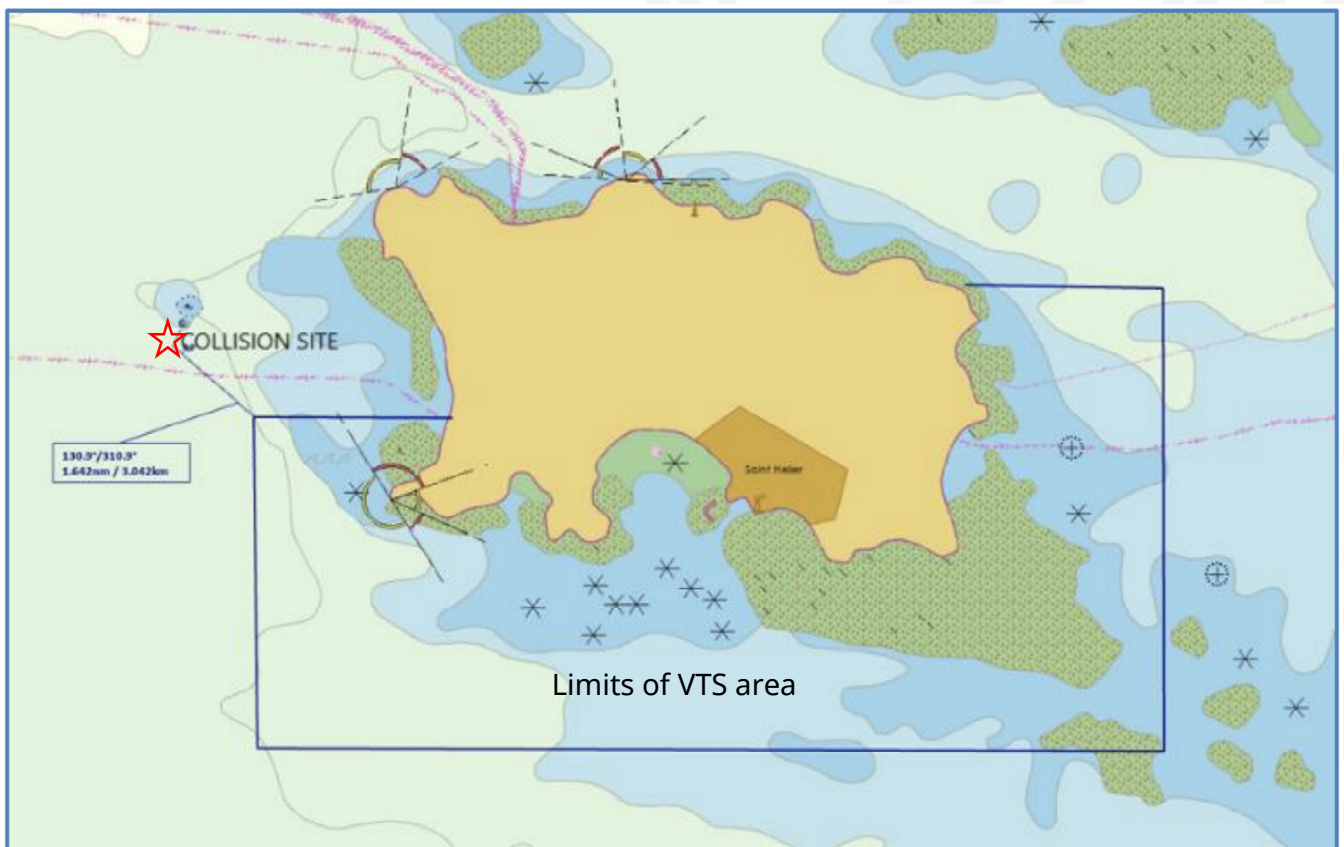
With L'Ecume II almost clear of the VTS area, and Commodore Goodwill having given notice but yet to enter, the watch officer took the opportunity to take a toilet break at 05:27. The watch officer was able to continue to monitor the VHF on loudspeaker, but not the screens. The watch officer returned to the monitoring station at 05:35, shortly after the collision.

**Limits of VTS area, location of collision**

- Commissioned an independent peer review of the limits of St Helier VTS. That review concluded that the existing VTS limits remain appropriate, subject to continuous review of the Navigational Risk Assessment. The most recent independent external audit, undertaken in April 2025, confirmed that the navigational control measures in place (including VTS) remain appropriate to the assessed level of risk.
- HM Coastguard conducted a peer review of Jersey Coastguard's response to the incident. Twelve recommendations for enhancement were identified; all have been reviewed and the resulting actions have been implemented.

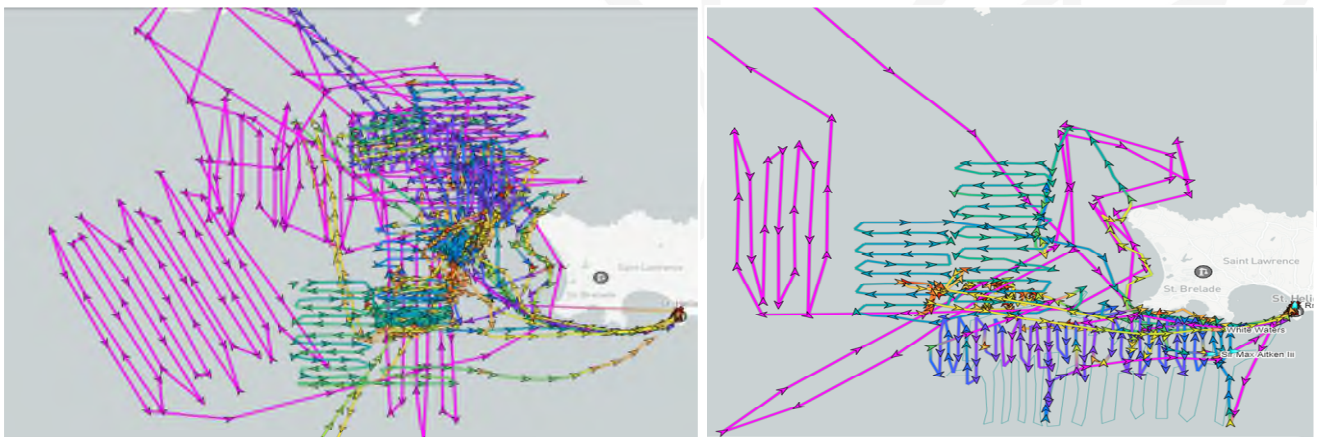
Over the course of 35 hours, search and rescue assets, including two fixed wing aircraft, two helicopters, three lifeboats and over a dozen volunteer vessels searched for the crew but they were not found.

**Combined asset search tracks, 8 & 9 December 2022**
