# Marine Safety Investigation Report

## Algoma Victory

Fall from height on 01 April 2026

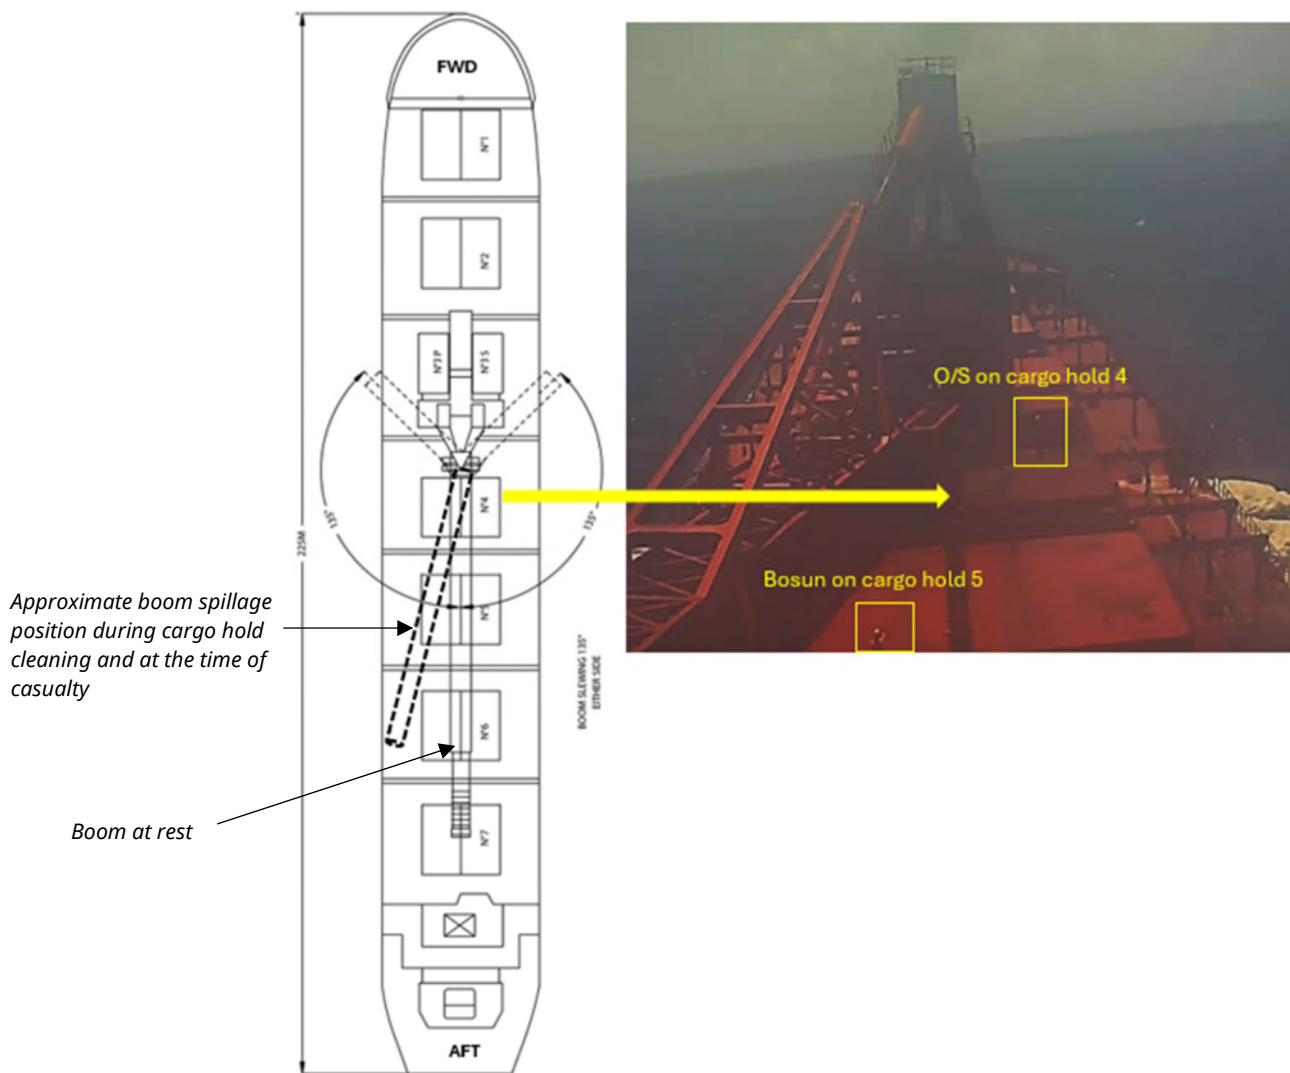
### General arrangement and boom orientation. CCTV snapshot before casualty

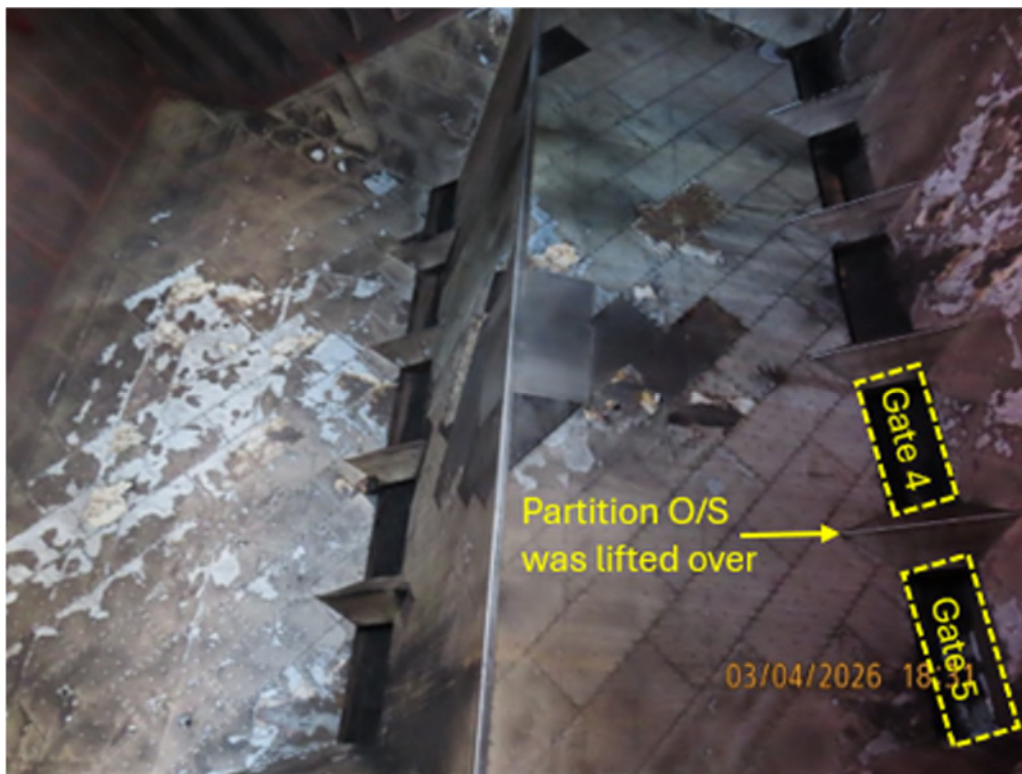
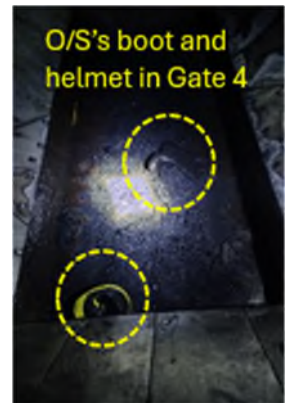
At 14:15, the C/O, assisted by two tunnel technicians and the bosun, lifted the O/S from gate 4, over the partition to gate 5, and pulled him through gate 5 onto the deck in the tunnel area. The O/S's hard hat and one

of his boots remained in gate 4. The C/O began administering CPR on the deck in the tunnel area but there were no signs of consciousness. He also observed the casualty was bleeding from his right ear.

**Bottom of cargo hold 4 (left) and gate 4 (right) after O/S was removed**

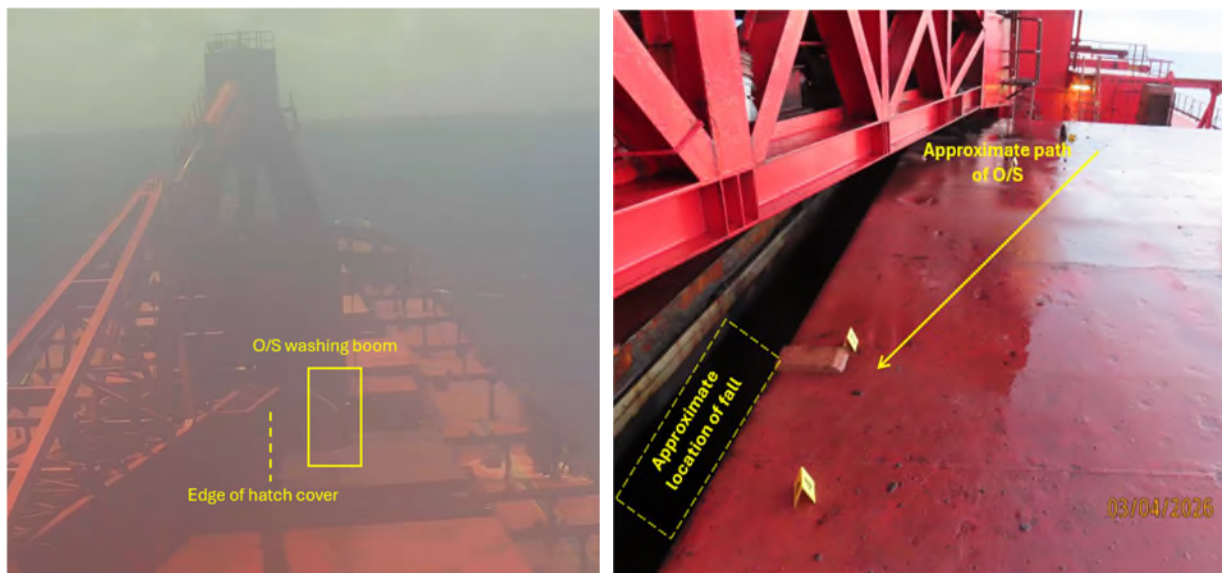
With the combination of these two factors, the more the O/S walked aft on top of the hatch cover while spraying the boom, the more he compensated for the increasing distance between himself and the boom by taking a few steps towards the boom, and ultimately into the gap between the hatch covers.

**CCTV capture of O/S washing boom (left) and closer look of area of fall (right)**

Additionally, there was nothing in place to contrast the cargo hold hatch covers from the cargo hold alignment markers fitted. These markers are raised (12.7mm) and directly on the edge of the hatch covers. Their colour is nearly identical to the hatch covers for the cargo holds (same colour, just faded).

It is likely the O/S either tripped on the hose he was using, or on the cargo hold marker. Ultimately, he eventually got closer than anticipated, and fell approximately 20m to his death into cargo hold 4 through an unguarded and unmarked opening.

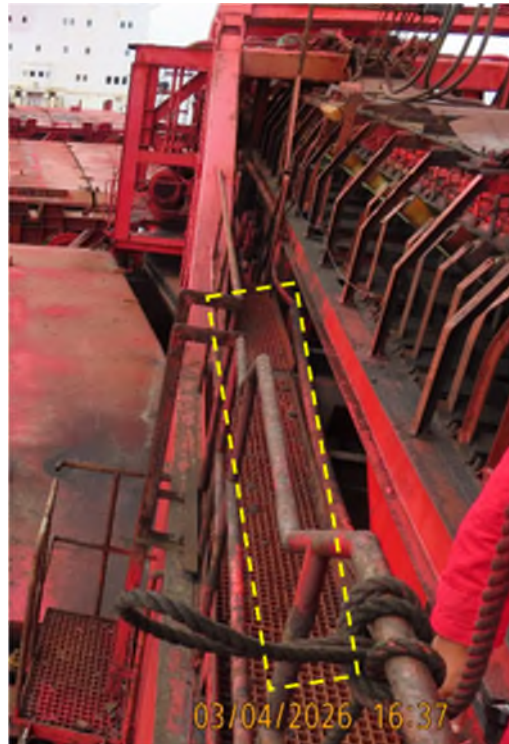
To carry out the starboard side boom washing, the O/S walked on the starboard side hatch cover of cargo hold number 4, which was still opened, as opposed to the protected catwalk area of the boom.

**Catwalk (highlighted in yellow) fitted on boom conveyor (starboard side)**
