Report on the investigation of the electrical blackout  
and subsequent grounding of the ro-ro cargo ship

***Moondance***

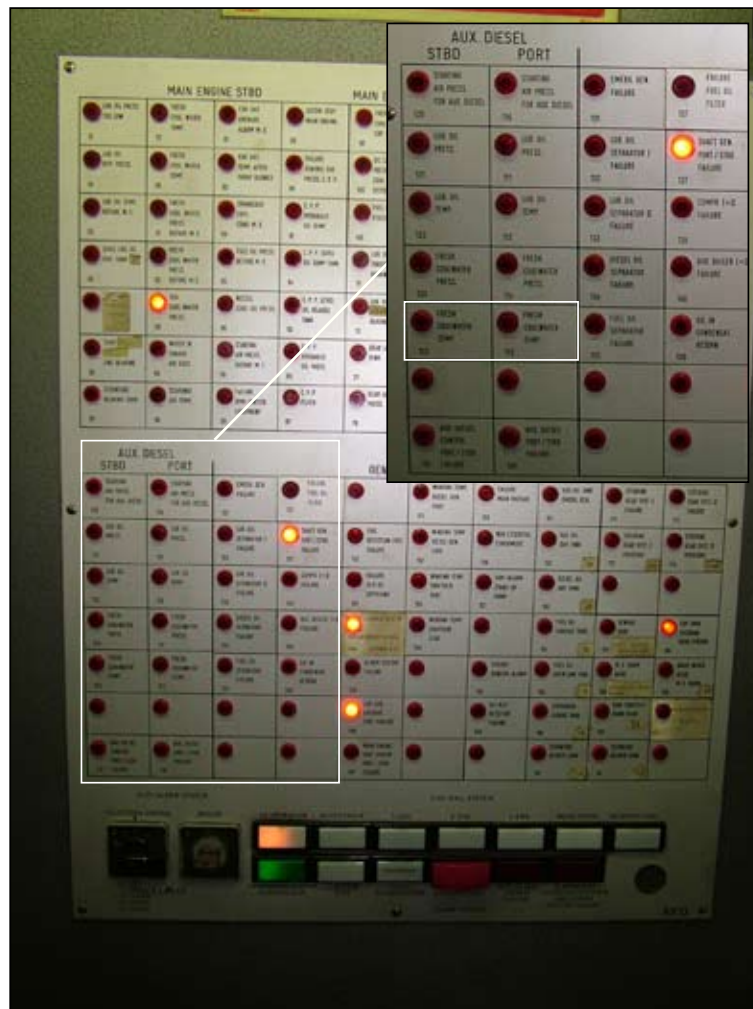
Engine Control Room alarm panel

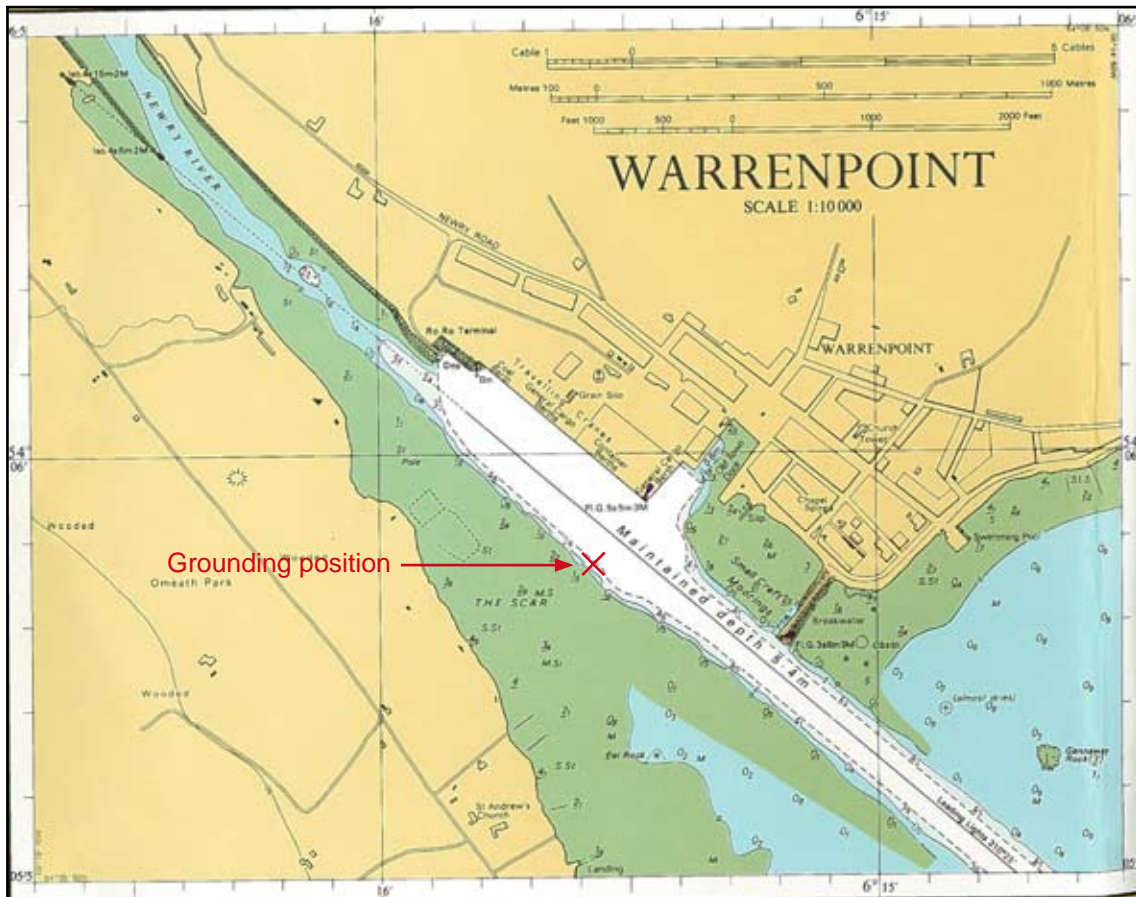
Chartlet of Warrenpoint Harbour, showing grounding position

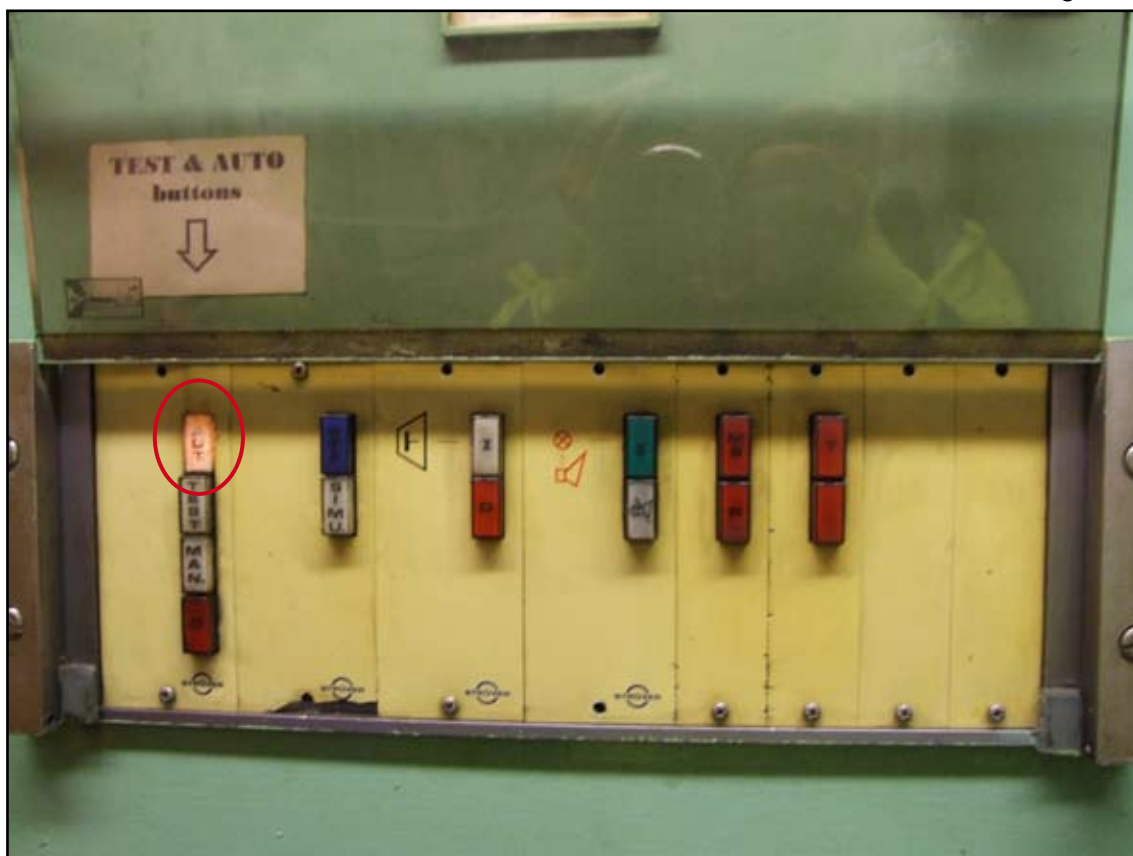
Emergency generator control panel shown in "auto" start position

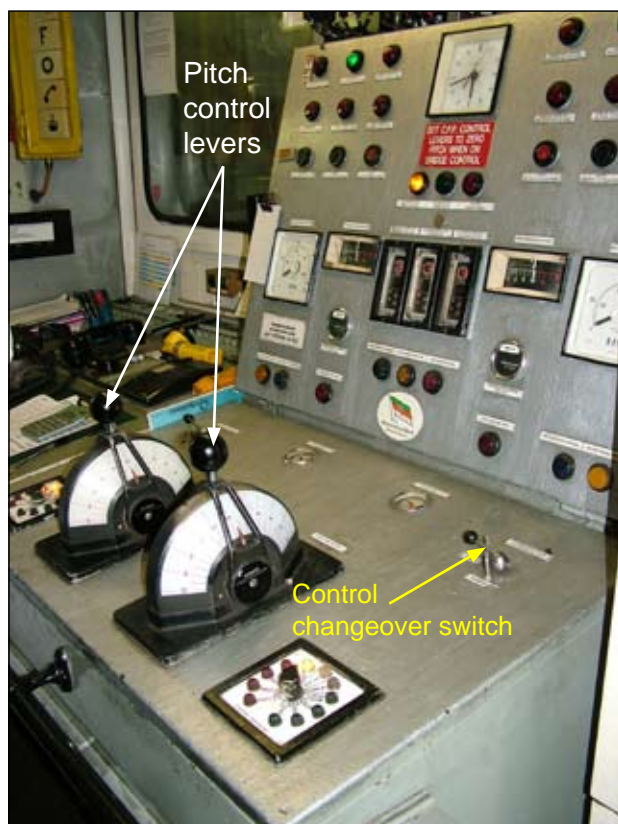
Position of Engine Control Room controllable pitch propeller levers, control changeover switch and instrumentation

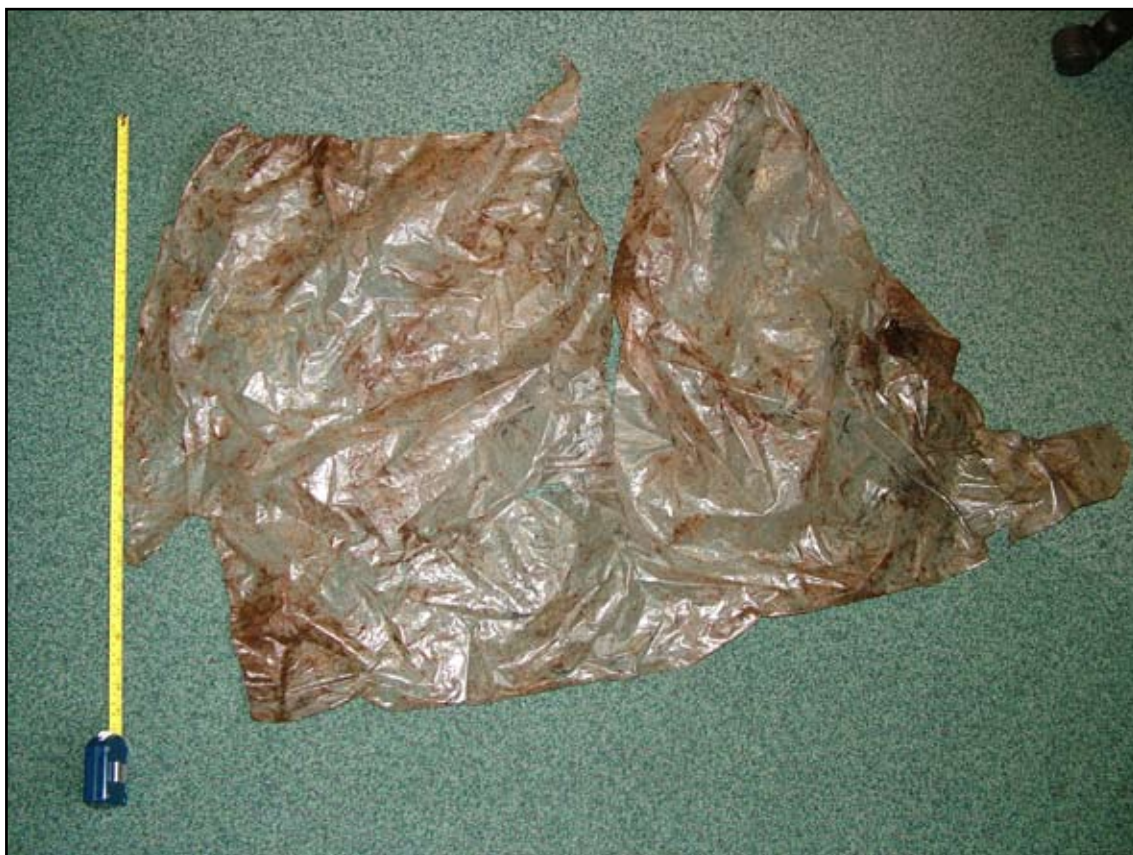
Plastic sheeting reported to have come from the main service pump strainer

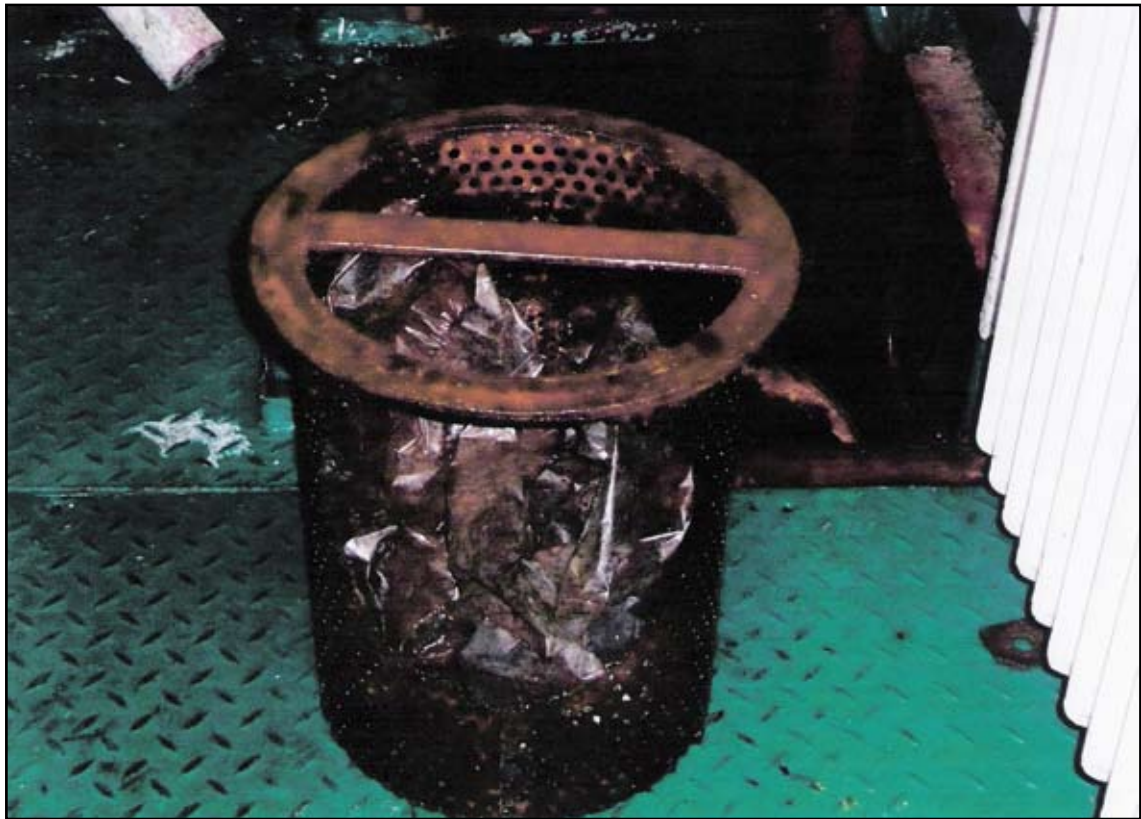
Reconstruction of purported blocked main service pump strainer - side view

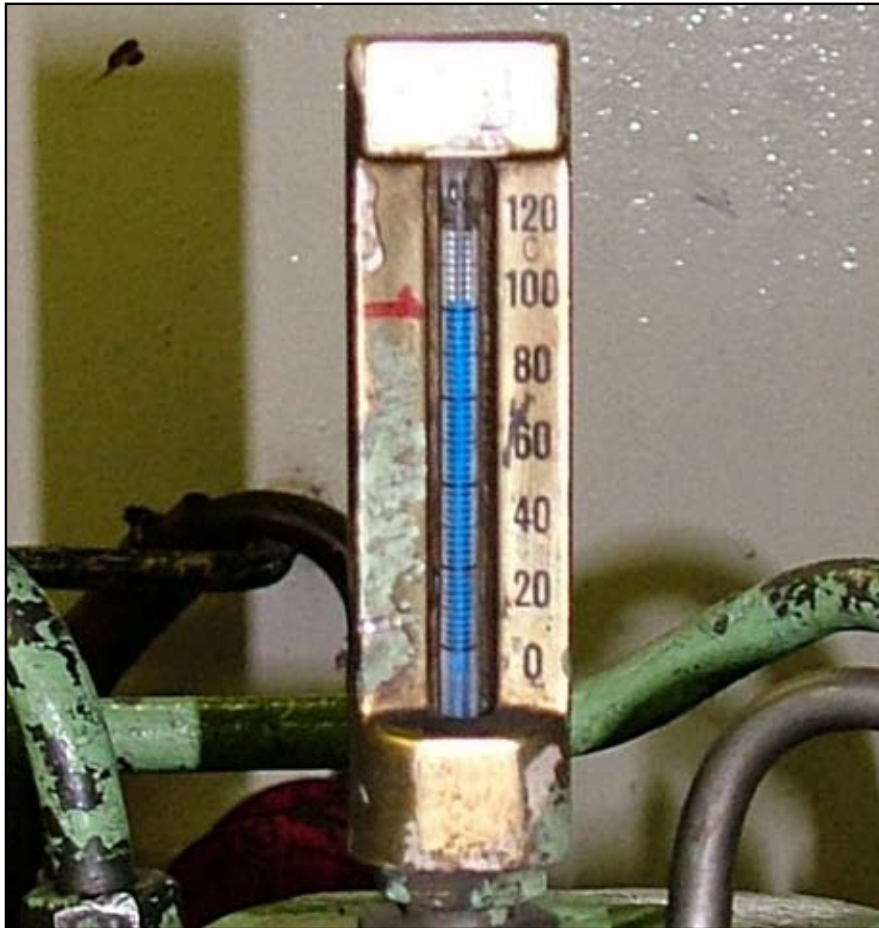
Port generator fresh water system thermometer

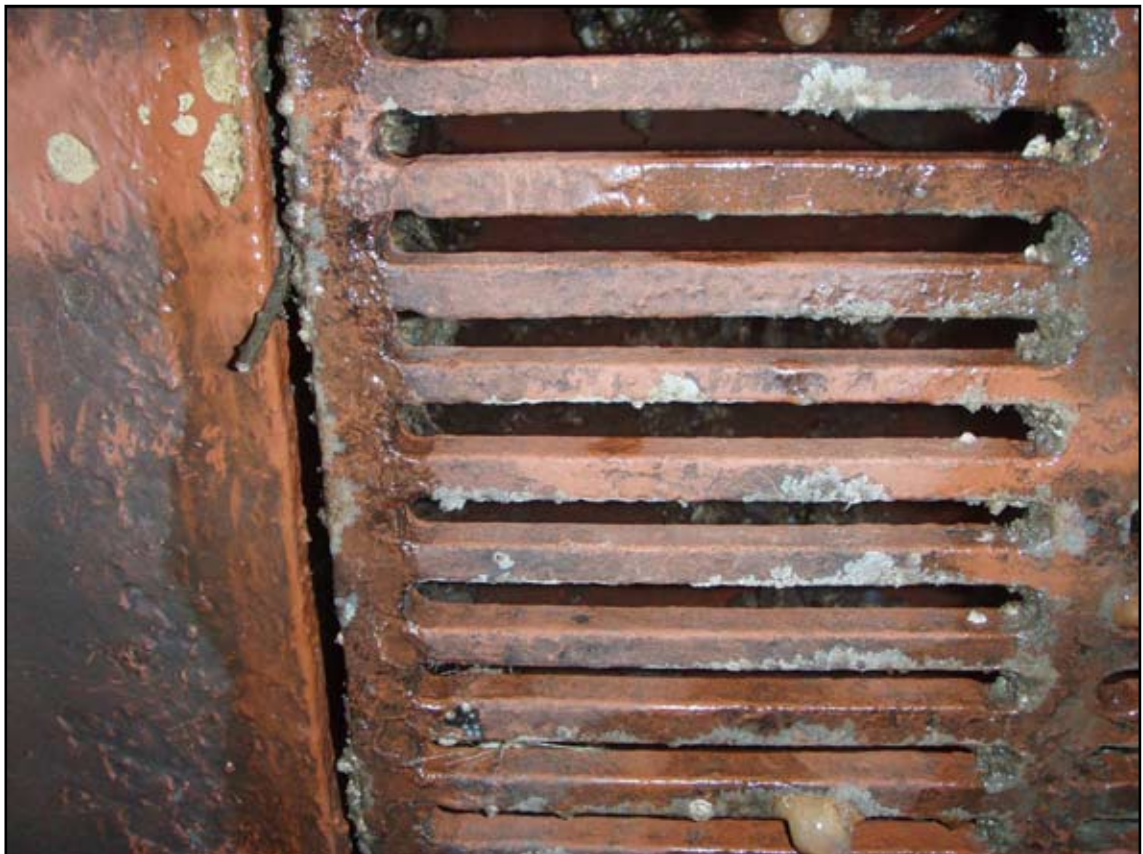
Starboard main service pump low level suction grating
